A METHOD FOR CEMENT INTEGRITY EVALUATION IN UNCONVENTIONAL
WELLS

A Thesis

Major Subject: Petroleum Engineering

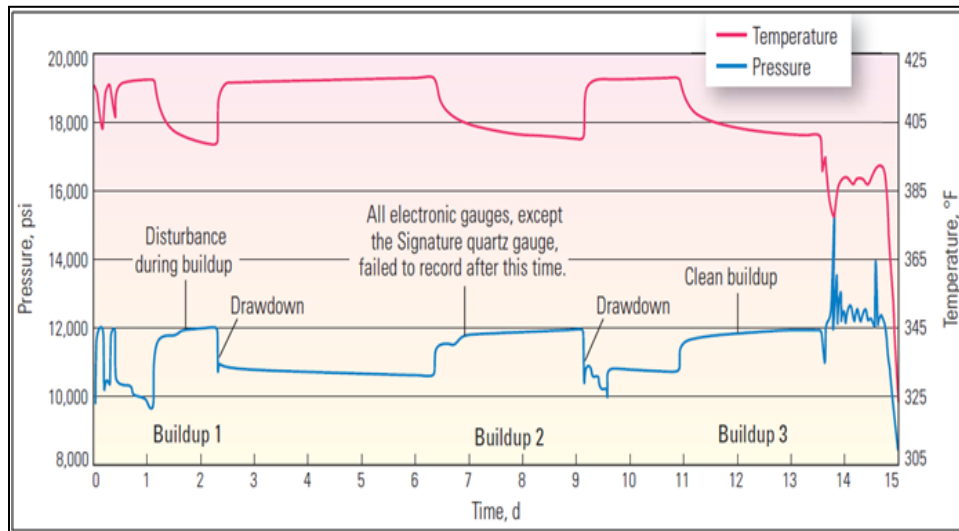
Figure 4. Extended well test results in pressure and temperature cycles.

Oil and gas wells usually go through low cycle and thermal fatigue during the life of a well. Occurrence of fatigue failure in the drill string is one of the most common and expensive type of failures in drilling operations. Cyclic stresses along with corrosion can considerably shorten the life of a drill pipe. **Figure 4** shows a long term pressure

transient test to understand the reservoir limits and define the reservoir potential. Such a test occurs with several pressure and temperature changes and it can cause low-cycle and thermal fatigue in the cement.

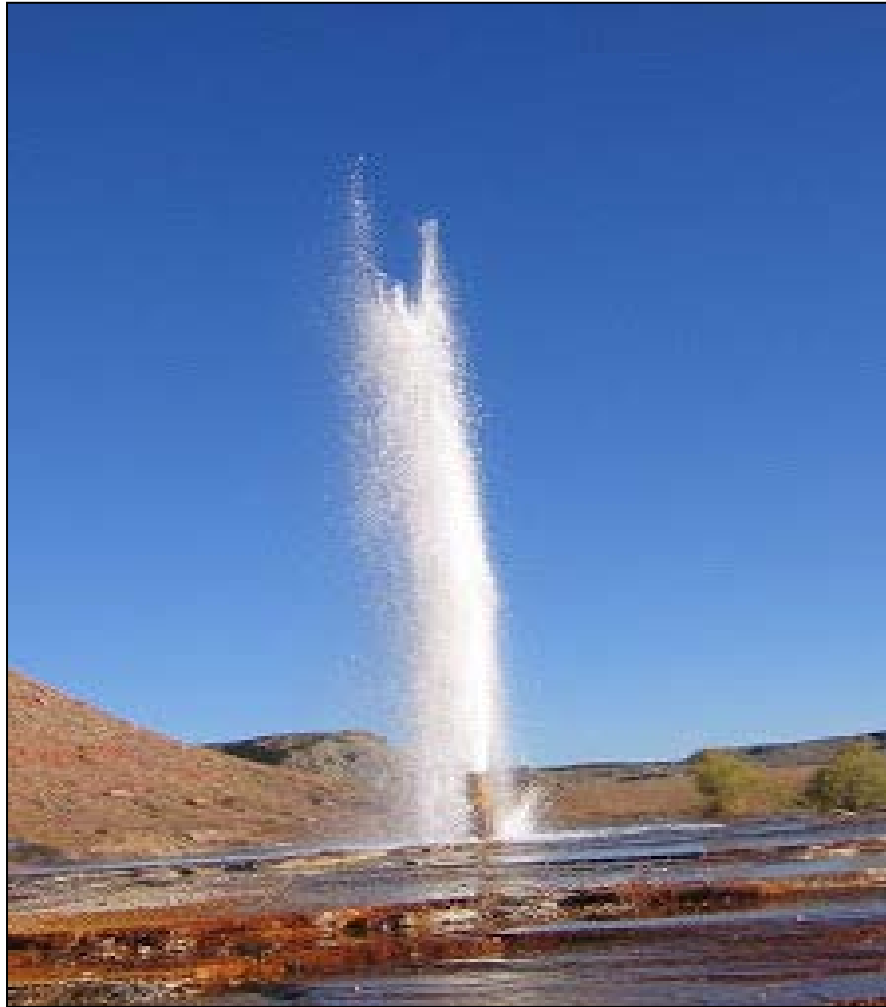
Figure 7. Crystal Geysers, CO₂ from abandoned well.

There are two main solutions for SCP. First, cement slurry should be designed with optimal elasticity and tensile strength which allows cement sheath to withstand cyclic loads and reduces the likelihood of fatigue failure. The second solution would be using self- healing cement which repairs itself automatically when is exposed to formation fluids such as crude oil or gas. **Figure 7** shows Crystal Geyser, where CO₂ is leaking out from an abandoned well, Photo courtesy of Gouveia2.

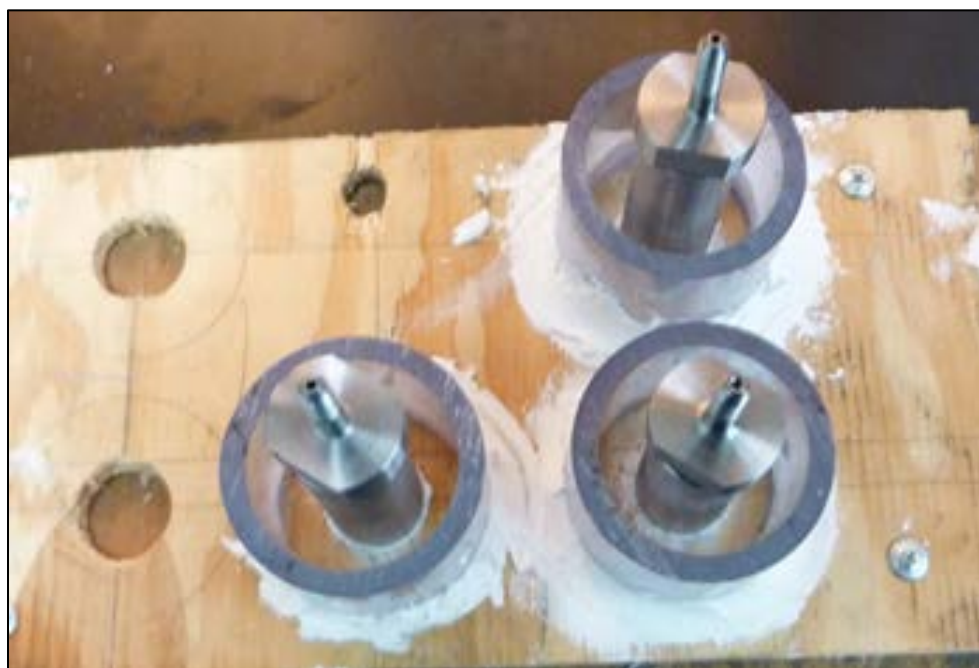
Figure 12. Chipboard, PVC pipes and small cells.

The preparation of the samples is one of the most important steps in the testing procedure and special attention should be given to this part of the experiment. The inner cell has to be molded with cement sheath which will be tested in the cell. The small cells should be kept clean at all times and in case they get rusted, they should be instantly cleaned. Chipboard should be prepared where the molds can be glued on; it should be around ½ inch thick. Circles of 4 inch indicate the position of the Plexiglas mold for the cement sheath and 1 inch holes are drilled into it to center the cement on the inner cell. Second chipboard is attached to the bottom of the first one to prevent the cement slurry from flowing out to the bottom, **Figure 12**.

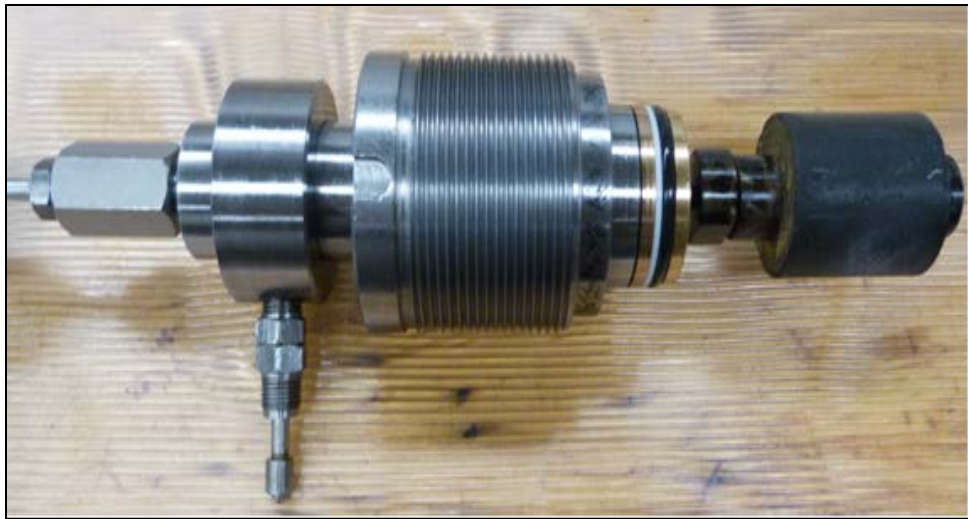
Figure 14. Cement sample.

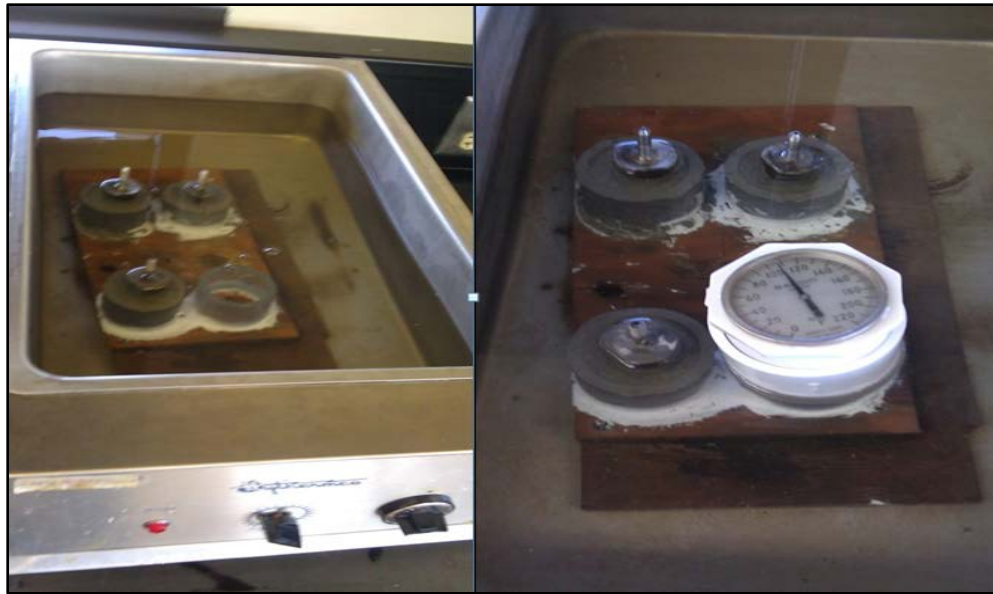
Figure 15. Set A, Class H cement.

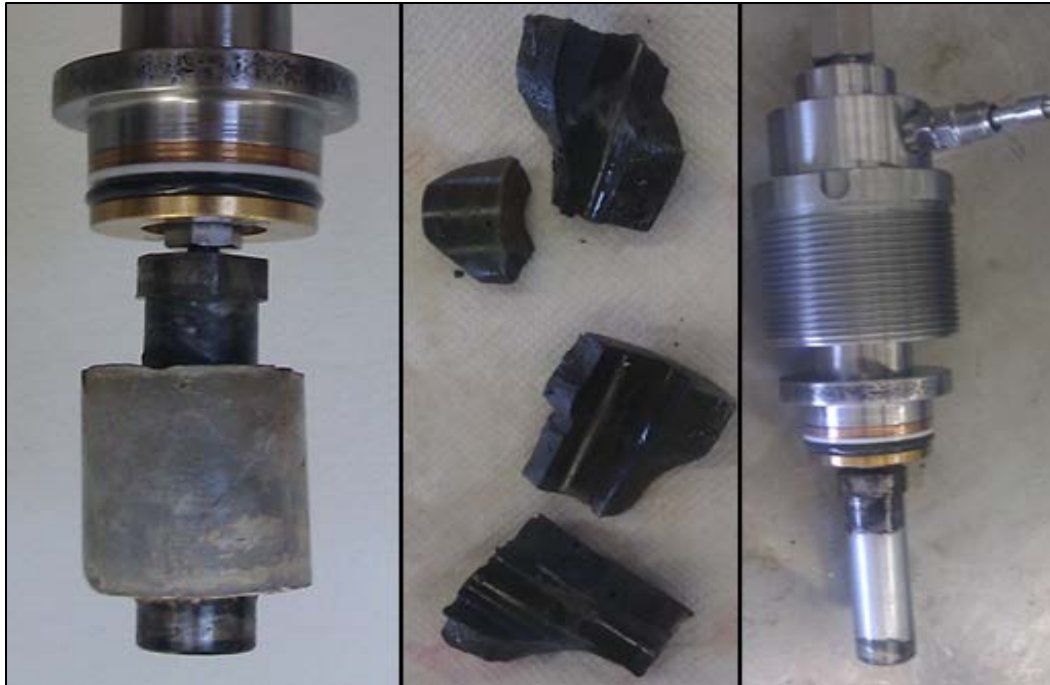
Figure 17. Inconsistent confining pressure caused severe cement sheath destruction.

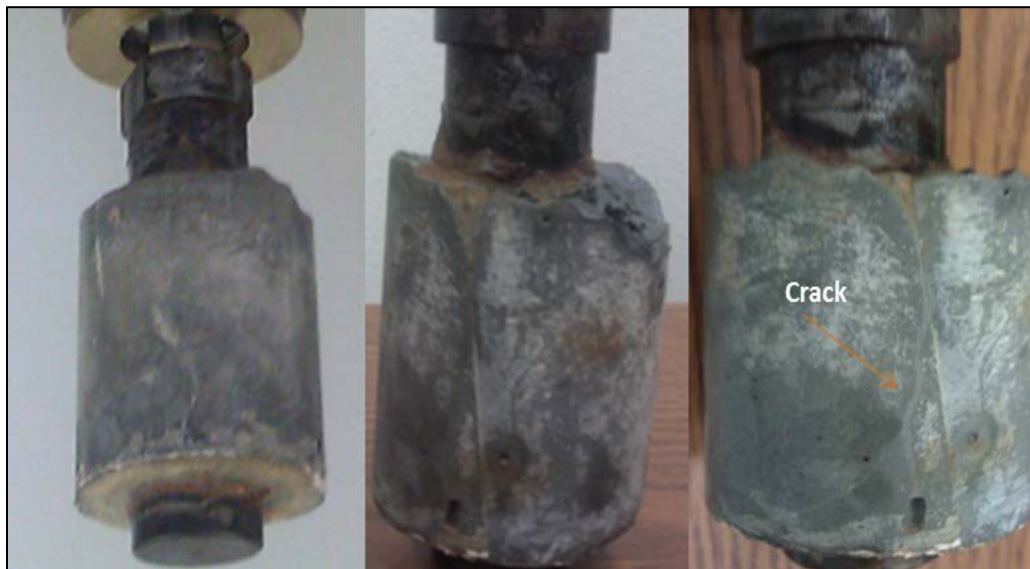
Figure 19. Cyclical loading caused a radial crack in sample II-A.

Sample II-A which was cured for two days under water was tested at HPHT conditions in a cyclical mode with different time intervals. For this test, the T valve remained open until the temperature of 300° F was achieved and the confining pressure remained constant while the casing pressure was changing from 8,000 to 17,000 psi, **Figure 18**. **Figure 19**, shows the sample II-A before (left) and after (middle and right). Cyclical loading at HPHT condition caused a radial crack.

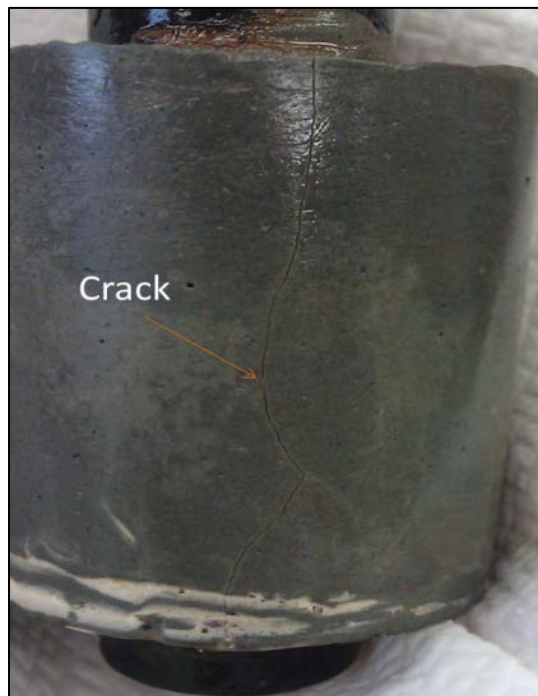
Figure 21. One radial crack in sample III-A after the test.

Sample III-A, which was cured for three days under water, got tested under HPHT conditions with the confining pressure of 8,000 psi and 35 casing pressure cycles between 8,000 psi and 17,000 psi, **Figure 20**. The purpose of this test was to evaluate the equipment capability for higher cycles at HPHT conditions. One radial crack was observed after the test. **Figure 21** displays One radial crack in sample III-A after the test.

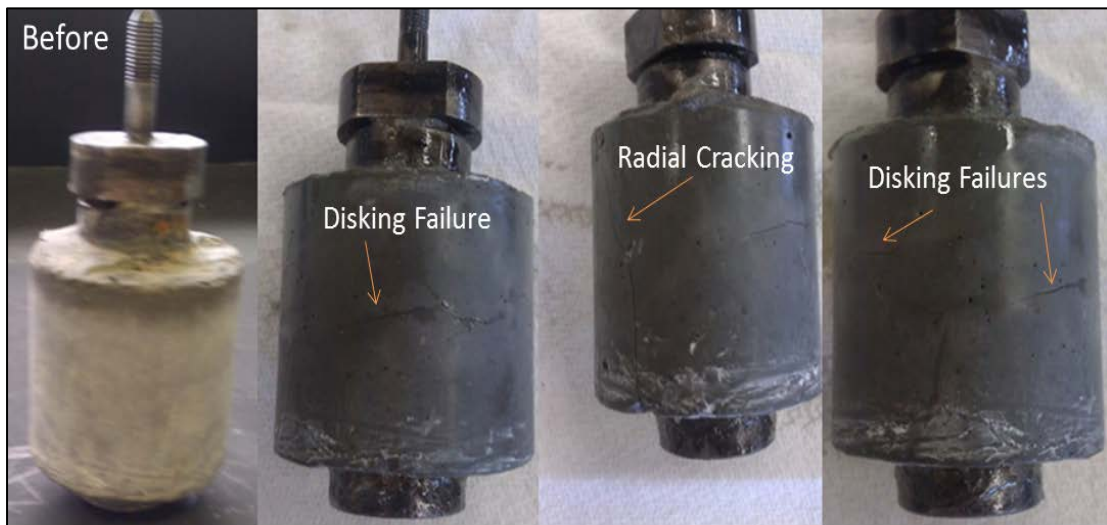
Figure 24. Sample I-B, radial cracking and disking, cement failures after 106 cycles.

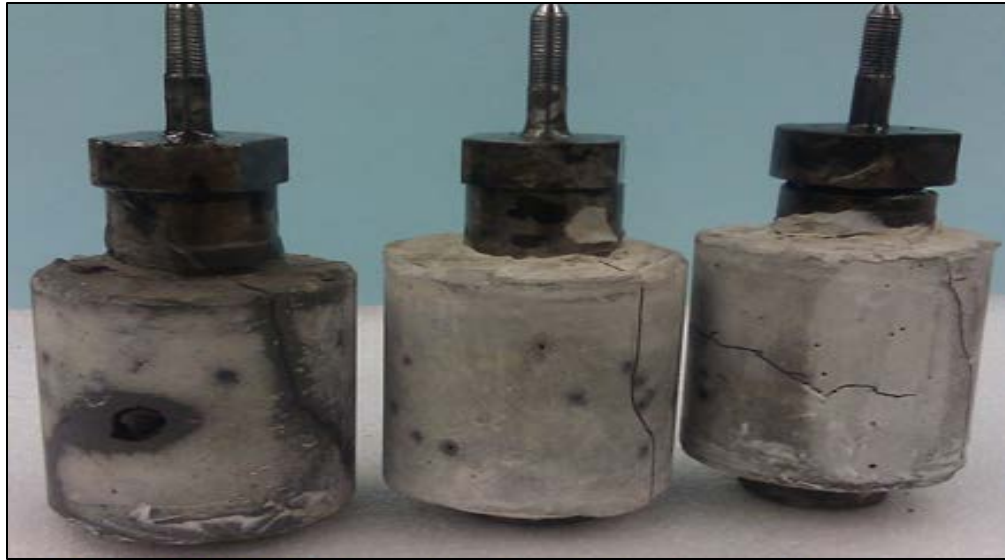
Figure 27. Set B, neat class H failures after the HPHT test

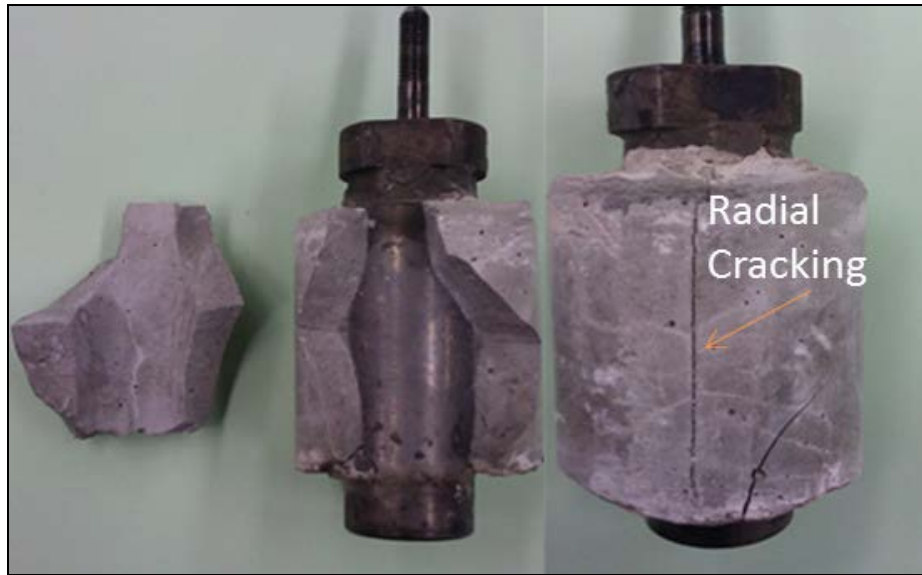
Figure 28:Sample I-C, slicing and radial failures for neat class H

Experiments performed in this section were intended to assure a successful HPHT curing process and subsequently perform cyclical loadings. Two samples were cured at 10,000 psi and 12,500 at least for 18 hours and the system stayed reliable. These tests showed samples can be cured at HPHT conditions prior to cyclical loadings.

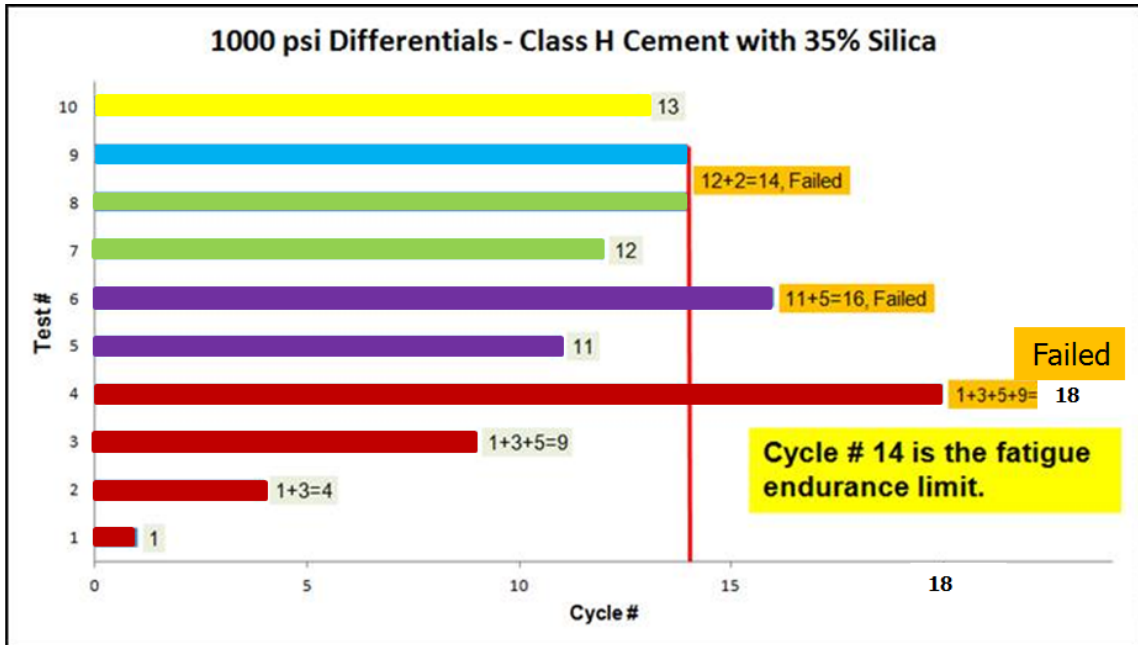
Figure 34. Failure cycle for 1,000 psi differential.

The fifth sample was cycled 13 times however no failure was observed. The 16.4 ppg class H cement with 35% Silica failed and radially cracked after the cumulative of 14 cycles of 1,000 psi differentials between the confining pressure and the maximum casing pressure. Cycle no. 14 is the fatigue endurance limit for 1,000 psi differential at 15,000 psi confining pressure. However this number might be different for various chemistries. It is clear that adding silica significantly added to the strength of cement. **Figure 34** summarizes all the experiments done on set E. Every color represents one sample which was tested.

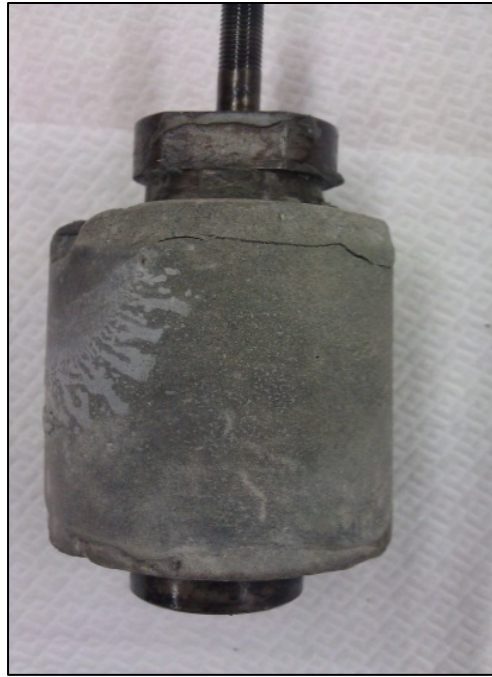
Figure 35. Sample I-F, a micro crack.

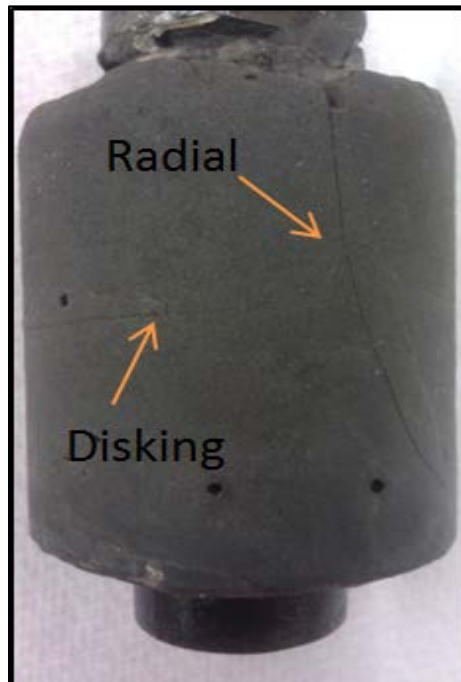
Figure 38. Sample II-F, cracked after 13 cycles.

After a cumulative of 8 cycles no failure was observed so it was cycled for 5 more cycles till finally it cracked. In fact at this time it was evident that 2,000 psi differential pressure after 13 cycles caused a crack in sample II-F. As a result the failure cycle should be more than 8 cycles and less than or equal to 13 cycles, **Figure 37** and **Figure 38**.

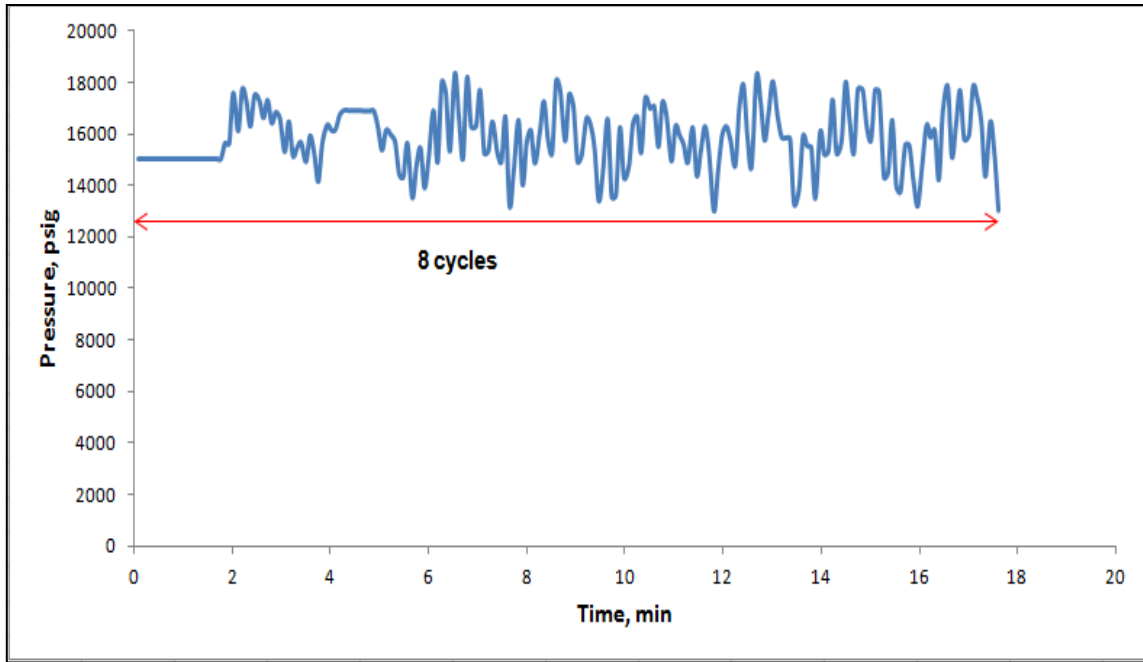
Figure 40. Sample IV-E, did not crack after 8 cycles, repeatability test.

A fourth sample, IV-F, was tested with 8 cycles followed by another 4 cycles and no crack was observed after a cumulative of 12 cycles, **Figure 40** and **Figure 41**. However when one more cycle is added, a failure happened. **Figure 42** summarizes the test on set E and shows cycle no. 13 as the failure cycle, fatigue endurance limit, for 2,000 psi differentials at the 15,000 psi confining pressure for class H cement plus 35% silica.

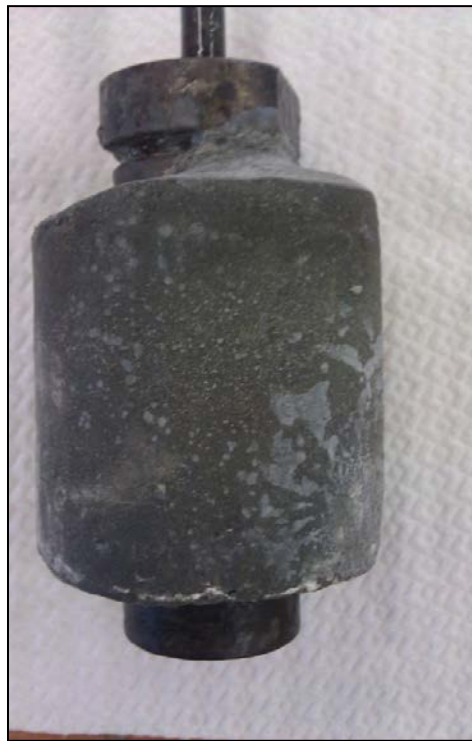
Figure 41. Sample IV-E, No crack after 8 cycles, repeatability test.

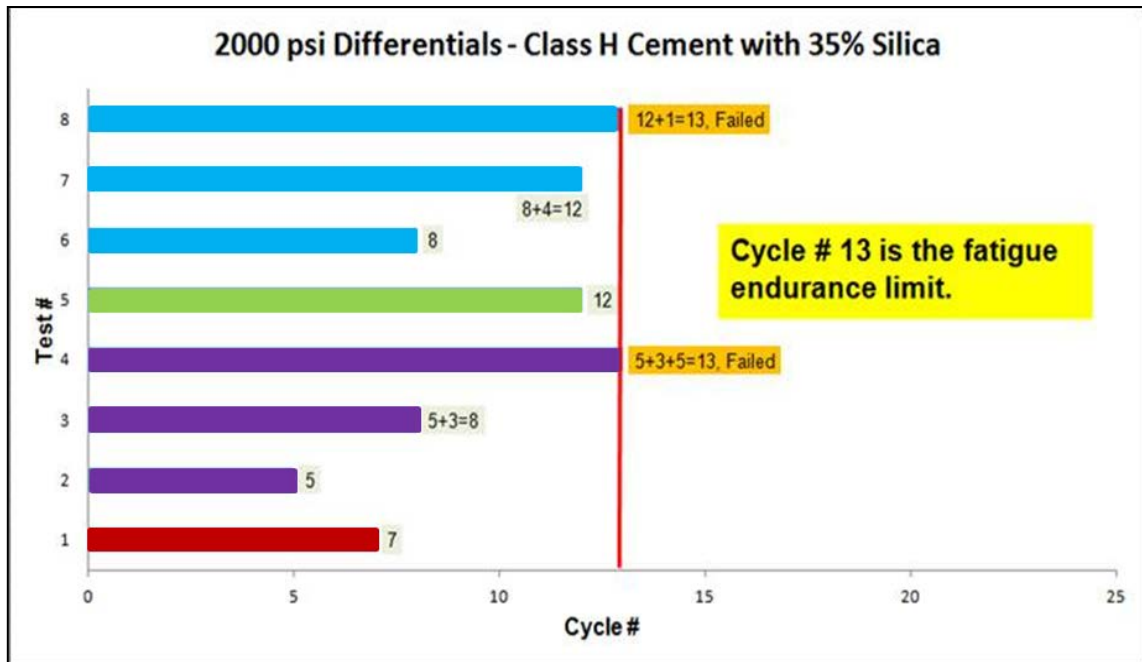
Figure 42. Failure cycle for 2,000 psi differential

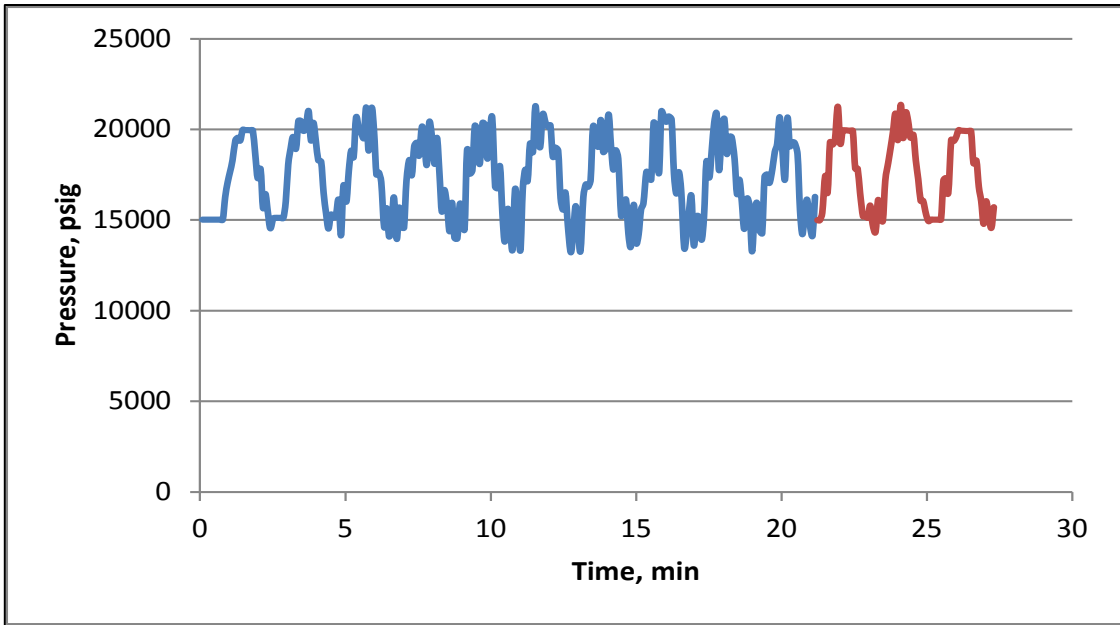
Figure 43. Sample I-G did not crack at 10 cycles but cracked after 13 cycles.

Set G was tested with 5,000 psi differentials. Confining pressure was kept constant at 15,000 psi and casing pressures varied from 15,000 psi to 20,000 psi. Sample I-G was cycled 10 times however it did not crack therefore it went through another 3 cycles. After the cumulative of 13 cycles, this sample cracked, **Figure 43**. Sample II-G was prepared and cured at the same conditions, **Figure 44** and **Figure 45**. It was then cycled for 11 straight cycles and hence it cracked. For repeatability, another sample (III-G) was cured at the same conditions of 15,000 psi and 330 °F. After cycling this sample for 10 times it was observed that it did not crack so another cycle was performed and sample III-G ultimately cracked. As a result cycle no. 11 is recognized the fatigue endurance limit for class H cement plus 35% silica with confining pressure of 15,000 psi and 5,000 psi differentials, **Figure 46**.

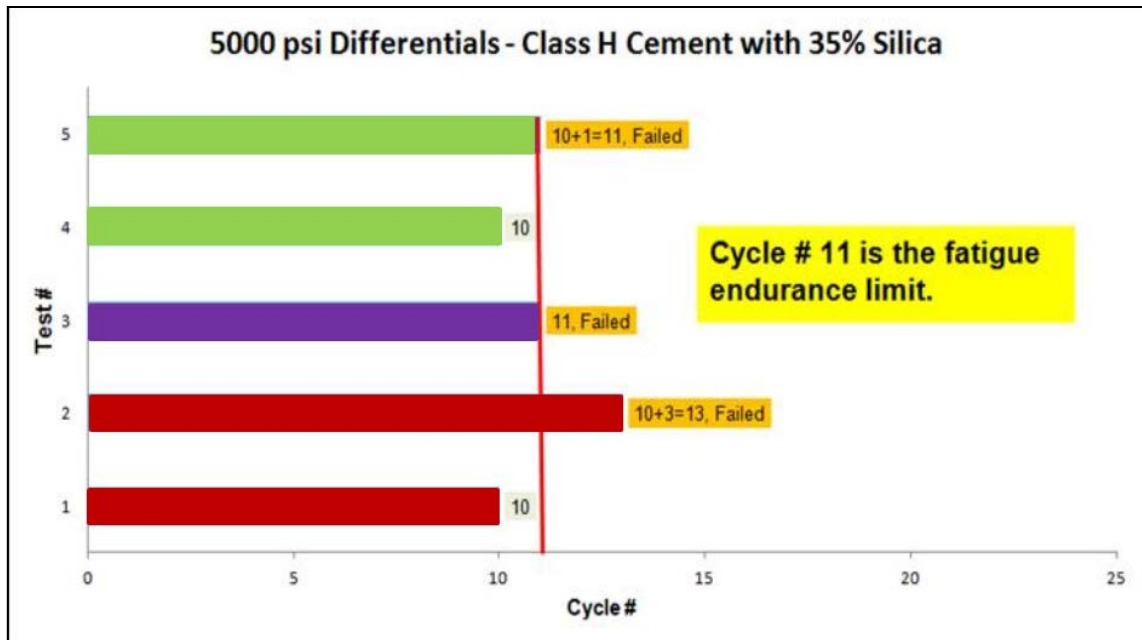
Figure 47. Failure cycle for 5,000 psi differential

Table 6 summarizes the failure cycle number and the type of failures for sets E, F and G. All samples were prepared and cured under the same condition of 15,000 psi and 330 °F. Set E was tested for the maximum pressure differentials of 1,000 psi. Running tests with low pressure differentials sometimes is hard and the pump steps should be tuned if low pressure differentials is intended to be achieved. Set F was tested for the maximum pressure differentials of 2,000 psi. Disking failure observed for this set is the only distinguishable criteria with 1,000 psi pressure differentials. Set G which was tested for the maximum pressure differentials of 5,000 psi more catastrophically failed at reaching its fatigue endurance limit.

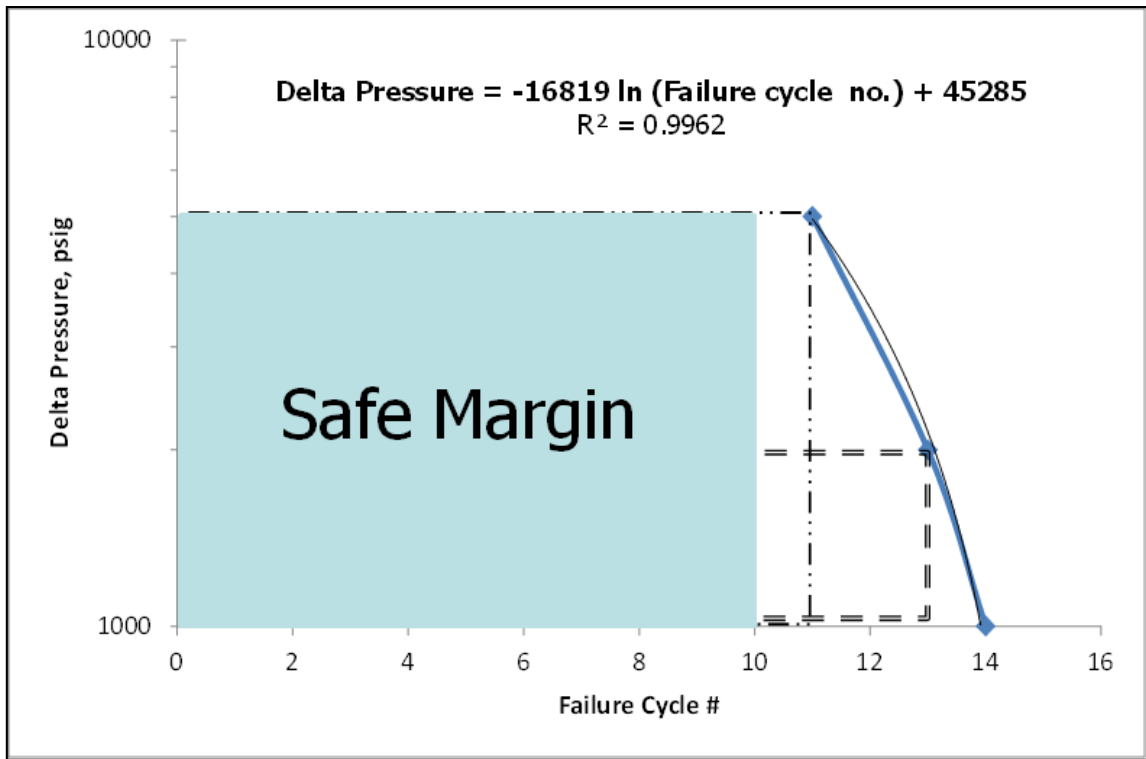
Figure 48. Delta Pressure vs. Failure Cycle #, Class H cement plus 35% silica.

Several mechanical failure tests emanated from civil engineering have been done on cement samples however results represent a more realistic picture of what happens to oil well cement. **Figure 48** shows the behavior of class H cement plus 35% silica which was cured at 15,000 psi and 330° F for 15 hours. Higher pressure differentials have caused the cement sheath to fail more catastrophically and at the lower cycle number. The failure behavior (failure cycle number) of class H cement plus 35% silica does not have a linear behavior at HPHT conditions.
