TOLERANCE MANAGEMENT OF ALUMINUM-FRAMED CURTAIN WALL
SYSTEMS: A CASE STUDY

A Thesis

Major Subject: Construction Management

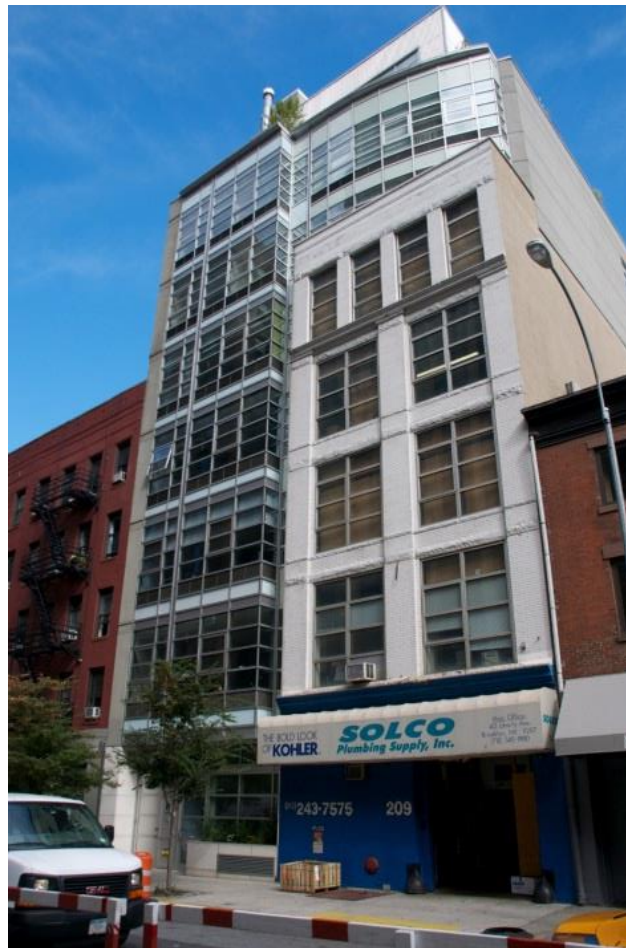
Figure 1. The stick curtain wall system. 211 W. 18th Street. New York, NY. Image: Andres Martinez.

The stick curtain wall system is commonly used in low and mid-rise constructions (Figure 1). The system components displayed in Figure 2 and Figure 3, are machine cut in the factory and supplied in a knockdown form to be assembled and installed on-site. They allow modifications in the field (cut-to-fit), and the system can be glazed at the job site (Simpson 1999). The stick curtain wall system is economical and extremely reliable

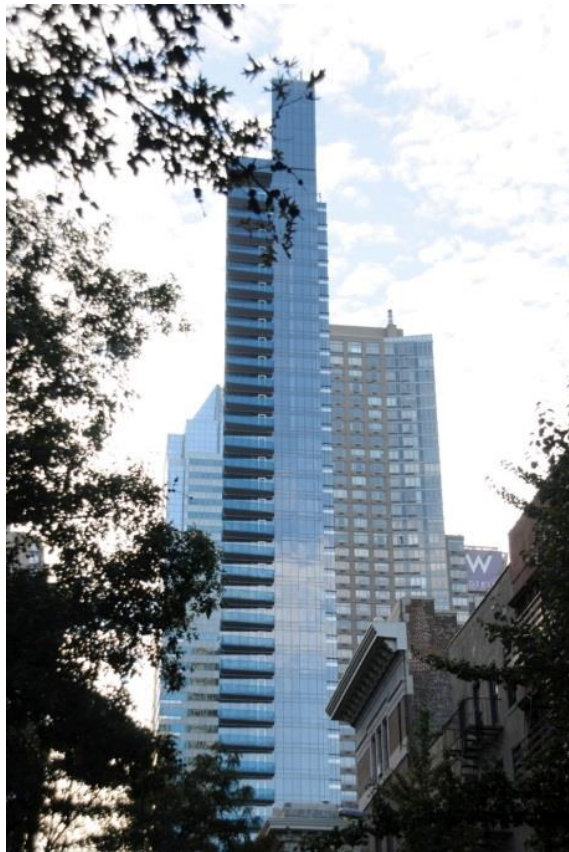
Figure 4. Unitized curtain wall system. 8th Avenue, New York, NY. Image: Andres Martinez.

The unitized curtain wall system is used in large high-rise buildings (Figure 4). The system frames and glass are pre-engineered, and factory assembled (Figure 5 and Figure 6), improving the quality control. This system can be installed from the interior. Its labor and installation cost is lower than stick curtain walls because its installation is faster. However, the use of this system increases storage and shipping cost because it requires expensive lifting equipment on site, careful site handling and longer lead times (Simpson 1999).

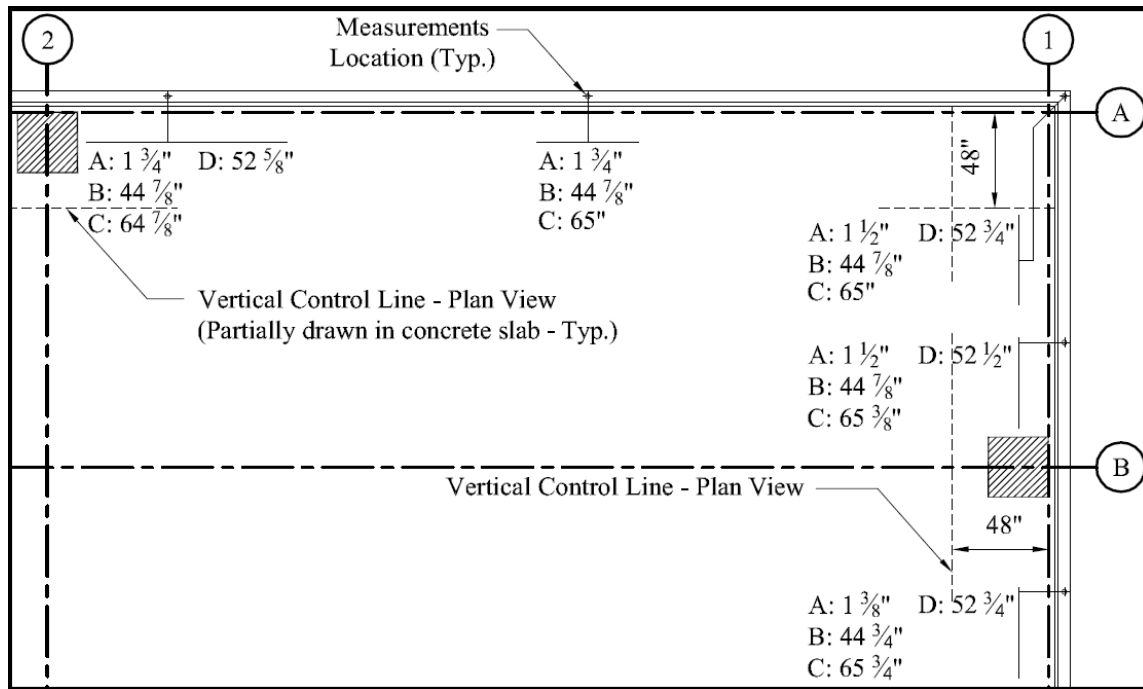
On floors where the curtain wall panels had not been installed (8th to 12th Floor), this research included measurements made along the concrete slab edge of the openings delimited by the precast panels (Figure 13). The existing control lines (Figure 14) were the reference used for the measuring instruments. A long range rotary laser with a 6-foot ruler were the tools used to measure openings. These tools overcome the challenges caused

Figure 13. Example of data collected from 8th to 11th floor. Letters A, B, C and D denote de measurements gathered in the field according to the façade section showed in Figure 14. Partial floor plan (Typ.). Adapted from Dietzmann, J. M., Jr. (2014).

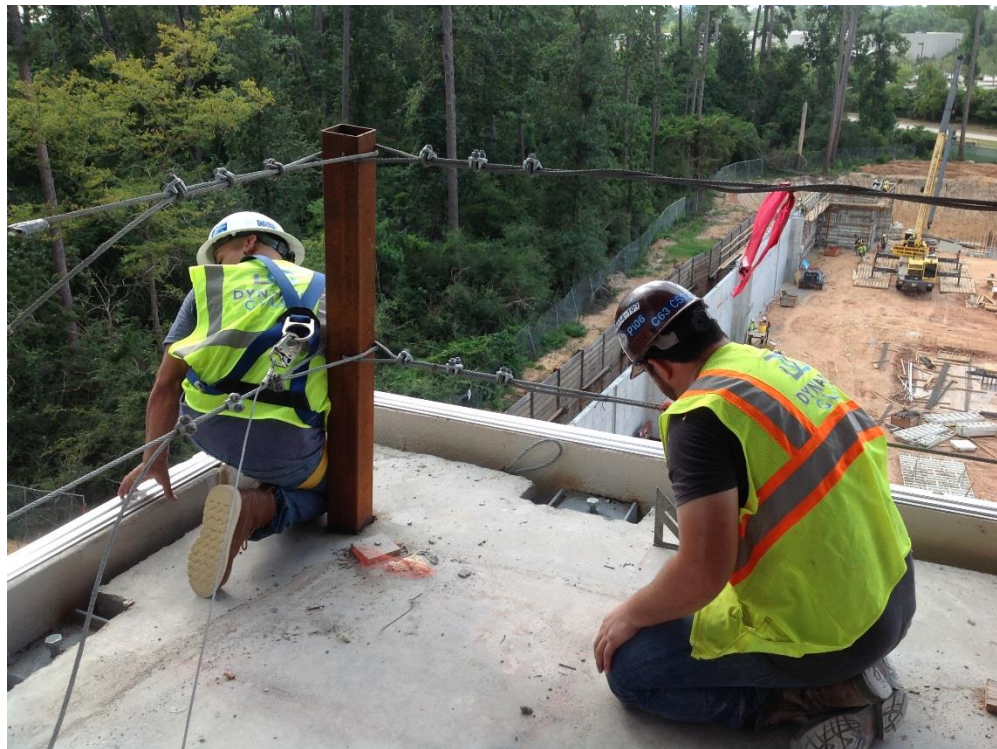
Figure 28. Sill rail installation process. Image: Andres Martinez.

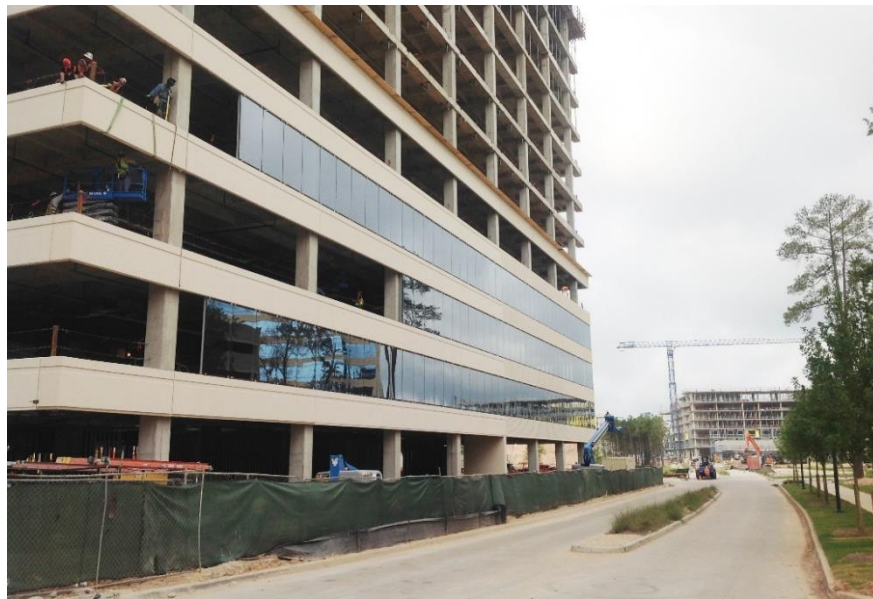
Figure 30. The progress of the curtain wall installation at the North façade. Image: Andres Martinez, dated July 28, 2014.

Figure 30 shows the 2nd, 3rd and 4th floors of the North façade. The curtain wall crew had already installed 147 panels. Figure 31 was taken 16 working days later, and the crew had installed 338 additional panels. Extrapolating the data obtained from Table 8, the crew may install 338 curtain wall panels in 8.5 workdays. However, they spent 16 workdays installing the same number of panels, which represents an 88% increase in time. The sequence installing the curtain wall panels presented in Figure 30 and Figure 31 shows interruptions in the workflow. Clashes between the curtain wall system with the precast panels forced the precast subcontractor to fix the problem. The sequence established by the general contractor interfered with the curtain wall subcontractor schedule. As a result, the curtain wall subcontractor mobilized the crew to other floors while the precast subcontractor corrected the problems.

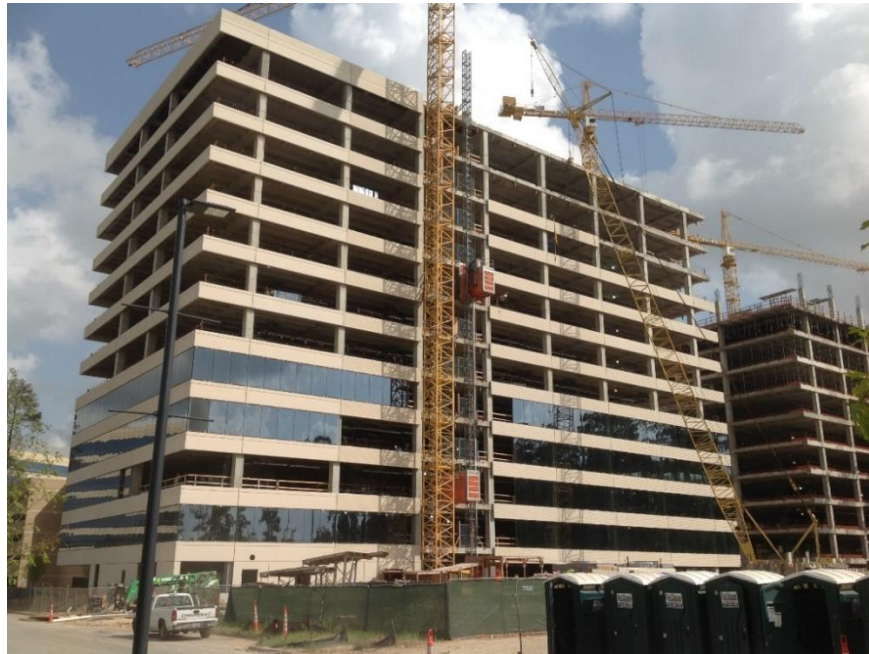
Figure 31. The progress of the curtain wall installation at the South façade. Image: Andres Martinez, dated August 18, 2014.

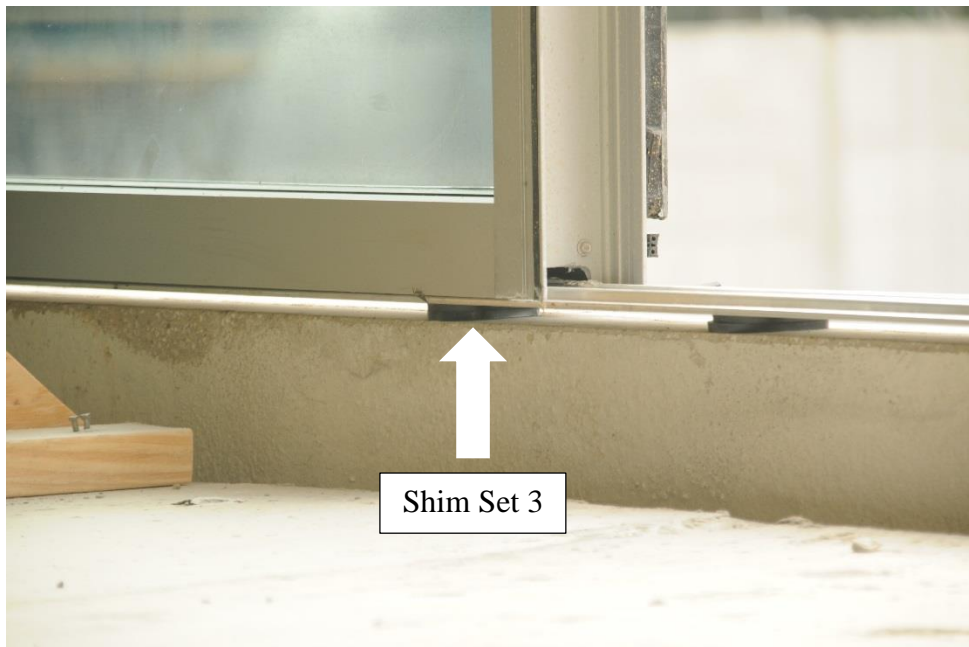
Figure 34. Detail of sill rail leveled with shim set 3. Image: Andres Martinez.

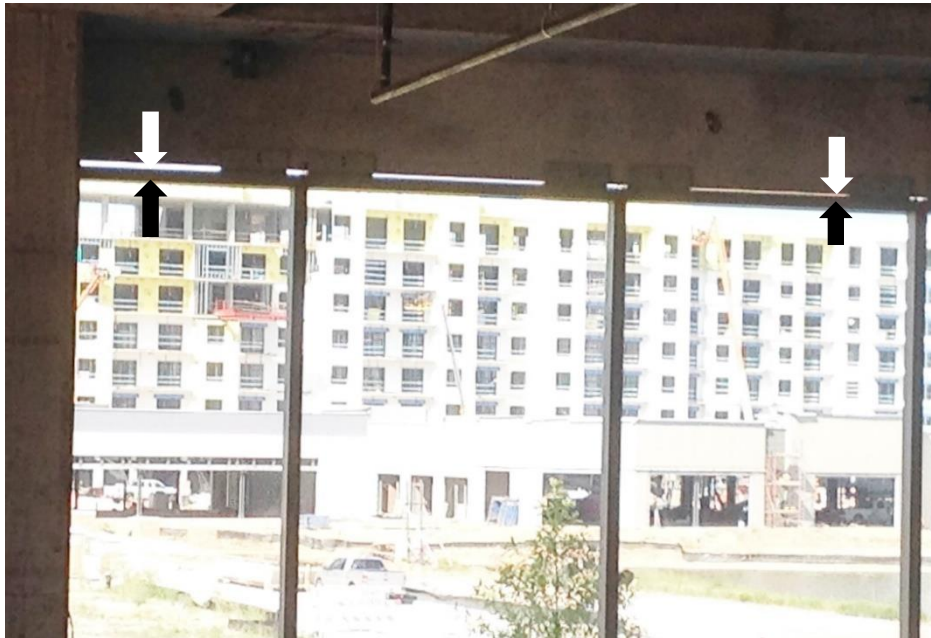
The interface between cladding components at the top of the curtain wall panels revealed different tolerance issues. The challenges faced by the curtain wall installers range from variable joint sizes to clashes between components. Figure 35 shows variable joint sizes along the cladding interface on a 15-foot span. This tolerance issue did not constitute a problem during the curtain wall installation. However, the caulking process affected the efficiency of the crew. They invested more time and materials sealing the joints properly to prevent water leaks. Wide joints required thicker backer rods to fill the gap and additional silicone to caulk the joints. Narrow gaps did not allow the use of backer rods to isolate the interior from the exterior, and the caulking might not have reached the required depth to prevent future leaks.

Figure 35. Tolerance issues at the top of the curtain wall panels. East façade, interior view. Image: Andres Martinez.

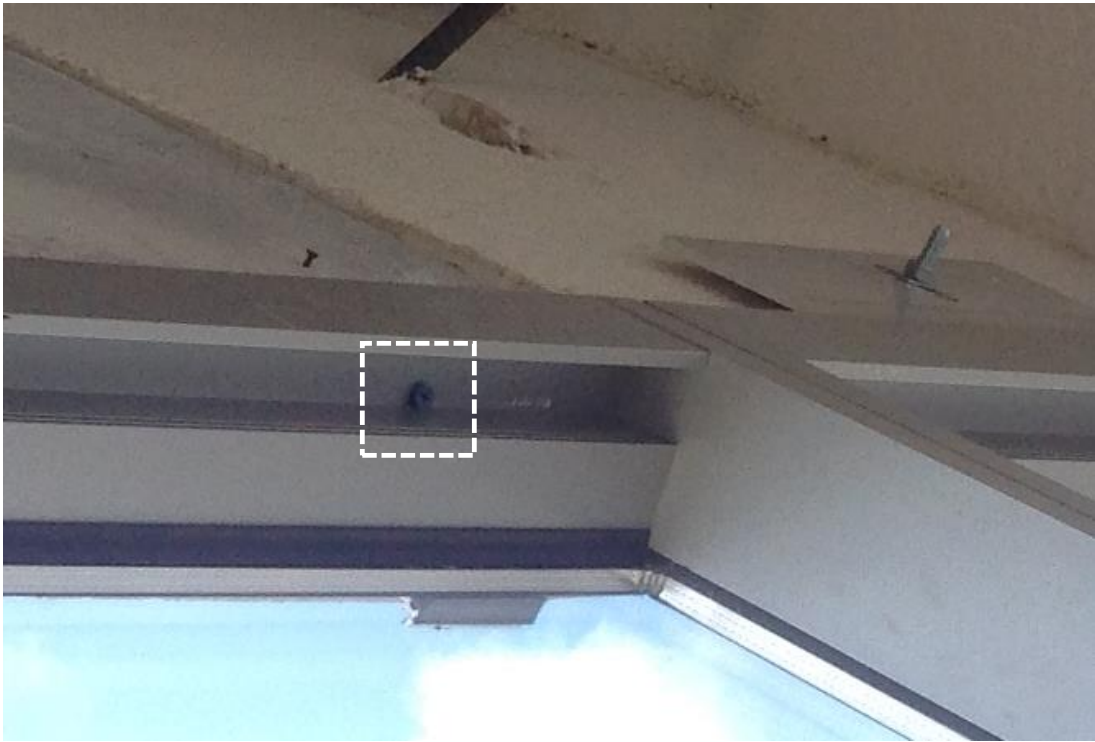
Figure 37. Detail of curtain wall panel screwed through the blind pocket. Image: Andres Martinez.

4) Inadequate tolerance management between the concrete slab and precast panels at the top of the curtain wall panels caused horizontal over shimming between the curtain wall anchor clips and the precast panels. In contrast, insufficient room for anchoring in other areas required the removal of the anchor clips and its replacement with a screw through the blind pocket.

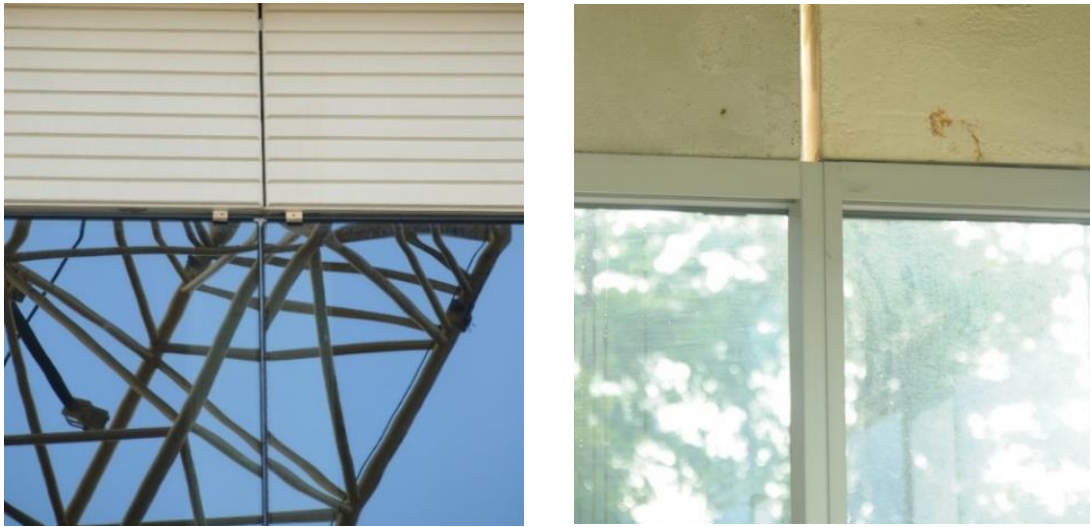
This study also found a displacement between the center lines of the curtain wall vertical mullions and the center lines of the precast panel joins across the building (Figure 38). The general contractor setup control lines over each concrete slab to provide a guide for all trades to execute their work. The general contractor also drew the center line of the concrete slab in each direction on every floor. The precast and curtain wall subcontractors had to use this reference to align the centerlines of their cladding systems with the center line of the concrete slabs (Figure 39).

Figure 38. Misalignment of the curtain wall and precast panel joints. Exterior view of at the North façade (left), interior view at West façade (right). Image: Andres Martinez.

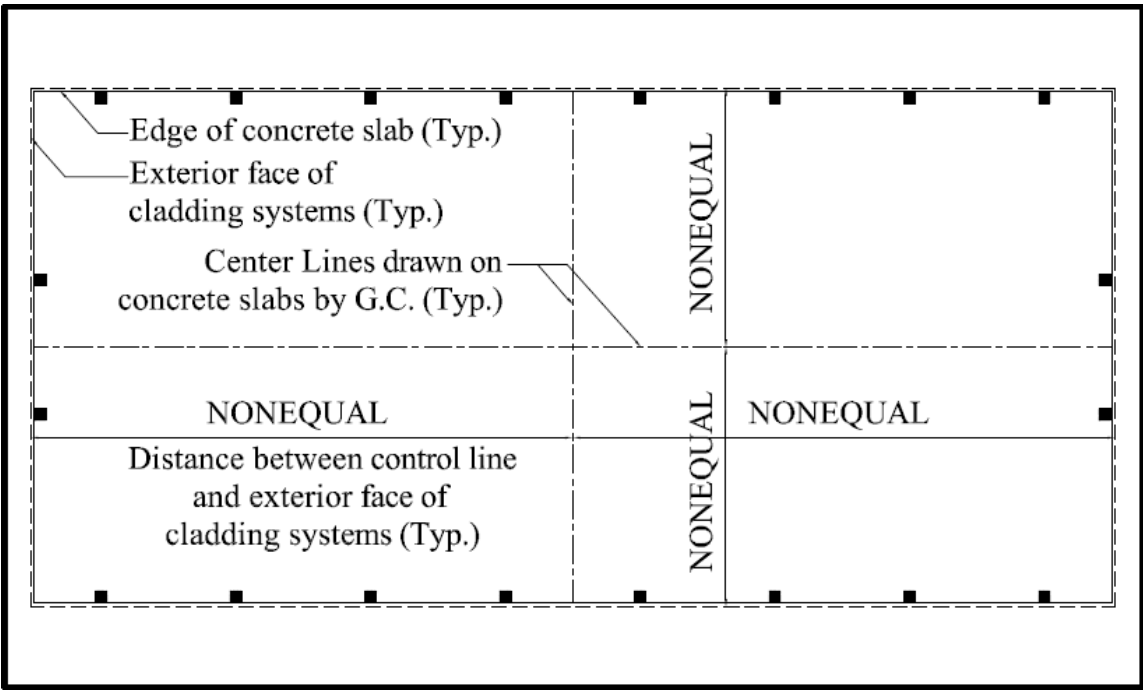
Field observations and measurements indicated a displacement between the center line of the concrete slabs and the center line of the precast panels in both directions (Figure 40). Similarly, this study found that the installation of the precast panels always began in the corners of the building, following the schedule of the tower cable car crane. The installation sequence followed by the precast subcontractor resulted in misalignments with the concrete slab center lines. As a result, the curtain wall subcontractor had to displace the curtain wall aluminum caps (Figure 41) to correct the alignment with the precast panel joints. The displacement of some aluminum caps can be observed from the interior of the building (Figure 42).

Figure 40. Alignment of the cladding system as per field observations and measurements. Adapted from Dietzmann, J. M., Jr. (2014).

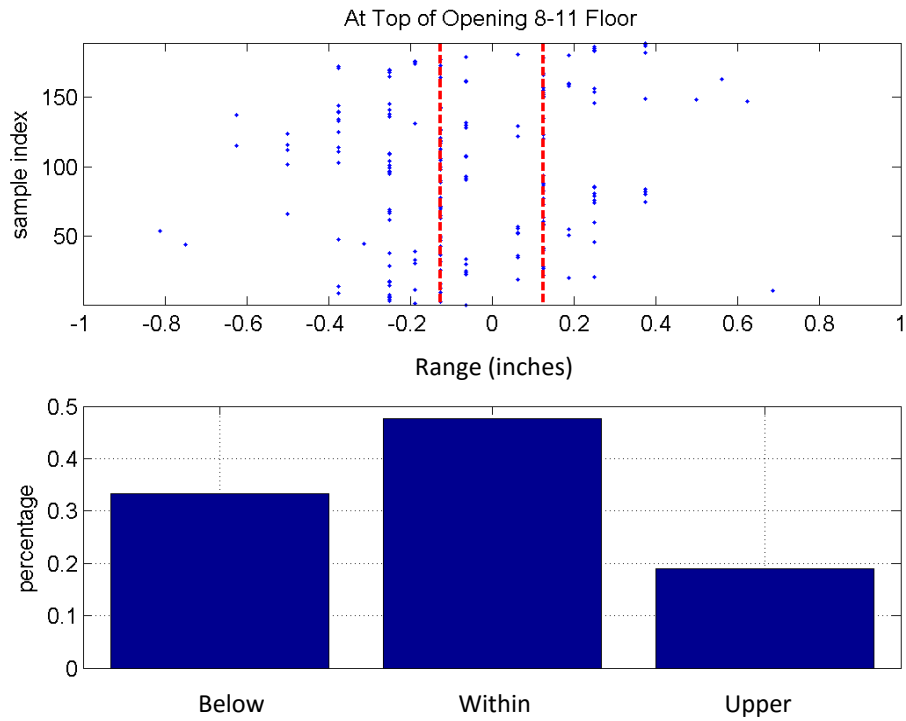
Figure 49. Plot of tolerance results at the top of the openings, from 8th to 11th floors.

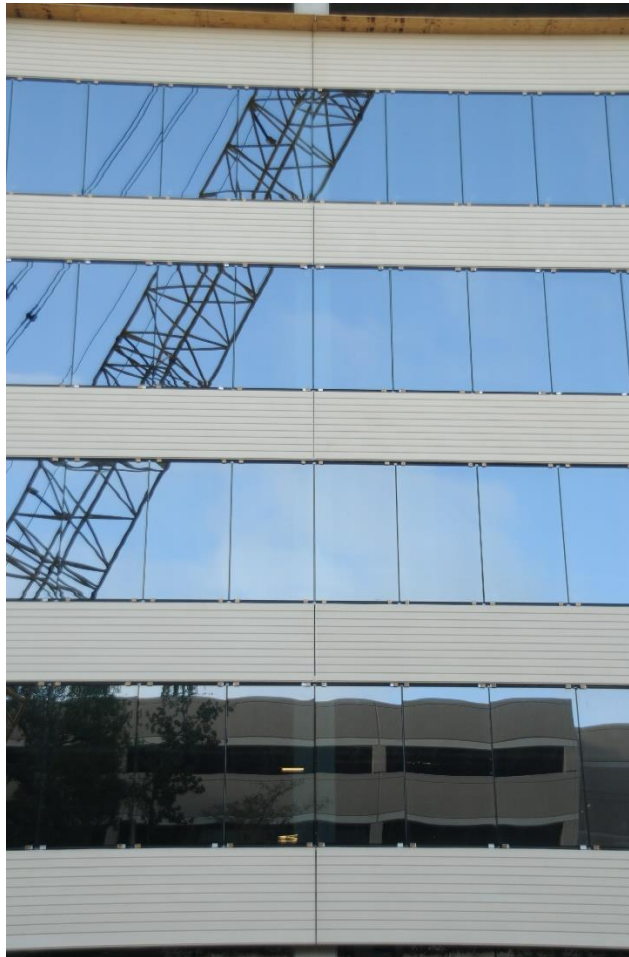
Figure A-1. Alignment of precast and curtain wall panels at North façade. Picture 1a. Image: Andres Martinez.

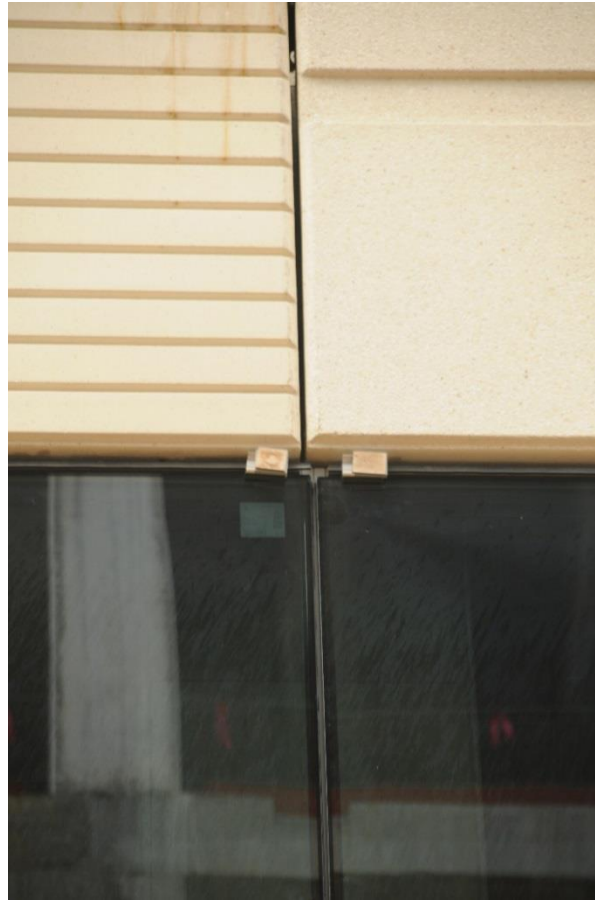
Figure A-2. Misalignment between precast and curtain wall panels joins at East façade. Picture 1b. Image: Andres Martinez.

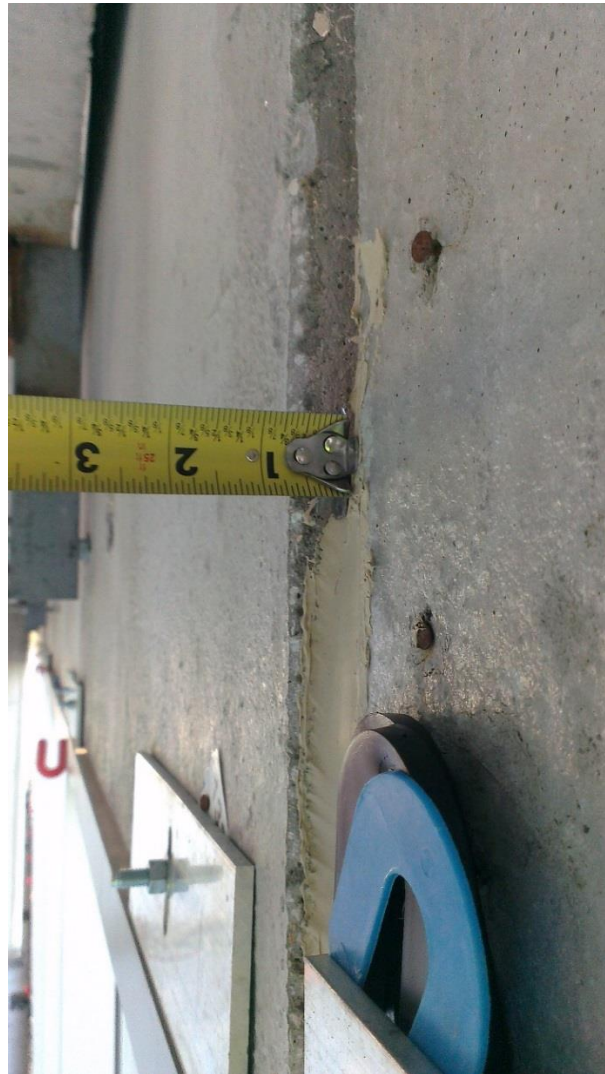
Figure A-3. Tolerance discrepancies between curtain wall anchor clips and precast panels. Picture 3a. Image: Andres Martinez.

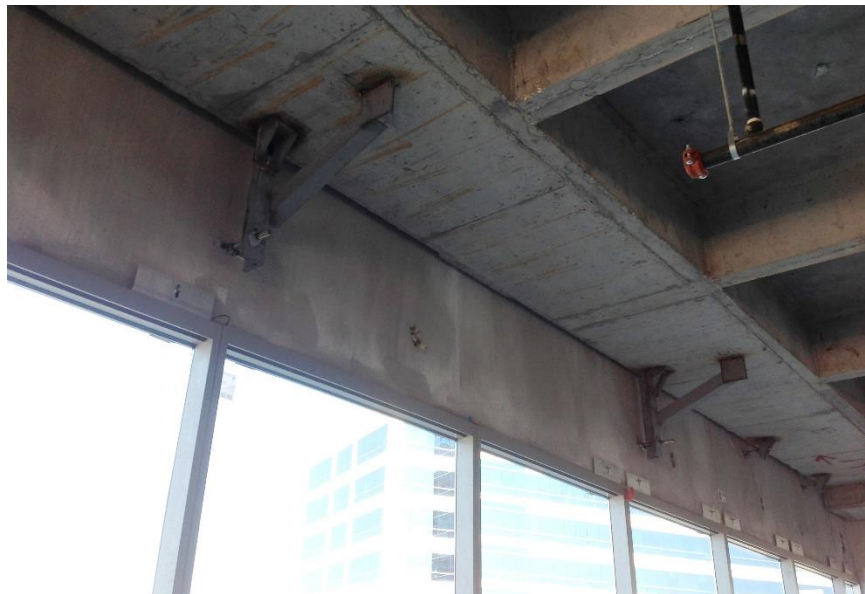
Interviewee: That's where the precast was too tight, so in one area we had to take the clips off, push the screws into the blind pocket, so right there, the precast, they shouldn't went off the tighter spot than going off the spot they have been going off instead of just doing whether the anchor point are.

Figure A-4. Evidence of removed curtain wall anchor clips at 3rd floor, West façade. Picture 3b. Image: Andres Martinez.

Author: This is the picture 3b (Figure A-4).

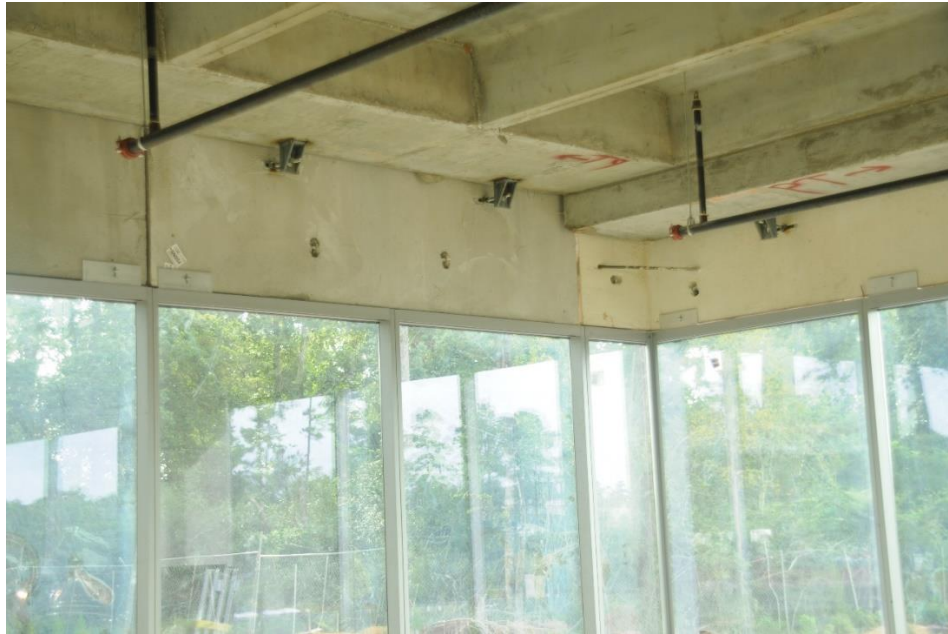
Interviewee: Yeah, you can actually see right here in the corner to the next piece of precast, the corner has a gap, next piece of precast way too low, you can see it. That's a big problem right there.

Figure A-5. Evidence of removed curtain wall anchor clips at 4th floor, Southeast corner. Picture 4a. Image: Andres Martinez.

Author: Also the picture 4a (Figure A-5). This is similar (to the picture 3b), and this is in the corners.

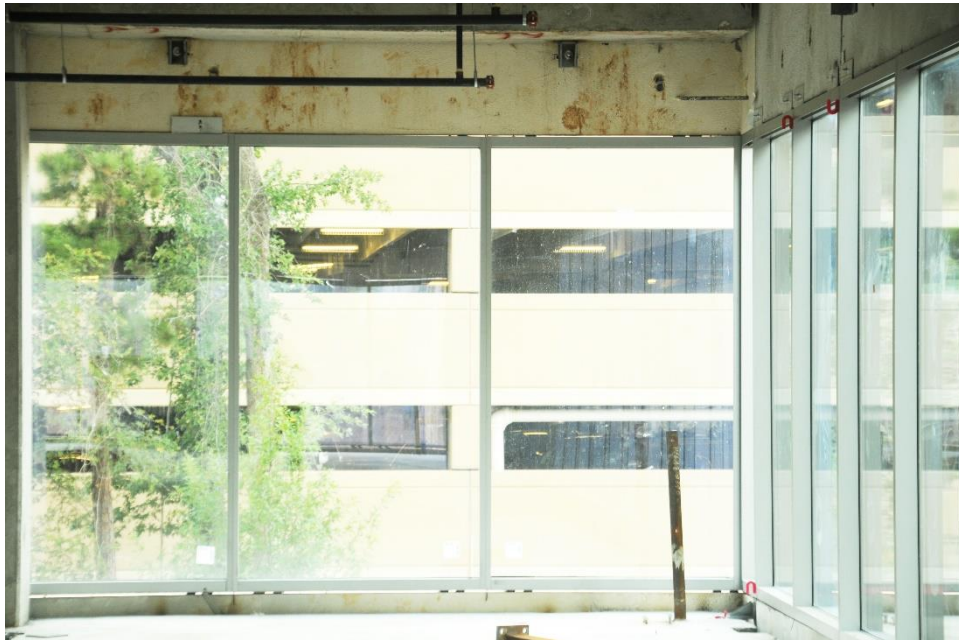
Interviewee: If you notice, here (refer to Figure A-7, top of curtain wall panels) is very tight and it has actually a bow. It is tight at the corner, middle of the two frames you see daylight and then goes back down so that precast has a bow in it. That's something might I'm not bear to fix, but I mean, they are supposed to give me an inch and a half (1 ½) bigger than my frame which they could raise it up.

Figure A-6. Uneven precast panels at top of curtain wall panel. Picture 4b. Image: Andres Martinez.

Author: Picture 4b (Figure A-6), at the bottom (of the curtain wall panels), looks pretty leveled, but at the top no (why?)

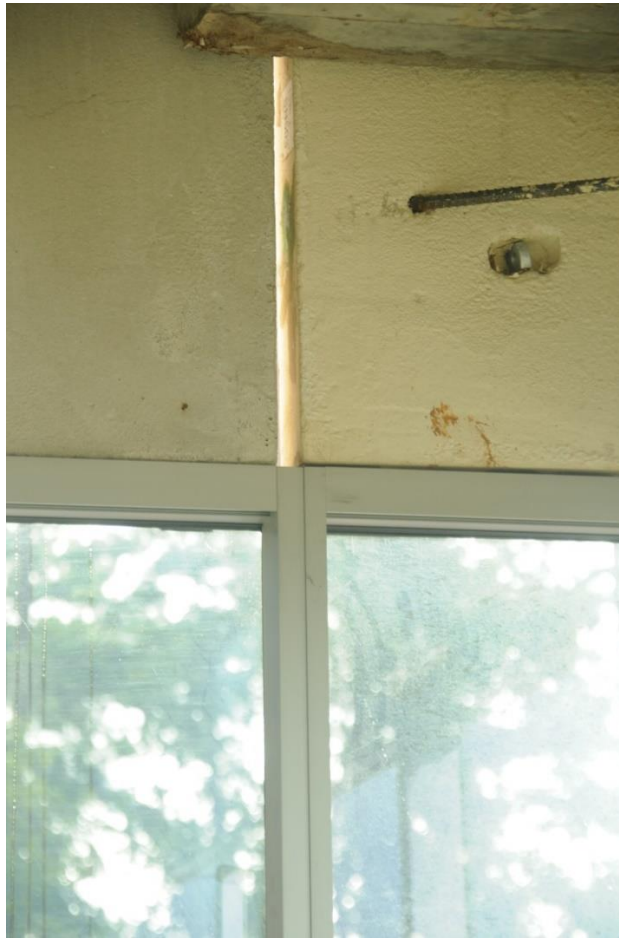
Figure A-7. Interior view of Joint misalignment between cladding systems. Picture 5. Image: Andres Martinez.

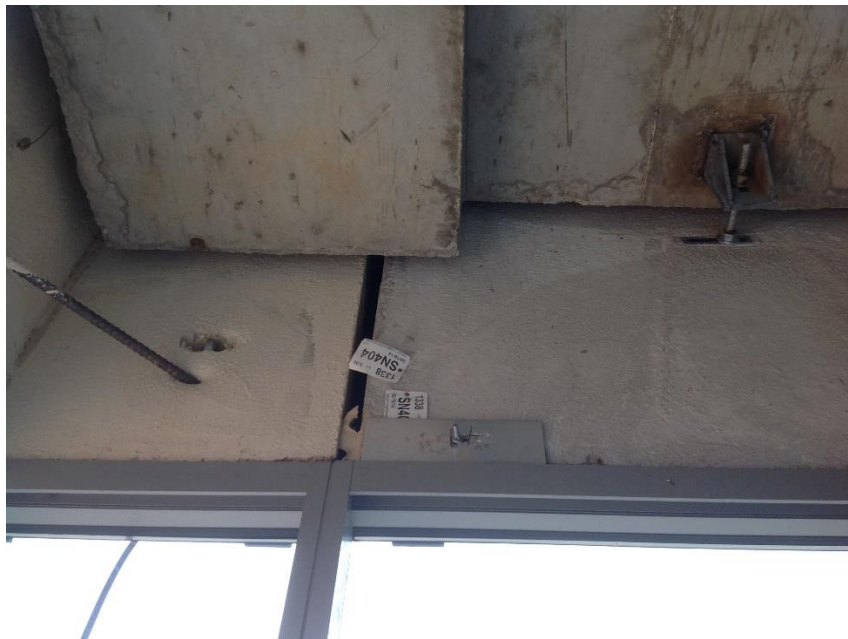
Figure A-8. Interior view of joint misalignment between cladding systems at building corner. Picture 8b. Image: Andres Martinez.

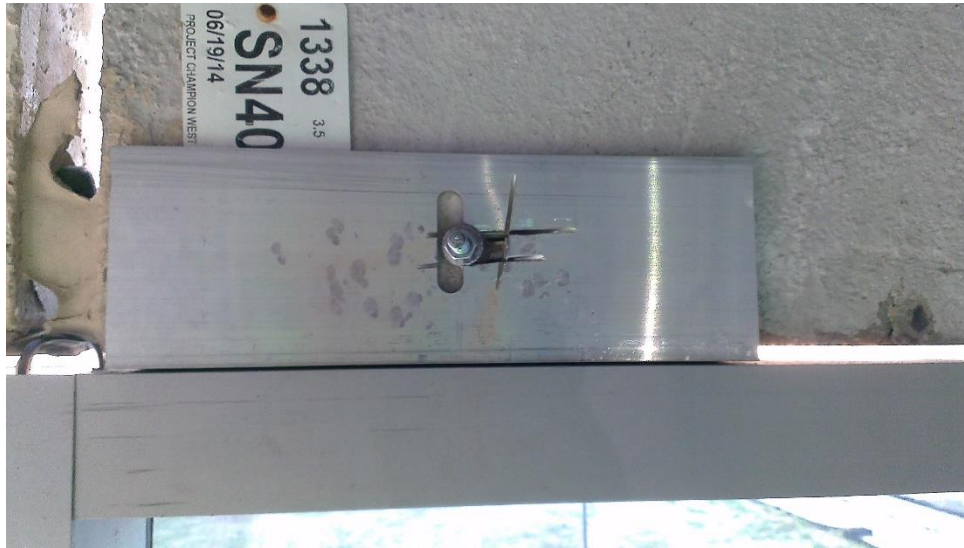
Figure A-9. Alteration of curtain wall anchor clip caused by horizontal displacement of the panel. Picture 8c. Image: Andres Martinez.

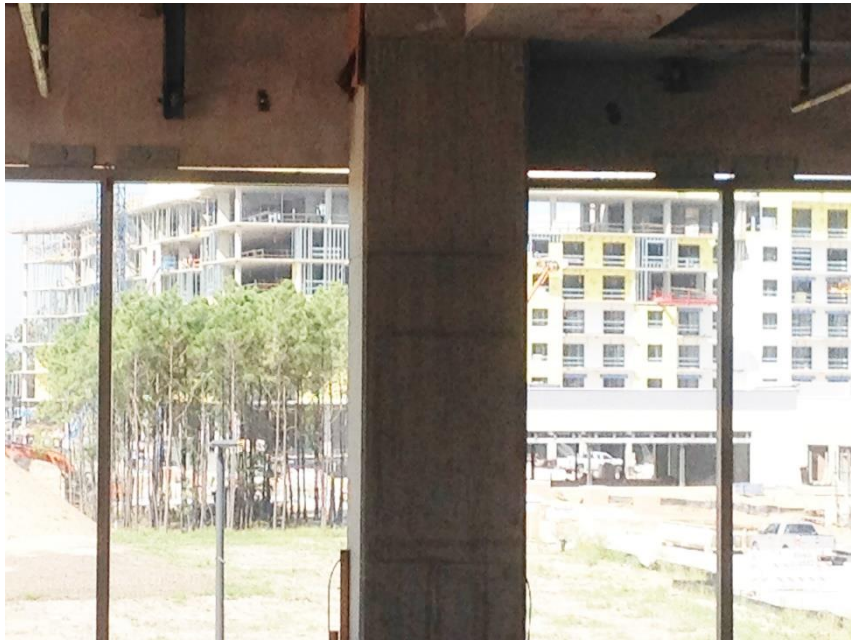
Figure A-10. Tolerance discrepancies between cladding systems and top of the curtain wall panels. Picture 9. Image: Andres Martinez.

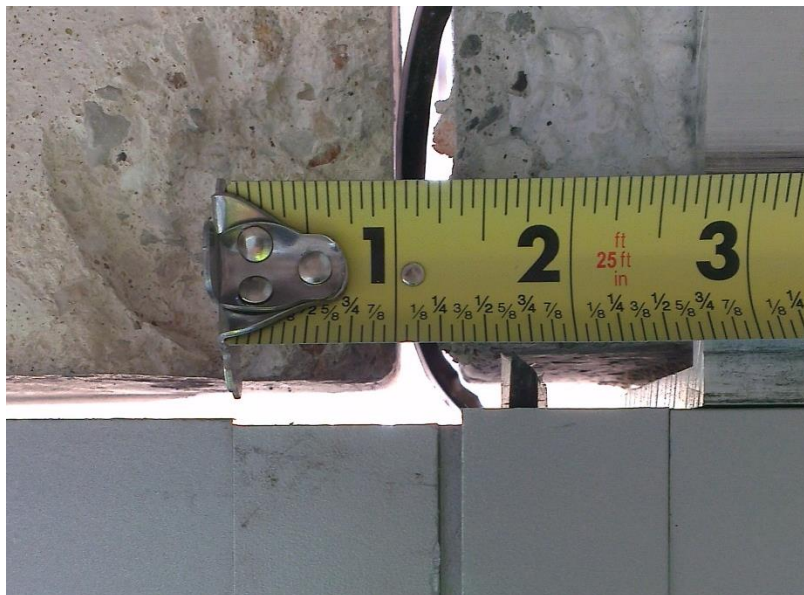
Figure A-12. Detail of horizontal misalignment between curtain wall and precast panels. Picture 6b. Image: Andres Martinez.

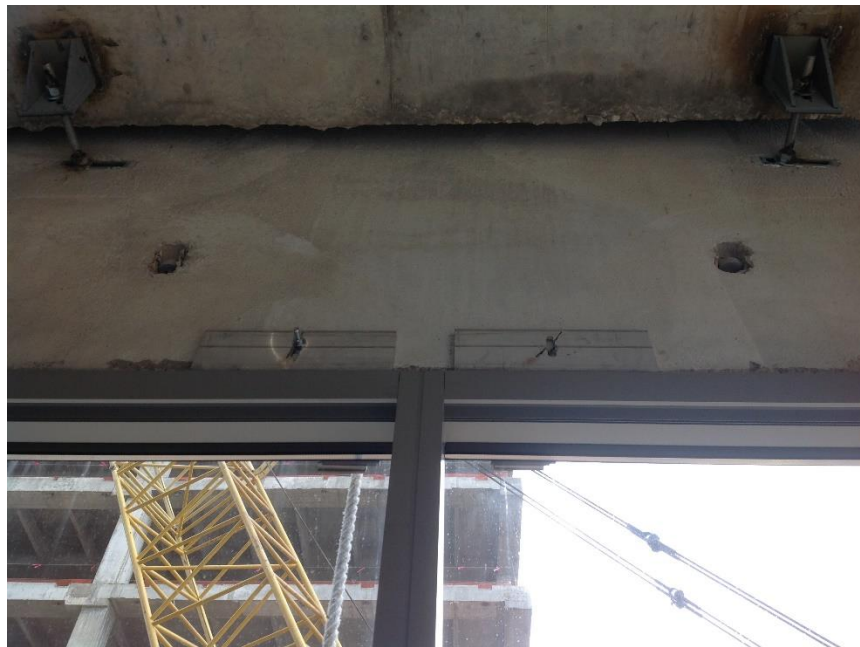
Figure A-13. Alteration of curtain wall anchor clips. Picture 8a. Image: Andres Martinez.

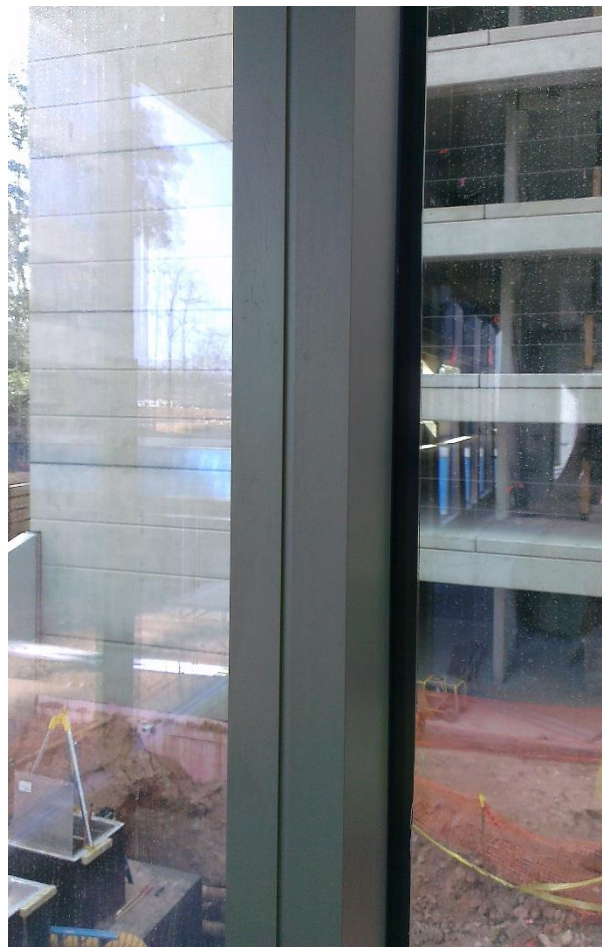
Interviewee: Third floor is the worst floor, it is off pretty bad. If you check the control lines to the frame, you can see fine but everything seems to be shifted in one way.

Figure A-14. Interior view of custom aluminum cover displaced at the exterior of the building. Picture 10. Image: Andres Martinez.

Author: I took a picture today (picture 10) (Figure A-14) in the second floor. The cover of the mullion (is displaced). (Why?)

Author: The beauty cap (in Figure A-14) seems displaced maybe one-quarter (1/4) inch...
