45TH **TURBOMACHINERY** & 32ND **PUMP SYMPOSIA**
HOUSTON, TEXAS | SEPTEMBER 12 – 15, 2016
GEORGE R. BROWN CONVENTION CENTER

Redesign of Centrifugal Compressor Impeller by means of Scalloping

Kirill Grebinnyk, Aerodynamics Engineer, Sulzer (USA)

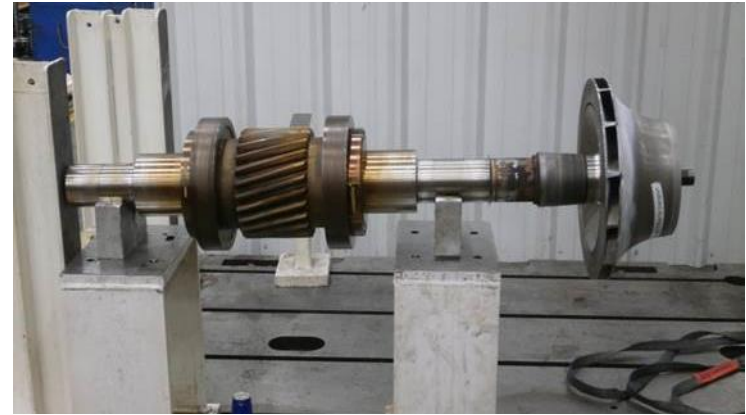
Layout of Integrally Geared Compressor

- Industrial gas company operates three stage integrally geared compressor at the air separation plant in Australia (>1,000 TPD of oxygen).
- Compressor characteristics:
 - Inlet air flow = 20,000 m³/hr (11,770 ACFM)
 - Pressure at the compressor discharge = 3,030 kPa (440 psia).
 - Compressor is driven by an electric motor at 1,500 RPM.
 - Power input = 9.5 MW (12,740 hp)

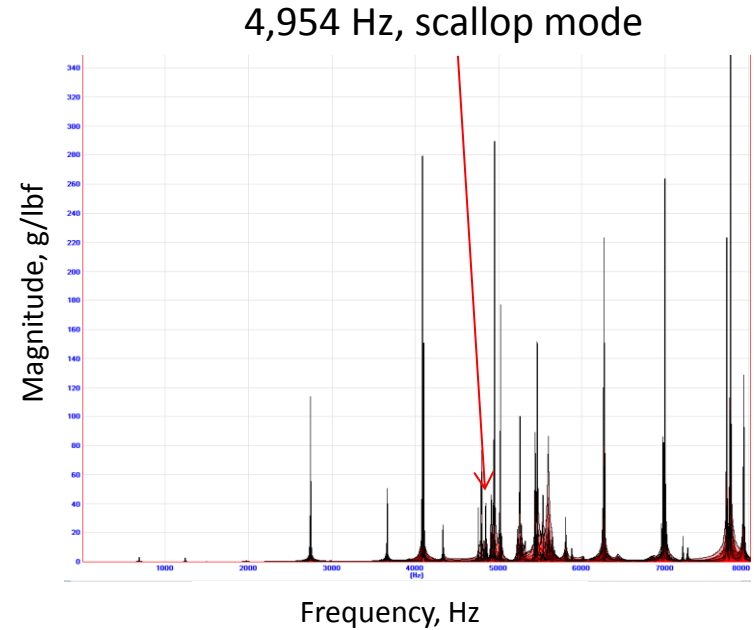
- Modal testing is performed to determine the natural frequencies of the impeller.
- Uniaxial accelerometer is attached to the impeller to collect the data. Calibrated hammer is used to impact the coverplate at 34 points.
- The data acquired during modal testing is post-processed and the natural frequencies are identified by the high response magnitude.
- The natural frequencies predicted by the FEA are in 3% range from the results of modal testing.

Modal testing results

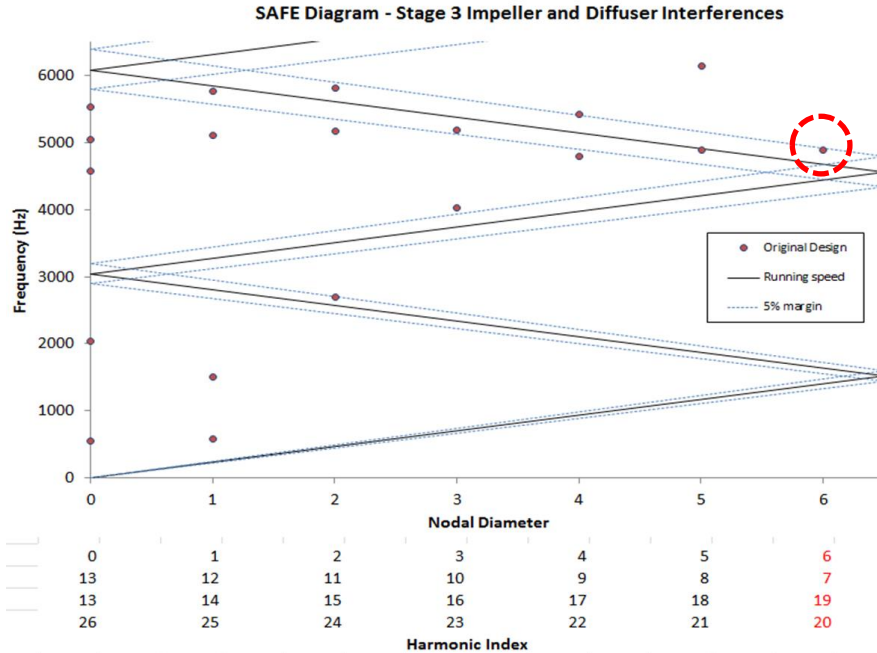
Natural frequency = 4,884 Hz, 6ND, coverplate only mode

- # of diffuser vanes = 20;
- # of impeller vanes = 13;
- Number of Impeller Nodal Diameters (ND) = 6
- Harmonic Indexes that can be excited are 6, 7, 19, 20

Interference (SAFE) diagram – Original Impeller

The Singh's Advanced Frequency Evaluation (SAFE) diagram approach introduces frequency and mode shape matching instead of just the frequency matching. See reference [1].

- Stress concentration at the coverplate does not exceed the material yield strength, but may cause a fatigue issues in conjunction with high alternating stresses due to resonance.
- Using Interference (SAFE) diagram the impeller natural frequency at 4,884 Hz was identified as the one being excited by the external forces. The mode can be excited with a 20X excitation, which corresponds to the diffuser vane count. The mode shape of this frequency closely resembles the failure pattern observed.
- Scalloping of the impeller coverplate and backplate is considered as the primary method for the redesign.
- The following issues needs to be mitigated: resonance with the impeller natural frequency at 4,884 Hz and high stress in the coverplate fillet.

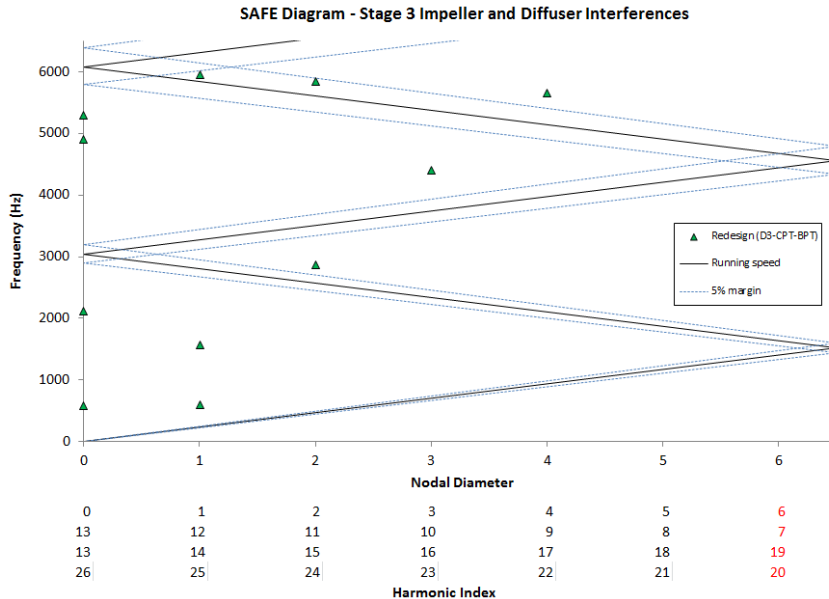
- Scalloping both coverplate and backplate appears to be beneficial for obtaining 5% separation margin between impeller's natural frequencies and potential interferences.
- In the new design no natural frequencies are having interference with the potential sources of excitation.

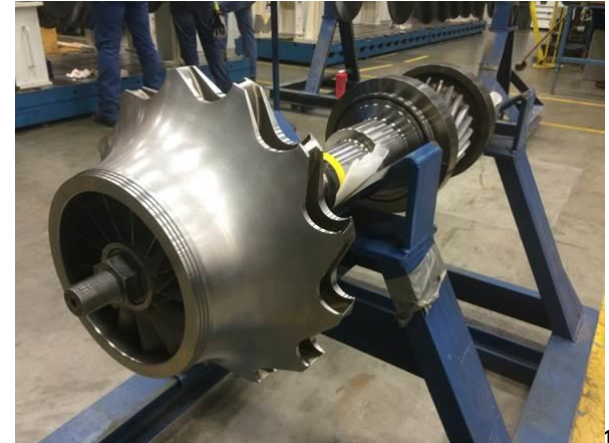
- The new impeller with the brazed coverplate was manufactured and tested within 20-week period after the engineering analysis is complete.
- The impeller was spin-tested at 15% above maximum operating speed (MOS) and non-destructively tested to confirm its structural integrity.
- Modal testing of the new impeller is performed. The obtained test results are within 2% range from the frequencies predicted numerically by modal FEA.
- As of May 2016 the pinion with the redesigned impeller has not been installed in the machine.
