The character of fracture of iron based thermal coating during fretting

Abstract. The character of destruction of thermal coatings during fretting has been investigated. An iron based plasma coating has been tested with oscillation amplitude from 30 to 200 microns. The tests were conducted in air. It has been determined that the main factor influencing the rate of the wear of the coating during fretting corrosion is the size of the coating area involved into the wear process. The coating exhibits high wear resistance when the amplitude of the oscillation is commensurate with the size of the sprayed particles. During destruction of the coating the leading role belongs to fatigue-oxidation processes. The wear of the coating acquires a catastrophic character when coating macro defects – pores and interlayer boundaries – are involved into the wear process.

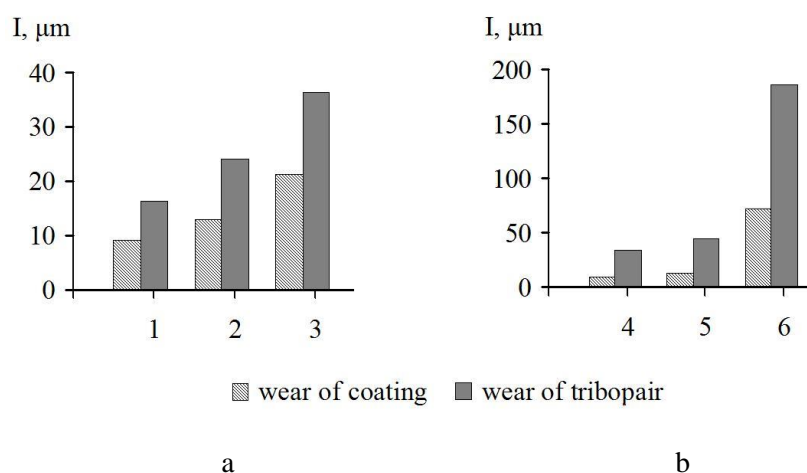
Figure 1. Wear values (I) of tribopairs and coatings under the test load of 25 MPa (a) and 50 MPa (b) and vibratory displacement amplitude: 1 – 30 μm ; 2 – 60 μm ; 3, 4 – 100 μm ; 5 – 150 μm ; 6 – 200 μm .

The analysis of obtained results showed that an increase in vibratory displacement amplitude enhances the wear of the coating and the tribopair. The growth of vibratory displacement amplitude from 30 to 100 μm under the load of 25 MPa leads to twice as much of wear increase of both coating and tribopair (Figure 1).

The load increase from 25 MPa to 50 MPa with vibratory displacement amplitude of 100 μm has practically not affected the wear. The wear of coating and tribopair increases during vibratory displacement amplitude increase up to 150 μm (Figure 1). The wear increase is due to the intensification of processes of setting and abrasion of wear particles on the friction surface. A wear pattern which is typical for fatigue-oxidation processes is observed during tests with vibratory displacements amplitude of 100 μm . Caverns and small amount of adhered wear particles are observed in the area of the friction track. (Figure 2a, b). A fatigue-oxidation wear mechanism is confirmed by optical metallography of the coating cross section after wear. As a result of fatigue-oxidation processes during fretting, the thickness of oxidized layers in the coating can be tens of micrometers. The other important outcome of the worn coatings structure analysis is the that roughening of coating fragments is of a wave nature. The size of these fragments is comparable to the motion amplitude [7].

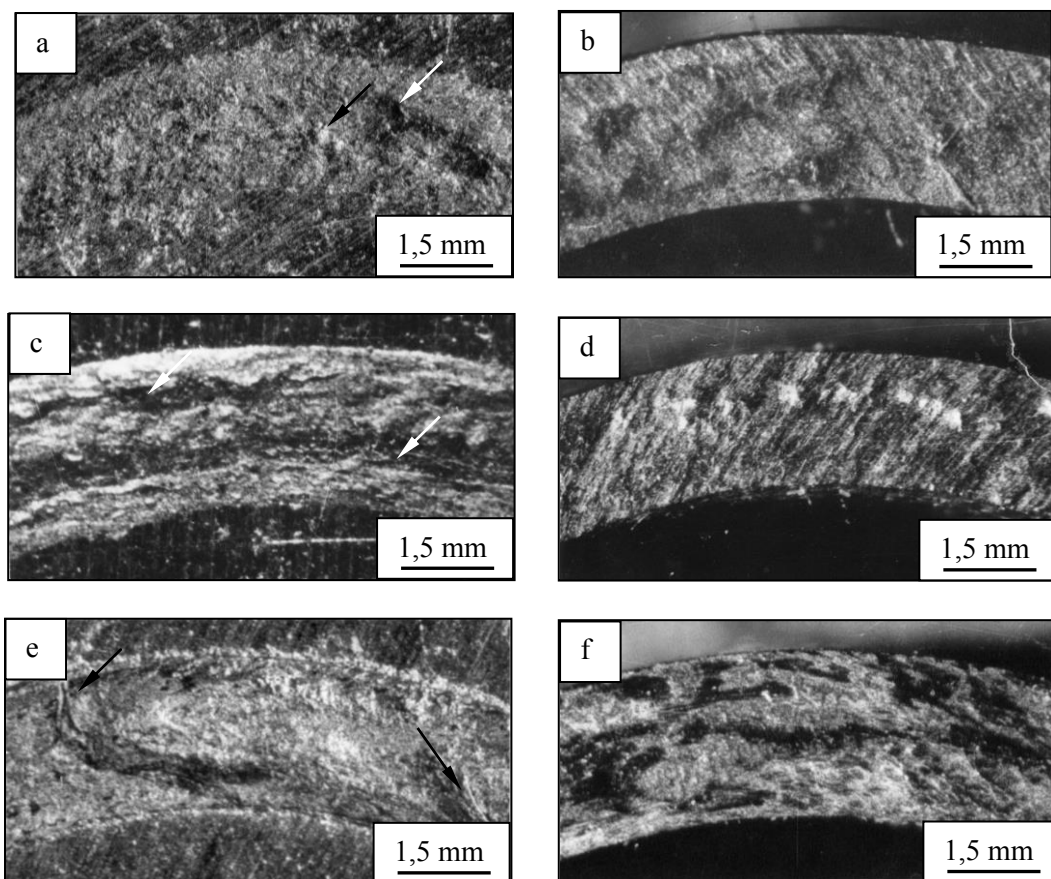
Figure 2. Fragments of coated friction tracks (a, c, e) and counterface (b, d, f). An experiment with amplitude vibratory displacement: a, b – 100 μm ; c, d – 150 μm ; e, f – 200 μm . Arrow marks on the photo show the following: white – cavity; black – adhered wear particles (a) should be abrasive damage (c), burrs (d).

Along with the fatigue-oxidation damages, the traces of abrasive damages with the increase in vibratory displacement amplitude up to 150 μm are clearly visible (Figure 2c, d). The friction coefficient increases with increasing vibratory displacement amplitude. Friction coefficient has values 0.35, 0.4, 0.5 and 0.55 when vibratory displacement amplitude equals 30, 60, 100 and 150 μm , respectively. The friction coefficient increase is due to the fact that wear yield from the friction zone is facilitated under large amplitude values. Thus the conditions for the direct contact of friction surfaces in the large area are created. In turn, the contact area increase leads to the increase of friction force and, hence, the friction coefficient.

The coating wear increases up to 70 μm and the tribopair wear increases up to 180 μm with increasing vibratory displacement amplitude up to 200 μm . A friction coefficient becomes 0.95. In this case the coating fragments are involved in the setting process. These fragments exceed the size of individual sprayed particles. The process of interaction of the coating material with the counter body proceeds to macro. Catastrophic wear of the coating illustrates the nature of the tribo damage of the friction surface (Figure 2e, f). Multiple teasers, cut away places and mutual material transfers are observed on the surface of the coating and its associated counterface.
