ANNALS OF GEOPHYSICS, 59, FAST TRACK 5, 2016; DOI: 10.4401/AG-7271

# Different damage observed in the villages of Pescara del Tronto and Vezzano after the M6.0 August 24, 2016 Central Italy earth- quake and site effects analysis

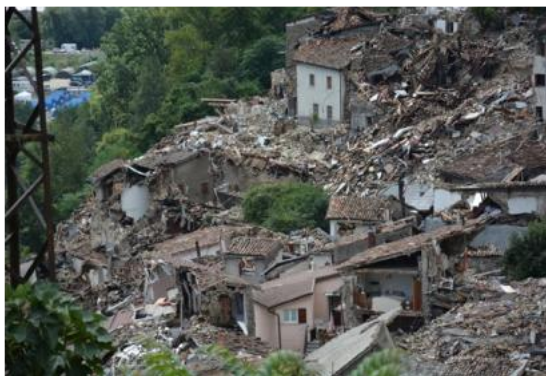
The extent of damage in Pescara del Tronto is clearly visible in Figure 2-a) showing the post-earthquake condition of a portion of the village. Figure 2-b) displays a partial collapse of a masonry building pointing out the poor quality of masonry walls without any connection between wythes. In some cases, the combined effect of in plane actions and out plane actions further exacerbated by pushing wooden roofs was responsible for the collapse. Heavy damage also occurred to buildings with reinforced concrete (RC) structure. An example is reported in Figure 3-a) and b), where the heavy damage occurred to a four storey RC building in Pescara del Tronto is shown. The infill walls of the second storey totally collapsed. They were made up of two 12 cm clay hollow brick layers with an interposed layer of insulating material.

**Figure 2:** a) Overview of Pescara del Tronto most damaged area and b) Collapse of a typical masonry building.

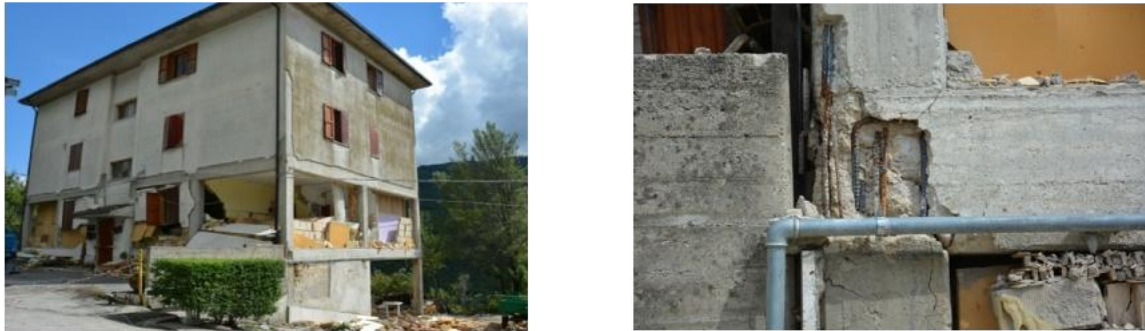
**Figure 3:** a) Reinforced concrete building in Pescara del Tronto, b) Detail of the damage to a beam-column joint.

Some structural damage was also found in a beam-column joint displayed in Figure 3-b). Concrete spalling affected the joint panel where no hoops are visible as expected considering design rules given in the building codes then in force (Masi et al., 2013; Manfredi and Masi, 2014; Masi et al., 2014). In fact, the presence of deformed reinforcing bars indicates design and construction could date back to the early 1980's (Masi et al., 2015), when Arquata del Tronto was classified as a seismic zone, forcing engineers to consider seismic activity without particular attention to structural details. A possible interaction with a retaining wall could also be partially responsible for the undesired seismic behaviour of the building. Both severity and extent of damage in Vezzano were

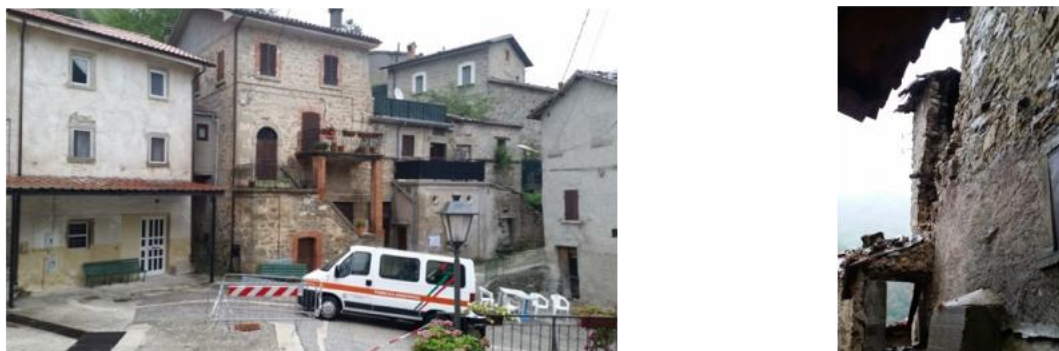
found to be quite different, as well as no fatalities or injuries were reported. The lack of heavy damage was confirmed during the rapid survey carried out by the authors and most of buildings appear to be undamaged (Figure 4-a), apart from a few abandoned and dilapidated buildings (Figure 4-b).

**Figure 4:** a) Undamaged buildings in the main square of Vezzano village and b) Partial collapse of an abandoned building.

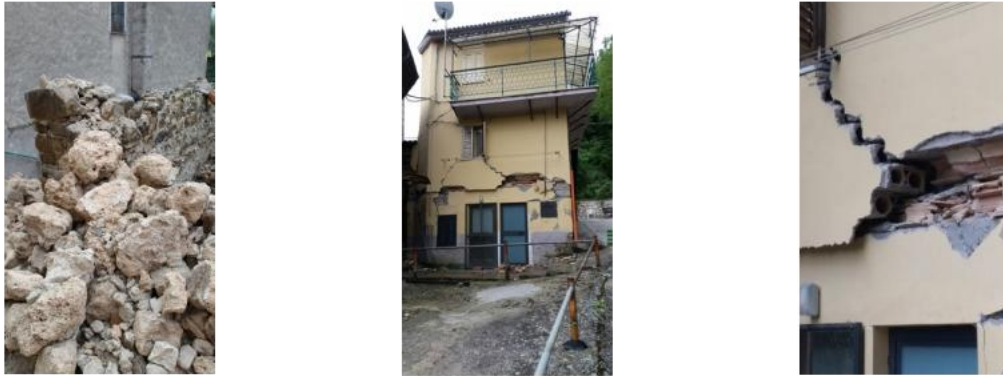
sometimes with brick elements or travertine stones (very soft and porous rock used mostly for aesthetic purposes, Figure 5-a), mortar quality was also checked and found to be very poor. Mortar generally appears to be made up of sand and hydraulic lime providing a very low bond between stones, mainly due to age deterioration, thus contributing to poor seismic performances. Several buildings in Pescara del Tronto had been subject to further construction adding one or two storeys. Figures 5-b and 5-c highlight a typical case of a building with a limestone basement and the upper two storeys made up of hollow clay bricks that appear inappropriate for structural purposes. Another prominent aspect related to the main structural characteristics of masonry buildings in Pescara del Tronto concerns the wall corners which are generally of poor construction quality,

**Figure 5:** a) Travertine blocks of a collapsed building, b) Building with two added floors made of hollow bricks, c) Detail of the hollow
