Time and Material. Interdisciplinary Study for Dating St. Francesco Convent in Cagliari (XIII-XXI Century)

This study concerns the Franciscan monastery, situated in the historic centre of Cagliari (Sardinia, Italy). It was founded in the 13th century, and transformed up to the present day. Its historical-stratigraphical complexity and the lack of data about its evolution led us to carry out an interdisciplinary inquiry. The investigation began with the use of a laser scanner survey aimed at defining a chronological hypothesis applied to the building which was based on reconstruction of historical maps, examination of masonry techniques and stratigraphic analyses. The dating obtained led to the choice of masonry samples to compare with other local and contemporary buildings where the chronology is well-known with the aim of confirming previous hypothesis. Analysis of the masonry samples allowed an understanding of their actual structure and composition, with reference to specific historical events. The mineralogical-petrographic characterization of building materials was essential. Plaster and mortar have been studied with instrumental techniques (OM, X-Ray diffraction) to analyze

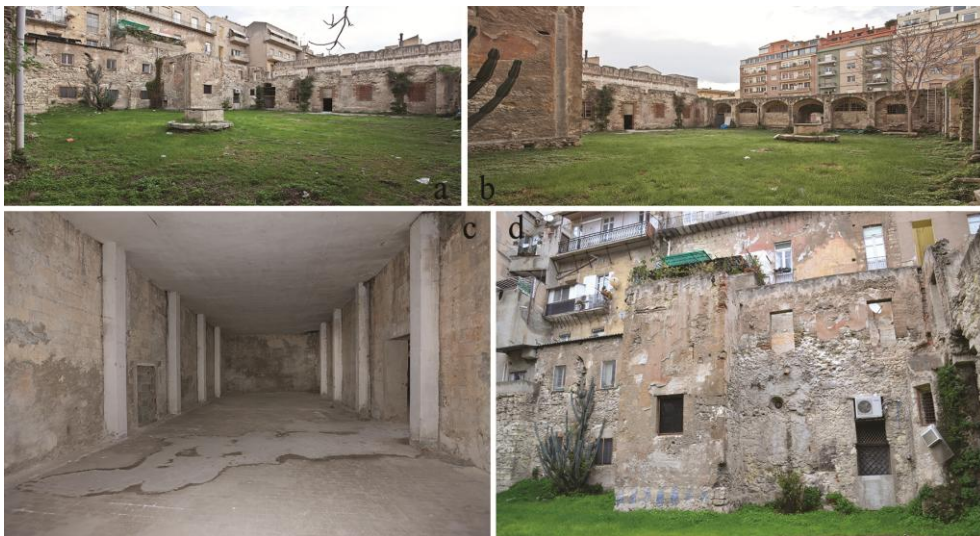
Figure 2. *The Cloister's Area (a-b-d) and the Inside of the Refectory (c)*
Source: Author Aldo Vanini.

As we said before, because of the succession of many events, it is now in an advanced state of decay. It only retains the ground floors of the eastern, southern and western parts which define the cloister area (see Figures 2a-b), and the west side, which originally housed the refectory (see Figure 2c). The northern part is the only one that has kept its upper level (see Figure 2d), although completely embedded in the newer buildings built in the late 19th century, consequent to the demolition of the church and the urban renewal of the area. Also, the southern part of the cloister is very compromised, having been partially demolished in order to open a new street in the middle of the 20th century.

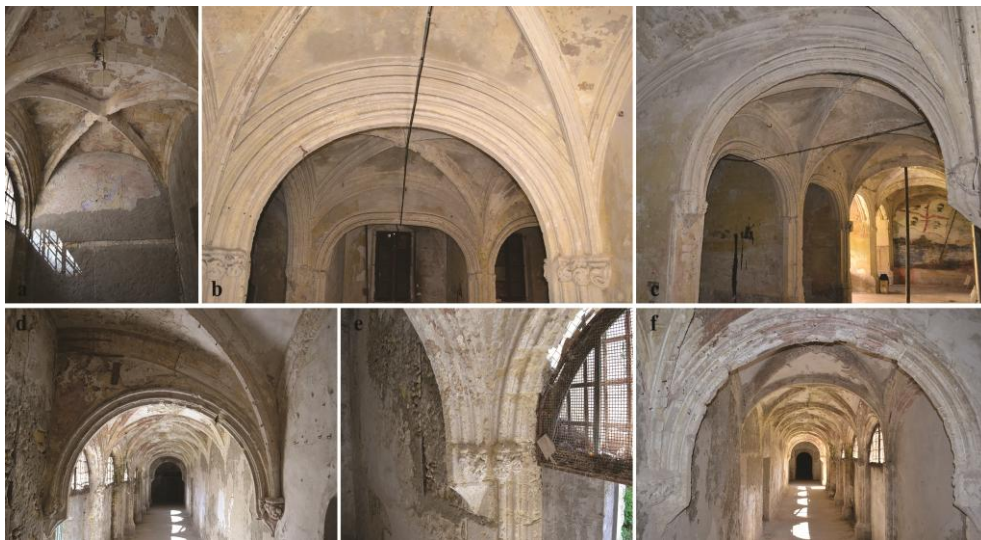
Figure 3. *The System of Vaults and Arches of San Francesco Convent*

The buildings that delimit the cloister on the north, south and west sides are characterized by a very simple decoration, with arches between the spans and crossed vaults with pendula (see Figure 3a). The west side is connected with the former refectory.

size and form. The two parts are connected by arches of different typologies (see Figure 3b).

The buildings facing the cloister show a floor plan articulated in square modules (see Figure 3c), with crossed vaults held up by finely decorated pillars and capitals (see Figure 3d), with some variants, caused by the subsequent stratifications which clearly compromised the original homogeneity of the architectural complex.

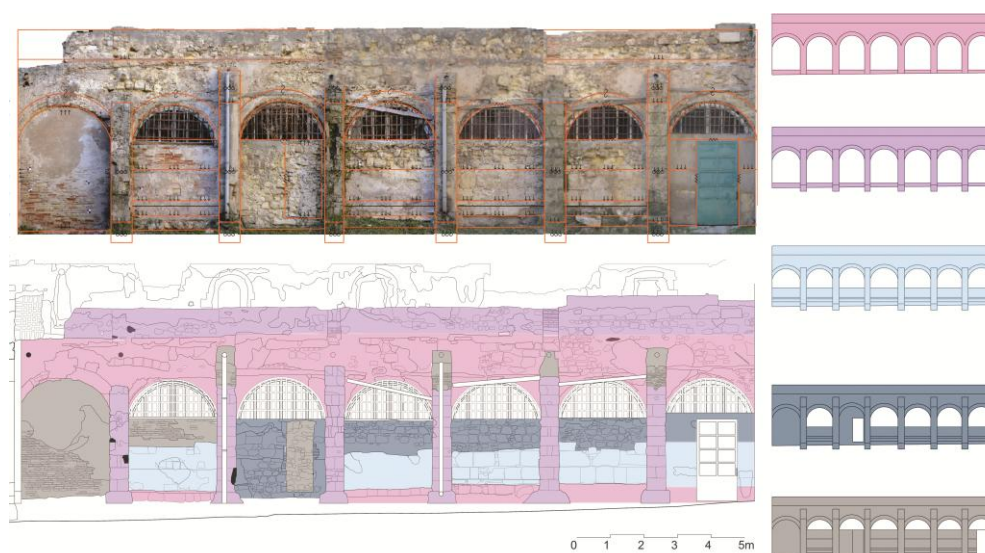
Figure 4. *The West Facade: Stratigraphic Analysis of the Structures, Dating and Transformations Hypothesis*

In detail, the stratigraphic method³ was divided into three main phases: a) identification of stratigraphic units (masonry stratigraphic units - msu; surface stratigraphic units - ssu; negative stratigraphic units - nsu); b) definition of connections between the stratigraphic units in order to establish diachronic or synchronic relationships between the parts; c) construction of a relative chronology between the same units (see Figures 4-5).

Actually, because of the lack of archival sources we could not obtain an absolute chronology, but on the basis of the relative one, it was possible to associate a temporal interval to each identified phase. Following this investigation, we were able to hypothesize that the complex was built in subsequent phases, some of them very close to each other.

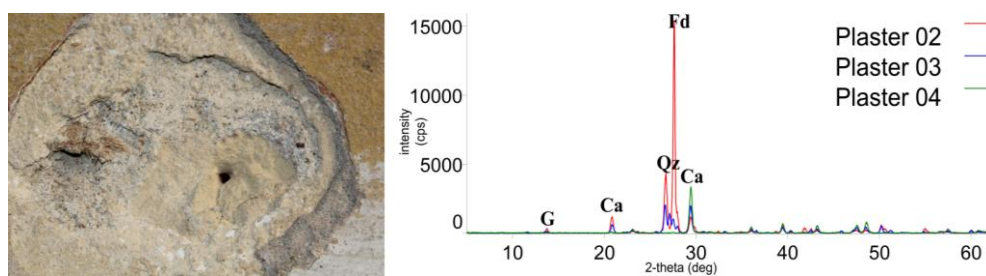
Figure 7. Sampling of the Different Layers of Plaster in the East Side, Indoor.

G: Gypsum; Ca: Calcite; Qz: Quartz; F: Feldspar

The samples of plaster 02-03-04 are successive layers in which Pl_04 is the one adhering to the masonry, Pl_02 is the outermost one, on which coating pictorial is still detectable and Pl_03 is the intermediate layer. The sample of mortar (Mo_08) was taken from the wall structure underlying these plasters, going deep in order to limit contamination.

The optical study of the aggregates and binder composition shows two types of plaster (1:pl_02-03 and 2:pl_04). Both of them consist of sandy aggregates made with a few fossil and lithic calcareous fragments with single crystal quartz grains and feldspars (see Figure 7). This composition, together with the granulometric and the morphometric characteristic of the aggregate grains are similar to those of the marine beach sand of the old city. The lime binder consists of micrite carbonates and sometimes shows a non-homogeneous texture due to the presence of lumps.

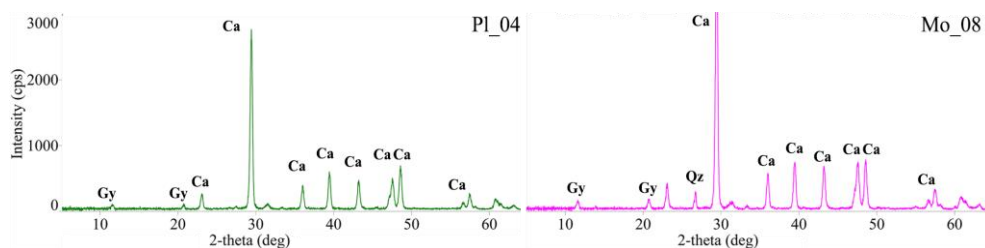
Figure 9. X-ray Diffractions of Plaster 04 (on the Left), and of Mortar 08 (on the Right). G: Gypsum; Ca: Calcite; Qz: Quartz

A comparison between diffractograms and thin sections (see Figures 8 and 9) of the three plasters show that: samples PI_2 and PI_3 have the same mineralogical composition characterized by an aggregate of quartz, feldspar, and a few organic carbonates, and lime is used as the binder for all three samples.⁵

The plaster 04, adhering to the wall is, however, very different, as emerged in the diffractogram and in the thin section: in fact, it consists mainly of lime, with a very low percentage of aggregate. The mortar joint suffered degradation with loss of material between limestone ashlar. The strong damage is mainly caused by sulfation, as testified by the presence of gypsum. The total absence of ettringite and other calcium sulfoaluminates supports the idea that the original mortar was a lime mortar. The weathering observed is associated with diffusion through the pores of the mortar and stone and it is related mainly to the deposition of sea salt accumulated in the masonry.
