OPERATIONAL METHODS FOR THE ASSESSMENT AND MANAGEMENT OF AGING INFRASTRUCTURE

Pietro Croce, Milan Holický et al.

**OPERATIONAL METHODS FOR THE ASSESSMENT
AND MANAGEMENT OF AGING INFRASTRUCTURE**

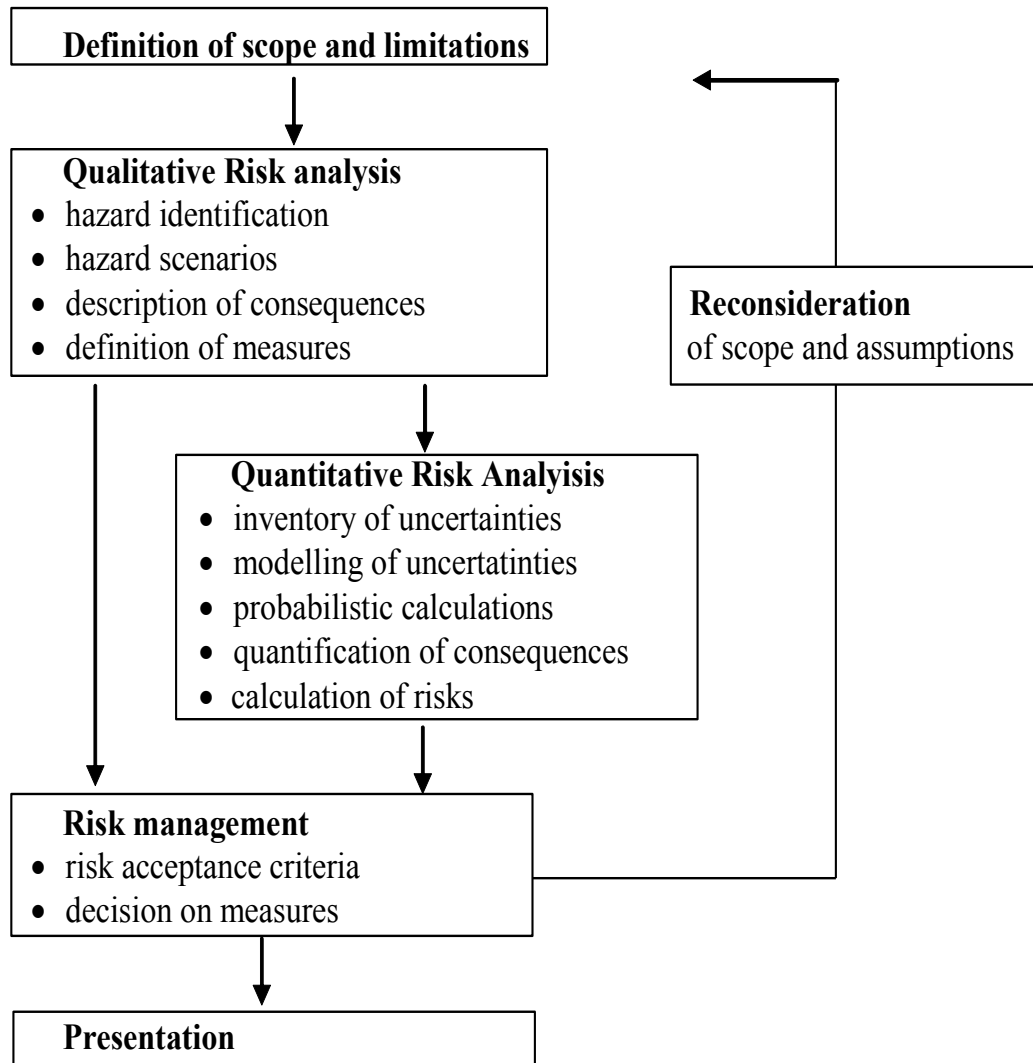
Figure 1. Risk analysis procedure as given in the Eurocodes

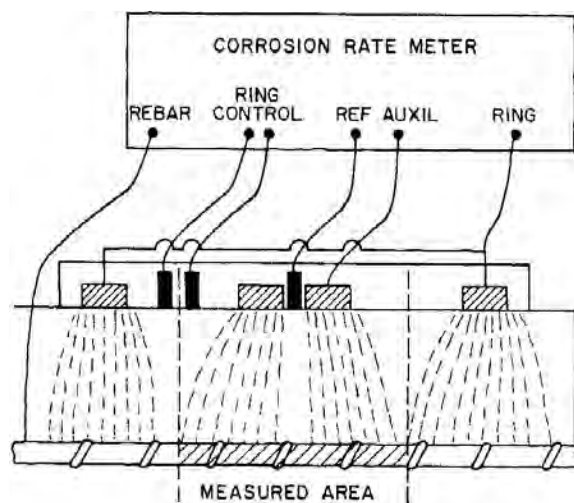
Figure 3.1 Modulated current confinement method [3]

The corrosion rate meters used must be able to accurately determine current dispersion over a given distance. That calls for applying the modulated confinement technique (controlled guard ring, see fig. 3.1) or the potential attenuation method. One of these two operating modes must be used, for otherwise an error of one or two orders of magnitude may be incurred [2].

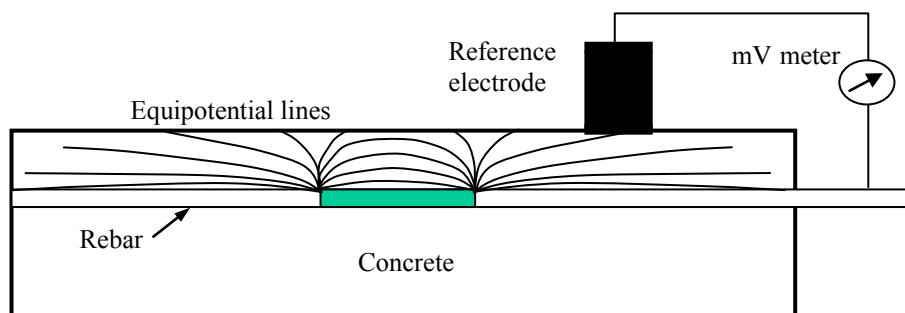
Figure 3.4 Measuring potential in concrete rebars with one reference electrode [2]

Potential measurements can be performed with a single electrode or with one or several wheel electrodes. The latter are used to check potential in structures such as large bridge decks or car park deck slabs, for they can cover up to 300 m^2 per hour when connected to microprocessor-controlled data-loggers.

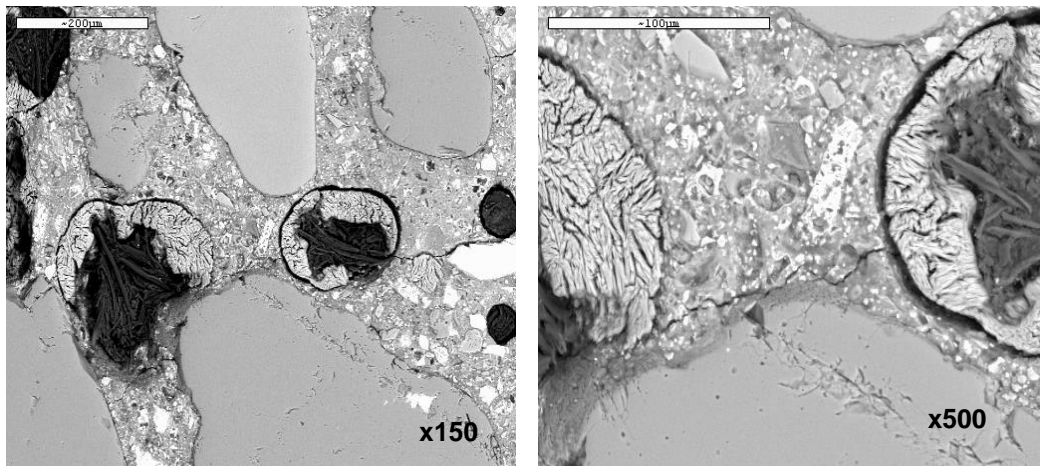
Figure 3.5 SEM images of a concrete sample. Left: ettringite induced micro-cracks (x150). Right: detailed view of ettringite formation (x500)

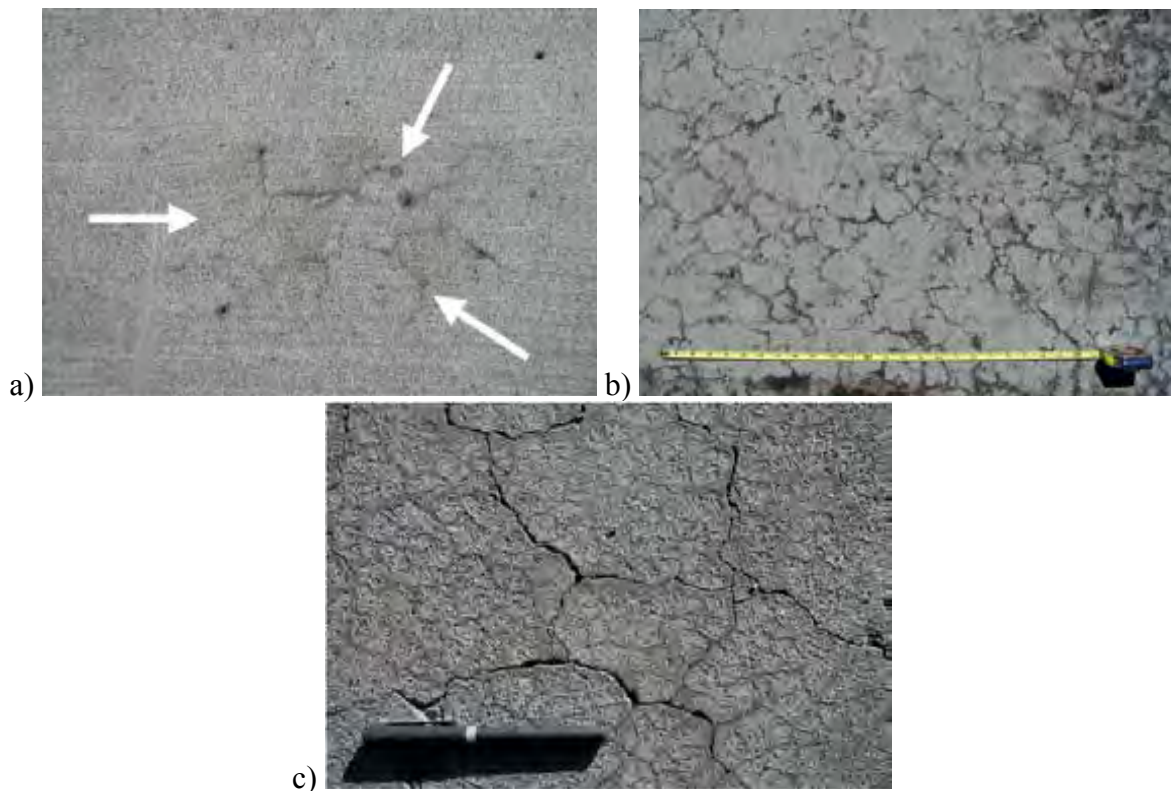
Figure 3.6 Examples of map-cracking on the concrete surface. a) Only a few cracks. b) Isolated areas of map-cracking. c) Severe map-cracking (Images taken from <http://www.faa.gov/>)

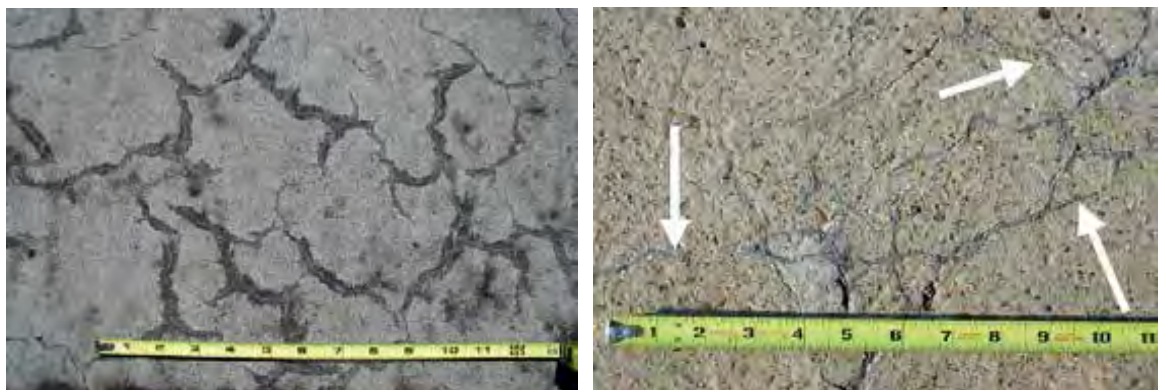
Figure 3.7 Examples of gel exudation through cracks [22]

concrete transports the AAR gel to the surface, where it exudes (see fig 3.7) [22].

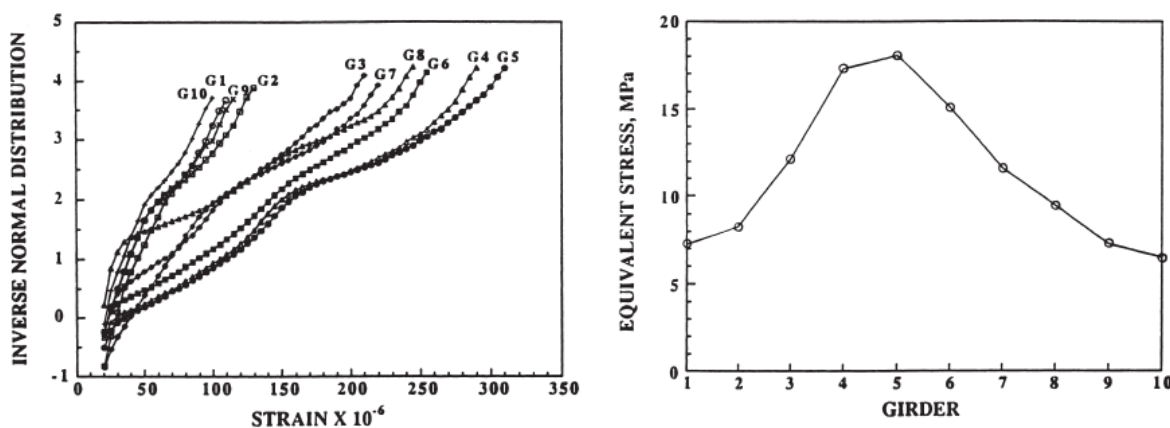
Figure 3.12 CDFs of strain (left) and the corresponding equivalent stresses (right), obtained from WIM measurements in a 10-girder steel bridge (taken from [33])

The results obtained from WIM measurements can be presented as traditional histograms or cumulative distributions functions (CDFs). Fig. 3.12 (left) [33] shows an example of CDFs of strains obtained using the WIM data from a 10-girders steel bridge and represented on the normal probability paper. The equivalent stresses, σ_{eq} , needed to find the number of cycles to failure from the $S-N$ relationship can be calculated on the basis of Miner's rule [38] and his assumption that the damage in material is accumulating in a linear way according to the applied number of load cycles. The equivalent stress values for the load spectra given in fig. 3.12 (left) are shown in fig. 3.12 (right) [33].

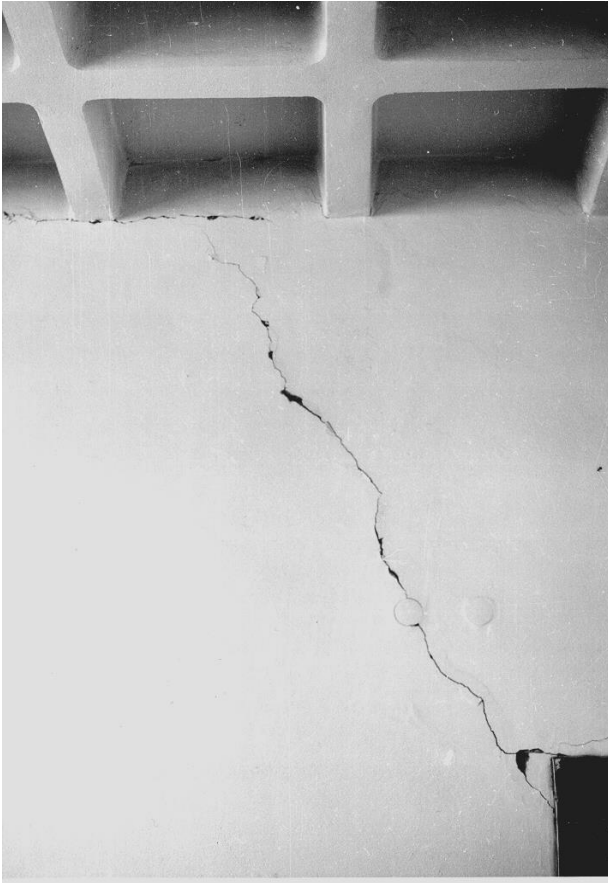
Figure 2 Partition wall

After few years in service serious performance problems concerning cladding as well as interior non-bearing structures have been observed and analysed [3,4]. The most alarming were perhaps the defects appearing in the non-bearing structures: cracks of partition walls (see Figure 2 and 3).

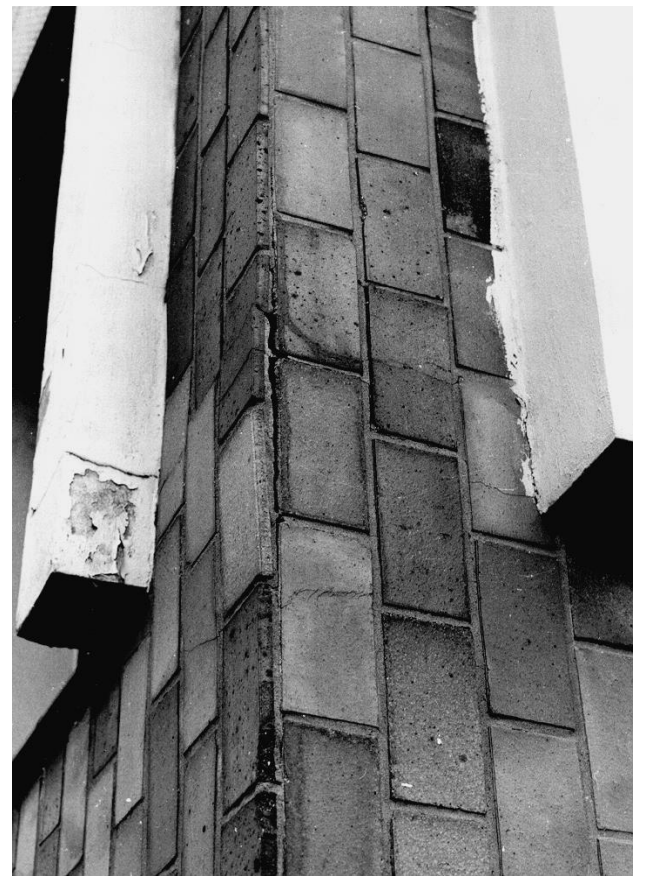
Figure 5 Façade wall

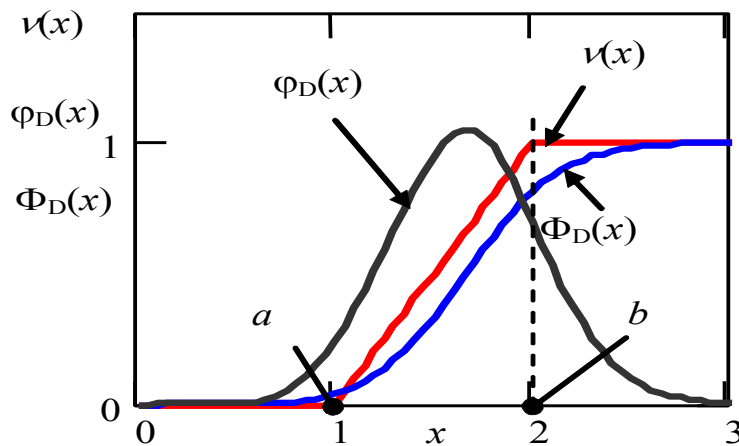
Figure 6. Perception model

Evaluation of public as well as expert assessments has indicated that there is no distinct point in any commonly used performance indicator x (e.g. deflection, crack width) that would uniquely separate acceptable and unacceptable structures. Rather there seemed to be a transition region $\langle a, b \rangle$ in which the structure gradually becomes unserviceable and the degree of caused damage $\nu(x)$ increases [4,7]. A conceivable model for $\nu(x)$ is indicated in Figure 6 as a trilinear function. Note that the values of $\nu(x)$ are within the conventional interval from 0 to 1. There is no damage below a certain lower limit value a , and full damage above the upper limit b .

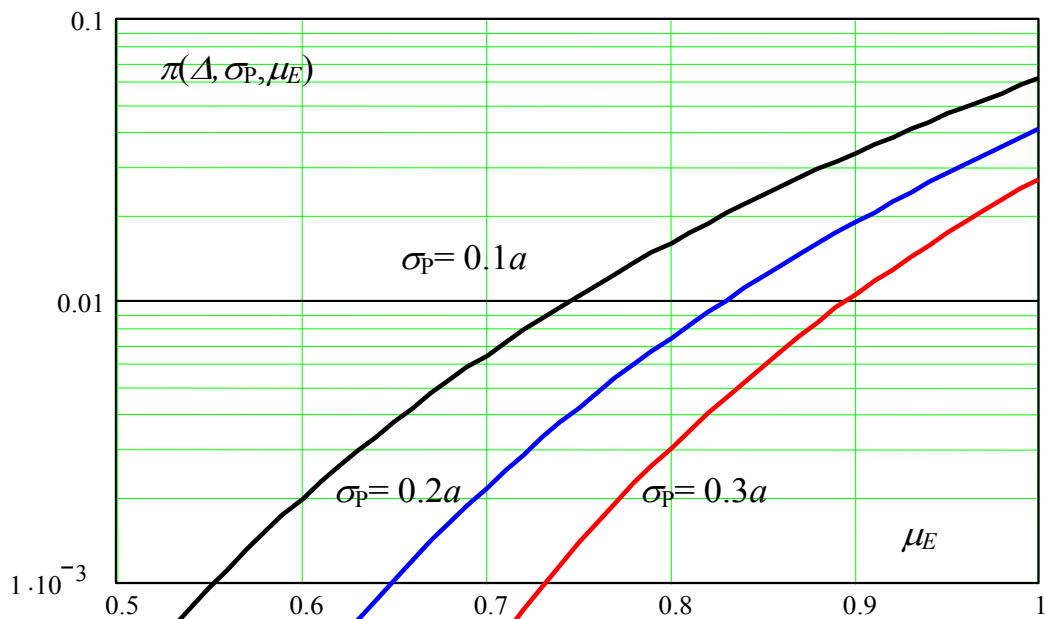
Figure 8 Perception level $\pi(\Delta, \sigma_P, \mu_E)$ for $\Delta = 1$

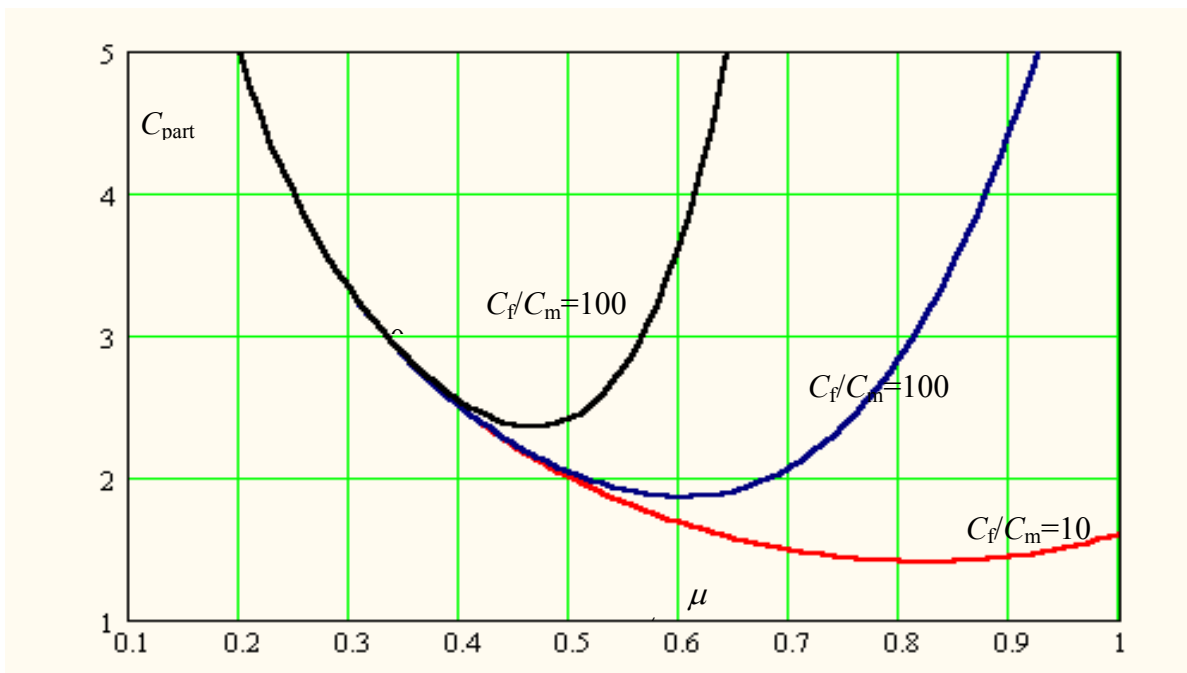
Figure 9 The partial cost C_{part} versus μ_E/a for $\Delta = (b-a)/a=1$, $\sigma_p=0.3a$, $\sigma_E=0.2\mu_E$

is the minimum, where $C_{part} = (C_{tot} - C_0)/ C_f$. Figure 9 shows the partial cost C_{part} for the following parameters: $(b-a)/a=1$, $\sigma_p=0.3a$, $\sigma_E=0.2\mu_E$.

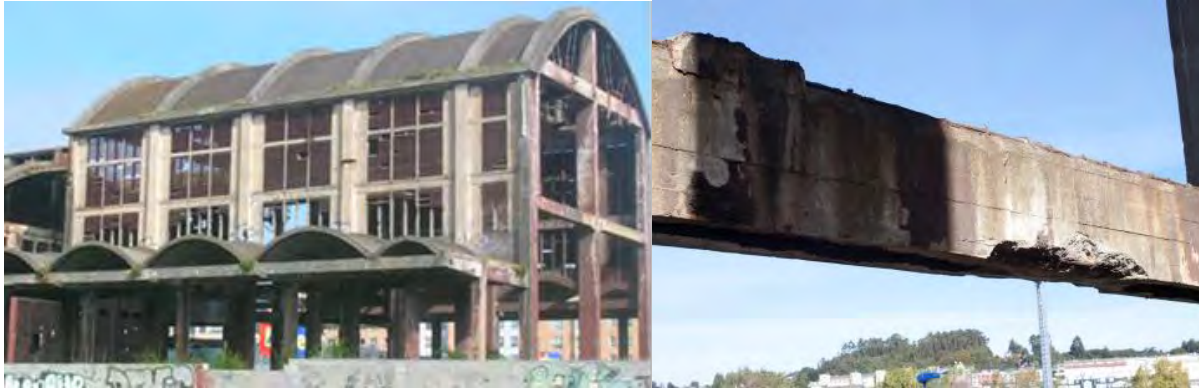
Figure 1 Existing industrial building before the transformation and one of the beams affected by corrosion

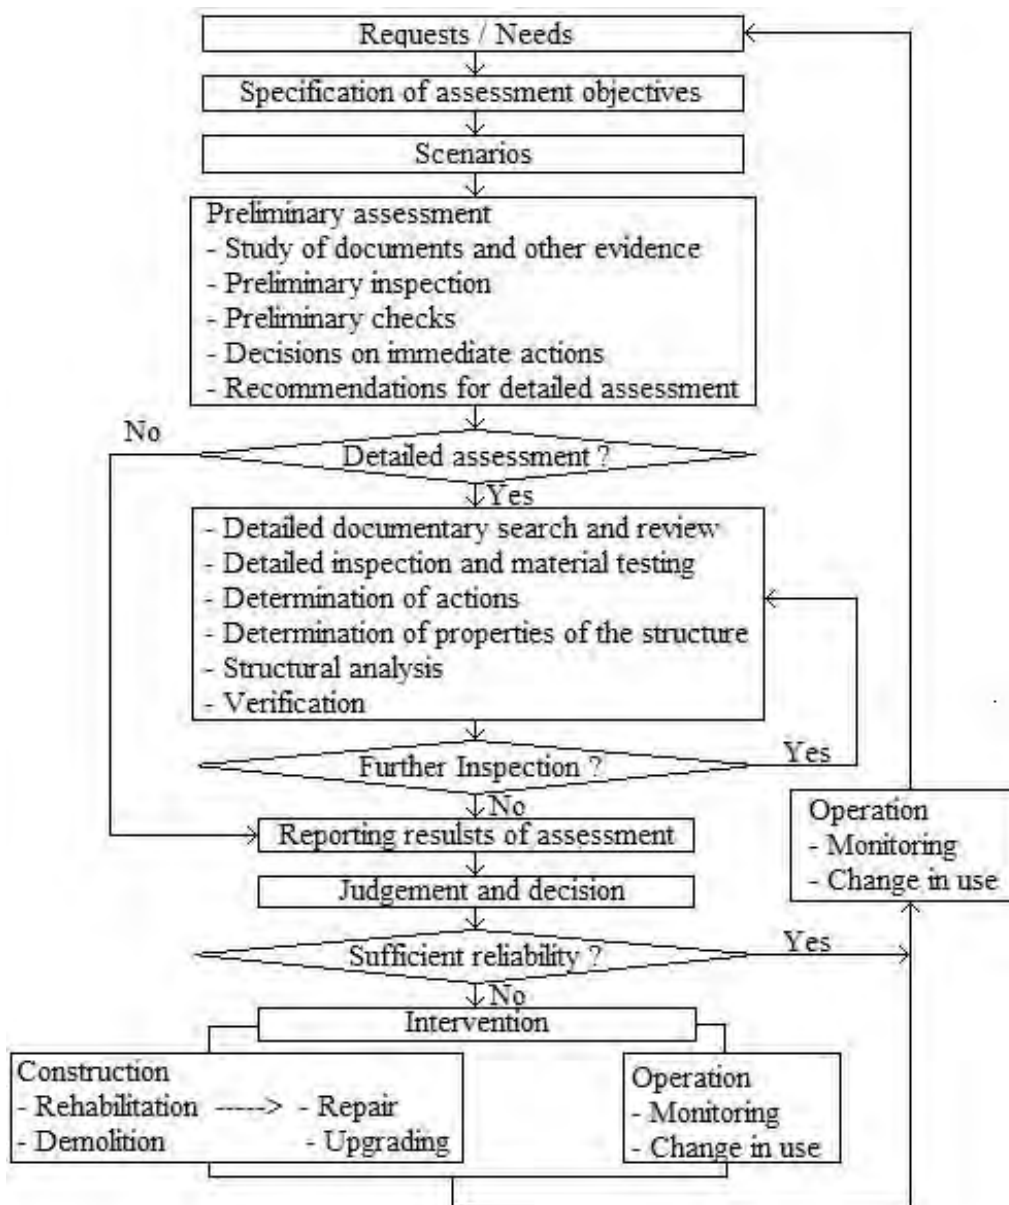
Figure 1 Flow chart of the ISO 13822

As recommended in [5], the study has been setup following the standardized procedure of the ISO 13822 [1], which is aimed to the evaluation of the actual reliability of a structure, through a preliminary assessment and, if necessary, a detailed assessment, organized in accordance with the step-by-step procedure outlined in the flow chart shown in figure 1.

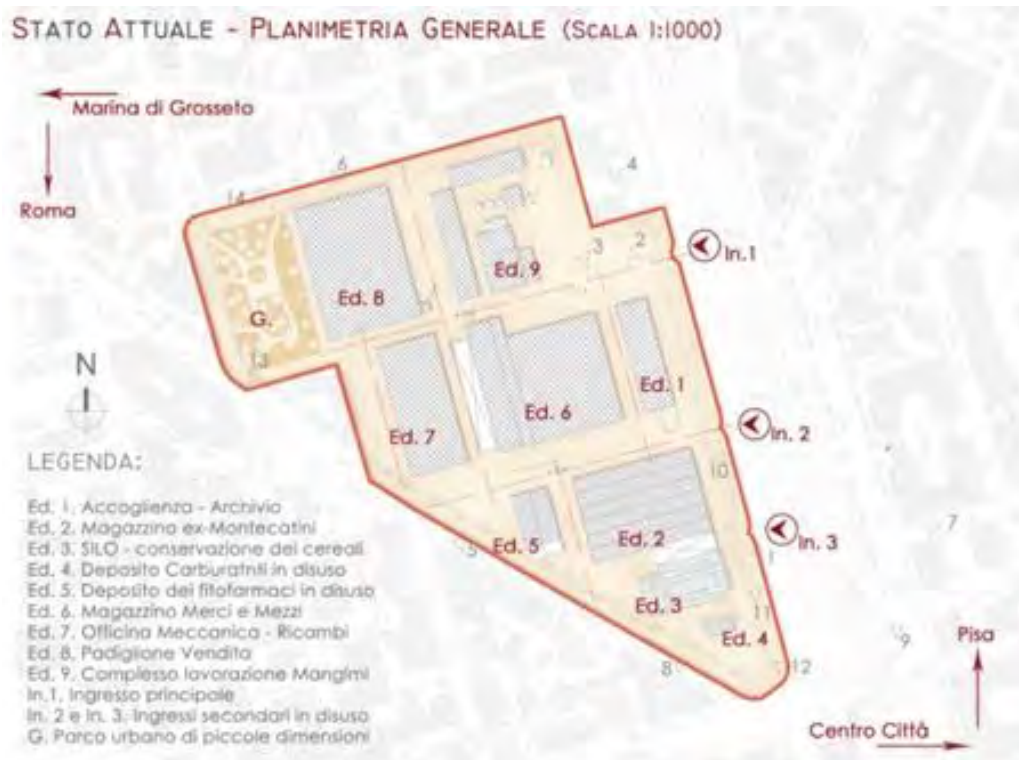
Figure 5 Plan of the silo

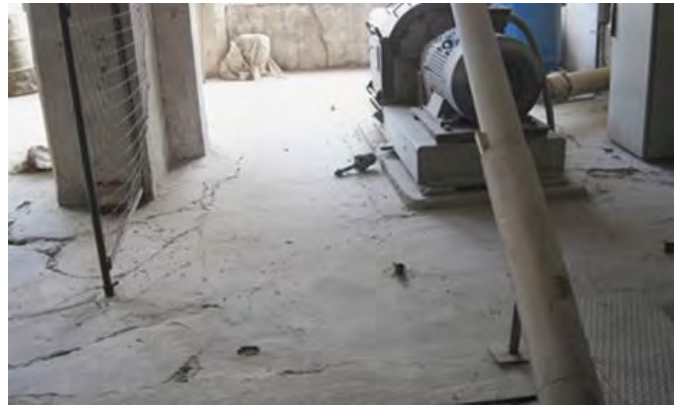
Picture 8: Detail of the flooring. Presence of several patina and relevant not cross cracks

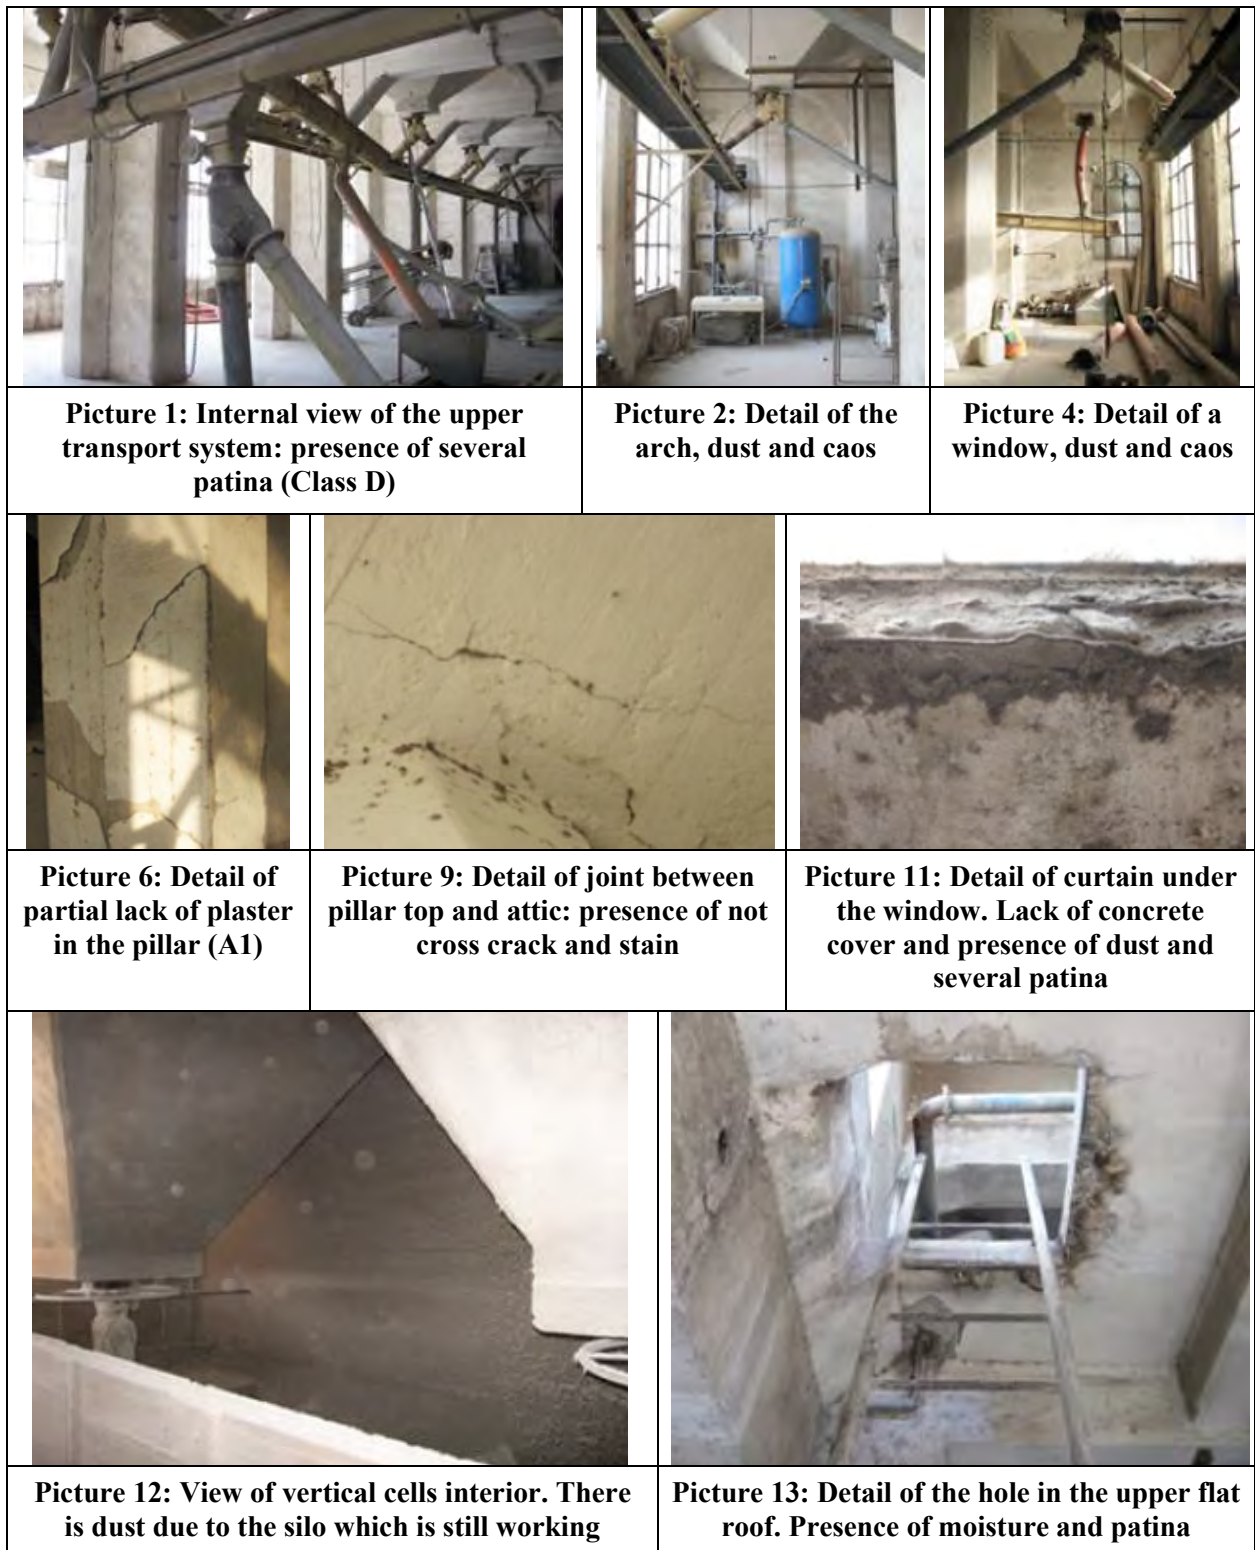
Figure 16 Photo gallery: longitudinal section BB' (with reference to Fig. 15)

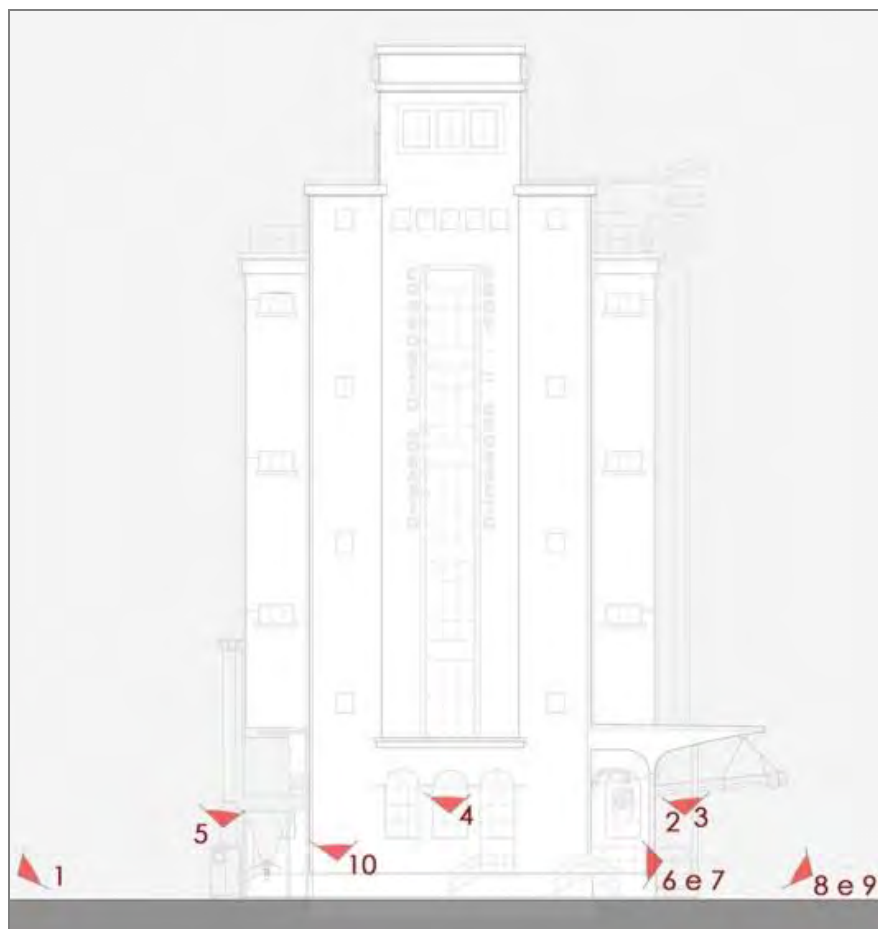
Figure 19 Example of decay survey: the main façade

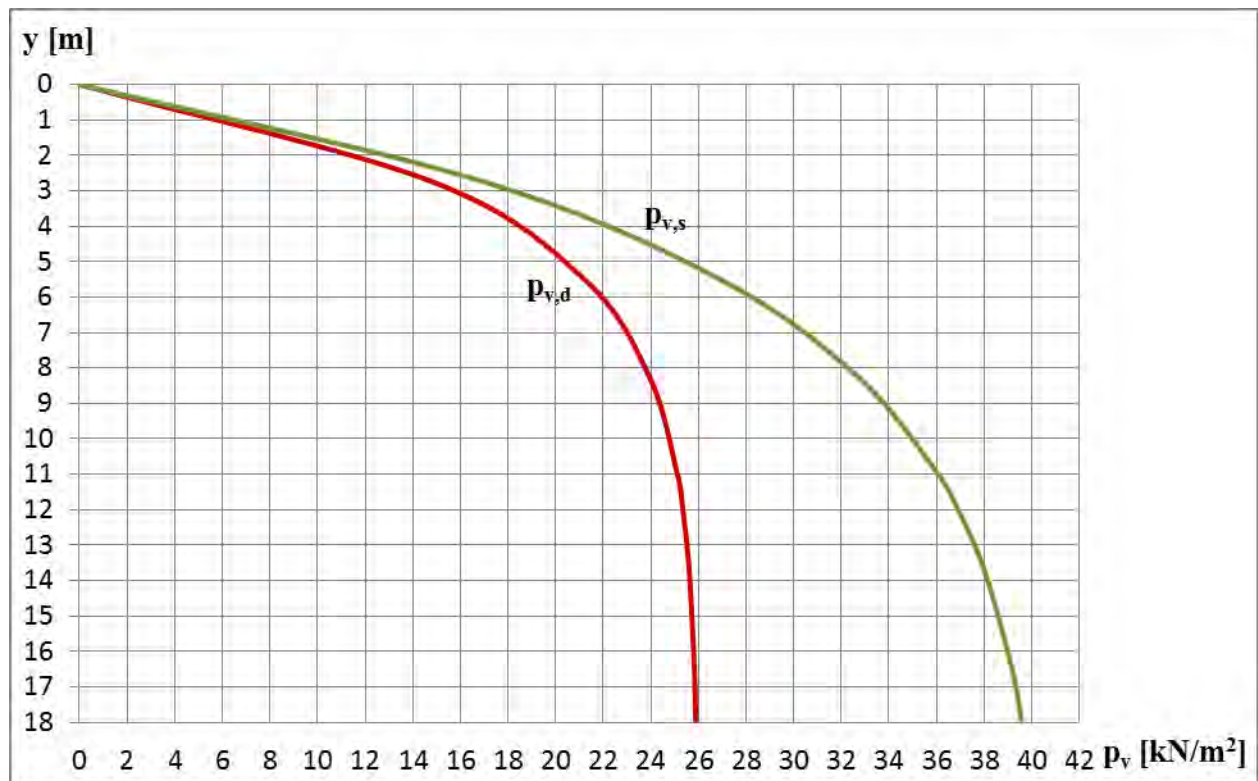
Figure 22 Actual vertical pressure diagram along the height of the cell

In figs. 22, 23, the diagrams of p_v and p_o for the single cell of the case study, both in the static and in the dynamic condition. In Annex A the evaluation of the pressures is illustrated.

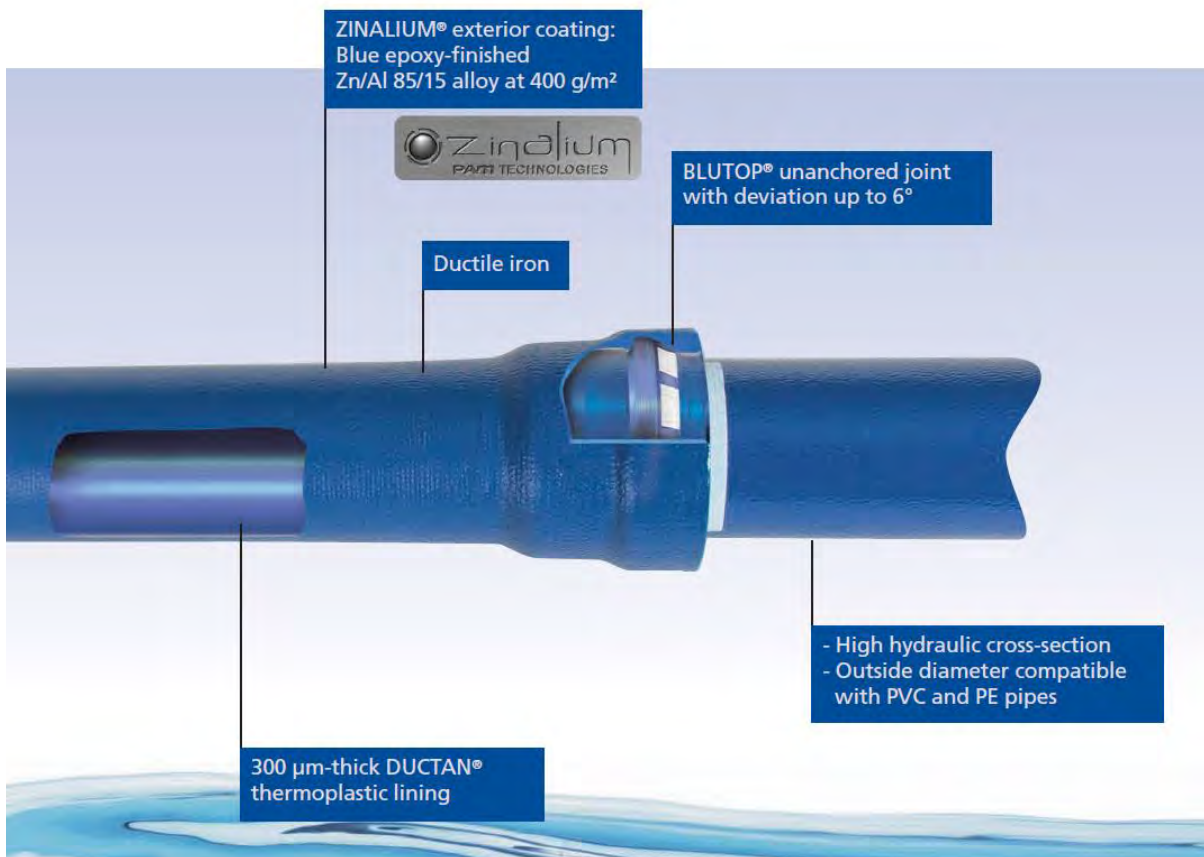
b) The Saint-Gobain PAM BLUTOP® jointing

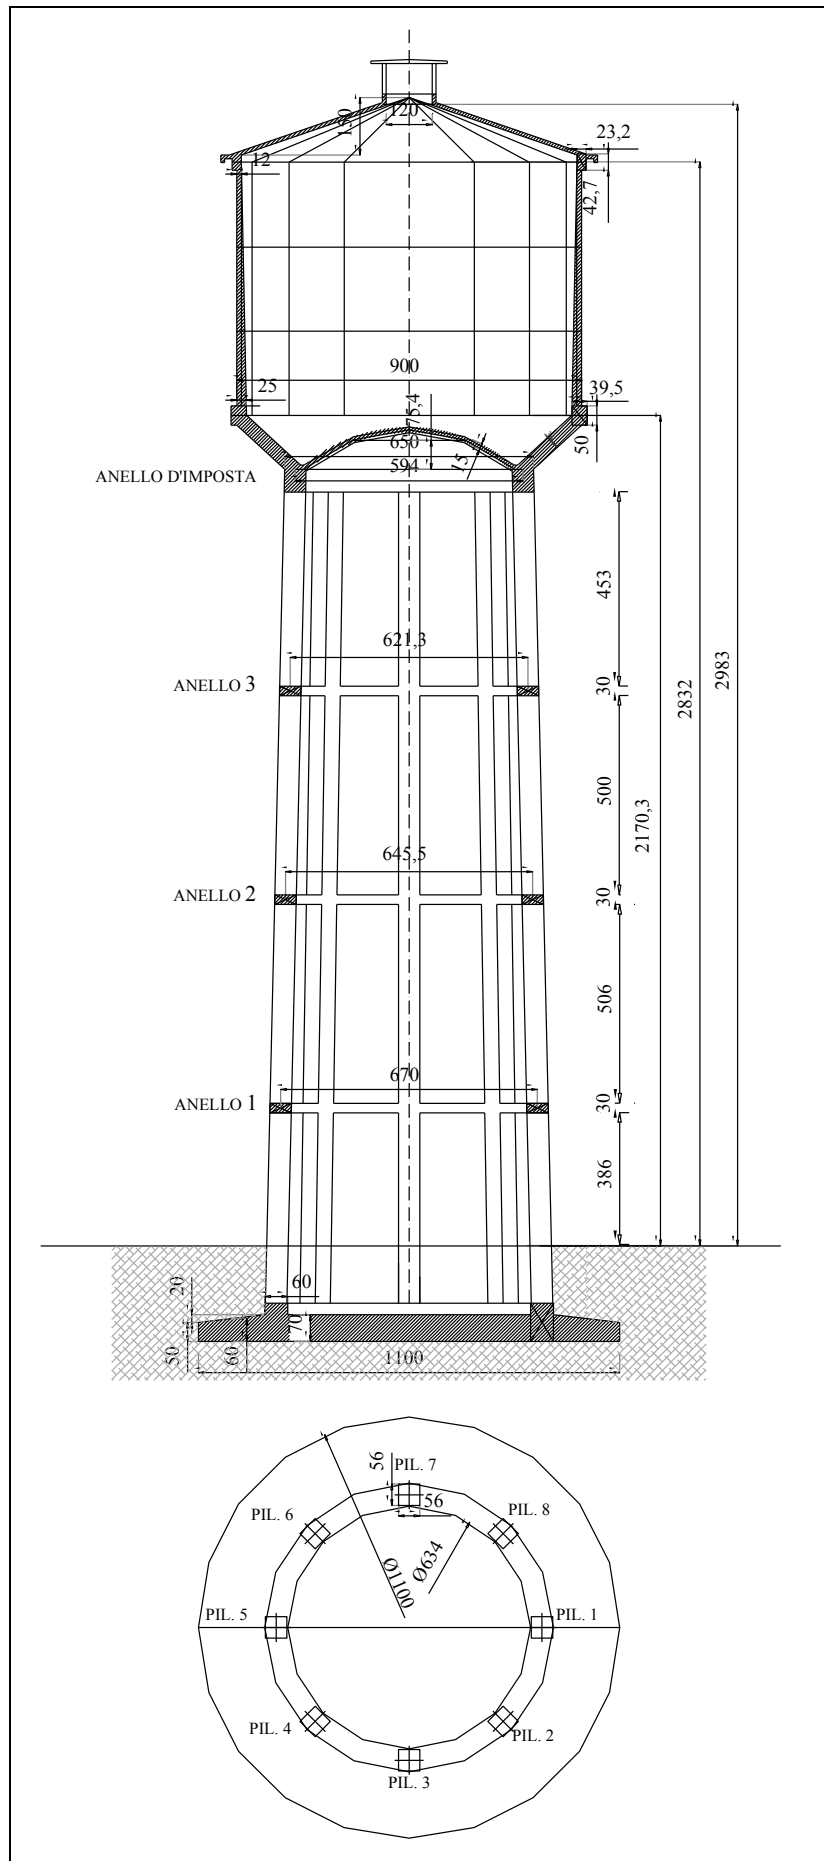
Figure 2 Sketch of the r.c. tank structure

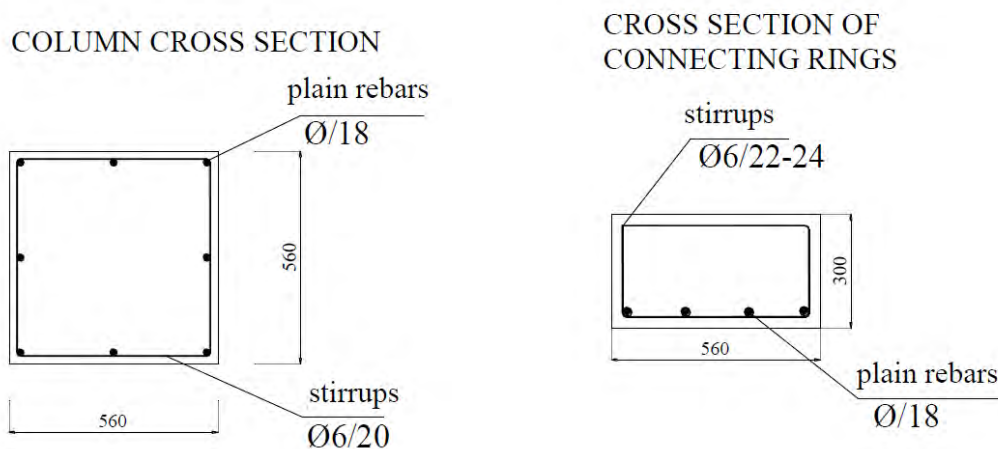
Figure 3 Details of structural elements

The reinforcement of the columns was formed, for the whole height, by 8 plain bars, 18 mm diameter; the overlapping joints of rebars were located at mid-height between the rings, while the stirrups are 6 mm plain bars at about 20 cm spacing. In the connecting rings, it was possible to detect only the reinforcement of the lower face, which was consisted of 4 longitudinal bars $\text{Ø}18$ and 6 mm stirrups, spaced 22-24 cm (see fig. 3).

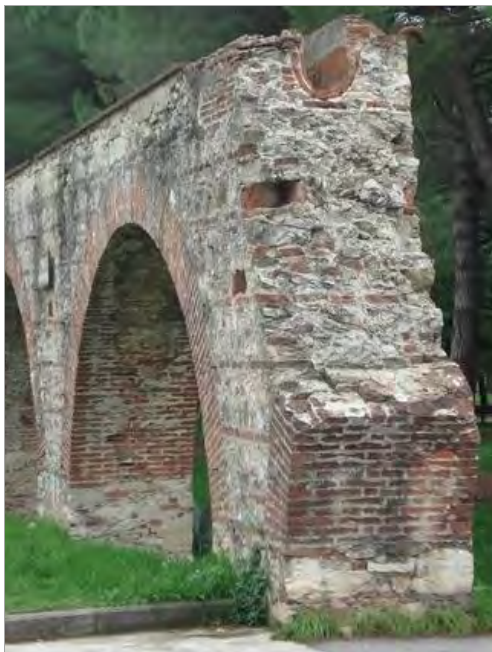
Figure 8 Arch nr. 58, where the core structure and the clay pipeline are visible

As said, the clay pipeline (fig. 8), with a semi-elliptical section, runs over the arches, covered by a sheet of stone (fig. 9) with protecting function. Nowadays, in the most degraded sections, the sheets of stone are no more in place.

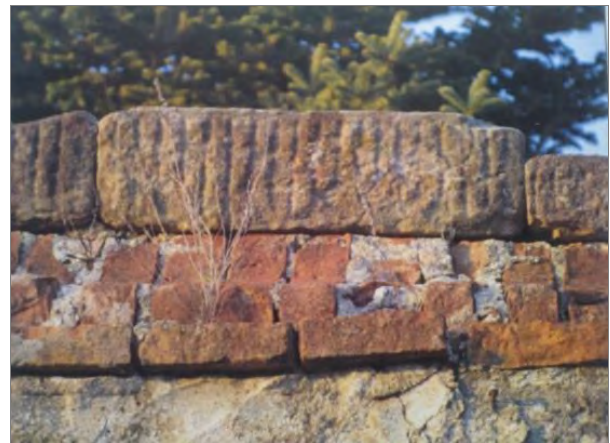
Figure 9 The sheet of stone that covers pipeline

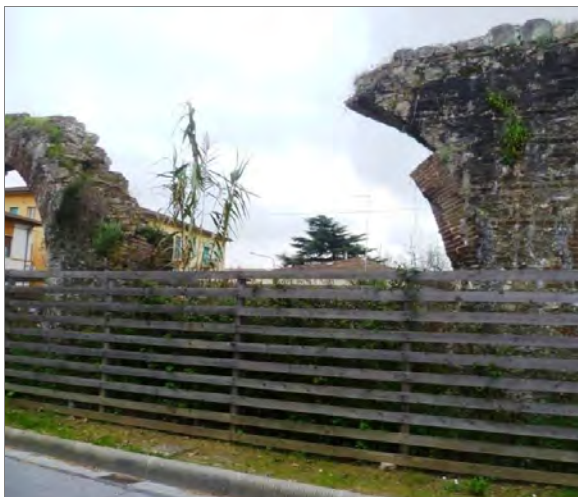
Figure 21 Arch nr. 99, collapsed

Nowadays, the observation of the work shows that it is in very critical condition: some arches are collapsed (fig. 21), other are damaged by vehicles impacts (fig. 22); many of them present various decay phenomena: the most evident are cross cracks and organic patinas, such as moisture stains or efflorescence. Over the years some elements, more probably those made almost exclusively in bricks, have been completely or partially rebuilt (figs. 23, 24).

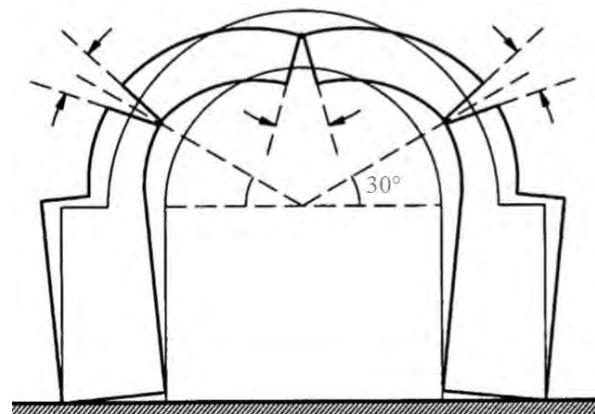
Figure 30 Mascheroni’s flexural failure mechanism of the arch

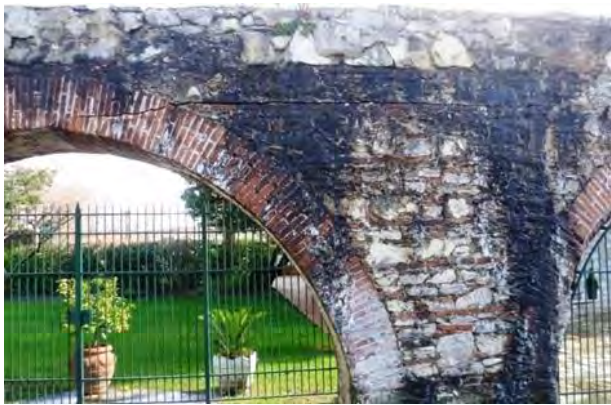
Arch n. 16, 17 – Side A
Vertical settlement appearing by a crack in the backfill, extended to arch's brick

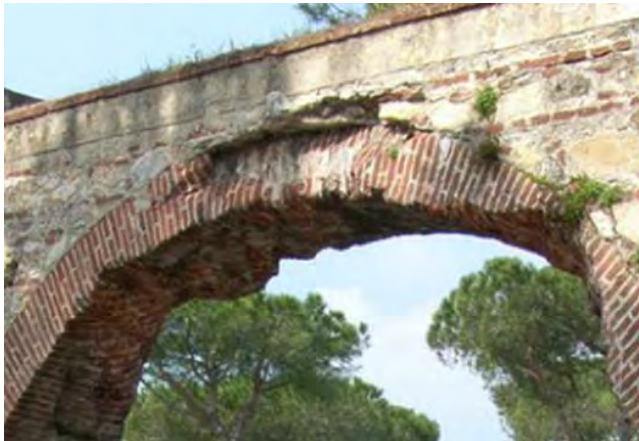
Arch n. 163 – Side A
Deterioration of arch's bricks at the extrados and intrados, caused by lorry impact

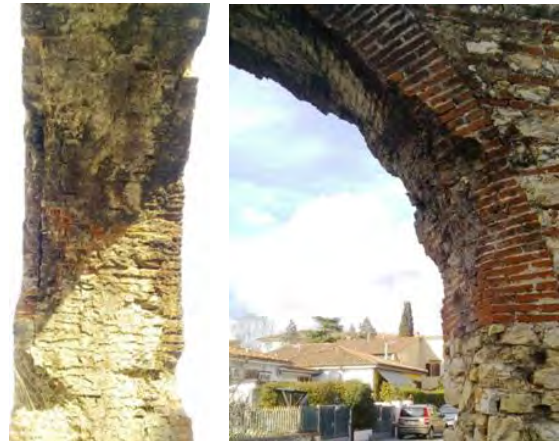
Arch n. 163 – Side A
Deterioration at the intrados of the arch and deterioration of the façade of the arch

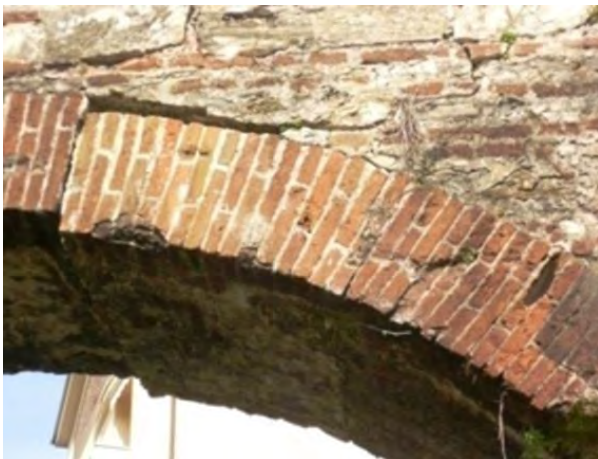
Arch n. 101 – Side A
Relative displacement in the mortar joint plane

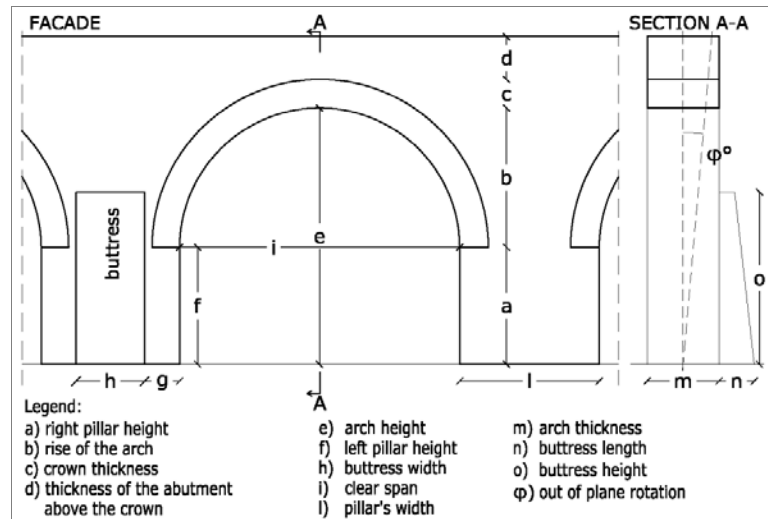
Figure 41 Arch survey form

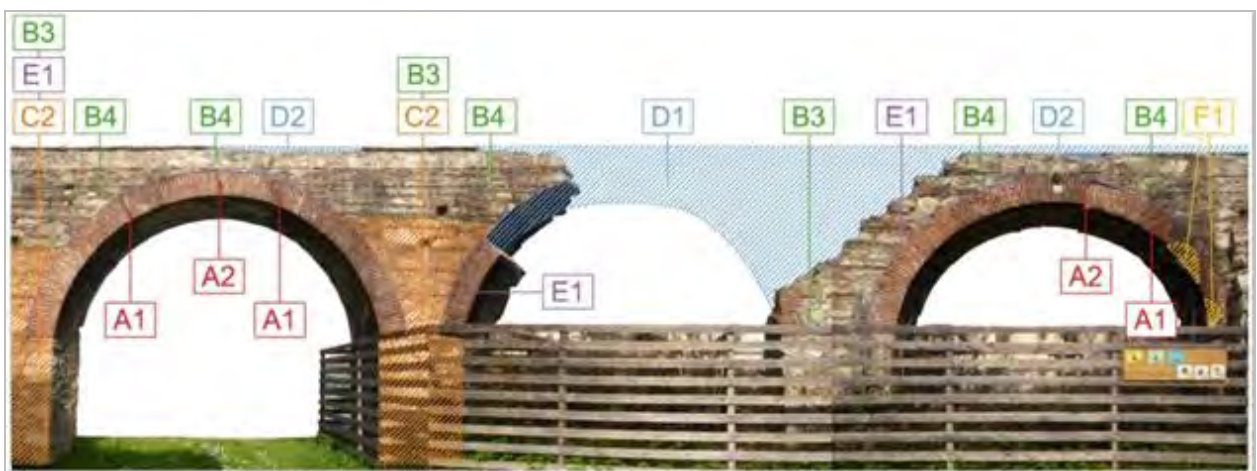
Figure 44 Crack pattern of arches n. 98, 99 and 100 – side B

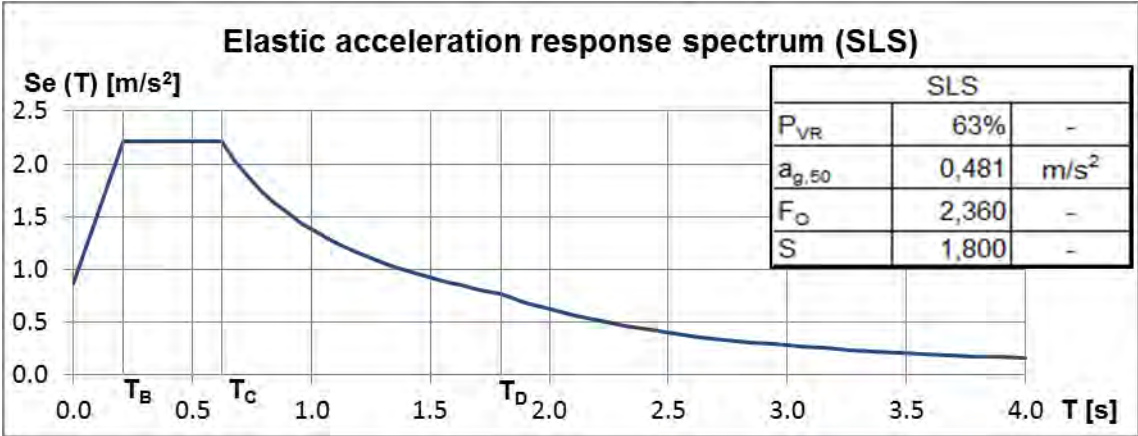
Figure 47 Elastic response spectrum of the horizontal component of the acceleration at SLS

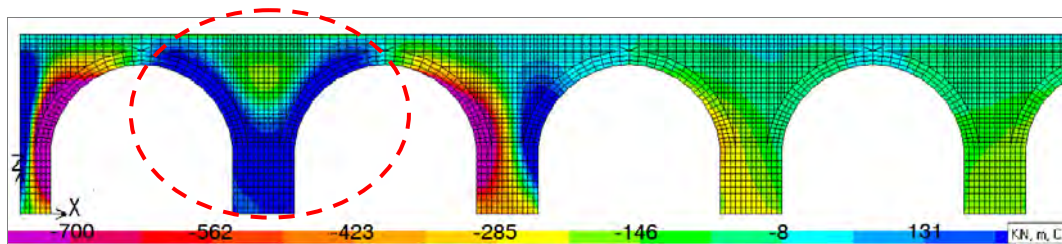
Figure 52 Level of stress, on the shells positive face, along Z direction, self-weight + vertical settlement of 30 mm applied at the foot of the highlighted pillar (values expressed in kN/m^2)

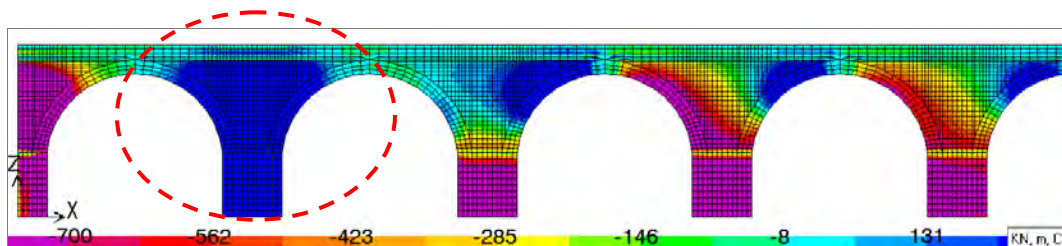
Figure 53 Level of stress, on the shells positive face, along Z direction, self-weight + out-of-plane rotation of 4° applied at the foot of the highlighted pillar (values expressed in kN/m^2)

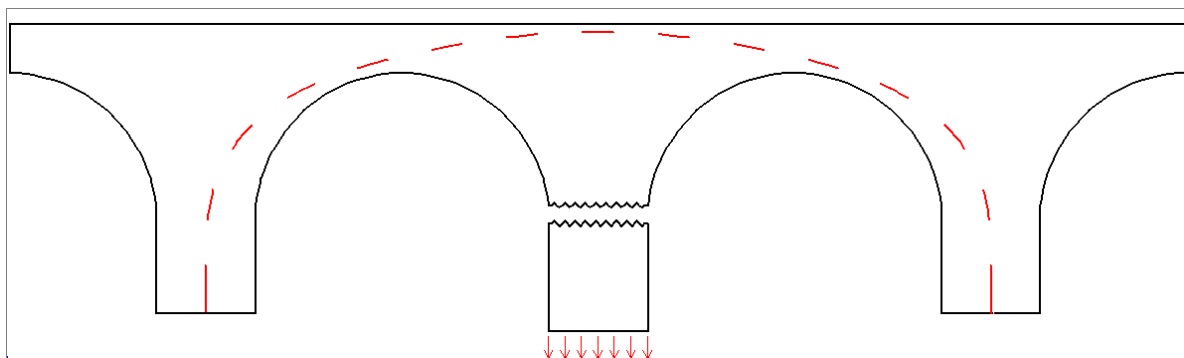
Figure 54 Probable formation of a new mechanism due to the vertical settlement of a pillar
