OPERATIONAL METHODS FOR THE ASSESSMENT AND MANAGEMENT OF AGING INFRASTRUCTURE

Pietro Croce, Milan Holický et al.

**OPERATIONAL METHODS FOR THE ASSESSMENT
AND MANAGEMENT OF AGING INFRASTRUCTURE**

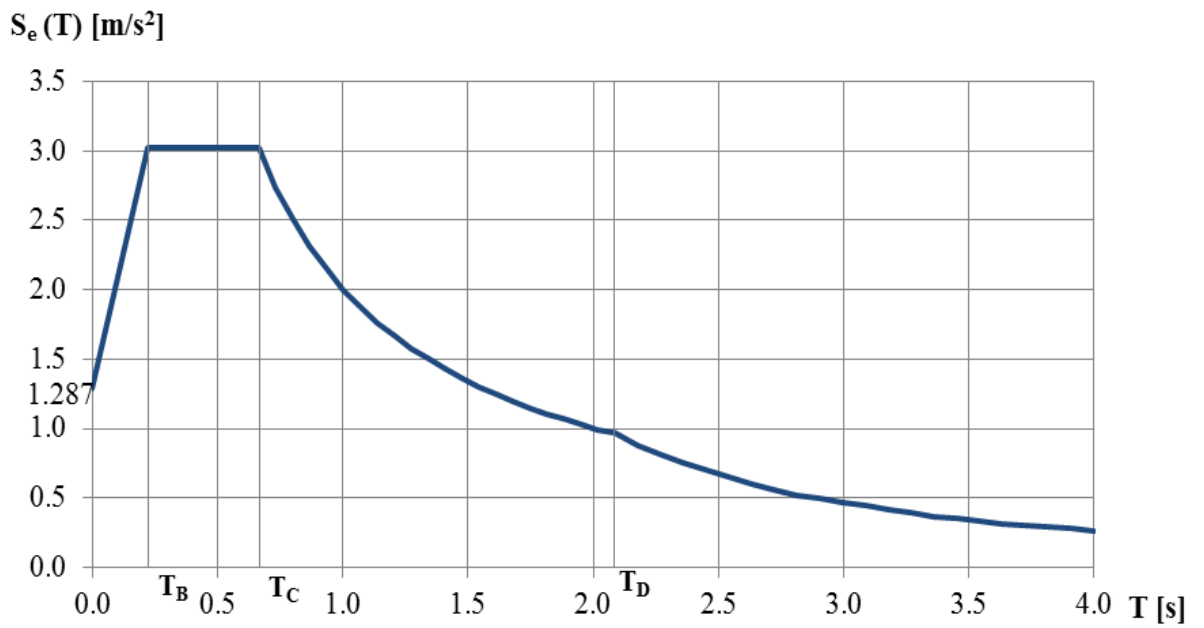
Figure 58 Reduced acceleration response spectrum

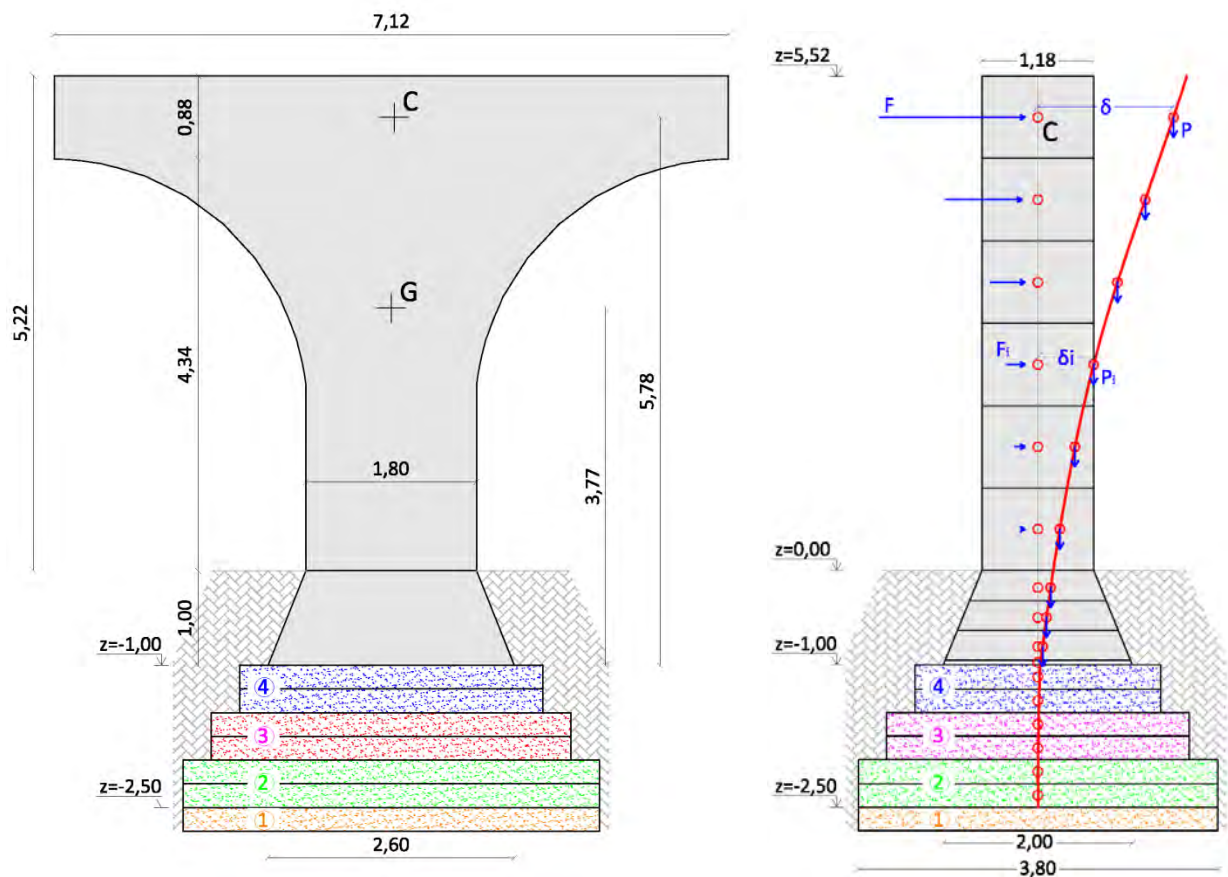
Figure 59 The system element+foundation+soil, modelled as a series of overlapped layers

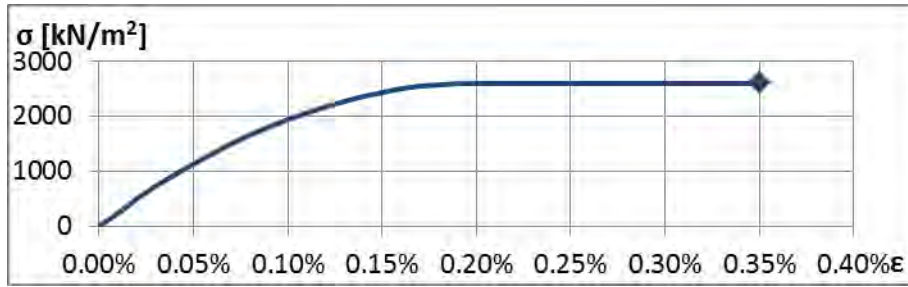
Figure 60 Stress-deformation diagram for masonry

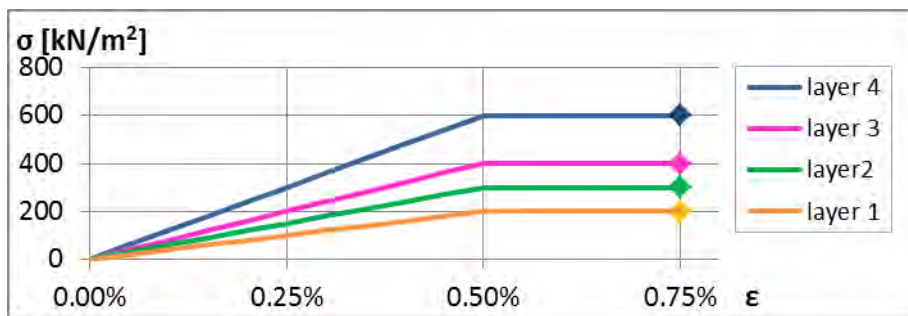
Figure 61 Stress-deformation diagrams for the 4 layers of soil at different depths

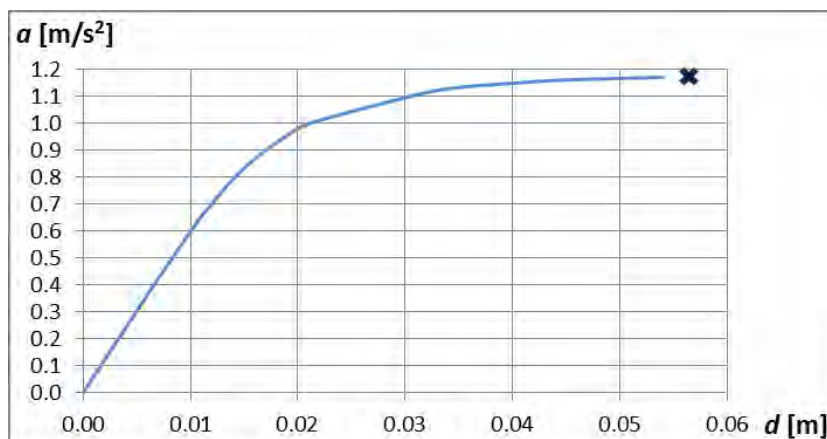
Figure 62 Capacity curve

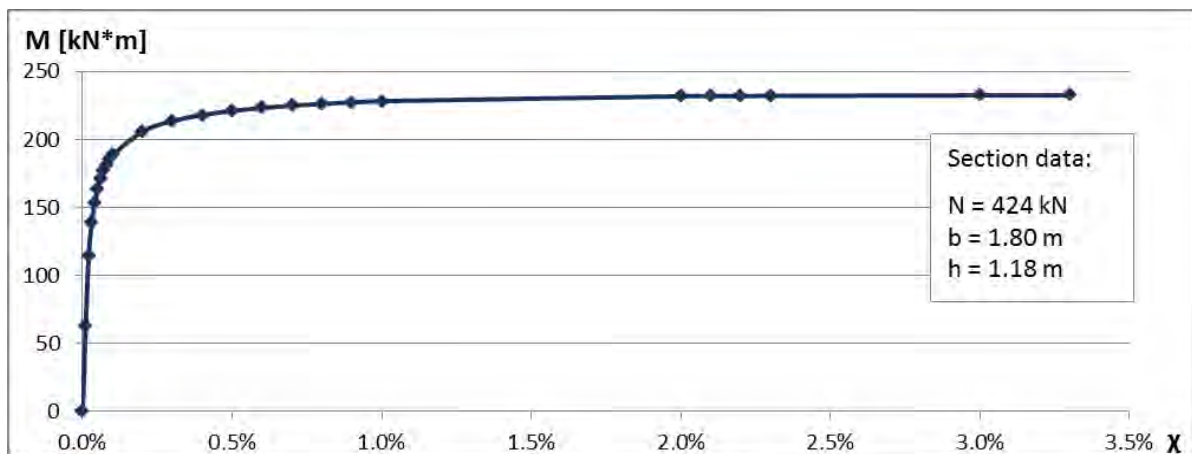
Figure E.1 Moment-curvature diagram corresponding to masonry section n°10

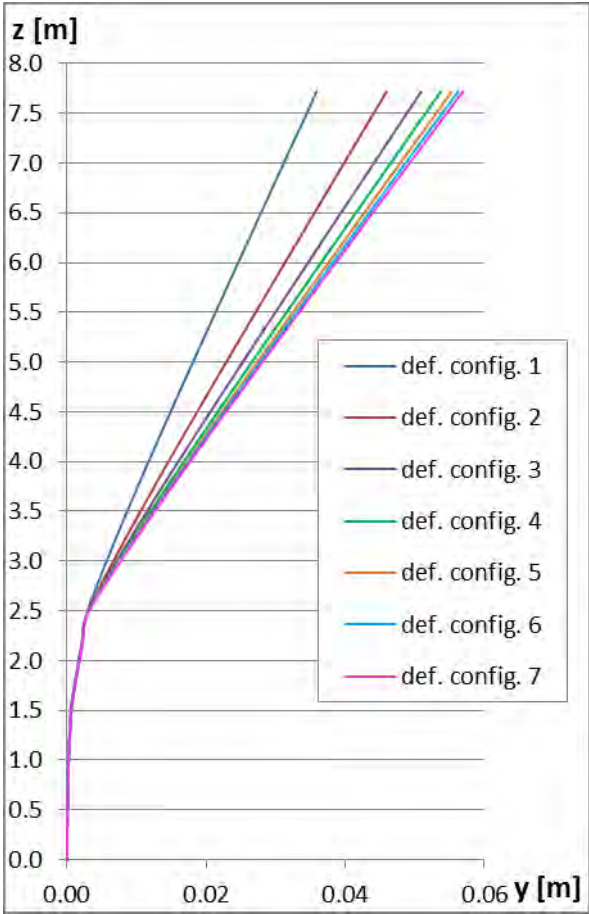
Figure E.2 Deformed configurations at each step for $a = 1,17 \text{ m/s}^2$

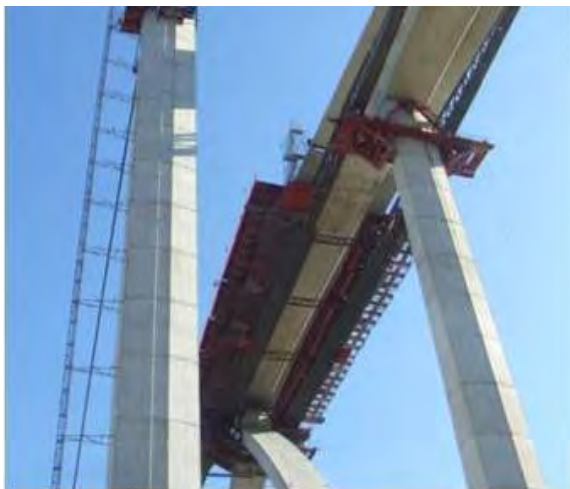
Figure 6 Position of the formwork before the accident

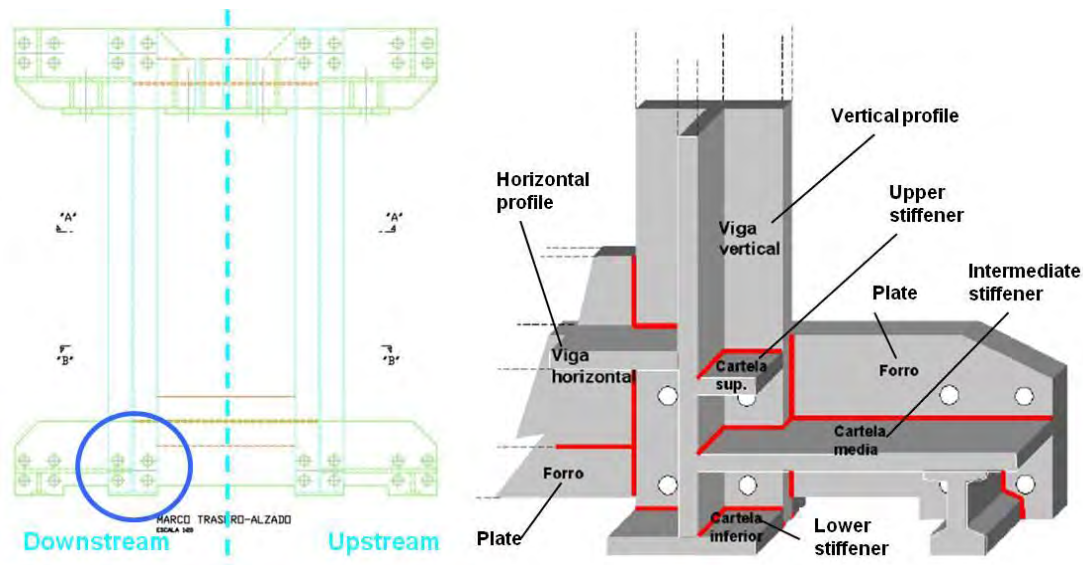
Figure 9 Position of critical joint in the connection frame (left); drawing of frame [6] (right)

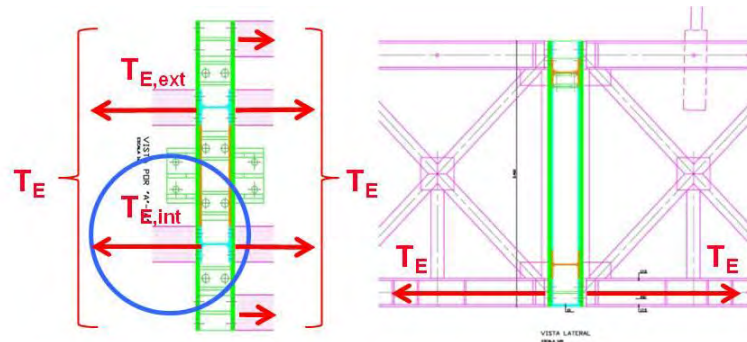
Figure 10 Tensile force transfer at the connection frame (left: plan view, right: elevation)

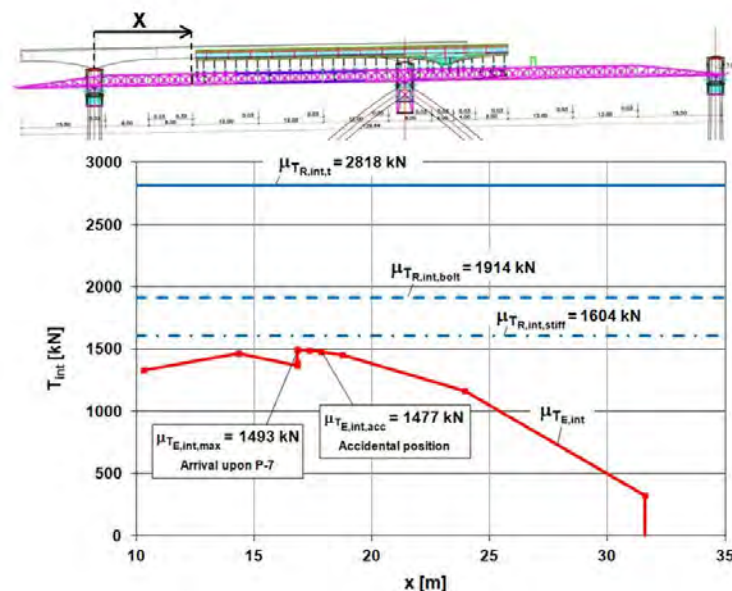
Figure 11 Variations in the expected action effects and resistance values at the critical joint

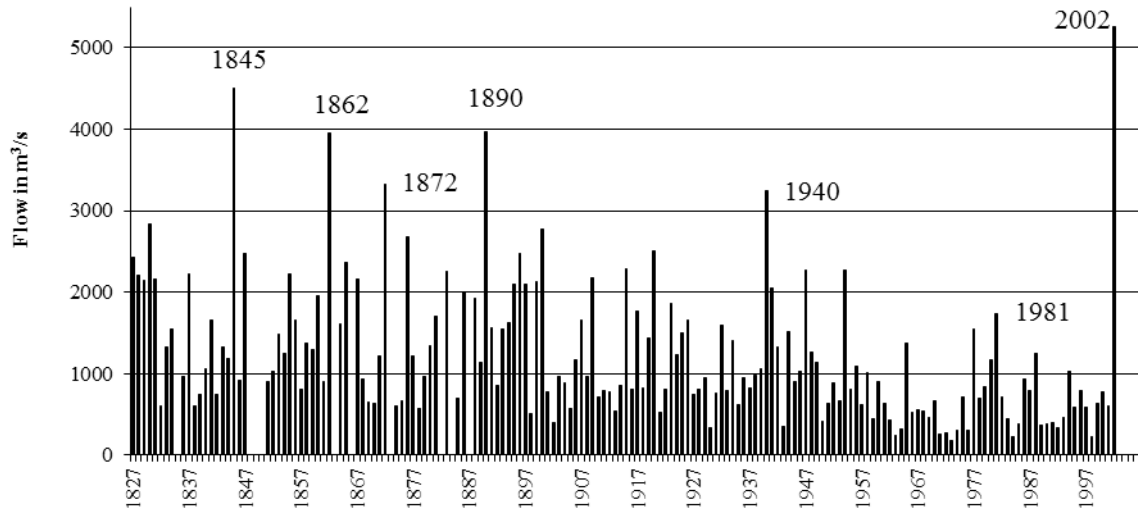
Figure 3 Annual maximum flows of the Vltava River in Prague

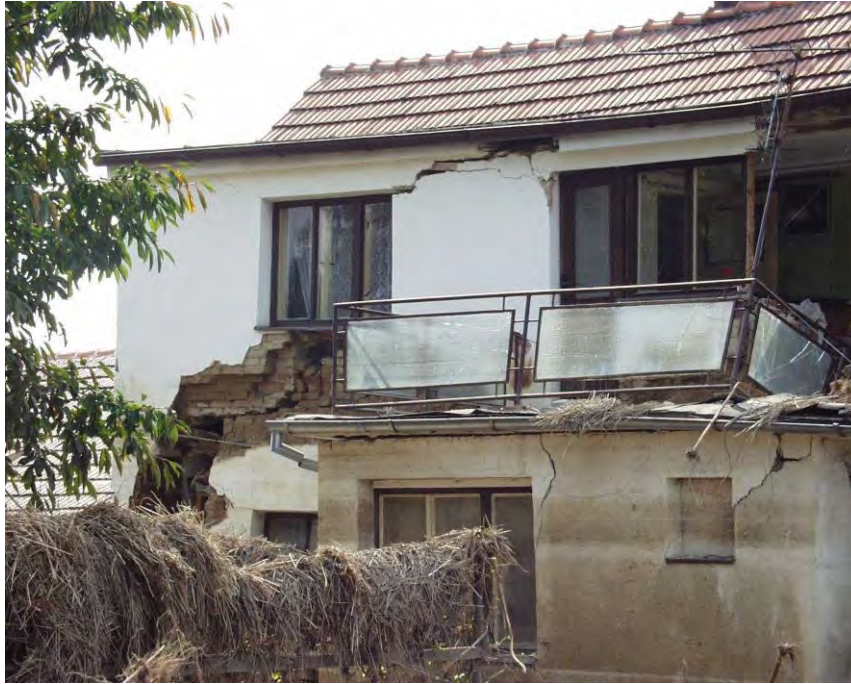
Figure 5 Damaged residential house with insufficient foundation.

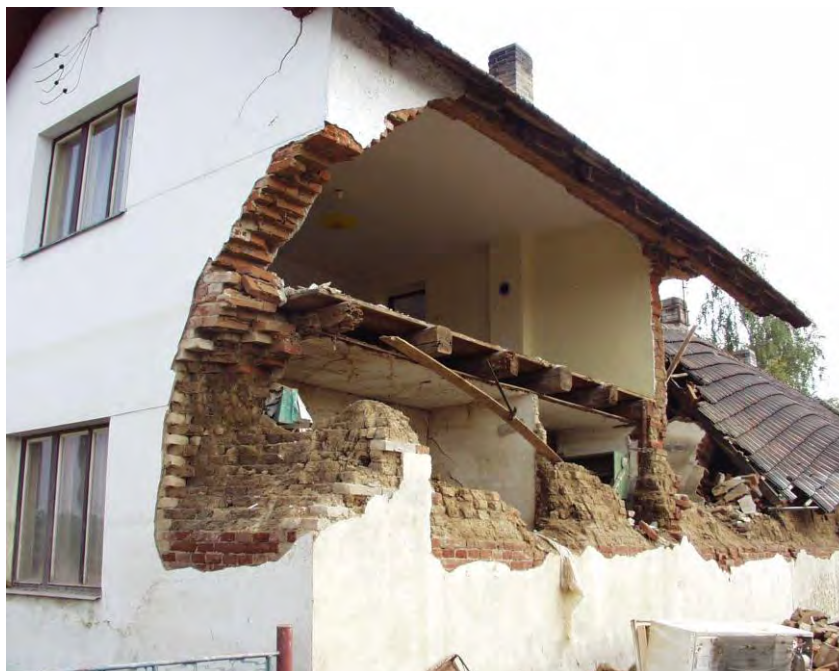
Figure 6 Partial collapse of a residential house without ring beams.

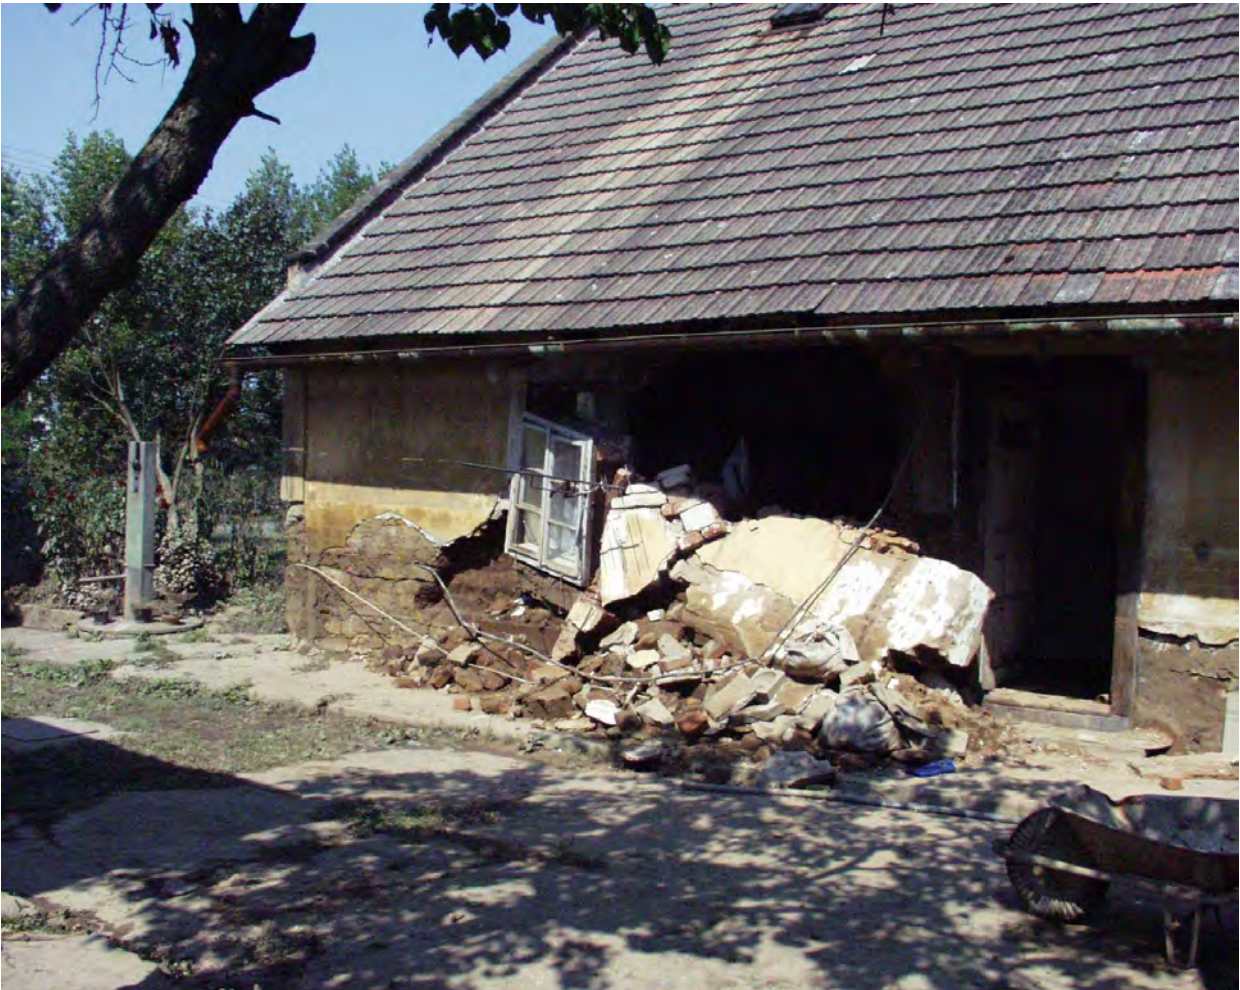
Figure 7 Failure of a structure with unfired masonry units.
