## NUMERICAL MODELLING, ANALYSIS AND RETROFIT OF THE HISTORICAL MASONRY BUILDING “LA SAPIENZA”

S. Caprili<sup>1</sup>, F. Mangini<sup>1</sup> and W. Salvatore<sup>1</sup>

<sup>1</sup> Department of Civil and Industrial Engineering, University of Pisa  
Largo L. Lazzarino 1, 56122 Pisa, Italy

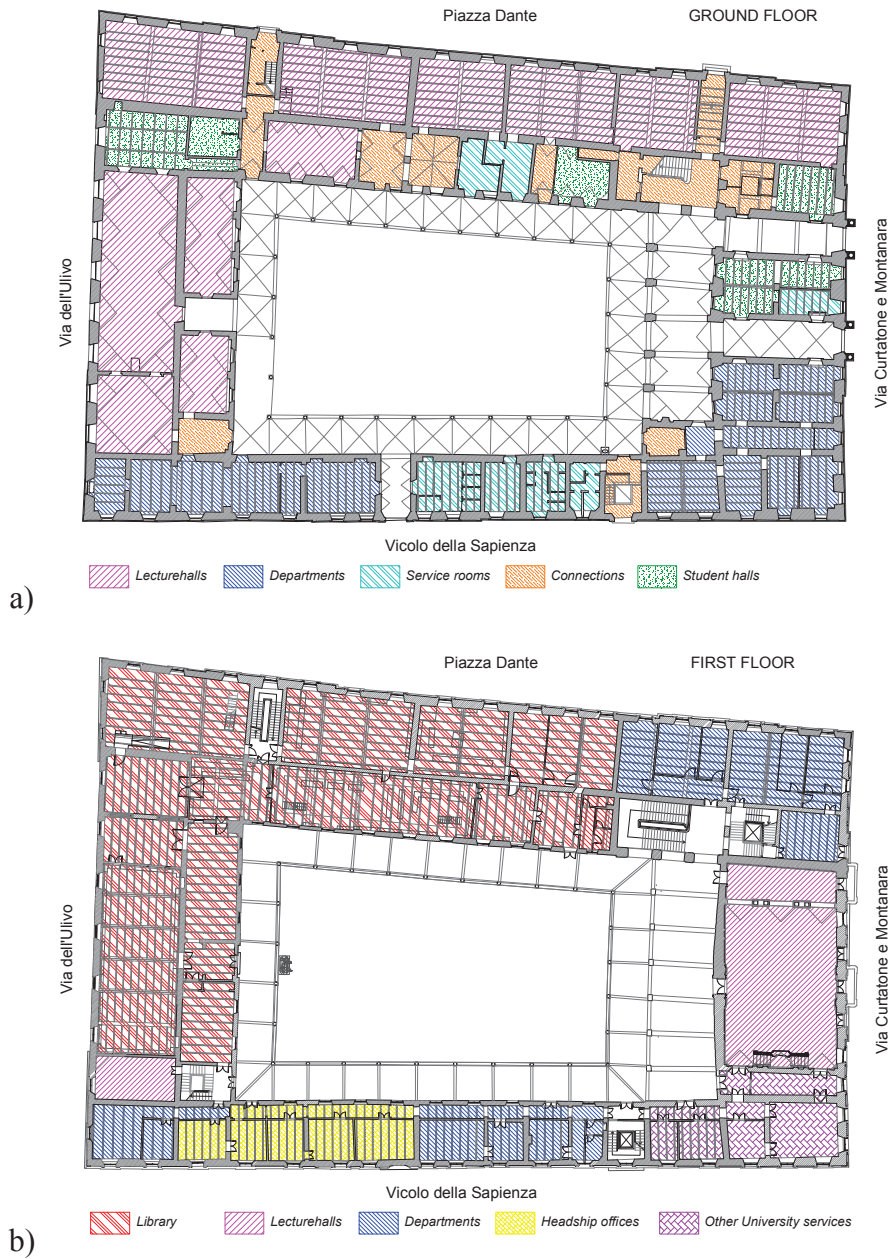
Figure 3: Plans of a) ground floor, b) first and c) second floor with indication of the activities housed.

ground floor), houses the University Library, which takes up the entire surface area of two sides of the building (along Piazza Dante square and Vicolo dell’Ulivo). The University Library also covers nearly the entire second floor, in part overlying the first floor sections, in part along the opposite side (along Via della Sapienza). Mezzanine floors and loft structures are, moreover, present in correspondence of the first and second floor of the library. The general plans of the building, with the indication of the different activities carried out, are presented in the Figure 3.

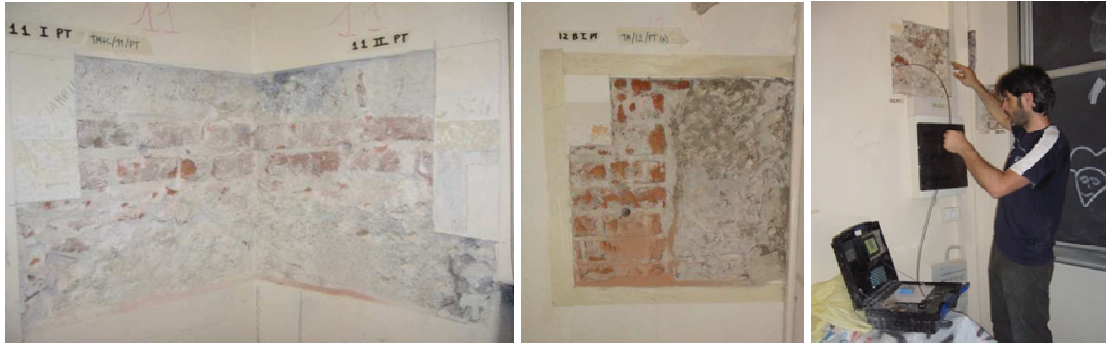
Figure 4: Execution of in situ investigations on masonry walls.

The masonry patterns were investigated by removing 50x50 cm plaster surface with following endoscopic examinations (Figure 4), necessary to determine the presence of air spaces or adjacent facings of different thickness and type. The studies revealed the presence of 5 different types of masonry patterns (i.e. full brick, full brick and split stone, stone with brick courses, etc.) and the absence of suitable connections between perpendicular walls. The distribution of the different masonry typologies present in the building's various floors was reconstructed bearing in mind the results of the historical analysis (Figure 5). In general, the different types of masonry corresponded to the different historical stages of the building's construction and modification; for example, the area at the corner between Via Curtatone e Montanara and Via della Sapienza, originated from the building's medieval walls and tower-houses, revealed greater complexity and heterogeneity, as well as already evidenced during the historical analysis. Three experimental flat jacks tests were then executed on three different masonry typologies to determine the compressive strength of the material and to estimate the effective actual stress state on vertical elements.

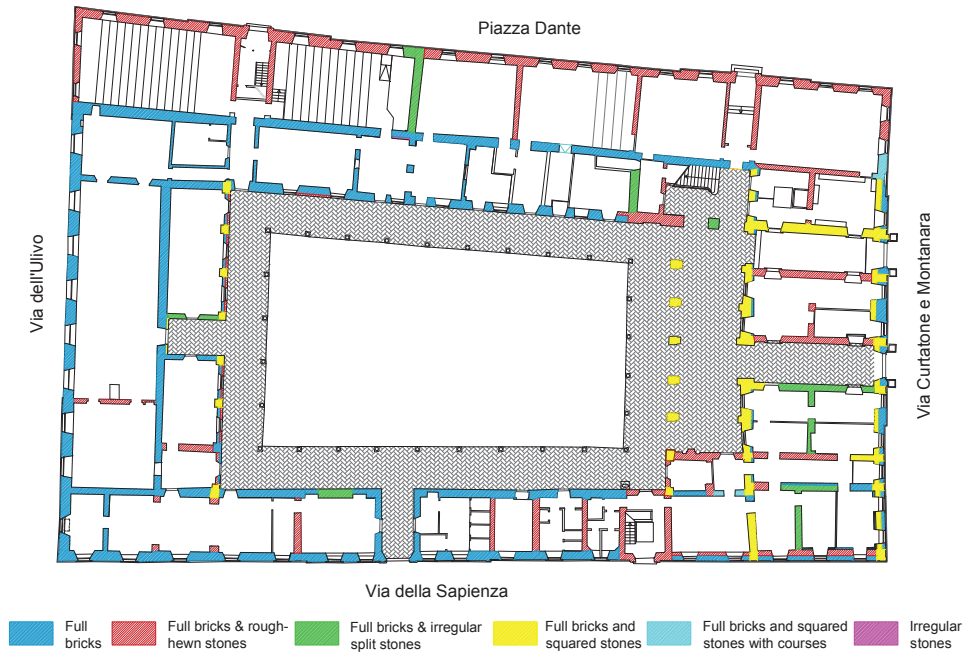
Figure 5: Plan of ground floor with indications of the various types of masonry

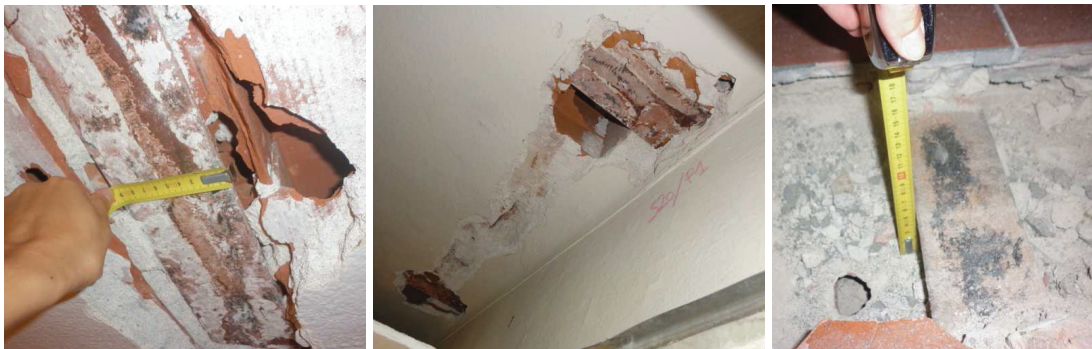
Figure 6: Execution of in situ investigations on horizontal floors with steel elements.

Similar investigations (removal of plaster and endoscopic analyses) were also executed on vaulted surfaces, in order to define the masonry typology, the disposition of blocks and the total thickness of the filling materials. The direct in situ survey of horizontal storeys allowed the determination of the steel profiles' dimensions and of the thickness of the slabs and flooring, necessary to estimate of the effective dead load (Figure 6).

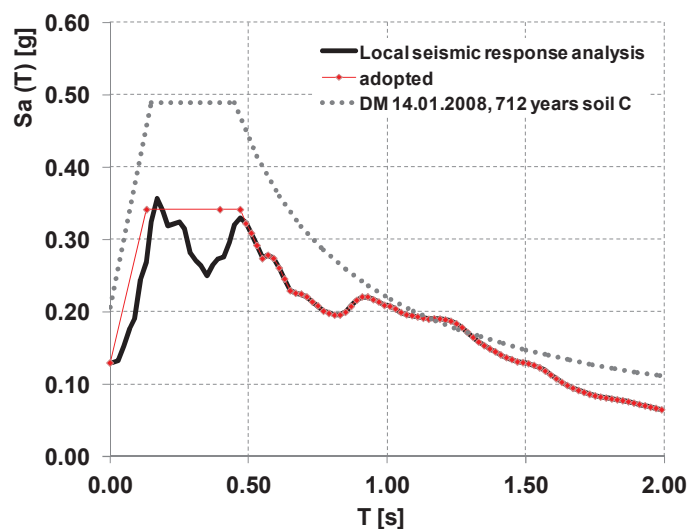
Figure 9: Elastic response spectrum results for the site in comparison to regulatory indications for type C soils.

Vertical loads were determined in relation to D.M. 14.01.2008; an accurate estimation of the effective weight of the books of the libraries was also executed in order to obtain more reliable evaluations and safety checks. For what concerns the evaluation of seismic action, due to the complexity of the building, a *local seismic response analysis* under free-field conditions (i.e. neglecting the presence of the building), aiming to evaluate the response spectrum to be used for the safety checks was executed. The definition of the seismic input was performed selecting seven spectrum-compatible accelerograms, scaled according to the site's reference design acceleration [17], and applying them directly to the representative model of the subsoil of the site on which the building rests. The subsoil model employed, made up of a finite number of parallel plane layers with infinite horizontal extension, was represented by an equivalent elastic medium set on a viscous-elastic half-space representing the bedrock. Each layer, assumed to be homogeneous and isotropic, was characterized by thickness  $h$ , density  $\rho$ , a transverse rigidity modulus  $G$  and damping factor  $D$  (Table 2). Applying this subsoil model to the seismic input to the bedrock enabled the determination of the specific response spectrum for the considered site. Analysis of the local seismic response was then conducted by calculating the average effects, in terms of acceleration over time at the depth of the foundation plane, of each of the seven accelerograms selected. Figure 9 shows the elastic response spectrum for the site under examination (soil type C) in comparison to the standard spectrum for return period  $T_R$  equal to 712 years. Linear dynamic analysis was then finally performed on the Palazzo della Sapienza using the response spectrum resulting from the foregoing determinations. A behaviour factor equal to 2.25 was adopted [15], minimum value allowable for masonry structures with irregular height, quite conservative respect to the value proposed by the Guidelines for cultural heritage [13], which specify a maximum value of 2.80.
