Evaluation of structural safety and seismic vulnerability of historical masonry buildings: studies and applications in the Tuscany Region

S. Caprili, F. Mangini & W. Salvatore

Department of Civil and Industrial Engineering, University of Pisa, Italy

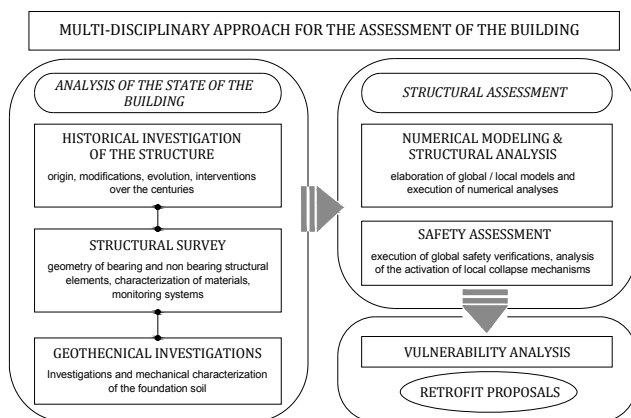
Figure 1: Scheme of the adopted methodology – integrated approach.

In this context, Italian Technical Regulations for Constructions [1], together with the “Guidelines of the Ministry of Culture and Heritage” [10], underlines the necessity to analyze, beside the global behaviour of structural aggregates, the activation of local collapse mechanisms of significant structural portions, identified on the base of the critical points and of the cracking scenario revealed during the in situ survey. Figure 1 shows the general scheme that shall adopted for the assessment of historical buildings, accounting for the multi-level procedure previously mentioned and including, as final step of the approach, the eventual retrofit.

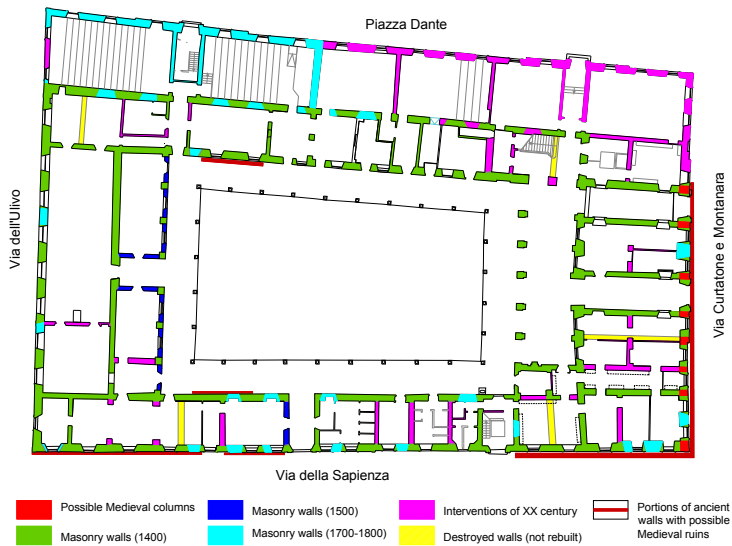
Figure 3: Evolutive development of Palazzo La Sapienza (ground floor).

with different profiles) are present; the useful height of the ground floor varies from 4.30 m to 5.50 m. The situations are similar on the first and second floors, where the maximum heights attained are respectively equal to 5.60 m and 5.20 m. Figure 3 shows the ground floor of the building with the indication of the construction period of the different portions.

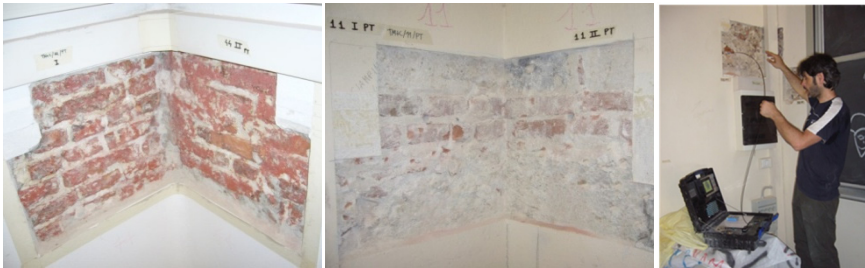
Figure 6: Endoscopic investigations on masonry walls (Palazzo La Sapienza).

A deep in situ survey campaign was executed, in the case of both Palazzo La Sapienza and Palazzo Ducale, aiming to determine the typologies of vertical bearing walls, horizontal floors (both storey slabs and vaulted surfaces) and the roof structure. Endoscopic analyses were executed on masonry walls in order to determine the masonry typology, the possible presence of cavities and the level of connections between perpendicular walls (Figure 6). Experimental in situ tests using double flat-jacks were also executed evaluating the mechanical properties of masonry to adopt for safety checks. Structural survey of horizontal floors, analyzing the shape, material and dimension of bearing elements (wooden, steel or r.c. elements) and the thickness of the slab including concrete, pavement, masonry lightening blocks and other (Figure 7) were finally conducted.
