Advanced Low-Floor Vehicle (ALFV) Specification Research

MNTRC Report 12-27

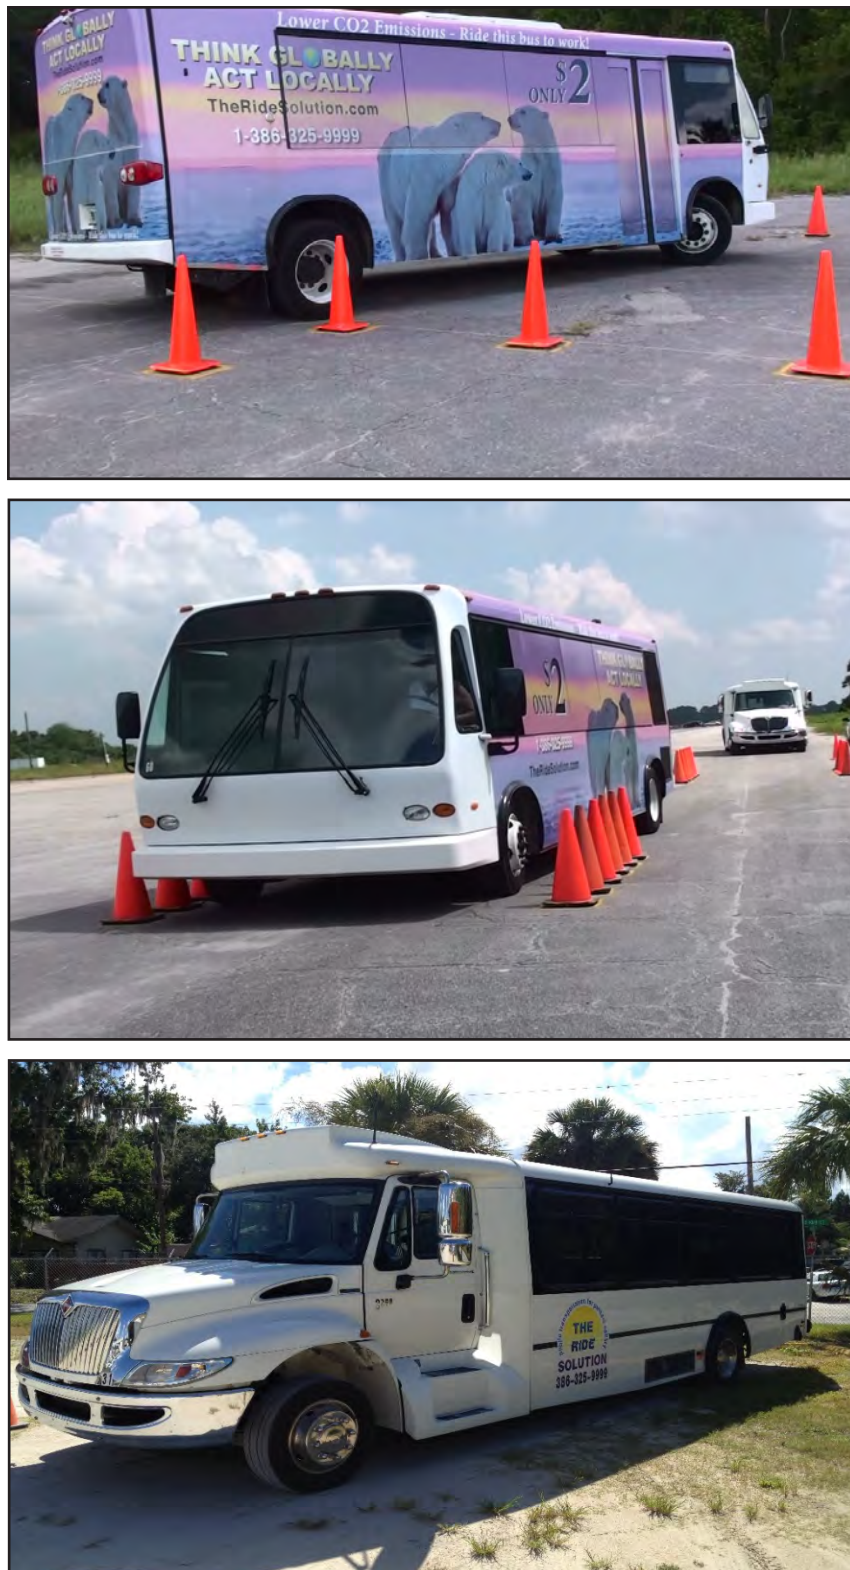
Figure 1. ALFV Operating through Two Bus Roдео Events, and Competing Bus

competing vehicle measured 31 feet (9.45 meters) long and 102 inches (2.59 meters) wide and was at a clear disadvantage in the bus Roadeo obstacles. It is the low-floor ALFV's unique ability to accommodate 25 passengers in 26 feet (7.92 meters) of vehicle length that gives it a time advantage both in the rodeo and in flex route services, which place a premium on route deviation. Vehicle agility can translate to savings due to reduced time in the operating budget and, by facilitating the flex-route format, can yield increased productivity. Photographs of the ALFV operating during one of the Bus Roadeo events and the competing vehicle are shown in Figure 1.

As shown in Figure 1, due to the better agility of the ALFV, the agility savings could add to \$1,597,709 for the 17 routes utilizing 17 vehicles over 20 years, if all the time saved during the roadeo were converted to time savings in service.

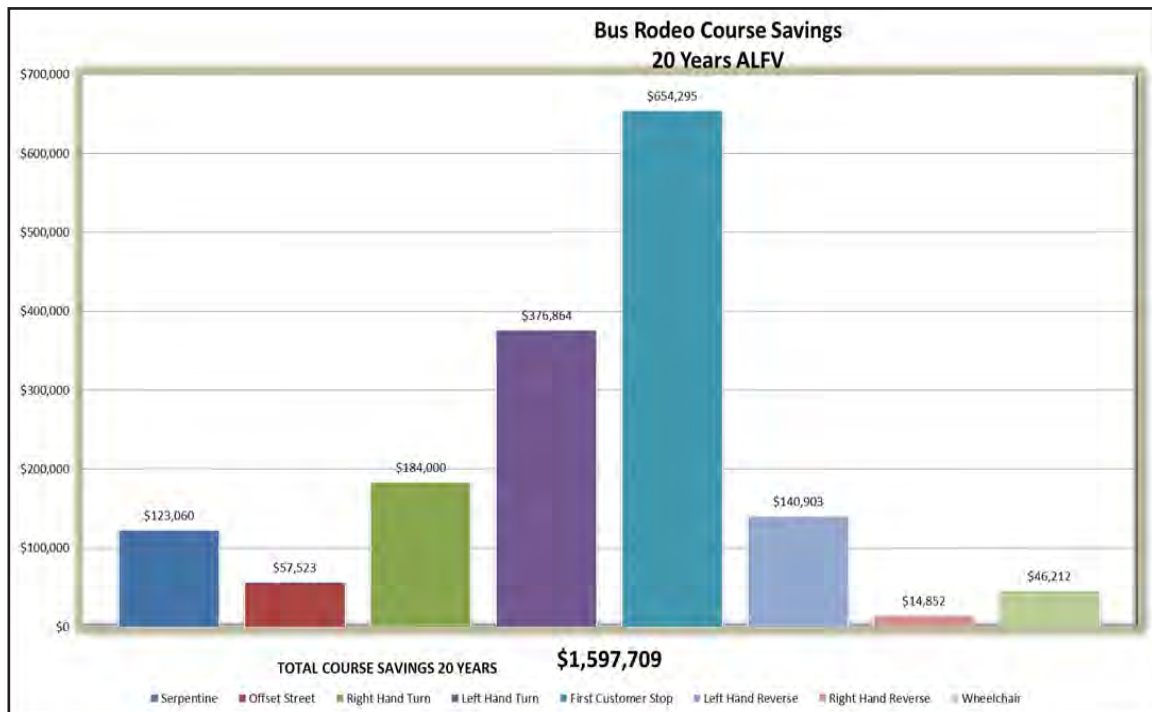
Figure 2. Maximum Maneuverability Operational Cost Savings Based on Roadeo Performance (Assuming a 20-Year Service Life)

APTA Roadeo time savings per hour per route were then accumulated over the projected AMPV 20-year lifetime for a 17-vehicle fleet. From these time savings, per hour and total cost savings for the 17-vehicle fleet were calculated using Ride Solution's cost allocation methodology employed to manage the overall system. This methodology establishes three cost centers in the operating line item budget: Miles Cost, Hours Cost, and Fixed Cost. Miles Cost is defined as fuel, oil, tires, and maintenance. Hours Cost is driver salary plus fringe, while Fixed Costs are all other budget line items. It is Hours Cost that is amenable to vehicle agility. The resulting calculated maximum savings based on Roadeo performance assuming 20-year service life are shown in Figure 2.

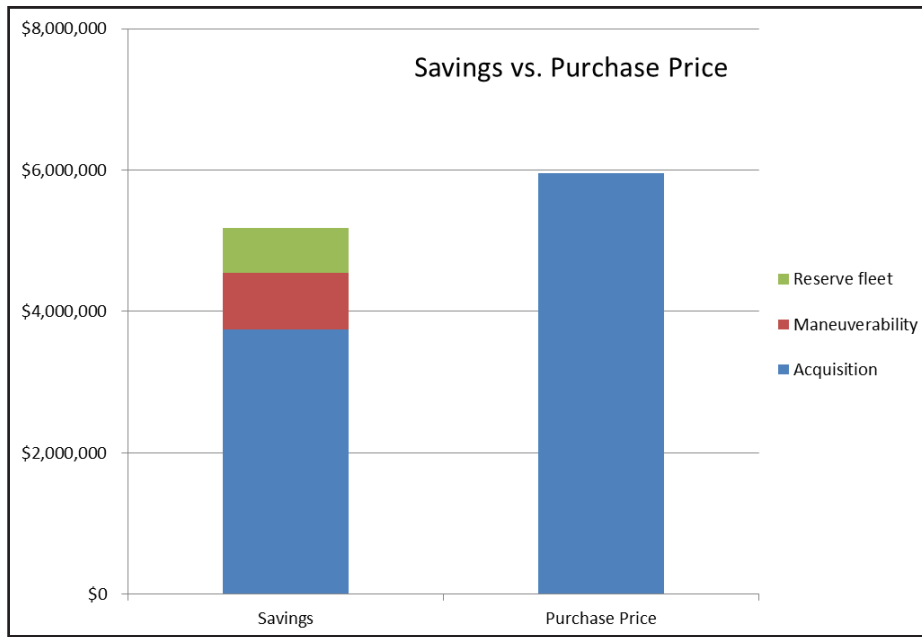
Figure 3. ALFV Savings versus Purchase Price

Long-Life Vehicle Capital Savings (as tested)	62.9%
Maneuverability Operational Savings (as tested, 50%)	13.5%
Reserve Fleet Operational Savings (as tested)	10.8%
Total Projected Savings based on Purchase Price	87.2%

This same information is shown graphically in Figure 3.

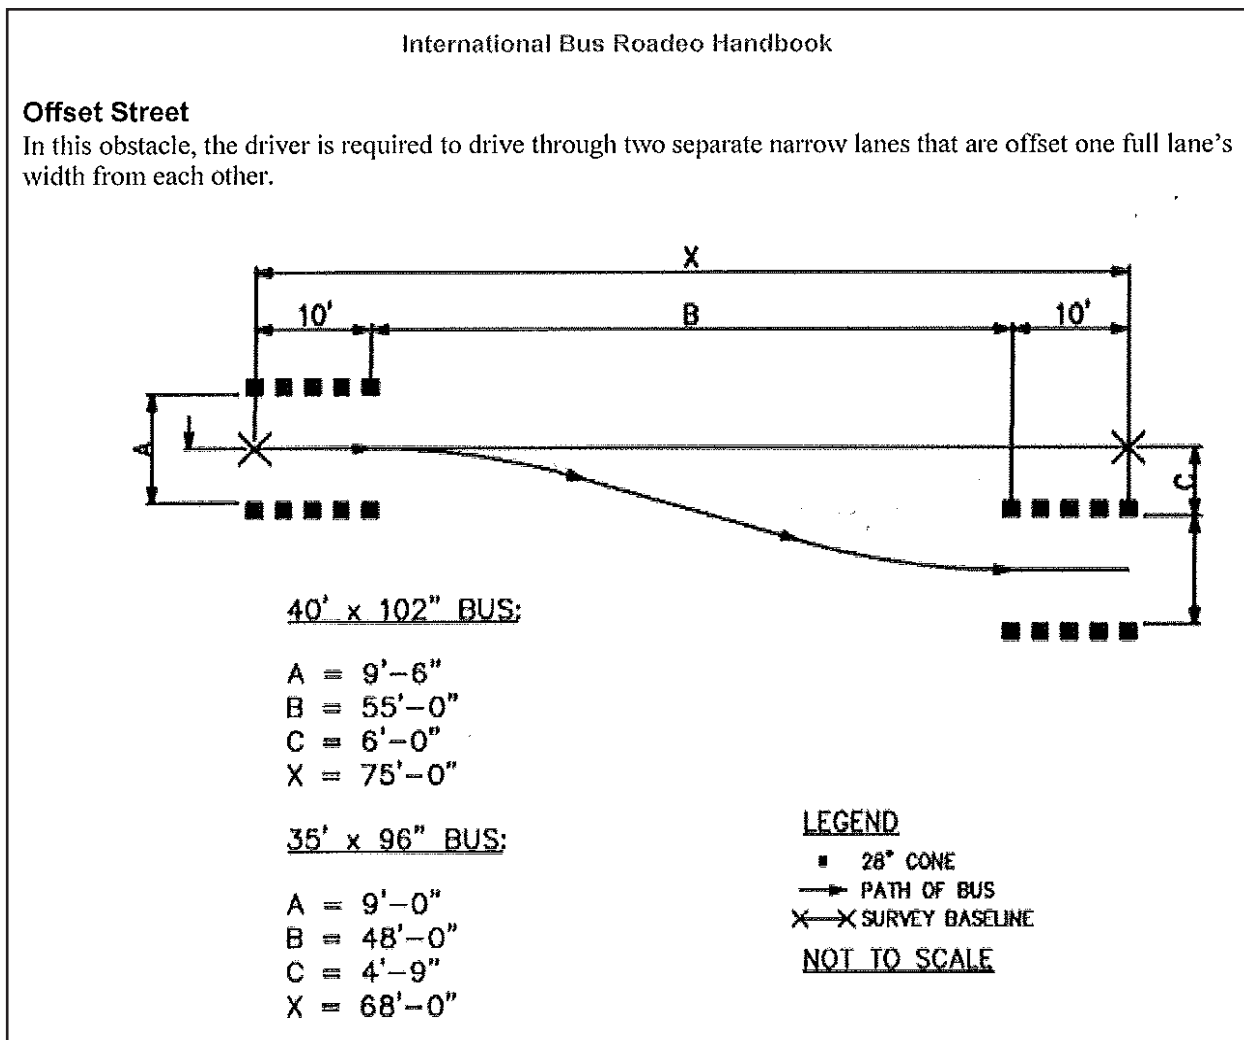
Figure 16. Diagram of the APTA Offset Street
