Evaluation of Cavitation Erosion Behavior of Commercial Steel Grades Used in the Design of Fluid Machinery

The erosion response under cavitation of different steel grades was assessed by studying the erosion rate, the volume removal, the roughness evolution, and the accumulated strain energy. A 20 kHz ultrasonic transducer with a probe diameter of 5 mm and peak-to-peak amplitude of 50 μm was deployed in distilled water to induce damage on the surface of commercial chromium and carbon steel samples. After a relatively short incubation period, cavitation induced the formation of pits, cracks, and craters whose features strongly depended on the hardness and composition of the tested steel. AISI 52100 chromium steel showed the best performance and is, therefore, a promising design candidate for replacing the existing fluid machinery materials that operate within potential cavitating environments.

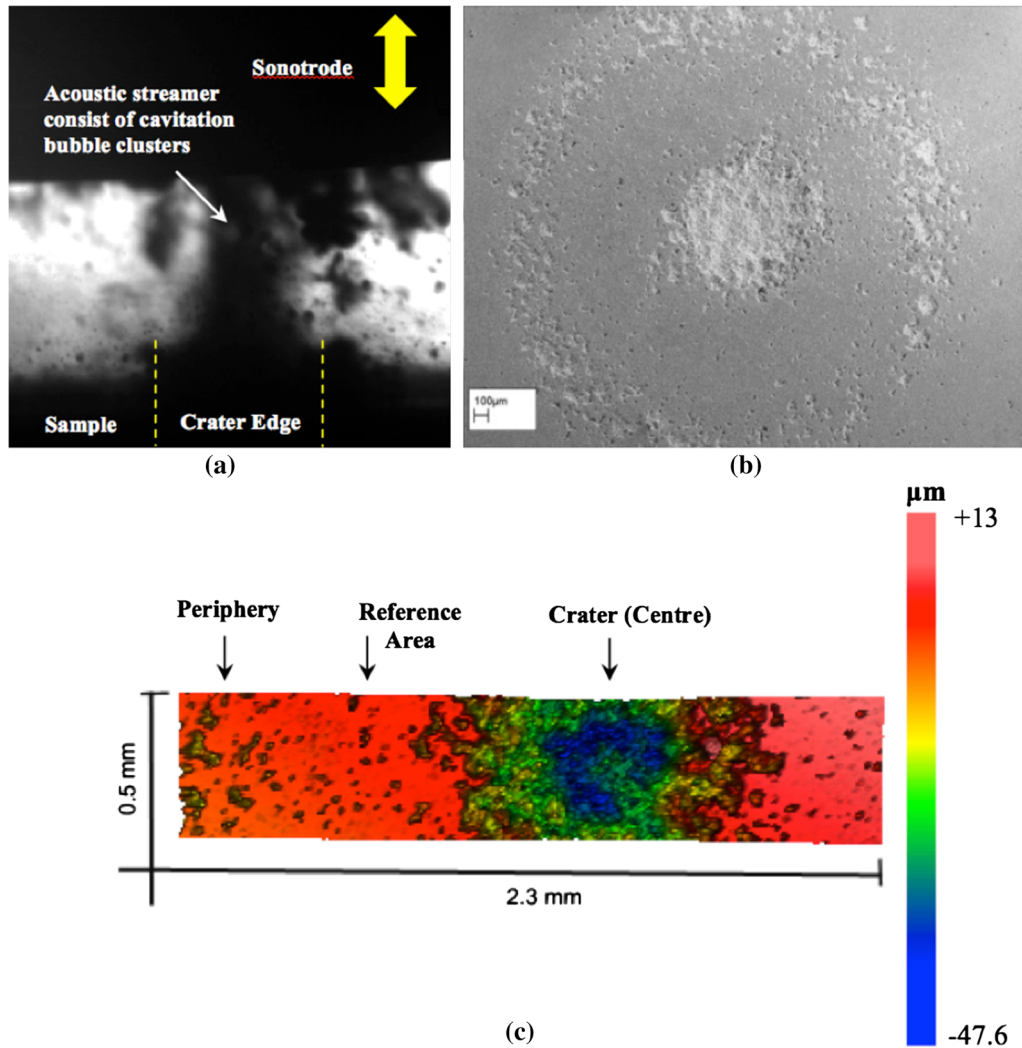
Fig. 5—Details of a cavitation ring area: (a) image of the high speed acoustic stream which consists of cavitation bubbles, (b) SEM micrograph of the outer annulus and the crater of the ring region, and (c) ZYGO interferometer image of the eroded area.

The cavitation pits formed in the early stages of cavitation (described in Reference 31) significantly grew by agglomeration of nearby pits, cracks, and grooves. The surface roughness substantially increased, accelerating the erosion rate of the materials. The enlargement of the pits was accompanied by the additional volume loss. The mechanism of pit growth leads to the formation of deep and wide craters penetrating the surface of the sample. These regions are called “cavitation ring areas” because of their typical shape and an example, which is representative for the four steel grades studied, is shown in Figure 5.

Three different areas can be distinguished in the damage profile as shown in Figure 5(c): the centre (crater), the periphery (outer annulus), and the area between those two (reference area). Cavitation erosion is substantially larger, deeper, and wider in the centre compared to the periphery. The lowest damage is found in the area between the centre and the periphery (reference area) where erosion is superficial, being dominated by isolated cavitation pits (Figure 5(b)). A detailed description of this grading of erosion damage can be found elsewhere.^[42] The intensity of cavitation is accumulated in the centre of the sample, as clearly indicated by the direction of the acoustic stream in Figure 5(a), (a full account of the cavitation high-speed monitoring process can be found in Reference 18) and also explained by Moussatov *et al.*^[43] by the conicity of the acoustic stream where streamlines tend to focus in a centre point. Therefore, the damage in that particular

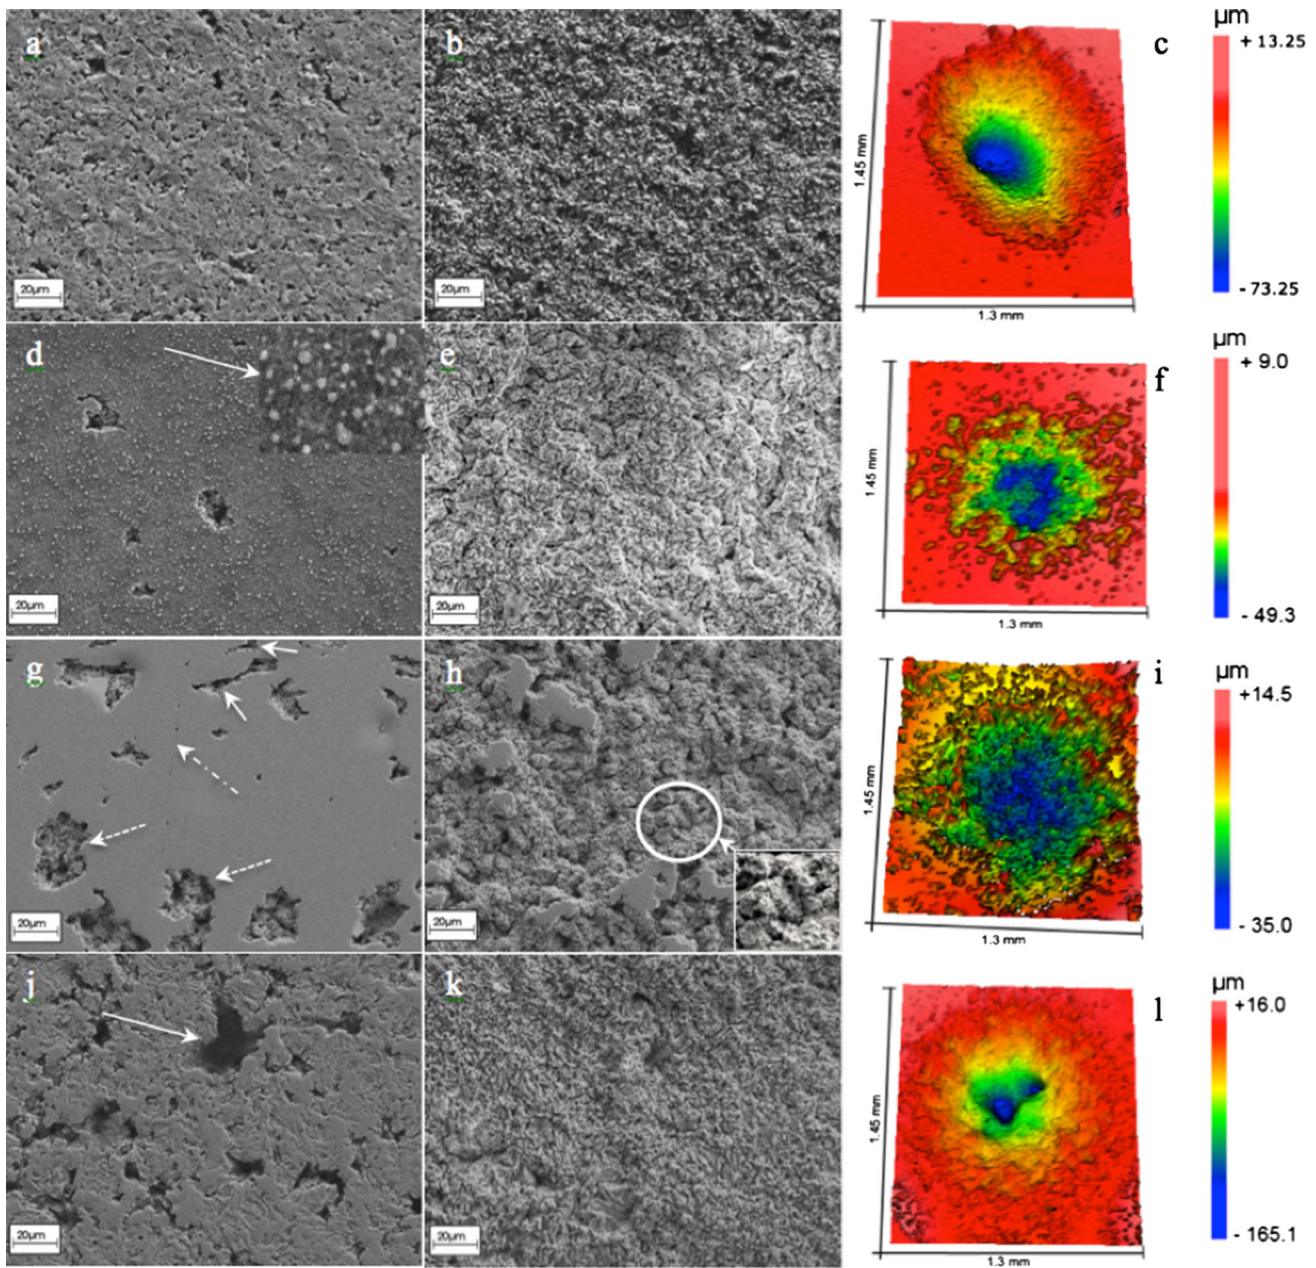
Fig. 6—SEM and ZYGO interferometer micrographs, respectively, showing the morphologies of the steel sample surface after 1 (*a, d, g, j*) and 8 (*b, c, e, f, h, i, k, l*) h exposure to cavitation erosion: *a–c*) AISI W1, *d–f*) AISI 52100, *g–i*) AISI 1085 and *j–l*) AISI 1020. (Color legends show the highest and lowest points for each micrograph individually and do not relate to each other. Results are explicitly presented in Table III).

Although the steel samples are characterized by different microstructural features (such as the presence of carbides) and different cavitation erosion resistance, they share similar brittle pattern of surface damage. This is illustrated in Figure 6 where SEM and optical

Figure 6(a) shows the initial stage of erosion pits and cracks formation after 1 hour of testing for the AISI W1 steel sample. Erosion mainly originated from pits and cleavage with their adjacent areas plastically deformed. As the cavitation time further increased, the pits coalesced and formed a larger crater. Gradually,

roughness increased, while the large craters coalesced and developed further to form a much larger crater, thereby leading to significant material removal. The surface layer was completely removed and a very rough surface was formed. The crater became progressively rougher and deeper with time. At the final stage of 8 hours (Figure 6(b)), erosive wear had sufficiently propagated, penetrating the surface, rapidly increasing the depth of the erosive region (Figure 6(c)).

Figures 6(d) and (e) shows the damage that occurred on the AISI 52100 steel surface. Chromium carbides approximately $1 \mu\text{m}$ in size (appeared on the surface of the sample/blistering effect) emerged to the surface due to the consecutive impacts by the cavitation bubbles creating a reinforced substrate contributing to an increase in the strength of the material against cavitation erosion.^[31] The stability of the surface was enhanced by the presence of fine, uniformly distributed carbides (Figure 6(d), in-set). However, when the matrix around these carbides became severely eroded, *i.e.*, after 8 hours, carbides were dislodged out of the surface of the sample. After 8 hours of exposure to

cavitation, surface was severely eroded forming a deep crater (Figure 6(f)).

acoustic stream (Figure 6(i)). However, this did not correspond to the highest erosion resistance against cavitation as the size of the crater is significantly larger compared to other steel grades, leading to larger amount of volume loss. A detailed analysis is conducted in Section IV.

As the cavitation erosion progressed on the surface of the AISI 1020, material could not withstand the impacts and started degradation which was notable even after the first hour of treatment (Figure 6(j)). Erosion originated from the cracks, and cleavage of large metal chunks about 50 μm (Figure 6(j), white arrow) was also observed. The collapse of bubbles within those cracks in

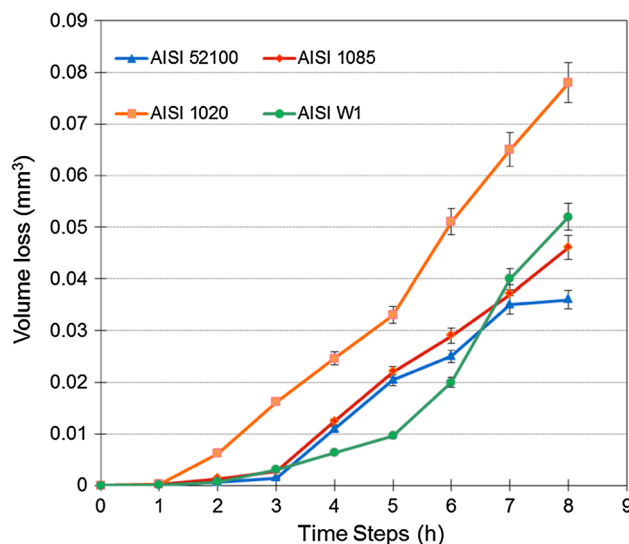
Fig. 7—Cumulative volume loss as a function of time for the examined materials under cavitation erosion.

The cavitation tests were carried out until a clear tendency had been established as explained in Section II-C. The relative resistance of a material to the cavitation erosion can be characterized through measuring the volume loss. The volume loss measured at different times under cavitation erosion is plotted against the treatment time in Figure 7. In general, there was negligible loss of the volume (mass) for all the studied steel grades during the incubation period of cavitation erosion. Volume loss commenced almost immediately after 1 hour exposure to cavitation in all the tests and subsequently increased at a nearly constant rate. It became obvious that AISI 52100 reached the declining period first as the slope curve started to reduce after 7 hours of exposure to cavitation. On the whole, the volume loss in AISI 52100 at the end of the tests was the lowest, approximately 52 pct less as compared with AISI 1020 and 28 pct with AISI W1, indicating the lowest maximum erosion rate among the tested steel grades.

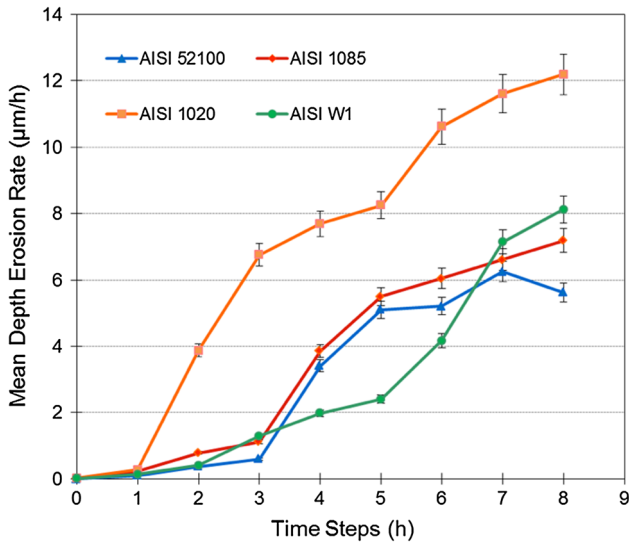
Fig. 8—Variation of the MDER parameter with the exposure time for different steel materials.

The variation of the MDER parameter with the exposure time is presented in Figure 8. It can be seen that in the first hour, the erosion rate increased very slowly for all the test samples, which is a typical feature of the incubation period. At this stage, due to the accumulated internal stresses across the surface layers, plastic deformation initiated and the material surface started to deform (work hardening). Thus, negligible

material loss was observed, although fatigue process could already occur during this period.^[45] Following this incubation period, the erosion process accelerated. For AISI 1020, the erosion rate started to increase after the first 1 hour of the test and continued until the end of 3 hours where a small attenuation was observed accompanied by a further increment after the end of 5 hours test. There is no evidence of reducing the MDER even after the end of the maximum run test at 8 hours. Thus, the 1 hour of exposure can be considered as the critical point after which AISI 1020 steel significantly decreases its strength and losses its durability. Conversely, for the other tested steel grades the erosion rate gradually increased during the first 3 hours whereupon the acceleration of erosion was observed. This behavior showed that the material was plastically deformed apparently exceeding its fatigue strength limit, which resulted in sudden fast fracture and formation of deep craters.^[46] In these stages, evolution of microcracks to macrocracks occurred, and large material removal was observed (see Figure 6). After the end of the acceleration stage, a local equilibrium between the erosive power of the cavitation field and the response of the material was achieved. The erosion process stabilised after 7 hours of exposure, indicating the steady period (change in slope) where the rate of mass loss reached the quasi-constant condition. However, this is the case only for AISI 52100, whereas the other steel grades exhibited an incremental rise in the erosion rate. The endurance of AISI W1 steel after 5 hours was considerably reduced, and the erosion rate steeply increased. Hence, over a prolonged period of exposure to cavitation impacts, the AISI W1 steel plate faced inevitable severe damage. Overall, the erosion rate of the AISI 52100 steel was measured to be the lowest among the samples, while its resistance was calculated to be the highest.

achieved by AISI W1 as can be seen from Figure 8. Then, roughness seemed to drastically increase after 5 hours reaching a R_a value of more than 15 μm .

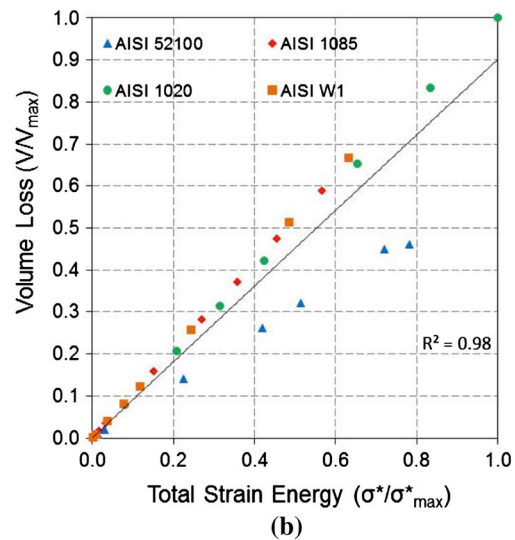
Fig. 11—General behavior of the tested steel grades is shown by the normalization of (a) elastic accumulated strain energy E_{el} and (b) total accumulated strain energy E_{tot} with the variation of the volume loss. All curves start from the origin, but for the same physical time, the tested materials reached different erosion stages (each point represents an hour time step up to 8 h).

Figure 11 presents data normalized to the maximum value of the accumulated strain energy with the volume loss according to Eqs. [3] and [4] with the data taken from Table II and Figure 8 in the case of brittle behavior (Figure 11(a)) and in the case of elastoplastic behavior (Figure 11(b)). The AISI 52100 steel exhibits

the best cavitation erosion performance among the tested steel samples, *i.e.*, for the same time exposure to cavitation damage (*i.e.*, 8 hours) much more accumulated strain energy is required in order to remove the same amount of material.

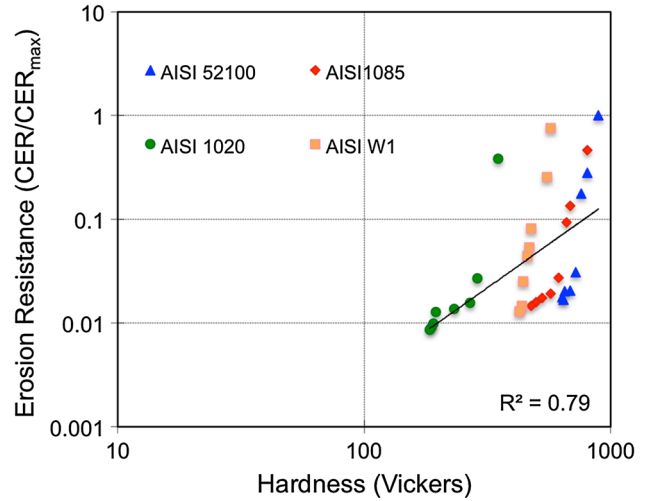
Fig. 12—Correlation of hardness to the cavitation erosion resistance for the studied steel grades (normalization curves).

In Table IV and Figure 12, the cavitation erosion resistance (CER) was evaluated in terms of hardness. It can be noticed that the drop of hardness after the end of cavitation incubation stage was very rapid for every material (compare initial hardness in Table II and measurements in Table IV). For the AISI 52100 and W1 steel grades, work hardening occurred during the first hour of cavitation erosion. Hardness increased by 2.5 and 5.5 pct for AISI 52100 and W1, respectively. There is a possibility (based on previous observations in References 31) that the changes in microstructure of the both steel grades resulted in the increased surface hardness due to martensite deformation within the martensitic laths, and then in the hardness decreased as a result of fatigue crack initiation and propagation, local fracture, and subsequent crater formation. In contrast, for the remaining two steel grades the hardness dropped to about 8.5 pct for the AISI 1085 and 15 pct for the AISI 1020 during the same period of time. AISI 1020 with the lowest carbon percentage was incapable of resisting severe impacts from the implosion of the cavitation bubbles as the material lost stability and experienced accelerated damage. Hardness reduction of AISI 52100 and AISI W1 steel grades during the testing period of 8 hours reached 26 and 21 pct, respectively, while for AISI 1085 and 1020 steel grades it reached 46 and 51 pct, correspondingly. These data clearly highlight

the counterbalancing effect of the work hardening component in the evaluation of durability of the material against cavitation and the attenuation of the micro-durability of the material as also shown by Krella.^[53] The overall behavior of the erosion resistance can be expressed as a function of the hardness H as per Eq. [8] where a is 0.9 and n is 7.8 ($R^2 = 0.79$) (Figure 12):
