Title: Fault detection in a centrifugal pump using vibration and motor current signature analysis

Kumar Pradhan, Prasanta & Ranjan Mohanty, Amiya & Nitaigour P, Mahalik & Ghosh Dastidar, Sabyasachi &. 2012. Fault detection in a centrifugal pump using vibration and motor current signature analysis. International Journal of Automation and Control. Volume 6, Nos. 3/4. ISSN 1740-7516 (electronic).

Fault detection in a centrifugal pump using vibration and motor current signature analysis

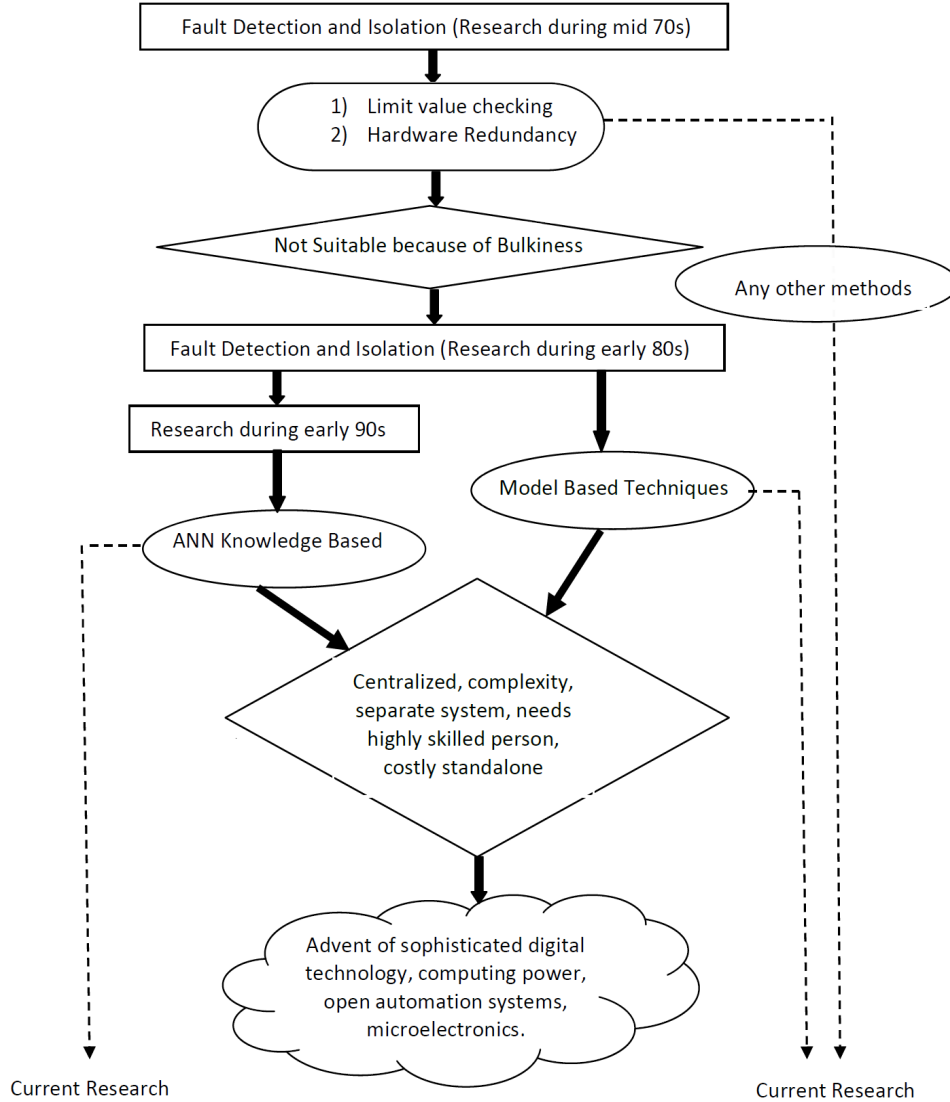
Figure 1 Progress on FDI

Next generation industrial systems will require more reliability, availability, safety, and embedded control strategy in response to provide highly customised products. The benefits that have been achieved so far through implementation of condition monitoring are now being significantly extended through the application of new theories, techniques, tools, and methods. Advances in computing tools and techniques have stimulated studies to design as well as realise autonomous machinery systems. Fault detection and isolation (FDI) is the main research topic that fall under the category of condition monitoring (Mohanty and Mahalik, 2007, 2011). Figure 1 (Mahalik et al., 1998) illustrates the progress on condition monitoring methods.

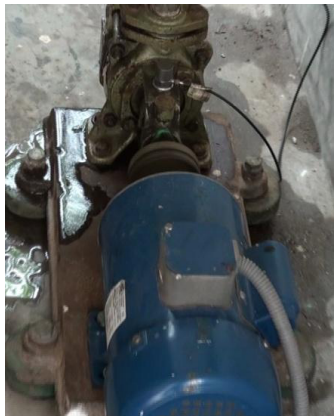
Figure 2 Accelerometer mounted on a pump (see online version for colours)

The accelerometer (PCB 353B33) was placed on the casing of the pump close to the bearing (as shown in Figure 2) to measure the vibration. Hall effect sensor (Tektronix A621, as shown in Figure 3) was kept around the phase terminal of motor current to measure the instantaneous motor current. The centrifugal pump (0.75 kW, 1,450 RPM, 240 V, make-Crompton Greaves, as shown in Figure 2) was operated under different working conditions of impeller like normal impeller (all vanes present), one vane broken impeller, two vanes broken impeller, three vanes broken impeller (as shown from Figures 4 to 8) sequentially.

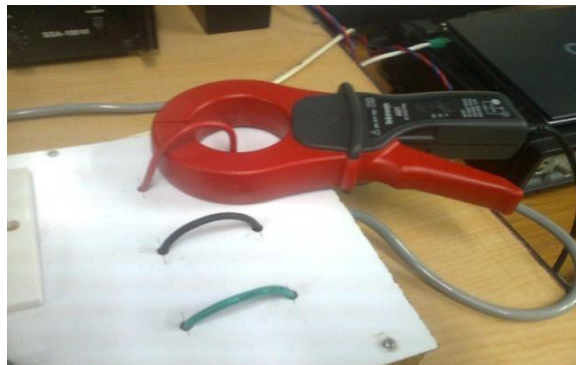
Figure 3 Hall effect sensor (see online version for colours)

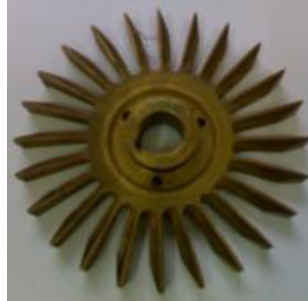
Figure 4 Normal impeller (see online version for colours)

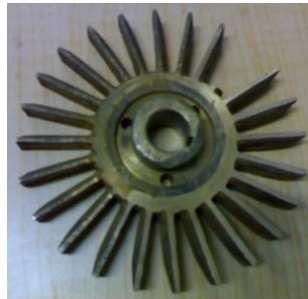
Figure 5 Broken impeller (one vane missing) (see online version for colours)

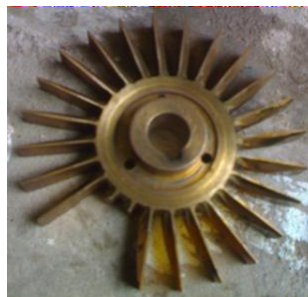
Figure 6 Broken impeller (two vane missing) (see online version for colours)

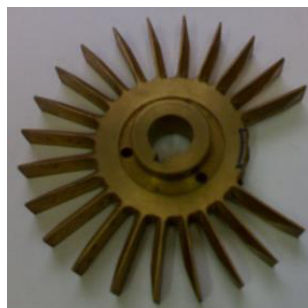
Figure 7 Broken impeller (three vane missing) (see online version for colours)

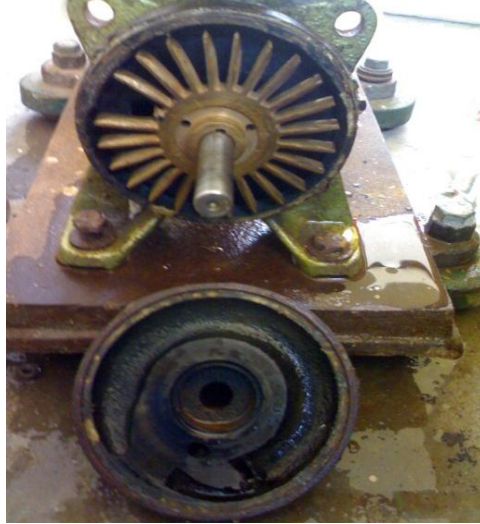
Figure 8 Broken impeller inside casing of the centrifugal pump (see online version for colours)

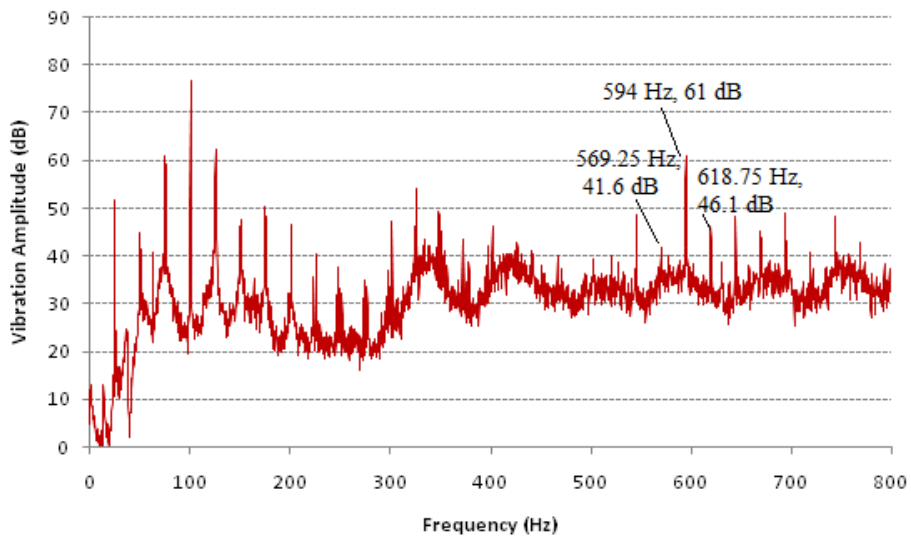
Figure 9 Vibration spectra of the normal impeller (see online version for colours)

From the vibration spectra it has been observed that the first high peak was at 24.75 Hz (52 dB) which happens to be the rotational speed (RPS) of the pump. This measurement was verified by an optical tachometer which indicated a rotational speed of 1,485 RPM. Also, the presence of VPF (i.e., $RPS \times \text{No. of vanes}$) was observed in the vibration spectra. Their corresponding amplitudes (in dB) and their SBs (at $VPF \pm RPS$) for different impellers were noticed. The observations of vibration spectra (as shown in Figures 9 to 12) for different impellers are summarised in Table 2.

From Table 2, it is observed that when the severity of the defect increases, height of SBs increases and the difference between the dB values of VPF and SBs decreases. Like as the severity of the rotor bar fault increases, the height of SB's peak increases (Thomson and Fenger, 2001). As vane/vanes of impeller of pump has/have been broken, the momentary torque exerted between two consecutive normal vanes (in between whose, vane has been broken) rises. Due to that, the amplitude of force as well as vibration at (VPF \pm RPS) increases. So, the peak height at (VPF \pm RPS) also increases.

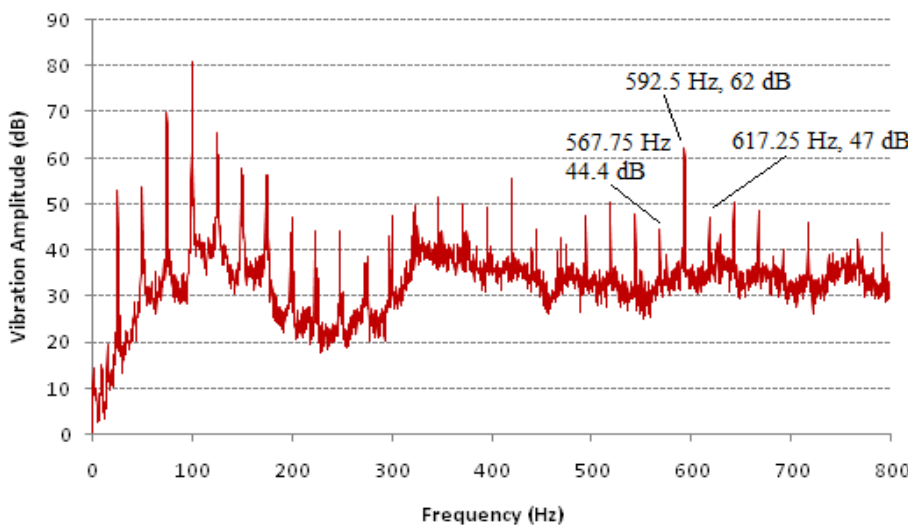
Figure 10 Vibration spectra of the defective impeller (with one vane missing) (see online version for colours)

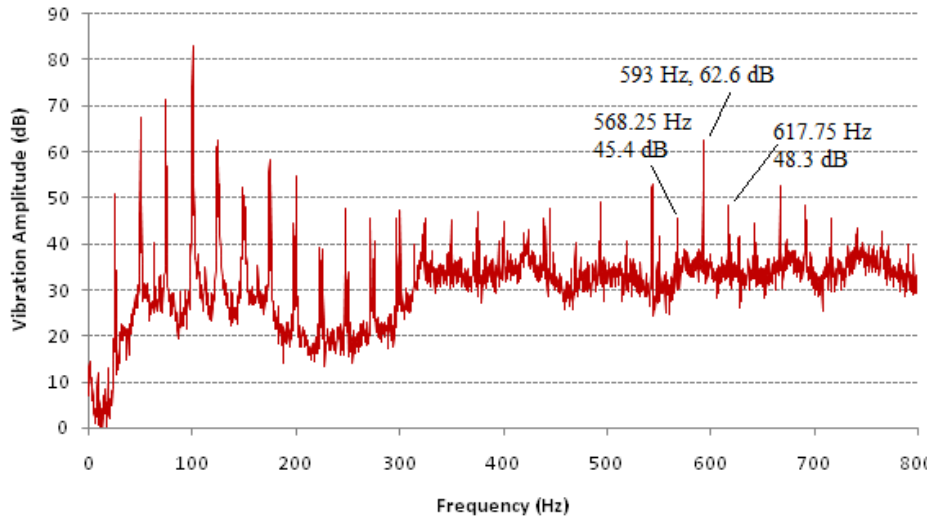
Figure 11 Vibration spectra of the defective impeller (with two vanes missing) (see online version for colours)

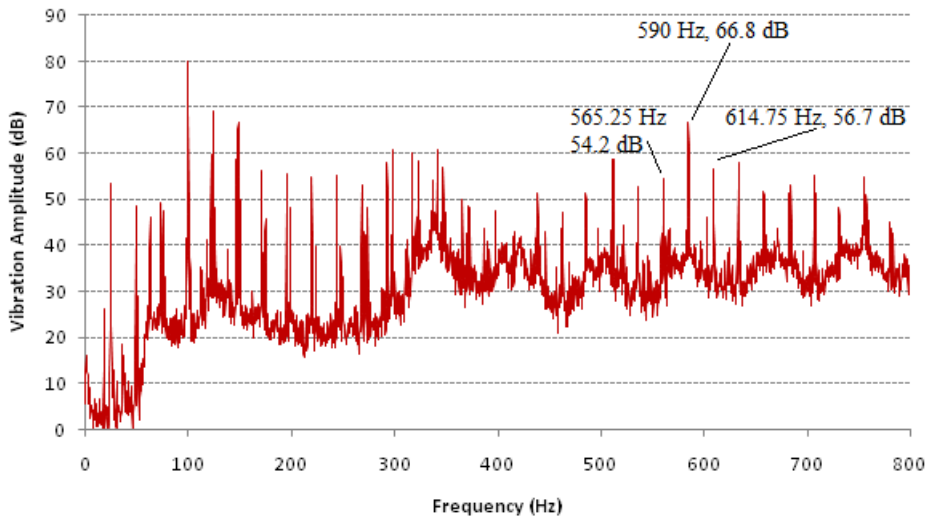
Figure 12 Vibration spectra of the defective impeller (with three vanes missing) (see online version for colours)

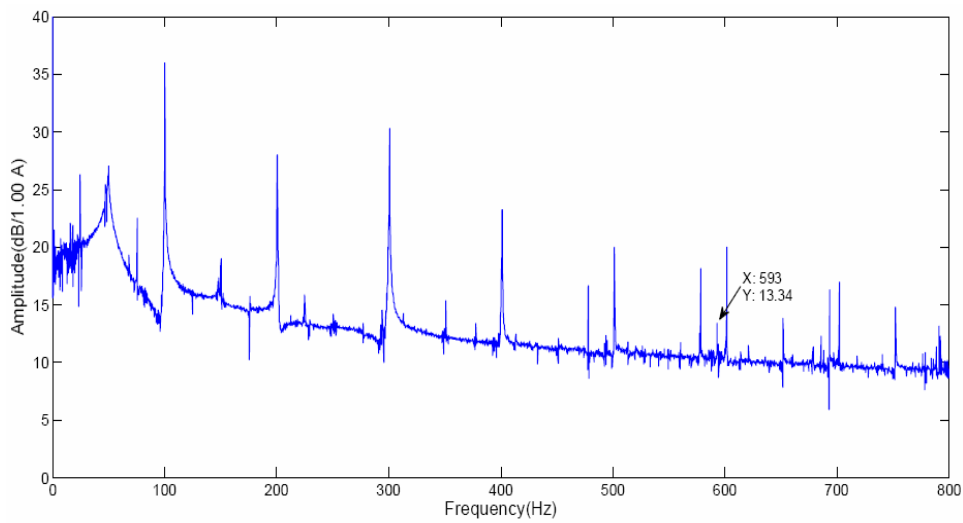
Figure 13 Demodulated current spectra of the normal impeller (see online version for colours)

From Figures 13 to 16, the VPFs and their respective amplitudes are summarised in Table 3. It is observed that when the severity of the defect increases, then the amplitude of the demodulated current signal at VPF increases.

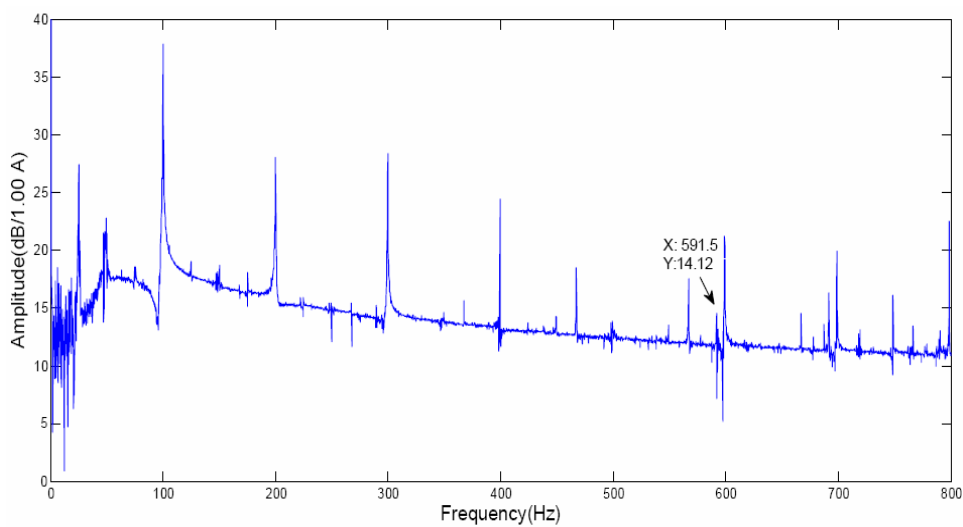
Figure 14 Demodulated current spectra of the defective impeller (with one vane missing) (see online version for colours)

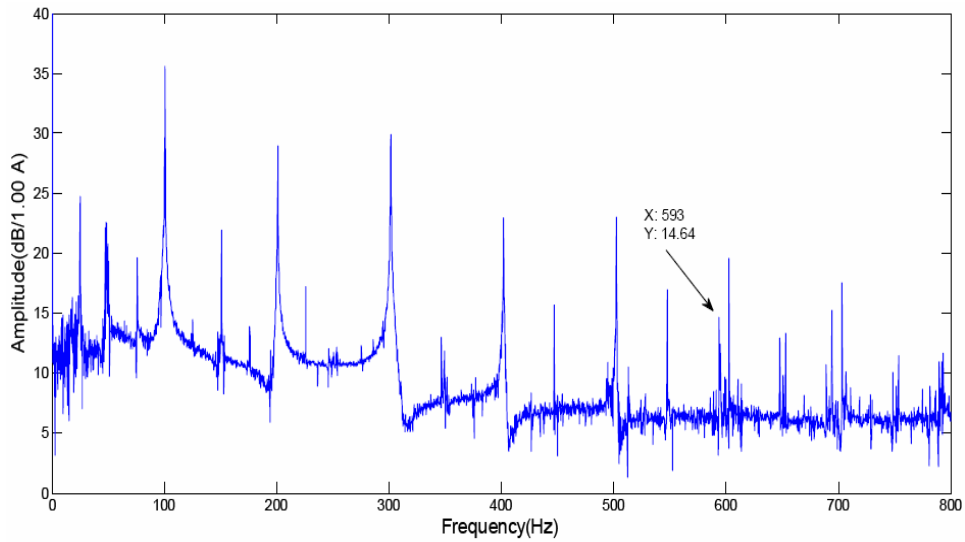
Figure 15 Demodulated current spectra of the defective impeller (with two vanes missing)
(see online version for colours)

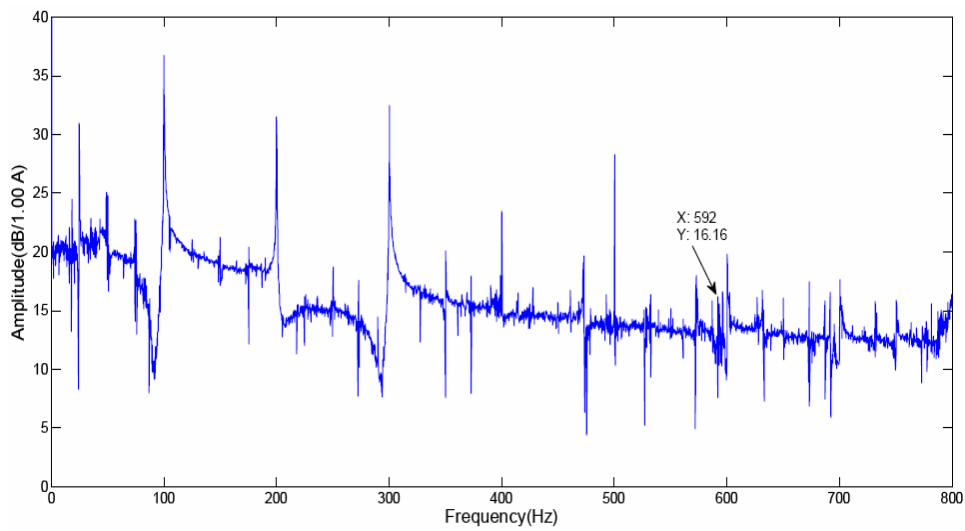
Figure 16 Demodulated current spectra of the defective impeller (with three vanes missing)
(see online version for colours)

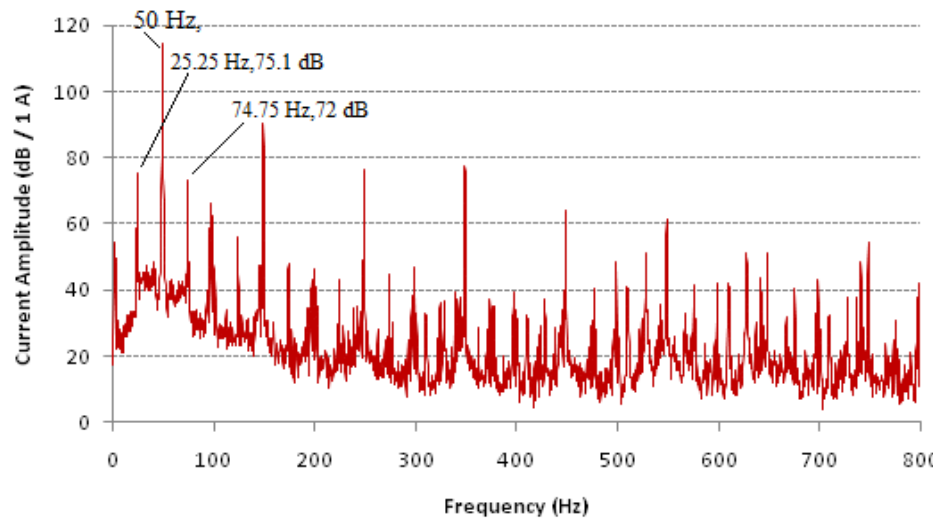
From the current spectrum (as shown in Figure 17), it was observed that the second (and highest) peak gives the supply frequency (in this case 50 Hz).

Figure 17 Current spectrum (see online version for colours)

Also, the current spectrum has been used to find out the rotating speed (RPS). From the current spectrum, it was observed that peaks are at supply frequency (50 Hz) and two SBs at $50 \pm$ RPS. These are at 25.25 Hz (75.1 dB) and 74.25 Hz (72 dB) respectively. The SBs occur because of the modulation of the current, due to variation in the air gap between stator and rotor during rotation of motor shaft. Since the rotational vibration which in turn varies the magnetic conductance and due to that instantaneous current signal is modulated. When it is demodulated in frequency domain, it shows as SBs around supply frequency.
