Surface Discharge Phenomena in Medium Voltage Terminations

Thesis submitted for examination for the degree of Master of
Science in Technology.
Espoo, 18.11.2015

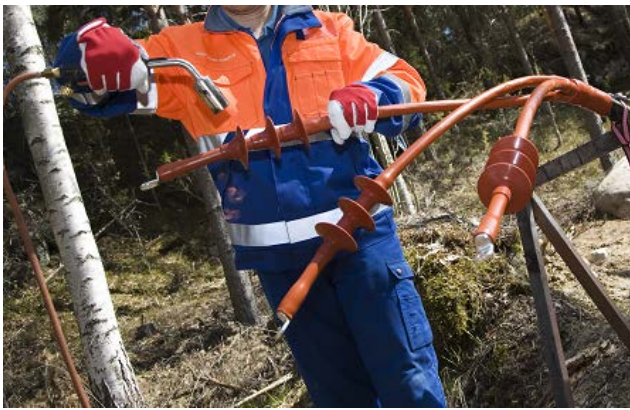
Figure 8: Heat-shrink termination installed onto a 20 kV three-core cable [14]

The heat-shrink technology was first introduced in the end of 1960's. The technology revolutionized the whole low and medium voltage cable accessory market and several advancements have been made ever since the introduction. Most of the improvements mainly concerned the design of materials and the formulations used in single-layer tubes but dual-layer products with dual-functionality have been introduced later on. [13]

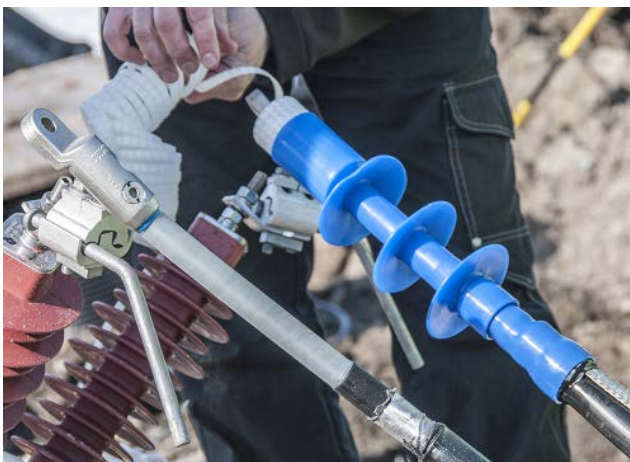
Figure 9: Pre-stretched cold-shrink termination installed onto extruded 20 kV cables [15]

Cold-shrink technology relies on elastomeric materials used in the same manner as heat-shrinks. Like heat-shrinks, the cold-shrinks can fit a wide range of cable diameters but offer some advantages related to the assembly of the accessory. Gas bottles and torches are not needed during assembly and the installation quality is less dependent on the skill of the installer. The elastomeric material continues to shrink towards its original shape after installation and does not stop shrinking like the heat shrink does when it cools down after installation. The product can either be of stretch rubber type (slip-on) or pre-stretched in the factory on to a plastic support tube (spiral tube) for easier installation (Figure 9). [12]

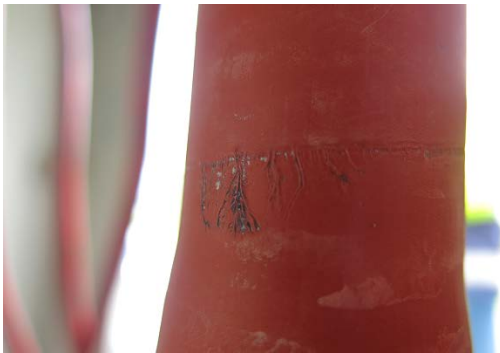
Figure 10: Anaerobic tracking paths under a loose rain shed in a heat-shrink termination

Tracking can also occur between two materials if discharges are formed by moisture at such an interphase. The by-products from the discharge are trapped between the materials and tracking will occur. This type of anaerobic tracking can occur for example in cable terminations if rain sheds are poorly installed or when PVC tape is used for phase marking (Figure 10). [16]

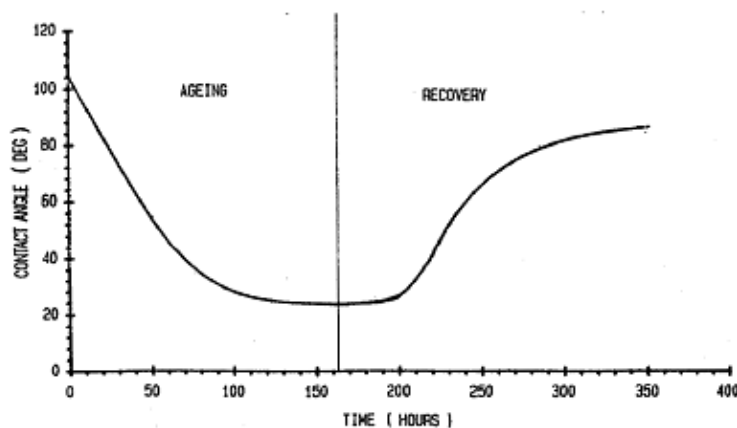
Figure 13: Recovery of hydrophobicity in a silicon insulator [20]

The hydrophobicity of a surface can be lost by the action of intense discharge activity. The surface generally recovers its hydrophobic properties to some extent, after a certain time when the discharge activity has stopped (Figure 13). [1] The recovery of the hydrophobic properties has received increasing attention as an important factor affecting the performance of outdoor polymer insulations. [19] Hydrophobic polymers such as silicon rubber have been successfully used in insulators located in polluted areas. [7] Silicon based grease can also be used to increase the hydrophobicity of an insulators surface. [4]

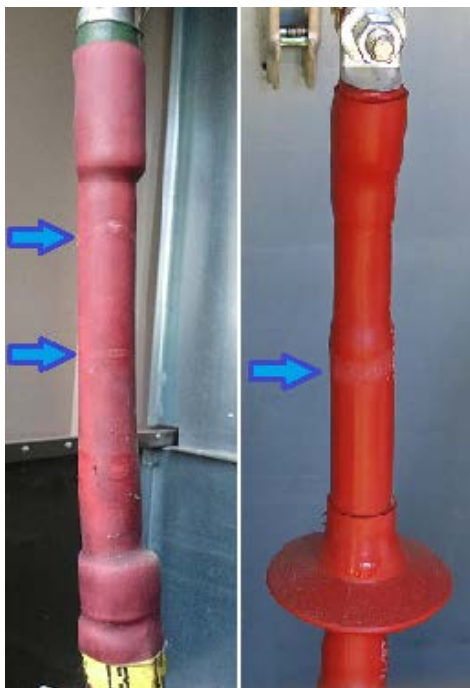
Figure 14: Faint marks of dry band arcing on termination surfaces

Recognizing the symptoms of discharges by bare eye can be quite challenging when the leakage current is not high enough to generate visible or audible arcing. A dry region is visible around the termination when the humidity is high enough to develop condensation on the surface and dry band arcing is occurring. The discharges are however not constantly occurring as the environmental conditions change over time. Traces of dry band arcing can usually be seen as pale rings around the surface of the termination, as seen in Figure 14. The rings on the surface are just a byproduct of the arcing phenomenon and do not require immediate actions. The performance of the termination is not endangered as long as the surface stays intact and the arcing is not too intense to cause a complete flashover. These rings are however a clear indication of the fact that continuous discharges have been occurring and some sort of maintenance or cleaning of the terminations is required.

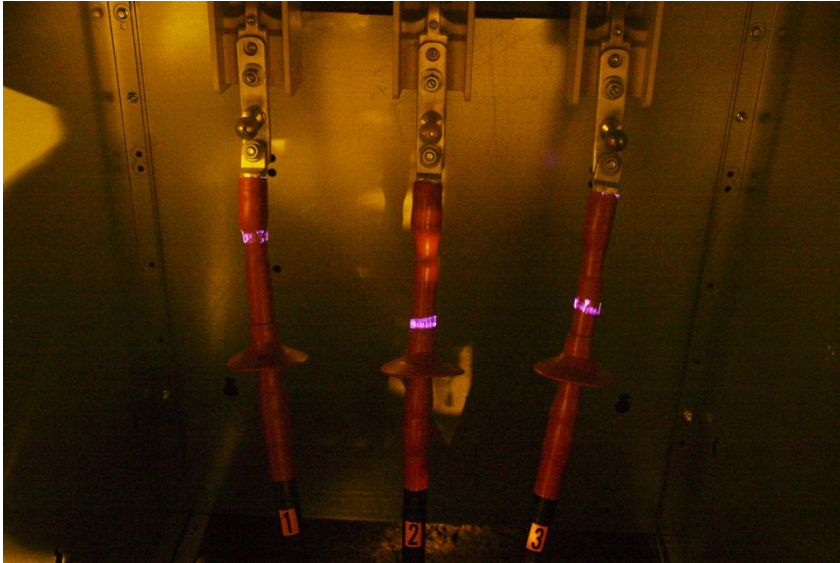
Figure 15: Visible dry band arcing in 20 kV indoor terminations

When the surface of a termination becomes moist and is covered by a well conducting layer of conducting particles, active dry band arcing can be heard and even seen on the surface (Figure 15). This type of visible arcing is not very commonly seen in the field if correct accessories are used, because the surface needs to be very conductive to achieve a high enough leakage current. Similar dry band arcing can be seen during the salt fog test for outdoor terminations where the discharges are artificially generated by spraying highly conducting salt fog on the terminations. Intensive arcing like this may seem dangerous to the accessory but the salt fog test is run for 1000 hours without extensive damage to the termination. Some maintenance actions should however be started to avoid permanent damage to the accessory.

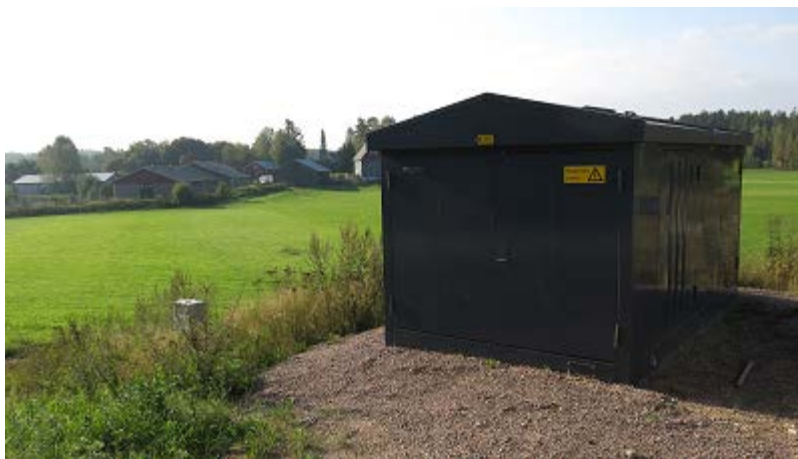
Figure 19: Conventional secondary outdoor substation located in the countryside

In urban areas where the network is cable-connected, the transformers are often located within commercial or apartment buildings, or inside prefabricated kiosk type single transformer secondary outdoor substations (Figure 19). Various different types and sizes of secondary outdoor substations are available, from bigger looped network models to smaller satellite type substations. [2]

The distribution transformer is often part of a looped network in urban areas. The incoming medium voltage feeders are normally equipped with load breaking disconnectors, with the transformer connected to the network loop through a load break switch and a current limiting fuse. [2] The distribution transformers in this kind of substations are generally in the range of 1000 kVA. [22]

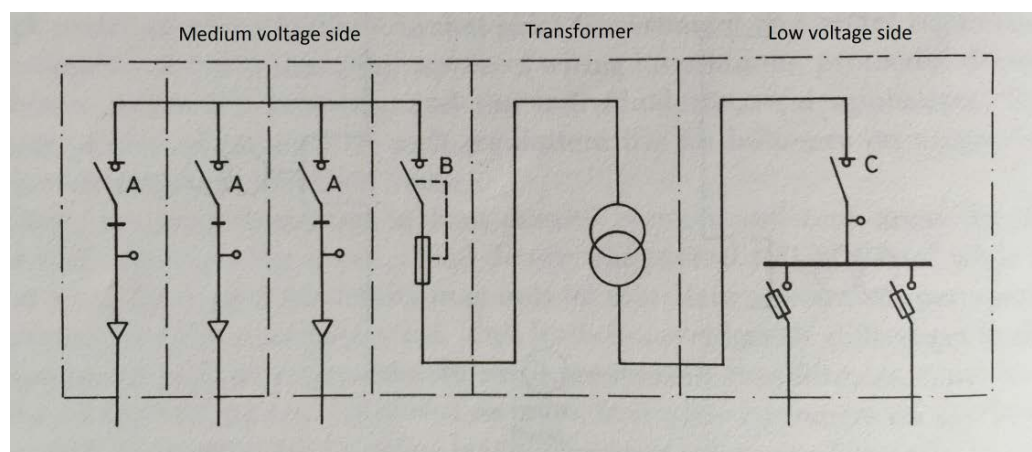
Figure 20: Schematic of a conventional secondary outdoor transformer [2]

Regardless of the dimensions, the general setup is to have the transformer positioned between the medium and low voltages compartments, according to Figure 20.

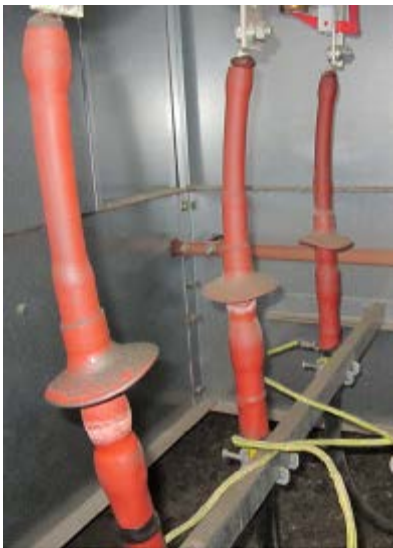
Figure 21: Severely polluted terminations inside a secondary outdoor substation

One of the main challenges from termination point of view is the environmental conditions inside a substation. A secondary outdoor substation is an unheated enclosure where accessories are installed inside a tight space. The enclosure protects the accessories and equipment inside it from rain and ultra-violet radiation, but it is not tight enough to prevent dust or other small particles from getting in. This result in a situation where the washing effect is prevented and pollution build up gets gradually worse in time (Figure 21).

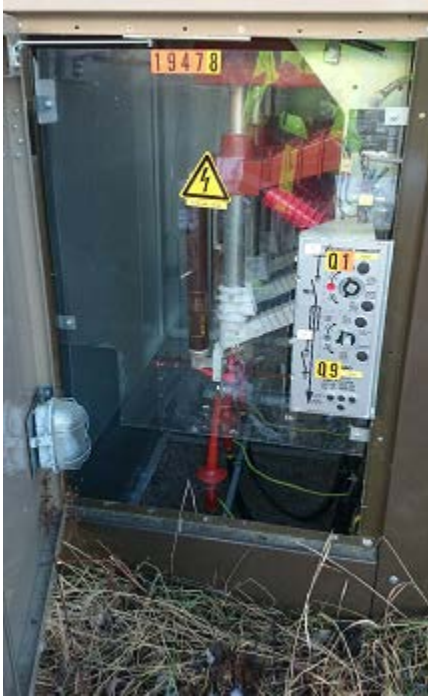
Figure 22: Partially submerged structure with terminations below ground level

The condensation of water combined with the pollution build up on the surfaces leads to a situation where surface discharges and dry band arcing are an inevitable consequence, especially if the substation is located in an unfavorable area with heavy pollutants, and also if wrong type of accessories are used.

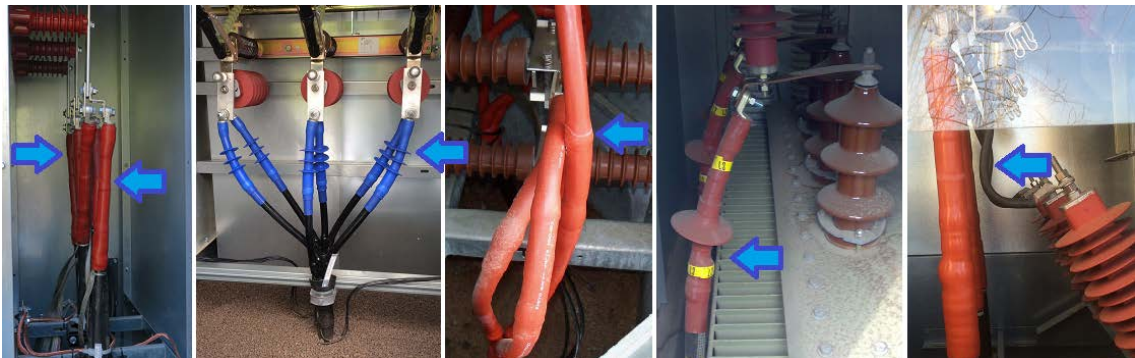
Figure 23: Problematic installations from real life

Issues related to the limited space inside the substation can sometimes be seen when parallel or different phases are touching each other, termination surfaces are in contact with ground or when the terminations are installed too close to live parts of auxiliary equipment, as seen in Figure 23. The electrical field strength on the surface of the termination becomes biased by these kinds of flaws and surface discharges can occur.

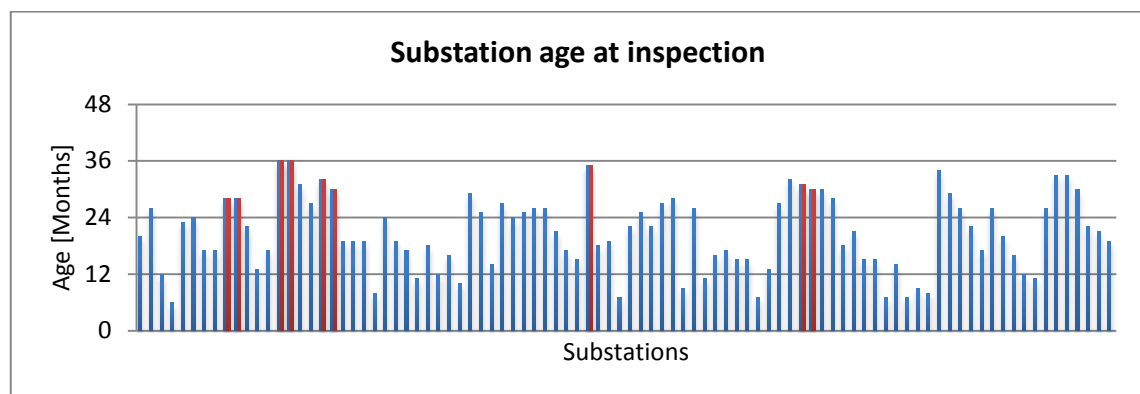
Graph 1: Substation age (Case 1)

The age of these 92 substations is presented by the blue bars in Graph 1. The red bars are used to visualize the substations where terminations with discharges traces were found.

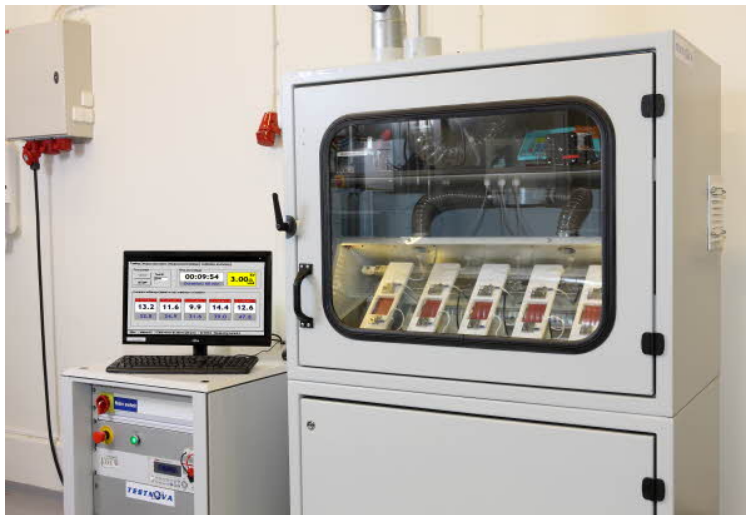
Figure 24: Test chamber for the inclined plane test

Performance of different material samples and surface coatings was studied in the inclined plane test (Tracking test). The resistance to tracking and erosion was compared by using liquid contaminant and inclined plane specimens. The test was performed in a tests chamber specially built for this purpose (Figure 24).

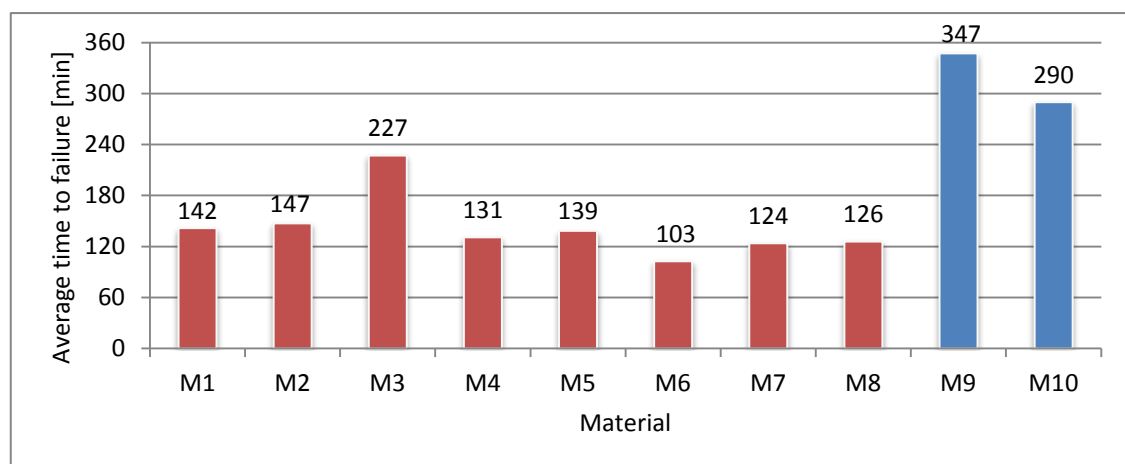
Graph 11: Average time to failure

The results contain some deviance between samples of the same material, so for easier comparison, an average time to failure is presented in Graph 11.

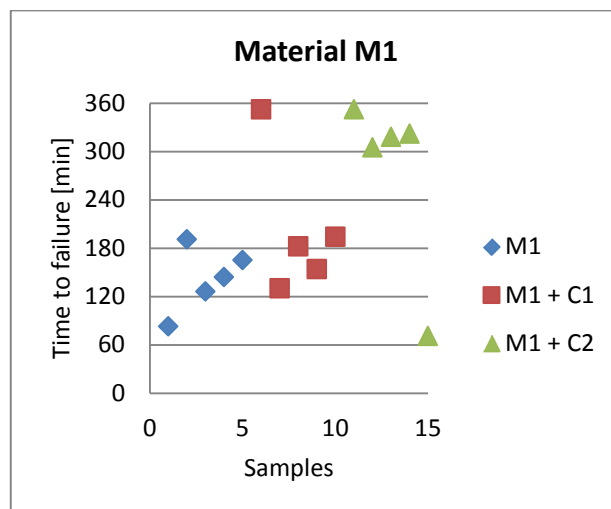
Graph 12: Effect of coatings C1 and C2 on material M1

Coating C1 was tested with materials M1, M2 and M3 and coating C2 was tested with materials M1 and M2. The results for these tests are presented in Graph 12, Graph 13 and Graph 14.

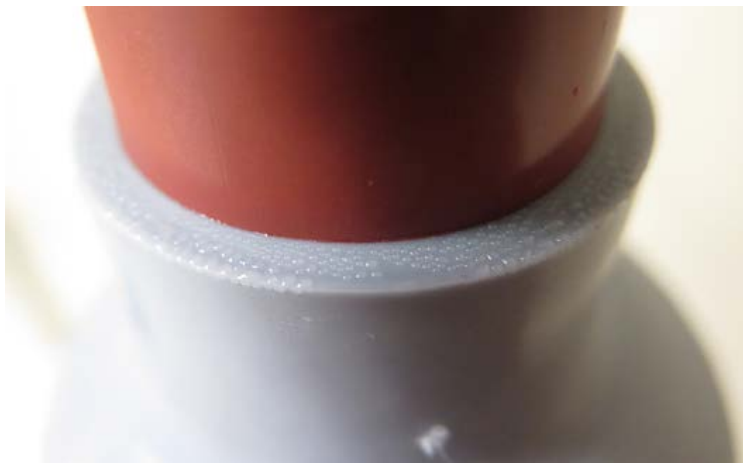
Figure 29: Water droplets on the edge of the rain shed

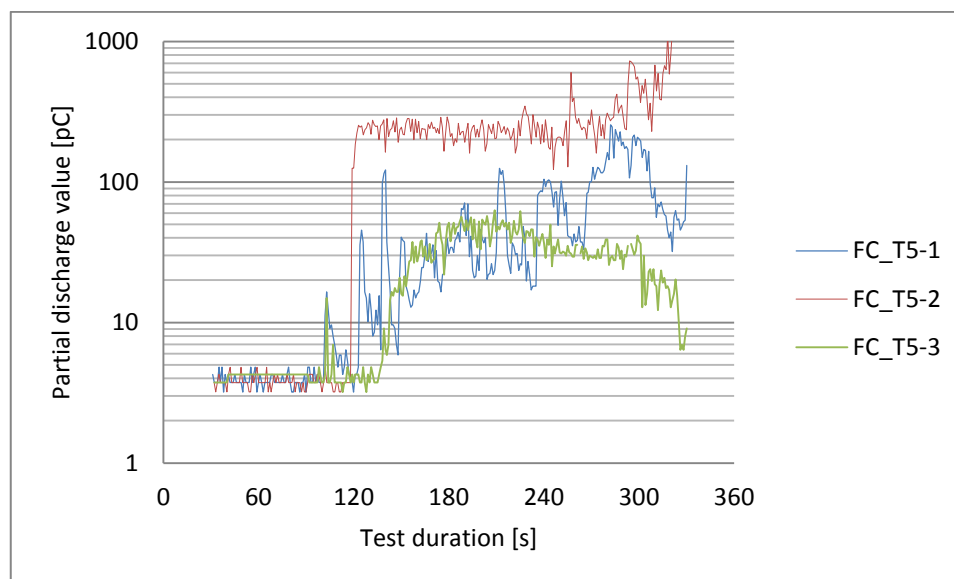
Graph 16: Discharge occurrence vs. test duration for the tested FC_T5 terminations
