**Title:** *Thermography Methodologies for Detecting Energy Related Building Defects*

Building thermography methodology, defect detection

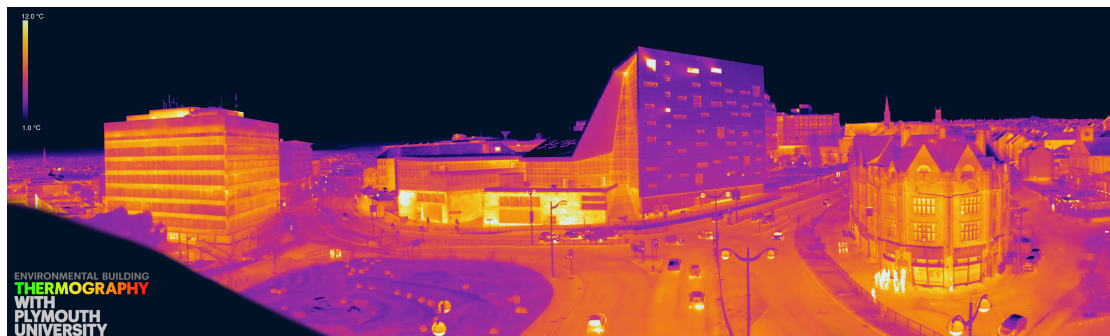
Figure 1. Thermal image of Plymouth University campus.

Figure 1 shows an example thermal image of the Plymouth University campus.

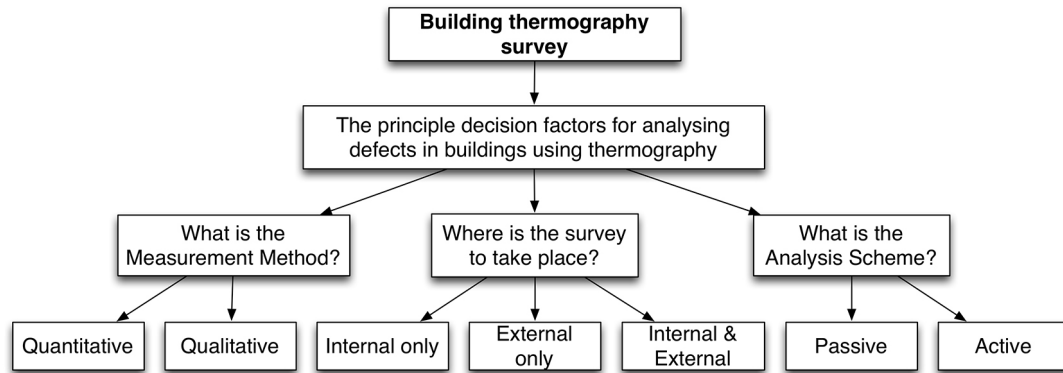
Figure 2. Key decision-making process for the determination of building thermography methodology. This figure has been based upon the author's training and hands-on experience of surveying buildings in the UK.

Before a building thermography inspection, thermographer's first need to question what principle methods they will use for analysis. This decision process will be shaped by the questions posed in figure 2.

classify ideas for analysis and further investigation [63]. Some of these filters were based on the key-decision making process diagram (figure 2); whilst others sought to determine the defect type, document type and application methodology.

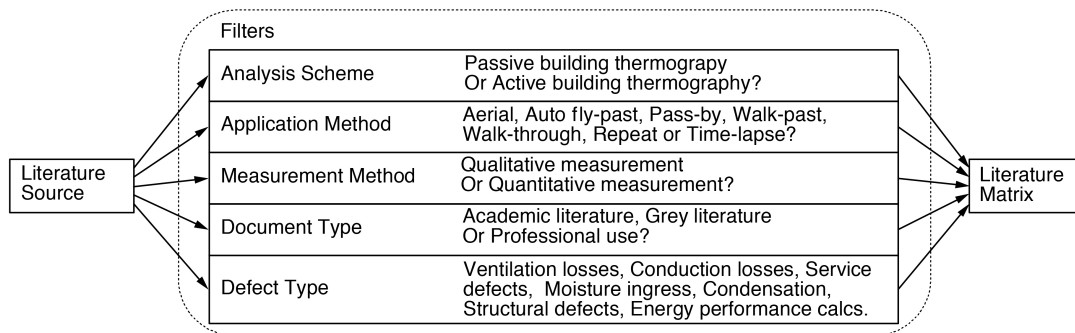
Figure 3. Literature filter diagram.

All collected literature was systematically reviewed and categorised based on a series of defined filters (see figure 3) that formed the basis of the key-word search and helped to

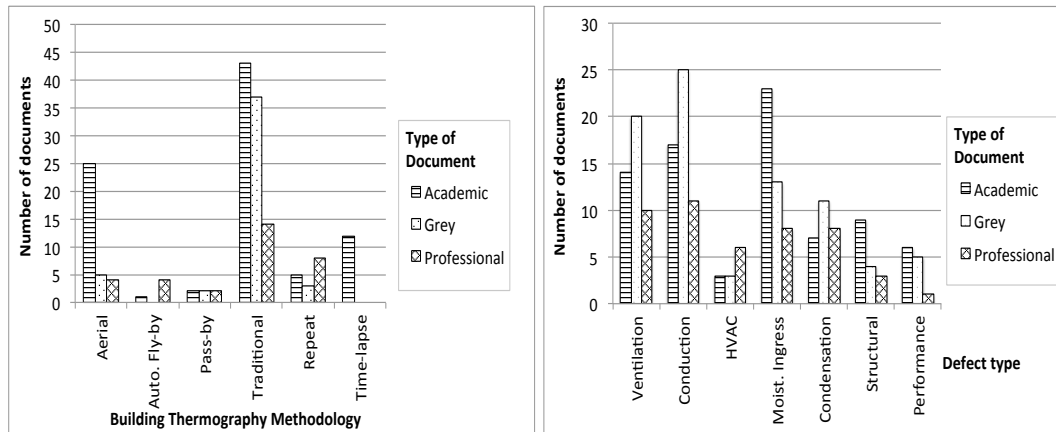
Figure 4. (Left) Literature by source and building thermography methodology. Figure 5. (Right) Literature by source and defect type for traditional passive building thermography methodology.

Figure 4 suggests that while academic work can be observed within all passive building thermography methodologies, a professional application is present in all but the time-lapse methodology. One theory for this may be a limited understanding of this methodology, while another could be because it is more disruptive (to occupants), time-consuming and more complex to set-up compared with the other passive building thermography methodologies.

Figure 4 also reinforces the hypothesis that much of the available literature centres on more traditional methodologies. The automated fly-by and repeat passive building thermography methodologies have seen more professional application than academic research. With regards to the limited academic and grey literature on fly-by thermography, this reinforces findings that this is a relatively new methodology and suggests room for future research.

Focusing on traditional passive building thermography, figure 5 shows that much of the documentation discussing ventilation losses, conduction losses and condensation defects comes from grey literature sources, while moisture ingress, structural and performance related issues appear academic led.

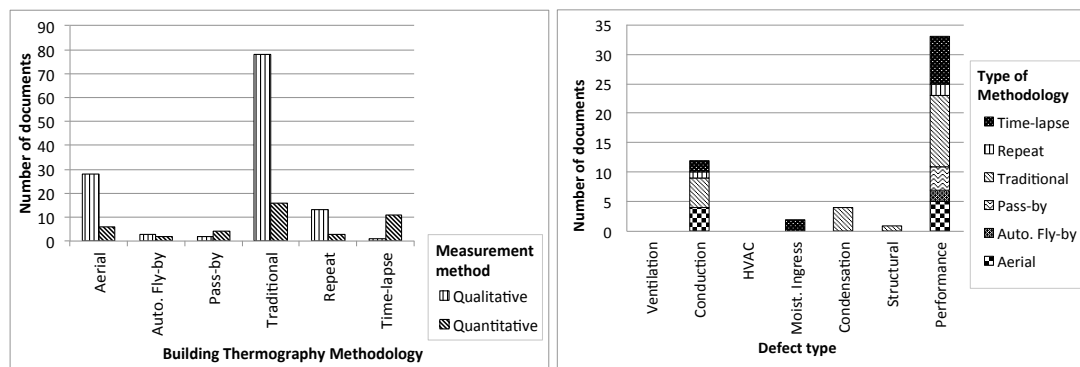
Figure 6. (Left) Literature by building thermography methodology. Figure 7. (Right) Quantitative literature only by building thermography methodology and by building defect type.

Comparing the data with regards to the measurement method applied for each of the application methodologies, figure 6 provides evidence that supports statements from Kee [108] and Kominsky *et al.* [41], that passive building thermography is primarily performed on a qualitative basis. However this does not appear to be the case for pass-by and time-lapse thermography, which held a greater degree of quantitative application.

However examining quantitative applications within passive building thermography methodologies, figure 7 shows that most of the research in this area targets energy performance estimation, which although not specifically classed as a building defect will

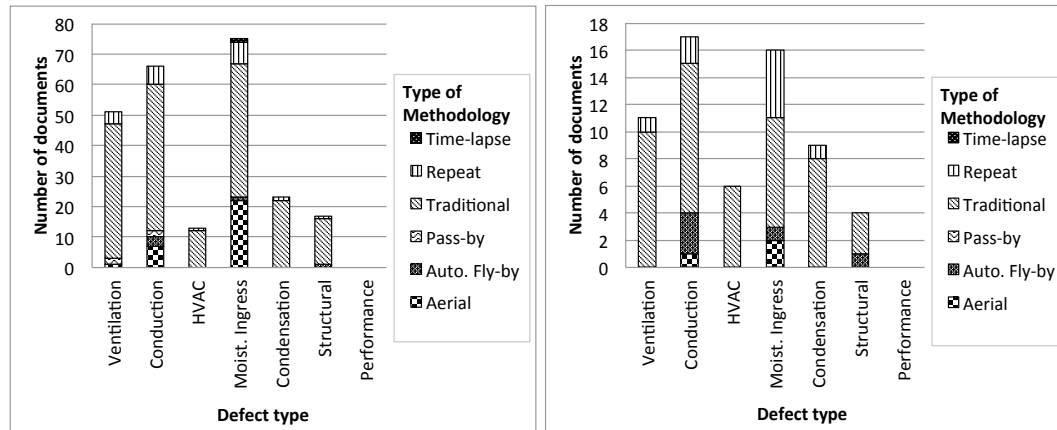
Figure 8 (Left) Qualitative literature analysis by passive building thermography methodology and by defect type for all literature sources. Figure 9 (Right) Qualitative literature by passive building thermography methodology and by building defect type for professional literature source only.

Figure 8 indicates how each of the passive building thermography methodologies are currently being utilised for qualitative defect detection. Confirming their significance in construction performance, the three defects: Ventilation losses, conductivity deficiencies and moisture ingress can be seen to have had considerable mention within academic and professional literature. Focusing on only the documented professional use, figure 9 shows that conductivity and moisture ingress again seem to be the defects with most focus.

Figures 8 and 9 also show that traditional methodologies are the most common form of defect detection, and that all thermally significant defects have been detected using traditional methodologies. This is possibly due to the frequent use of this methodology, however it could also suggest limitations within the other passive building thermography methodologies. For example, repeat thermography is the only other methodology that has also been recorded as observing condensation defects, which could suggest a difficulty in obtaining a qualitative result using methodologies that are externally focused.

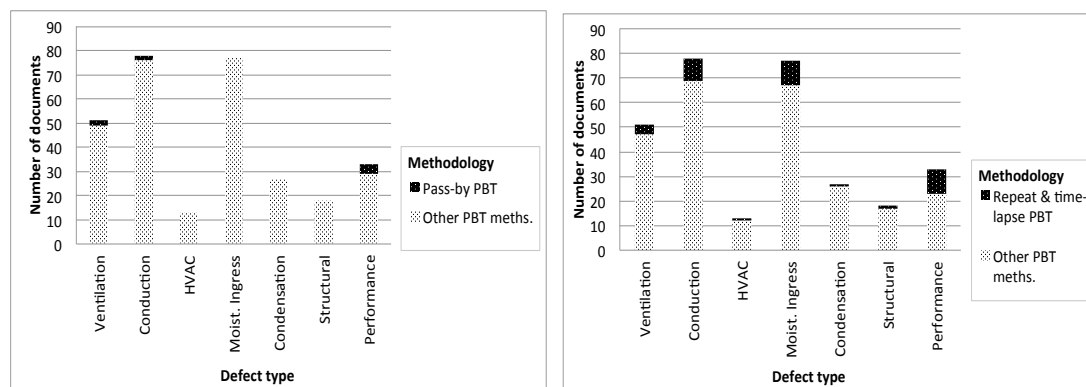
Figure 10. (Left) Literature by defect type with a focus on pass-by passive building thermography. Figure 11. (Right) Literature by defect type with a focus on repeat and time-lapse passive building thermography.

Figure 10 supports this position, showing that only ventilation and conduction loss defects have been identified to date using a pass-by methodology (in addition to total energy performance estimations), therefore missing one of the main thermally significant defect groups, moisture.

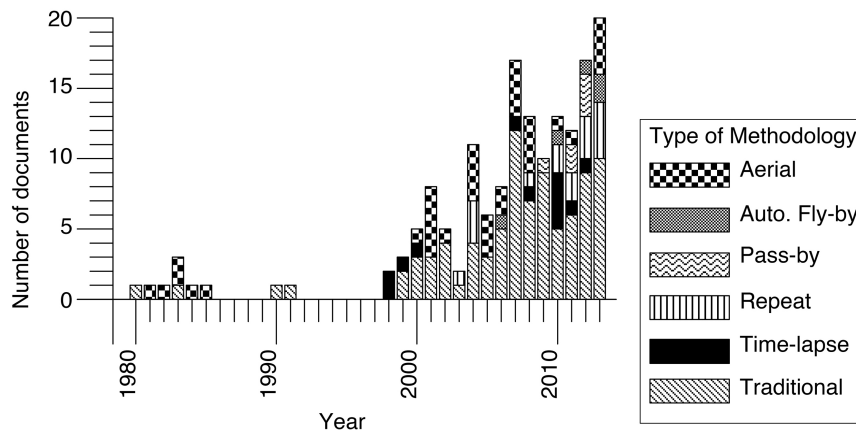
Figure 12. Occurrence of literature by passive building thermography methodology and by date.

Recent advances in thermal camera technology such as the digitisation of image collection [32] have likely helped to shape the way in which passive building thermography methodologies are performed. This is supported by figure 12, which shows the documented patterns of passive building thermography methodology occurrence by documentation publication date. It is interesting to note that early reported methodologies consisted of either aerial or traditional methods for passive building thermography, while newer methodologies have been introduced and most significantly reported on within the past 10 years. It is also interesting to observe the more recent accumulation of literature on passive building thermography, which underlines the growing application of thermography for building assessment.
