Characterization of concrete from Roman buildings for public spectacles in *Emerita Augusta* (Mérida, Spain)

The present study focuses on the compositional characterization of Roman concrete from Roman buildings for public spectacles, theatre and amphitheatre, from *Emerita Augusta*, Mérida, Spain. An advanced knowledge of the Roman concrete composition is required to get a reliable restoration and preservation of these ancient monuments. The concrete was studied through mineralogical (petrographic microscope and X ray diffraction) and petrophysical (bulk and real density, open porosity, mercury intrusion porosimetry, compressive strength and ultrasonic pulse velocity) analyses. With this work, it is possible to fill the gap which exists in this field, the characterization of the materials used in the Roman concrete from these two buildings, never previously studied, despite the significance of this archaeological ensemble, declared a World Heritage Site by UNESCO in 1993. The obtained results of the studied samples, allowed us to determine the composition of the concrete and to infer the provenance of the aggregates used in it.

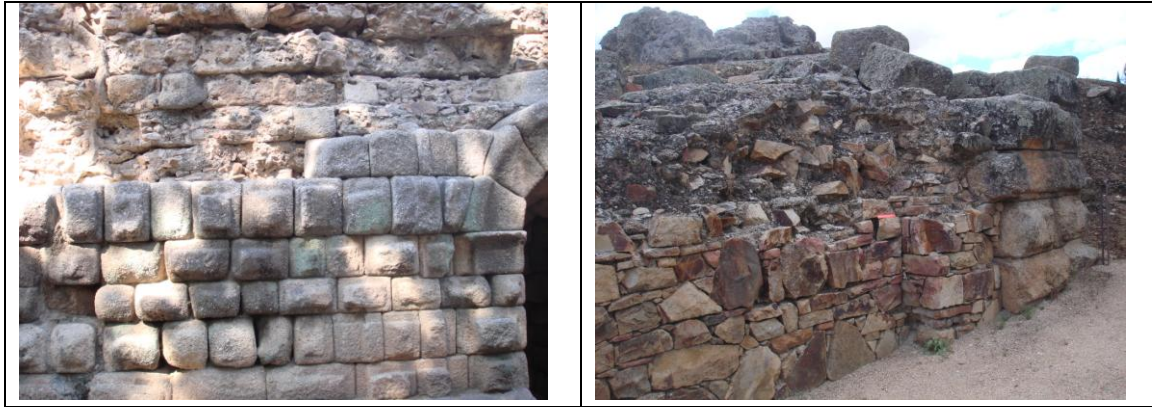
Fig. 2. External wall from the theatre (left) and amphitheatre (right).

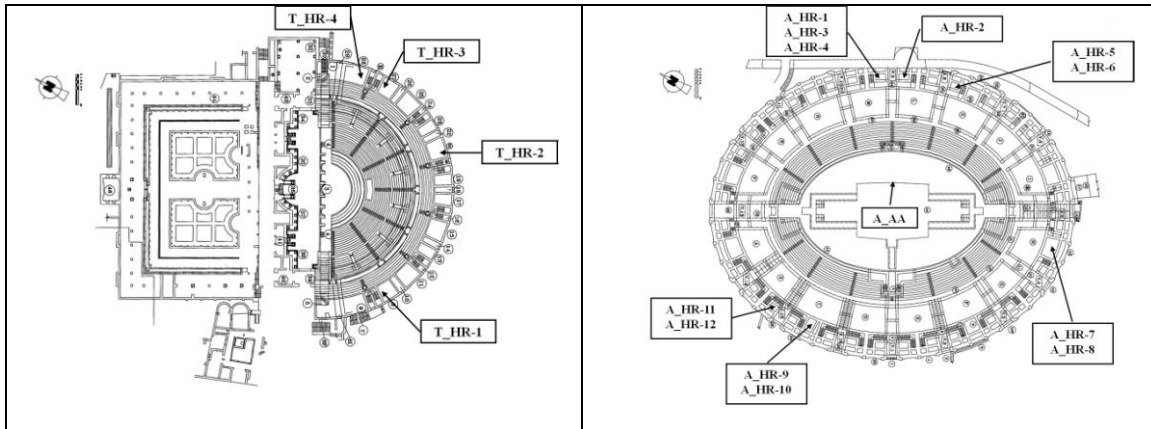
Fig. 4. Locations of the sampling of the studied concretes in theatre (left) and amphitheatre (right). Plan from Duran Cabello (2004).

Due to the historical classification of these buildings, which belong to the Archaeological Ensemble of Mérida, listed as World Heritage Site in Spain, the sampling of the concrete was very restricted even with legal authorization from the competent institution in charge of the structures. Twelve concrete samples were taken from the amphitheatre and four samples from the theatre, being these samples representative enough for the whole building (Table 1 and Fig. 4). The location of the samples is shown in Fig. 4.

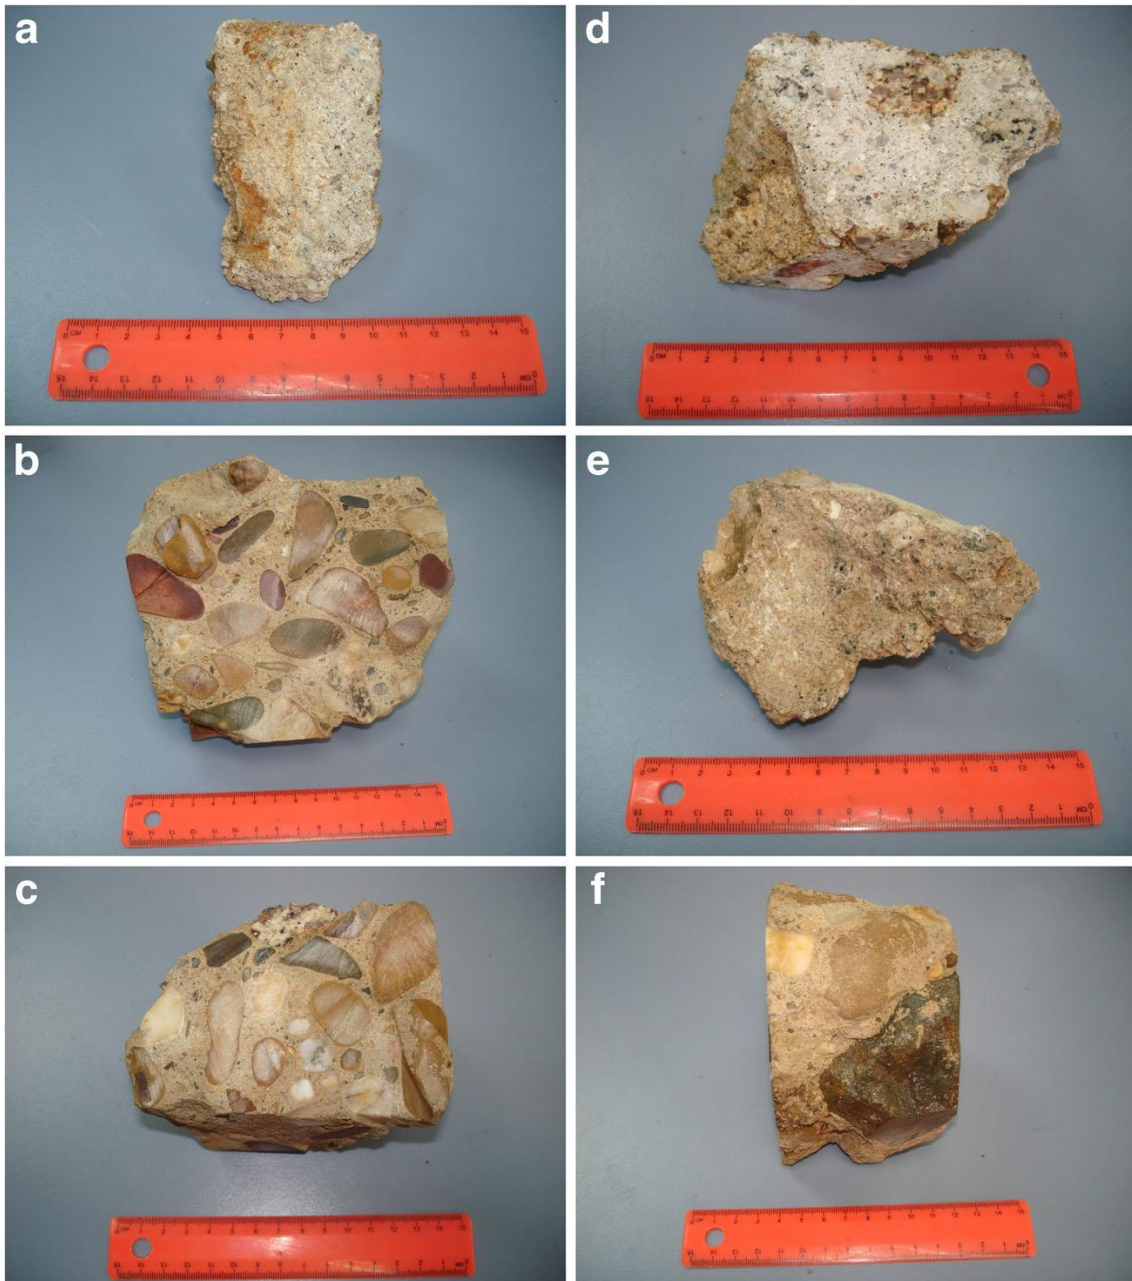
Fig. 5. Photographs of the concrete samples T_HR-1 (a), T_HR-2 (b), A_HR-6 (c) and A_HR-11 (d).

The samples were cut from a concrete core (5 cm diameter) extracted from inside the masonry walls, trying to obtain an undamaged material (Fig. 5). A sufficient quantity of sample was taken to allow the development of the entire set of planned analyses in all cases. The external and more decayed part of the samples was removed and discarded in order to ensure the collection of non-altered material (Álvarez et al. 1999).

The concrete samples from both monuments were characterized by aggregates having sizes up to 10 cm (Fig. 5) and a whitish binder, observing, in the case of the theatre, fragments of gray granite (2 cm), quartzite (4 cm), feldspars and ceramic, besides the presence of pores having different sizes. The aggregates show coarse grain sizes, larger than 2 cm. In the case of the amphitheatre, the mortar samples, according to macroscopic observation of the type of aggregate used, could be separated into two categories, those that present fragments of green schists (A_HR-1, A_HR-3, A_HR-5, A_HR-6, A_HR-7, A_HR-10, A_HR-11), and those that present fragments of metamorphic rocks (A_HR-2, A_HR-4, A_HR-8, A_HR-12). The aggregates in these samples showed a coarse grain size, ranging from 2 cm to 7 cm. These aggregates, minerals and rock fragments, showed sub-angular to rounded shape.

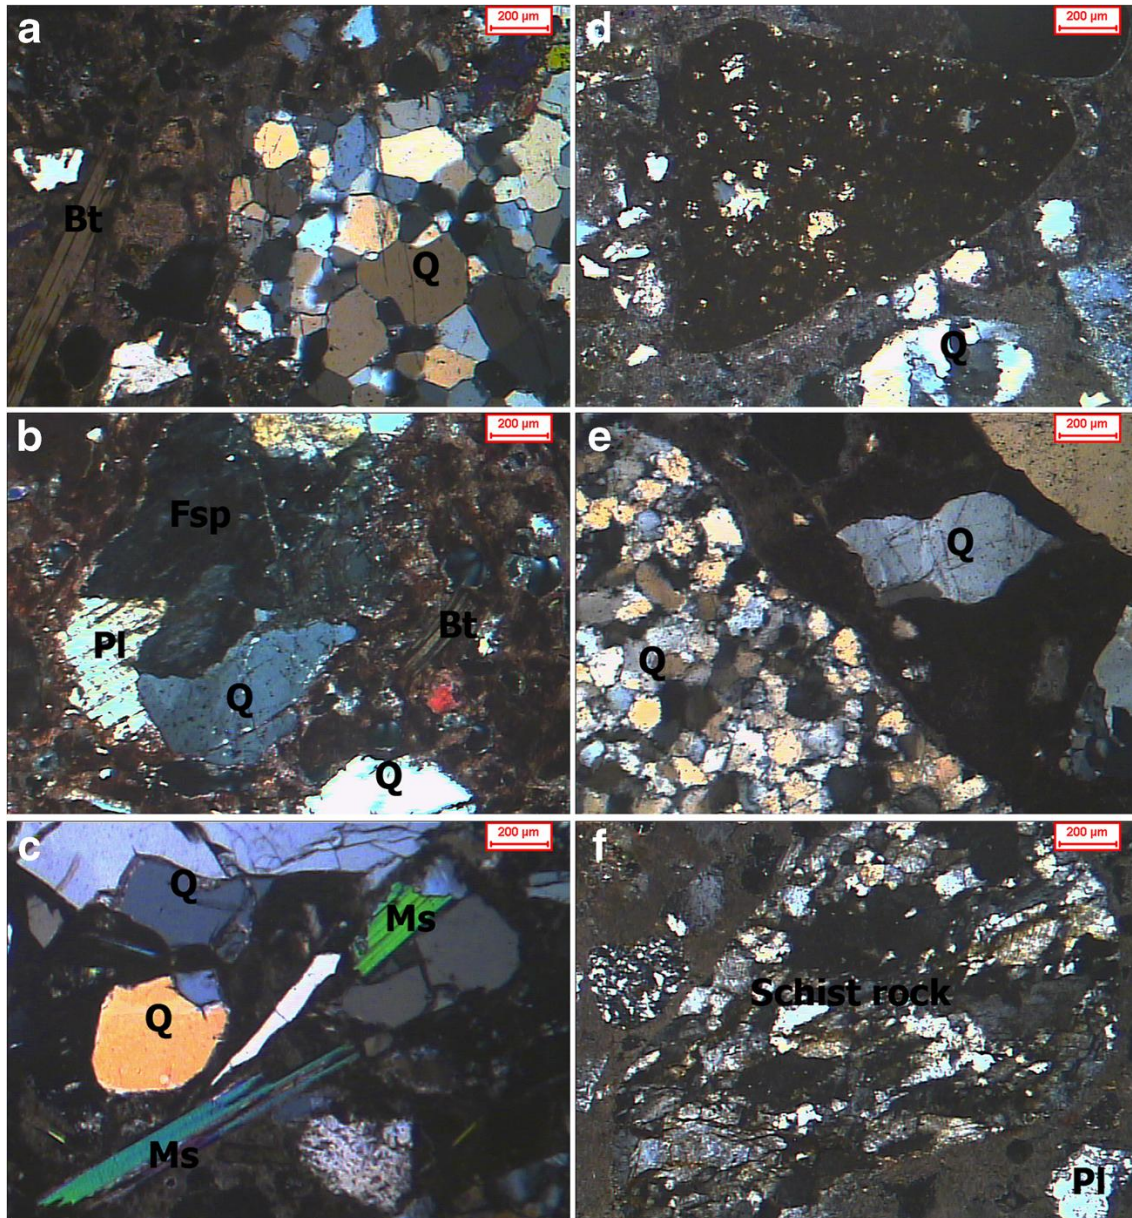
Fig. 6. Thin-section images of the mortar samples in crossed polars. (a) Sample T_HR-3. Biotite grains and a fragment of quartzitic rock made of a quartz grains mosaic, in a carbonated matrix and the presence of pores. (b) Sample T_HR-4. Angular quartz grains, potassium feldspar, plagioclase and biotite in a carbonated matrix. (c) Sample A_HR-12. Rounded clast of quartz (left) and muscovite grains floating in a carbonated matrix. Some pores and fractures are present in the sample. (d) Sample A_HR-4. Polycrystalline quartz and angular ceramic fragment floating on a fine-grained cohesive lime binder. (e) Sample A_HR-6. Angular

quartz grain and a fragment of quartzitic rock, made up of a mosaic of quartz grains, in a carbonated matrix. (f) Sample A_HR-7. Fragment of schist rock and plagioclase floating in a carbonated matrix.

The petrographic analyses revealed the presence of calcite (binder areas were red stained), having a micrite size, resulting from the carbonation of the lime used as binder (Velosa et al. 2007). This fine-grain size is the responsible for the cohesive petrofabric of the lime binders studied, displaying a perfect aggregate bond and scarce fissures that suggest a high reactivity, water retention capacity and low shrinkage of the lime (Pavía and Caro 2008), fissures that usually are present in ancient mortars or concretes having low quality (Malinowski 1979). Besides, it could be shown the presence of numerous tiny pores (0.06 mm to 1.15 mm), having inter-granular type, in certain zones. Micrographs of T_HR-3, T_HR-4, A_HR-4, A_HR-6, A_HR-7 and A_HR-12 samples are shown in Fig. 6.

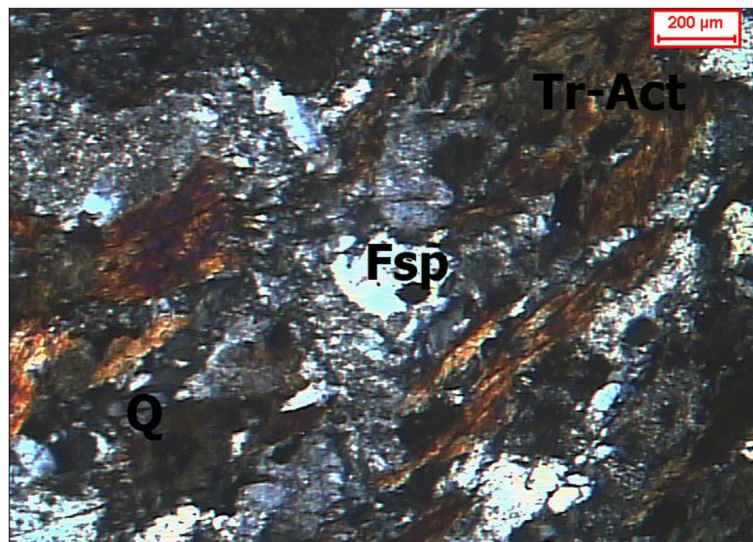
Fig. 7. Thin-section observation of the sample from the *arena* outcrop in cross polarized light. Sample A_AA. Nematogranoblastic rock, with quartz grains, potassium feldspar and tremolite.

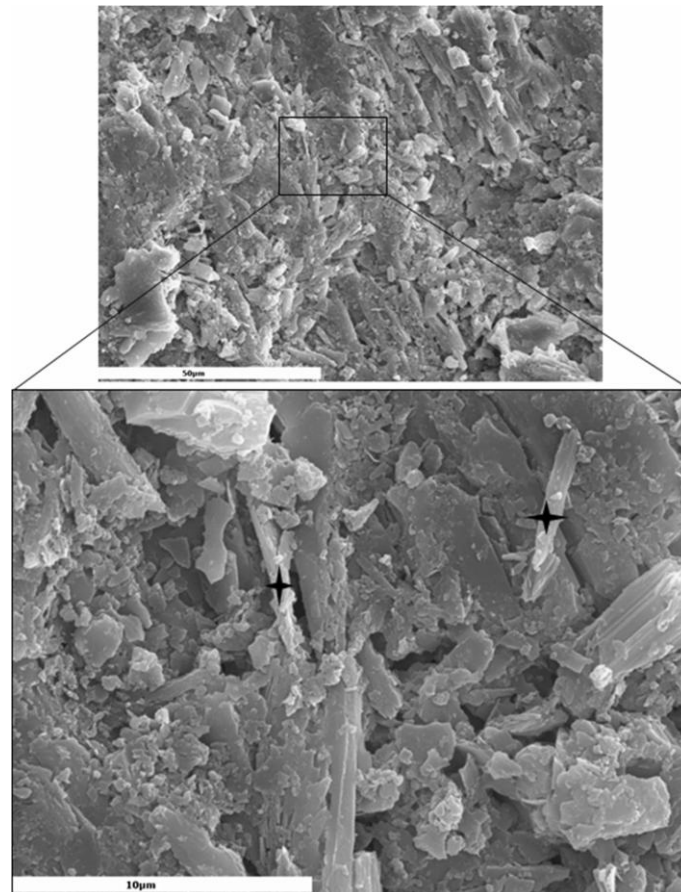
Fig. 10. SEM micrographs of T-HR-3 sample showing the needle shape calcium silicate aluminium hydrate (CSAH) crystals in the border of the binder and ceramic fragment (EDS analysis on the points indicated in the picture with black star show the presence of Ca, Si, Al and Fe).

et al. 2010). The pozzolanic effect is attributed to the adhesion reaction that happens in the interface ceramic fragments and the matrix, in which calcium silicate is formed (Fig. 10). SEM-EDS give additional information about the microstructure of the binder, aggregate and reactions between them. In all mortars quartz aggregates and brick fragments were detected as embedded in the lumpy appearance calcitic lime binder. Needle like CSAH crystals are observed inside the cracks and pores of the ceramic fragments and in the boundary between aggregate and binder. Lime can seep inside de ceramic fragments, and can reduce the pore size, increasing real density, achieving a great compression strength in the Roman concrete (Moropoulou et al. 2003, 2005). This can explain its acceptable conservation state and stability in the time.
