ROAD SAFETY ASSESSMENTS AND ROAD SAFETY AUDITS ON THE EXISTING ABU DHABI INTERNAL ROAD NETWORK

Siegfried GROSSKOPF, Tawab KAZEMI*, John HUGHES* & Sami ALMUSAWI Bani Hashim#

Parsons International Limited, P O Box 9123, DUBAI, UAE

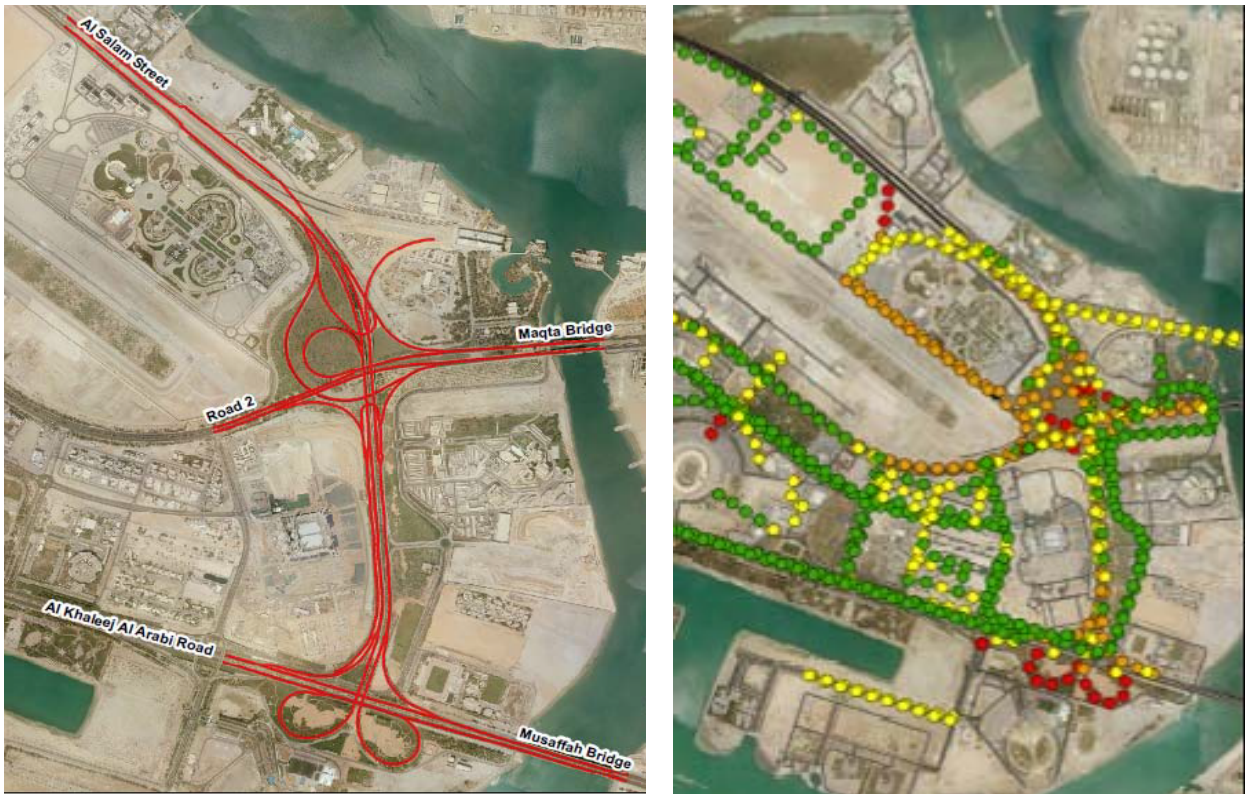
The project audited the Musaffah and Maqta Bridge free flow interchanges as well as the roundabout Interchange (IP145) on Airport Road (Road 2) and comprised about 29 carriageway-km. . The layouts of the Maqta Bridge and Musaffah Bridge Interchanges are on the left shown in Figure 1. The risk levels of the NetRisk Scores that had been developed from the video assessment and used to determine the road sections to be subjected to road safety auditing for this portion are shown on the right in Figure 1. (After reviewing the NetRisk Scores and the variation thereof on the interchanges, it was decided that it would be appropriate to conduct an audit on the entire interchange rather than only selectively.)

Figure 1: Layout of Maqta Bridge and Musaffah Bridge Interchanges with NetRisk risk levels

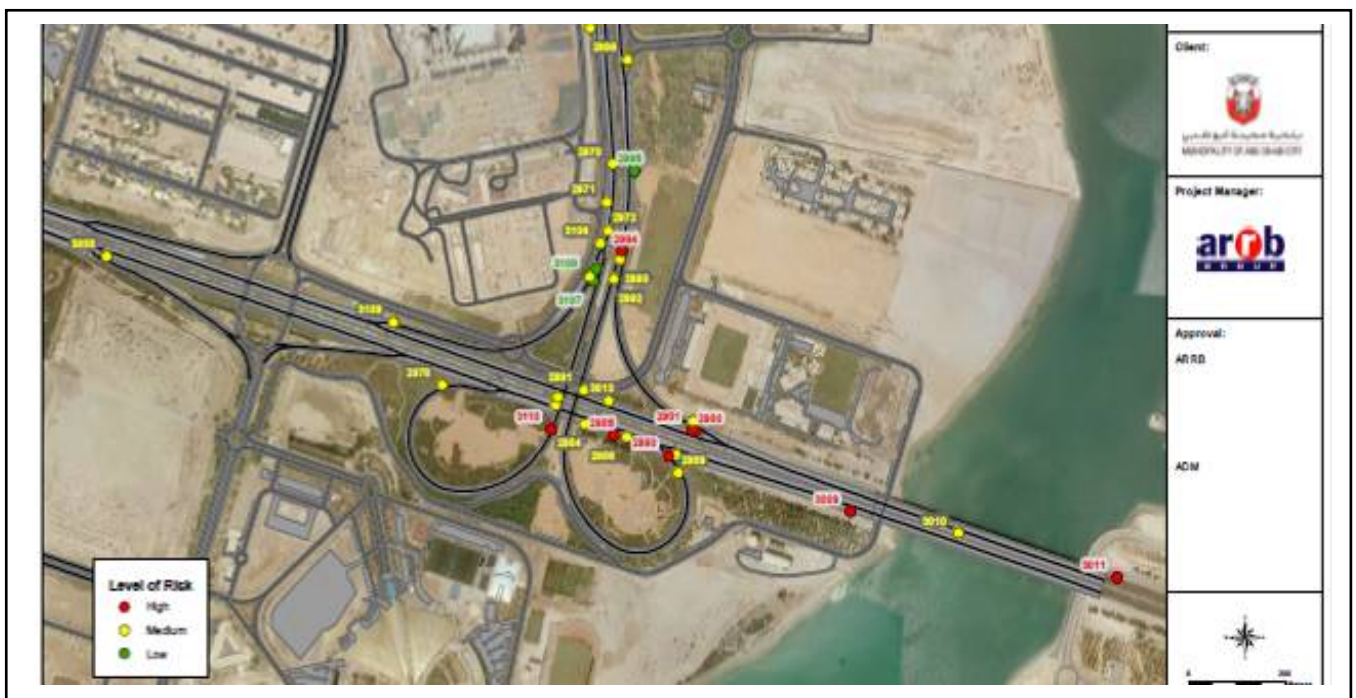
Figure 2 is an extract from the GIS map for the Musaffah Bridge interchange showing specific problem locations and the associated level of risk for these problems.

Figure 2: Problem locations on Musaffah Bridge Interchange

A first order estimate had been made to identify the potential cost to remedy the specific problem issues on this section of the project. The estimate for improving the safety based on the 192 identified problems amounted to AED 7,096,000. (USD 1.93Million)

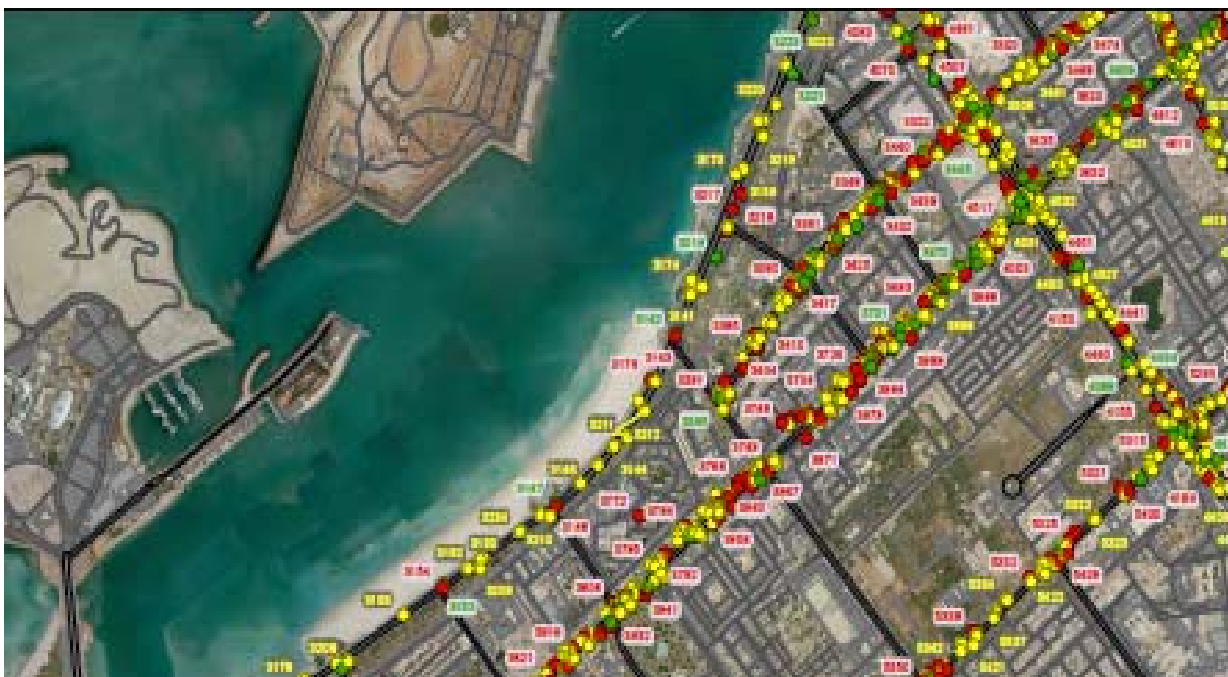
Figure 4: Typical problem locations on Arterial Roads showing level of risk
