# An Uncommon Presentation of Breast Implant Rupture

**Summary:** Late periprosthetic seroma has lately been concerning for breast implant-associated anaplastic large cell lymphoma. The authors present an uncommon presentation of breast implant rupture with a seroma and skin rash forming 2 years after insertion of the implant. (*Plast Reconstr Surg Glob Open* 2016;4:e719; doi: 10.1097/GOX.0000000000000699; Published online 26 May 2016.)

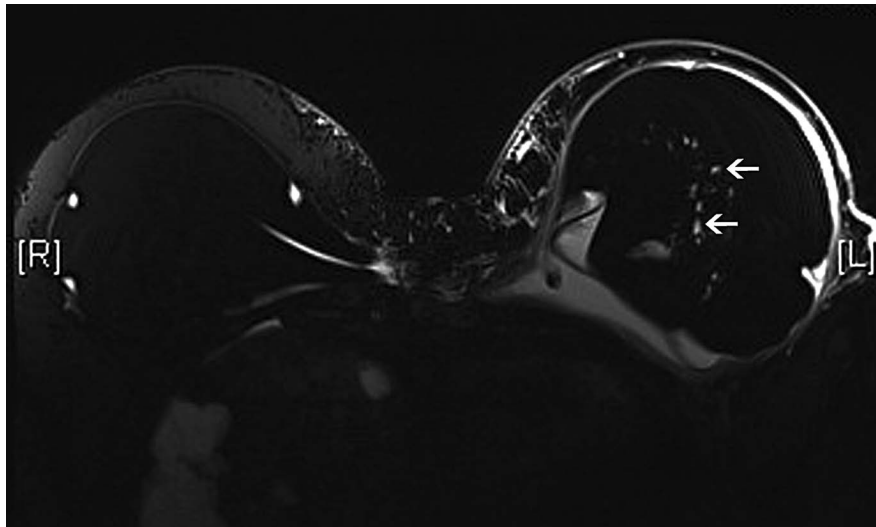
**Fig. 3.** Magnetic resonance imaging showing breach of the envelope at the deep aspect of the implant. Multiple areas of water signal content are noted within the silicone in the implant.
