Seismic Safety Assessment of Historical Structures Using Updated Numerical Models: the Case of Mallorca Cathedral in Spain

Abstract

2 MALLORCA CATHEDRAL

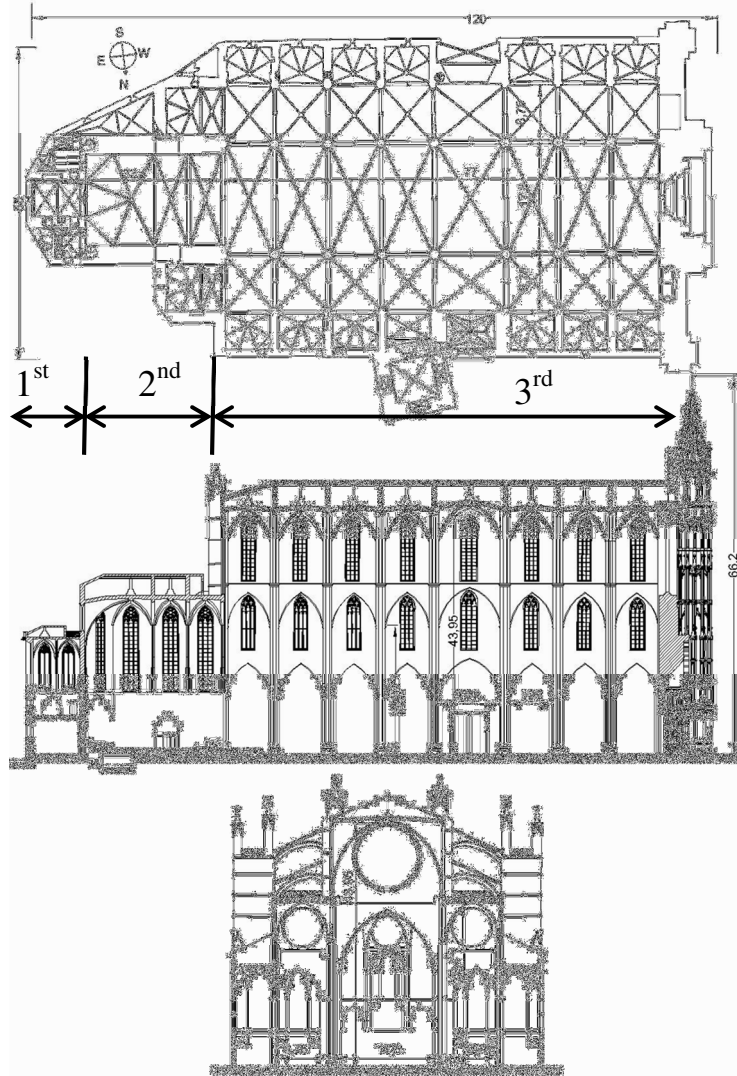
Figure 2. Mallorca cathedral: plan (top); longitudinal section (center); and transversal section (bottom) (from Director Plan of Mallorca Cathedral).

Mallorca cathedral is located in the city of Palma, Mallorca Island (Spain). It is a Gothic construction built from 14th to 16th centuries (Figure 1). The construction started around the year 1300. The Trinity Chapel (1st part in the plan in Figure 2) was completed in year 1311 while the Royal Chapel (2nd part in the plan in Figure 2) was finished around year 1370. The imposing main large nave and the west facade (3rd part in the plan in Figure 2) were completed by the year 1601.

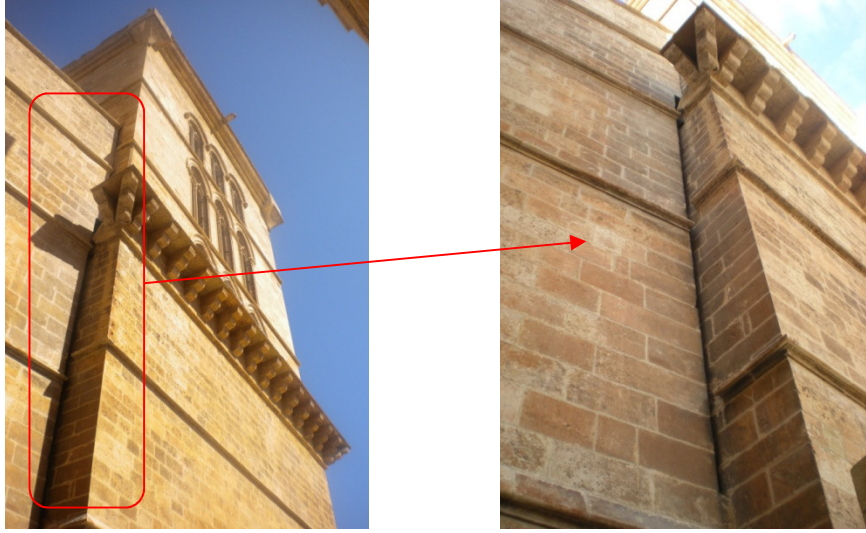
Figure 3. View to the tower-buttress relation (left); and zoom to the separation (right).

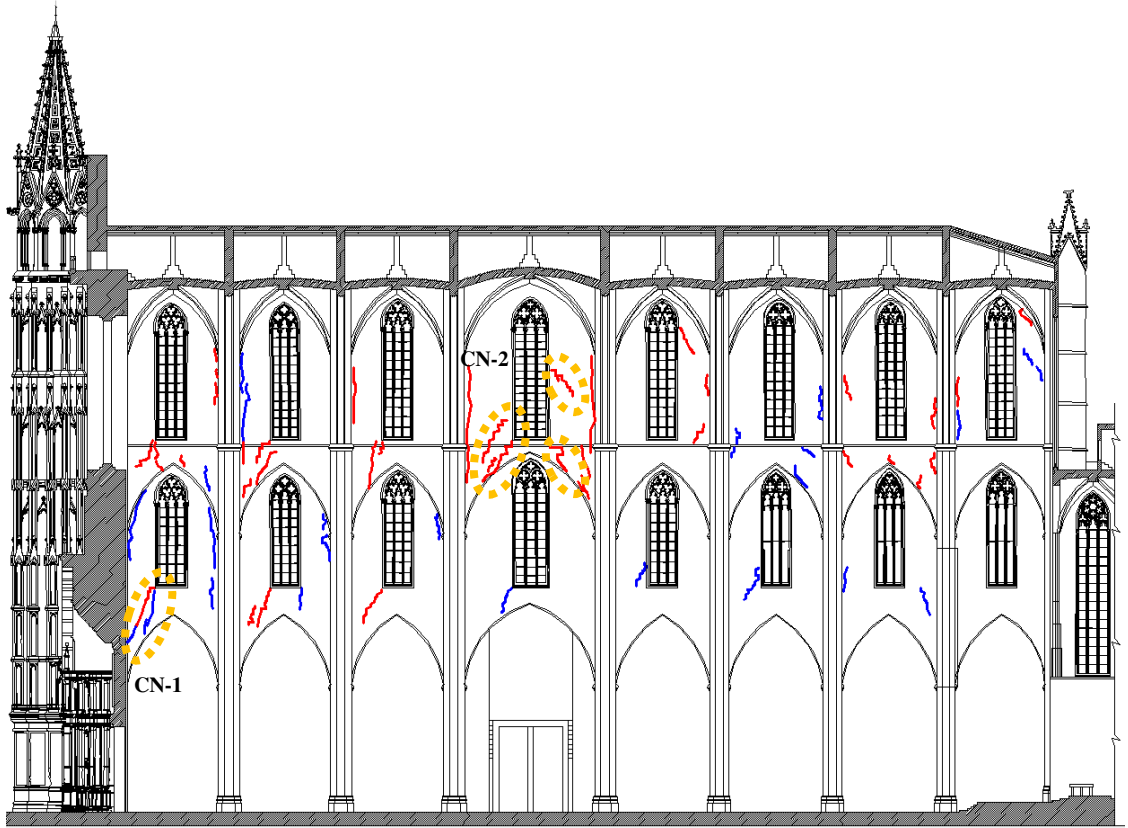
Figure 4. Crack survey of north (top) and south (bottom) clerestory walls before a recent repair. Red cracks are wider than blue ones. Pictures of cracks surrounded by ellipses are shown in the next figure.

Cracking survey revealed presence of cracking and other damage in some of the structural elements of the cathedral [26, 29-30]. In some columns locally distributed vertical or oblique cracks are found. These cracks tend to concentrate close to the less confined parts of the section, i.e., the corners. Additionally, GPR and seismic tomography exploration of the columns has pointed out that some columns have minor inner defects [31]. Figure 4 reports the crack survey of the north and the south clerestory and exterior walls as can be seen from inside the cathedral. It must be noted that some of this damage has been repaired in recent restoration works. Pictures of these cracks are shown in Figure 5. It was noticed that all the bays of the clerestory walls were cracked. The first four bays from the west façade showed more intensive cracking pattern when compared to the bays near the east façade. The bay with the longest span exhibited more cracks than the other bays. Regarding the cracks shapes, two types could be noticed, the first were the diagonal cracks around the openings of the windows. The second were the vertical cracks between the walls and the supporting elements whether (columns or buttresses). The distribution of the diagonal cracks is similar to that of the damage predicted by the pushover analysis (discussed later in section 6.2.1), which suggest that it might be related to the seismic history of the island of Mallorca. Cracks also exist in other elements such buttresses and lateral nave vaults.

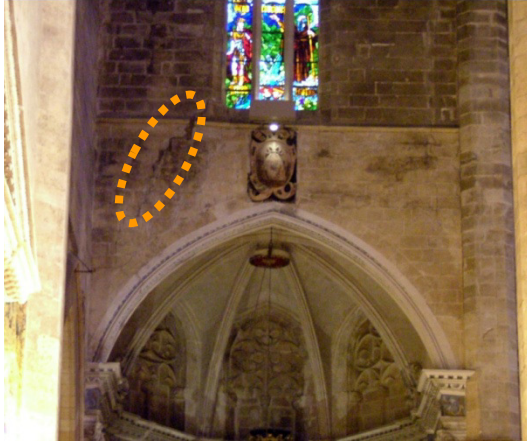
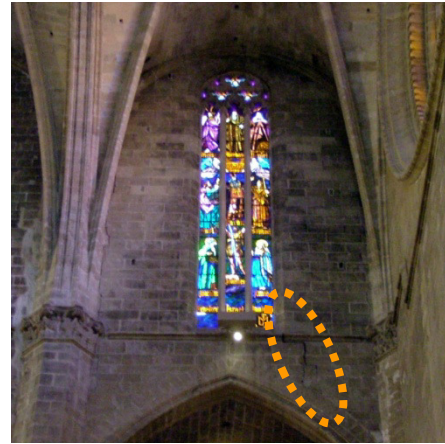
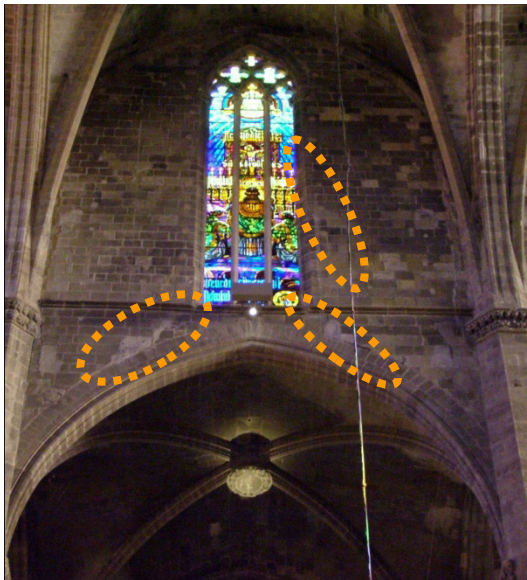
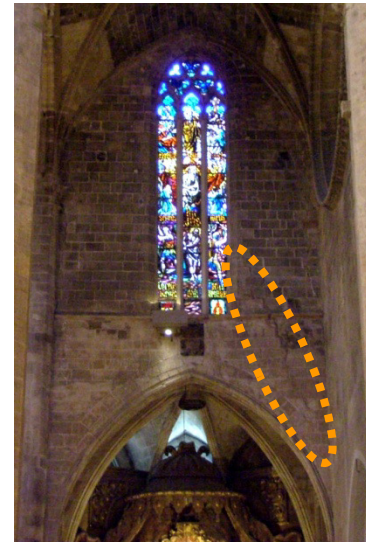
Figure 5. Pictures of some of the cracks indicated of the previous figure seen from the interior of the cathedral.

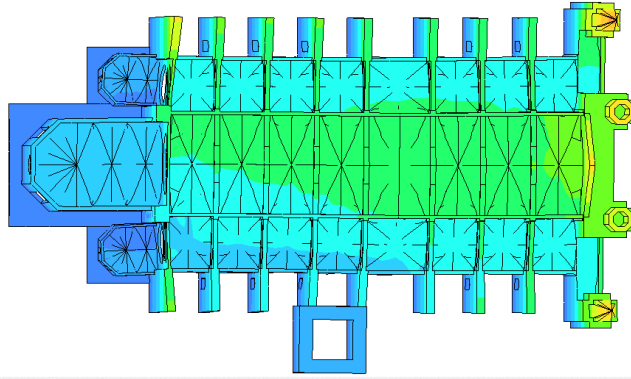
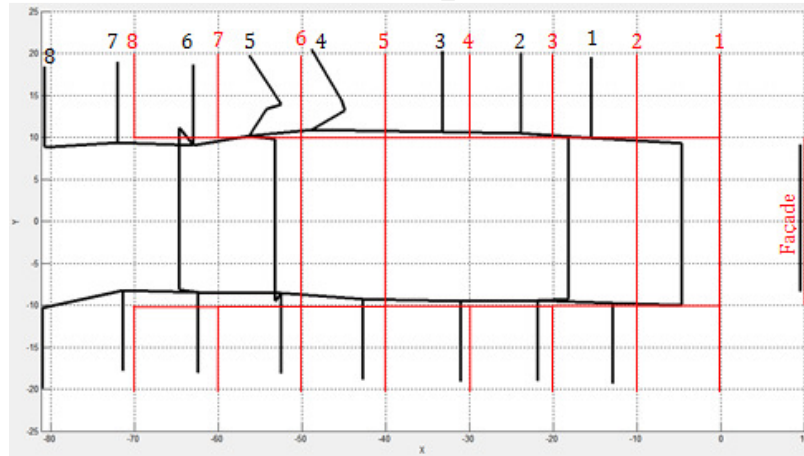
Figure 7. (a) First numerical mode shape, and (b) second experimental mode shape.

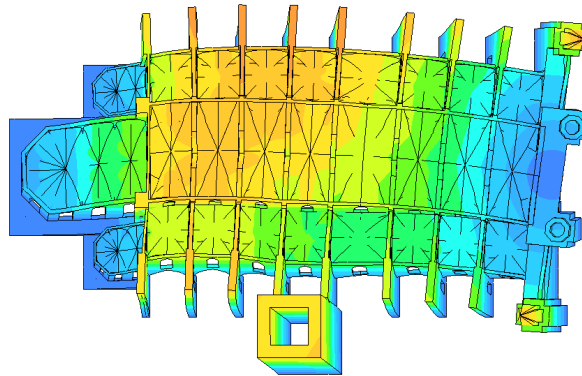
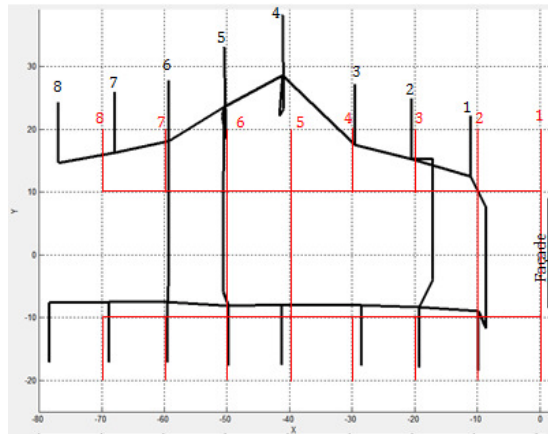
Figure 8. (a) Second numerical mode shape, and (b) fourth experimental mode shape.

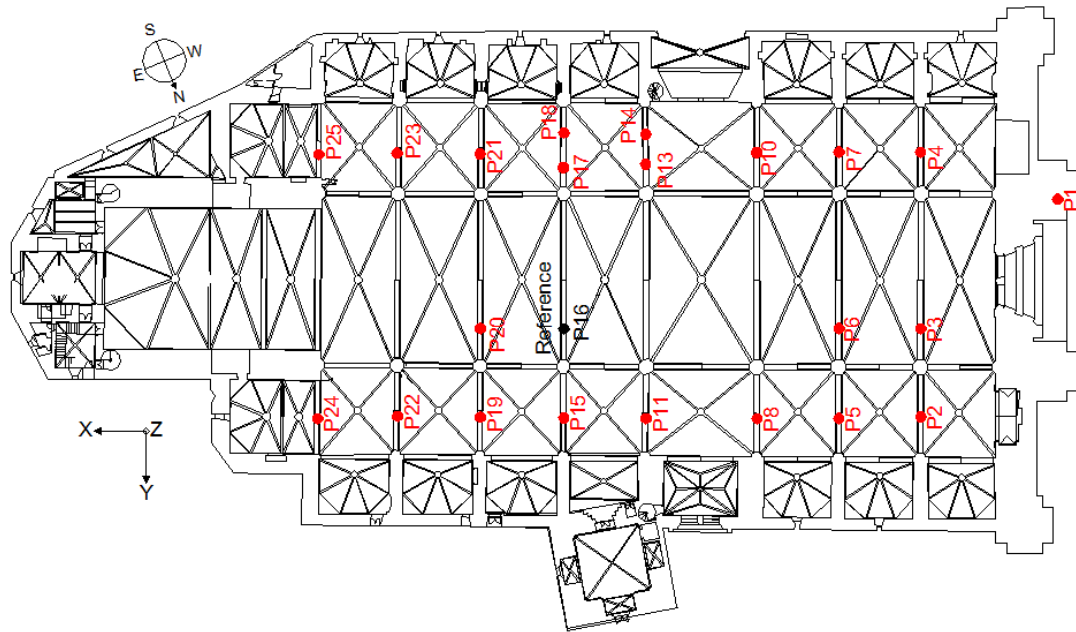
Figure 9. Locations of sensors during AVT. All the points were located on the roof of the cathedral.

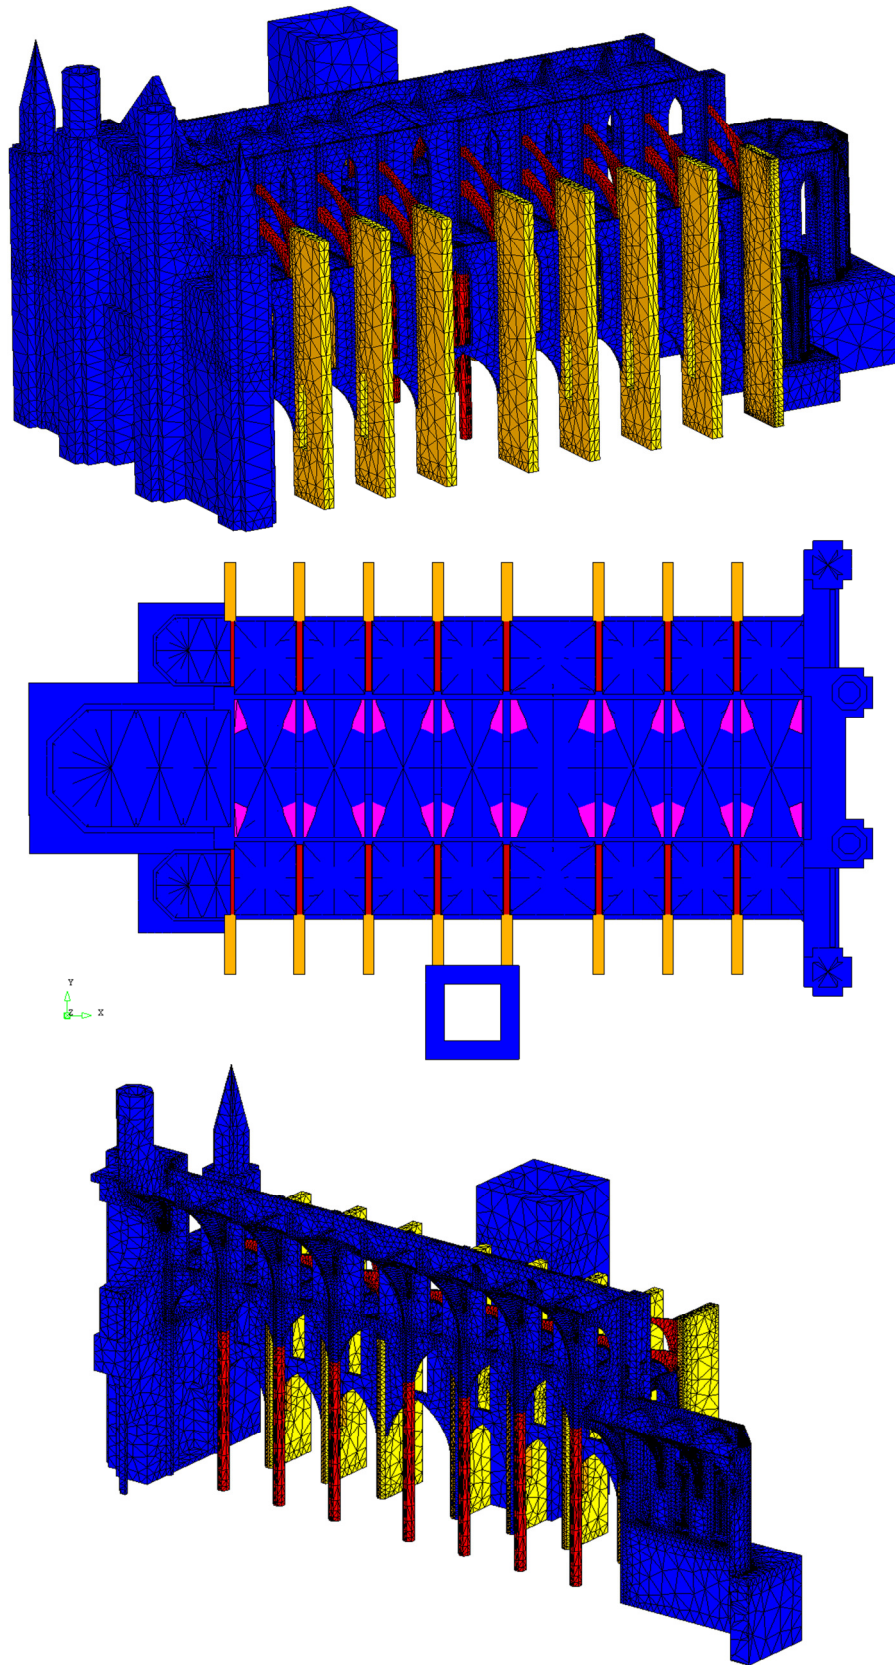
Figure 10. Views of the FE model: complete model (top); plan showing filling above vaults in

magenta (center); and longitudinal section (bottom).

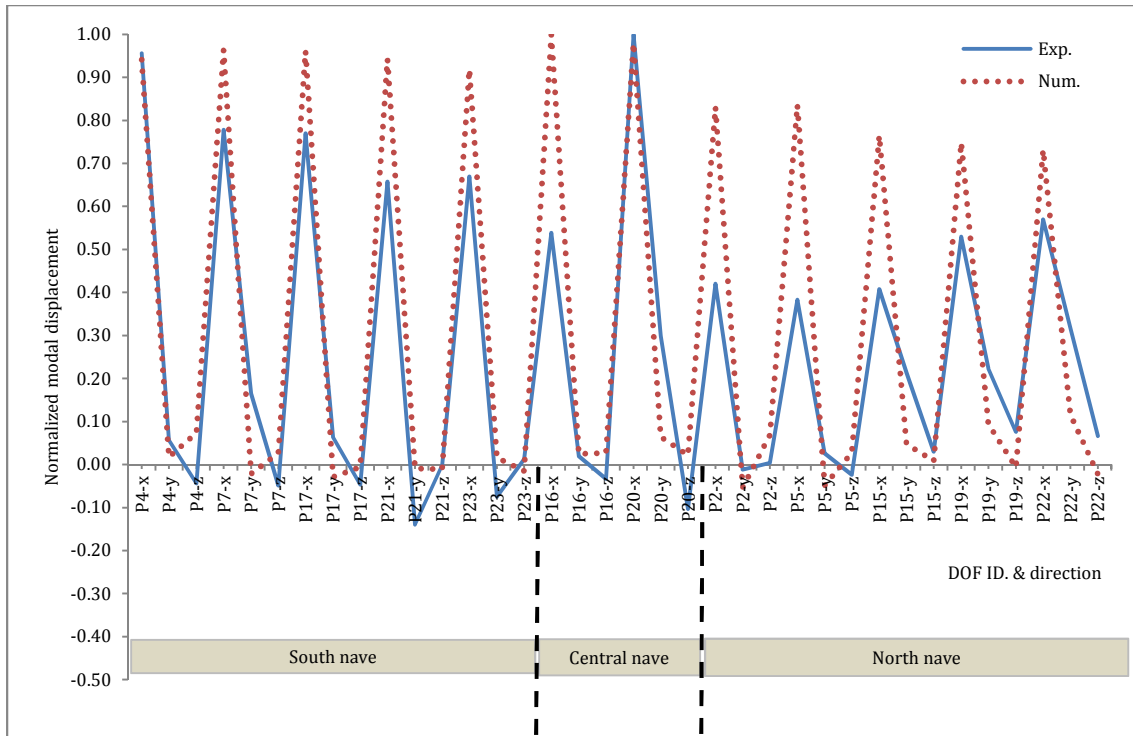
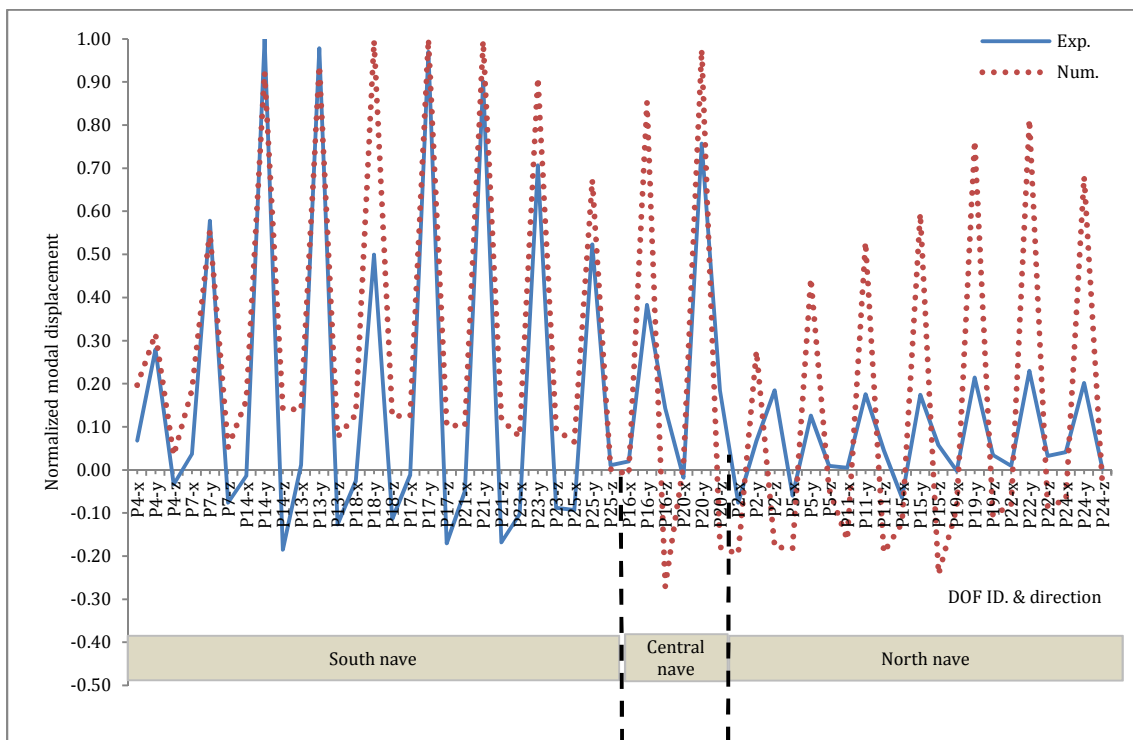
Figure 11. Comparison between mode shapes of 1Num-2Exp (top); and 2Num-4Exp (bottom). The points on the horizontal axes refer to measurement points during AVT.

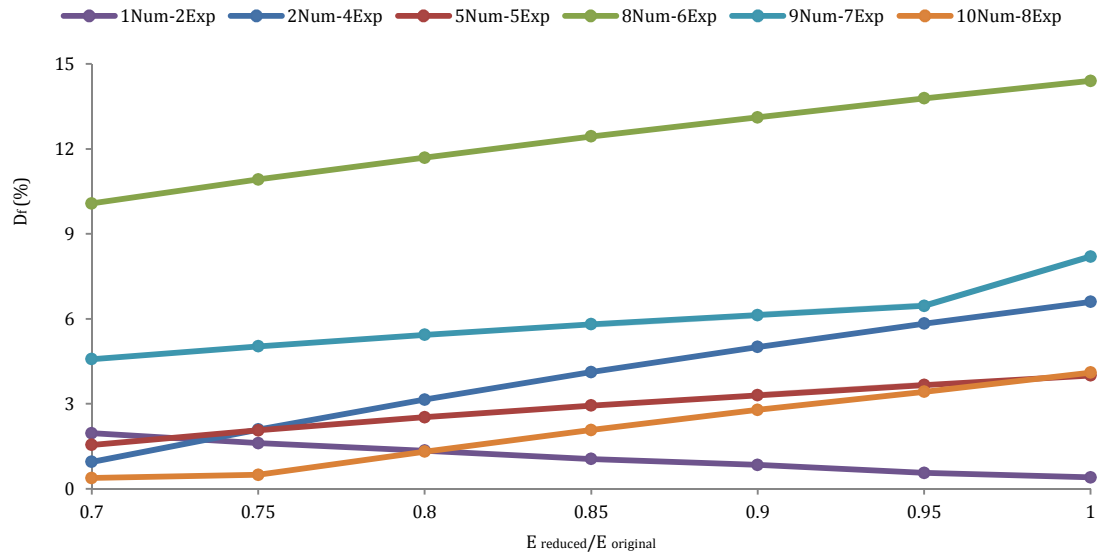
Figure 12. Variation of the D_f of different vibration modes with the elasticity modulus of the buttresses.

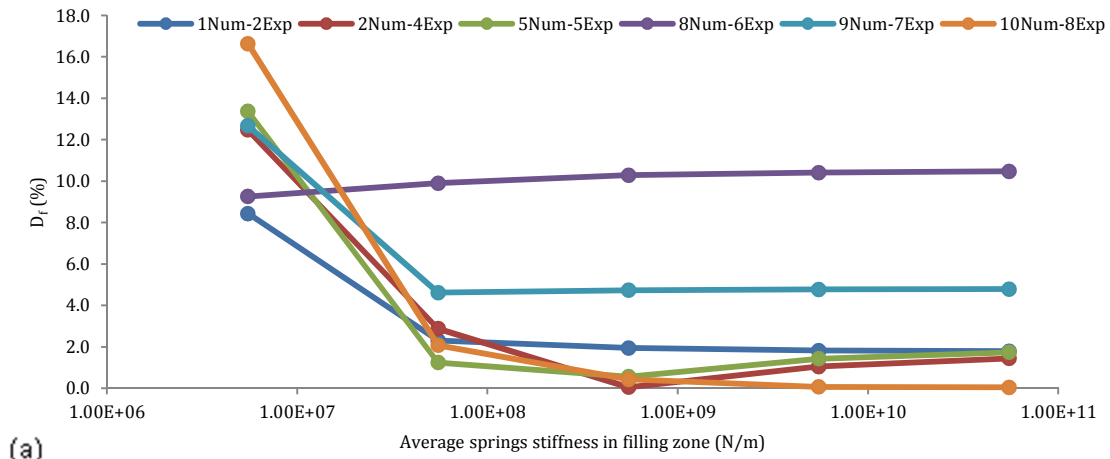
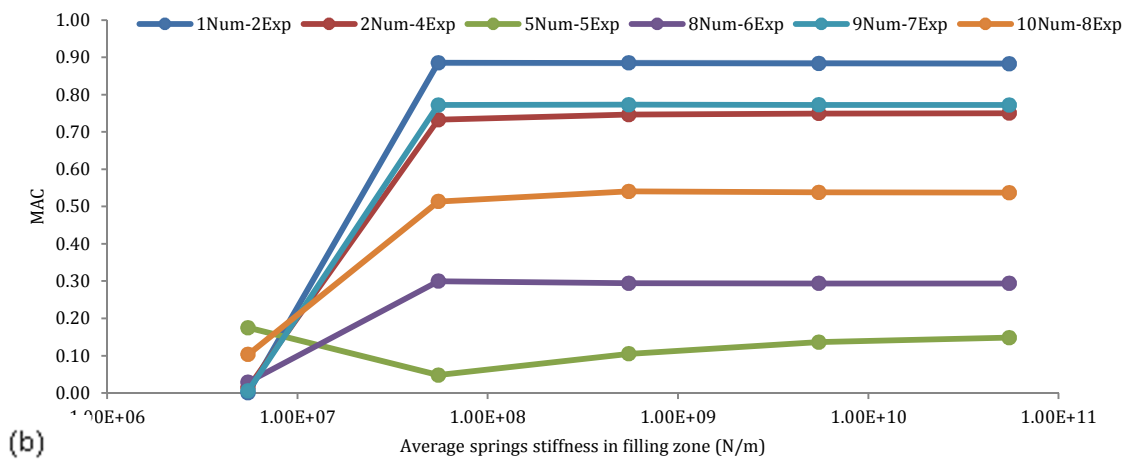
Figure 13. Effect of changing the average spring stiffness in the filling zone on: (a) D_f ; and (b) MAC.

For the first variable, increasing the initial value with two orders of magnitude, improved slightly the D_f values. For the last variable when using values more than 10%, no changes occurred in the D_f and MAC values for all modes. Summarizing, the best values for the average spring stiffness were $6,89E11$ N/m and $5,51E8$ N/m in the rock and the filling zones, respectively. The optimal horizontal stiffness was 10% of the vertical stiffness for any spring in the two zones. Table 4 reports the matching after adjusting the elastic foundations. As can be

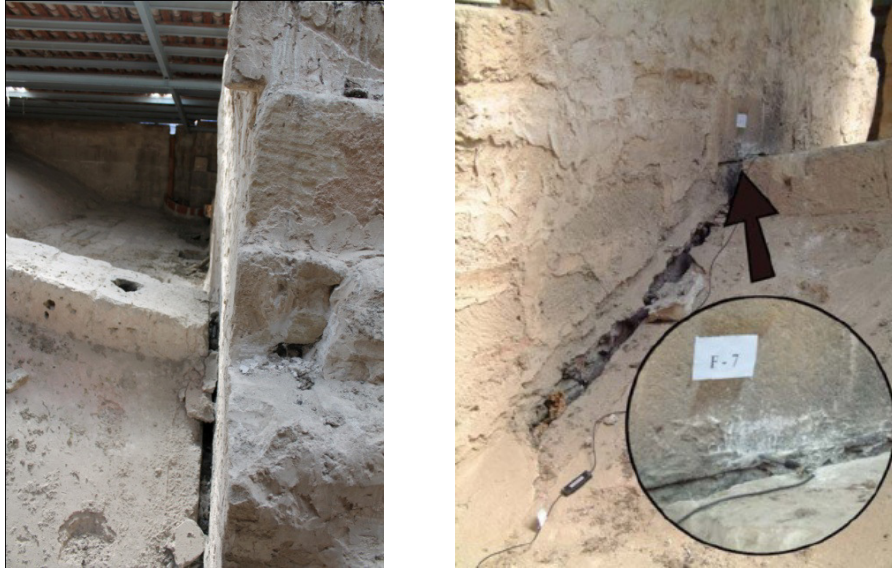
Figure 14. The crack between the third arch and the fourth vault (left) and a zoom to the static monitoring sensor (right).

The last updating trial was to simulate the damage experienced by the cathedral. Among the most significant damage was the cracking that can be seen in many places. One of the significant cracks is the one located between the third arch and the fourth vault from the west façade, Figure 14. It was previously monitored for a period of about five years and proved to be active with a rate of 1cm/century [26]. The static monitoring system aimed at measuring the crack widths, the tilts and the distance variations (openings) at some critical positions in the cathedral, in addition to measuring the environmental actions of the temperature, the humidity and the wind. The cracks were monitored at three columns, two locations at the upper south clerestory wall and two vaults. Base line extensometers were implemented to measure the opening of selected arches and vaults, at the level of their springing. The tilts were monitored at two positions, one of them aimed at measuring the tilt of the west facade.

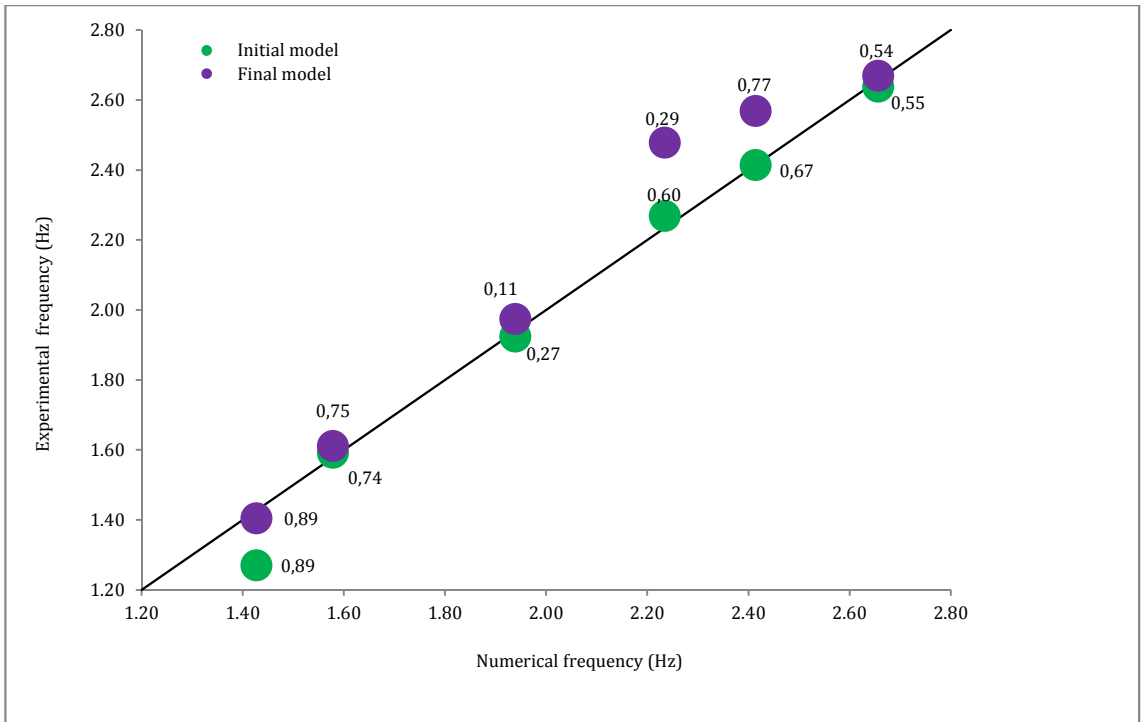
Figure 15. Comparison between the experimental frequencies and the frequencies of the initial and the final models, the MAC values are shown beside the dots.

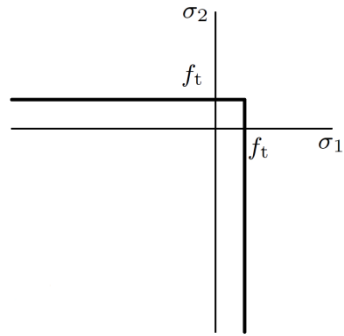
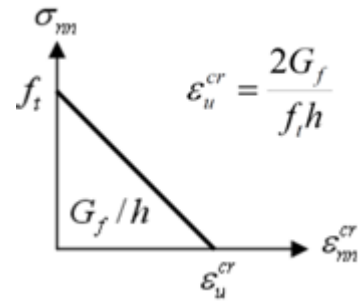
Figure 16. Representation of (a) tension cut-off and (b) tension softening (DIANA, 2009). σ_1 and σ_2 are the two-dimensional principal stresses. G_f is the fracture energy in tension, ϵ_u^{cr} is the ultimate crack strain, h is the crack band width taken as the cubic root of the element volume.

To simulate the nonlinear behavior of the masonry, tensile regime was modeled using smeared cracking, in specific, multi-directional fixed crack model. In this model cracking was specified as a combination of tension cut-off (Figure 16-a), tension softening (Figure 16-b), and shear retention. Compressive regime was modeled using isotropic plastic Drucker-Prager model. Table 5 lists the used properties of materials not mentioned in Table 2 above. The compressive strength f_c of the first three materials were taken as found by [52] who carried out compressive tests on samples of the stone. For the filling material a low compressive strength was assumed. For all the materials, the tensile strength f_t was assumed as 5% of f_c , the shear retention factor was taken as 0,01 and the two angles of internal friction and dilatancy were assumed equal (associated plasticity) with a value of 10° . Those values were reasonably assumed based on studies on similar historical construction [52-56].

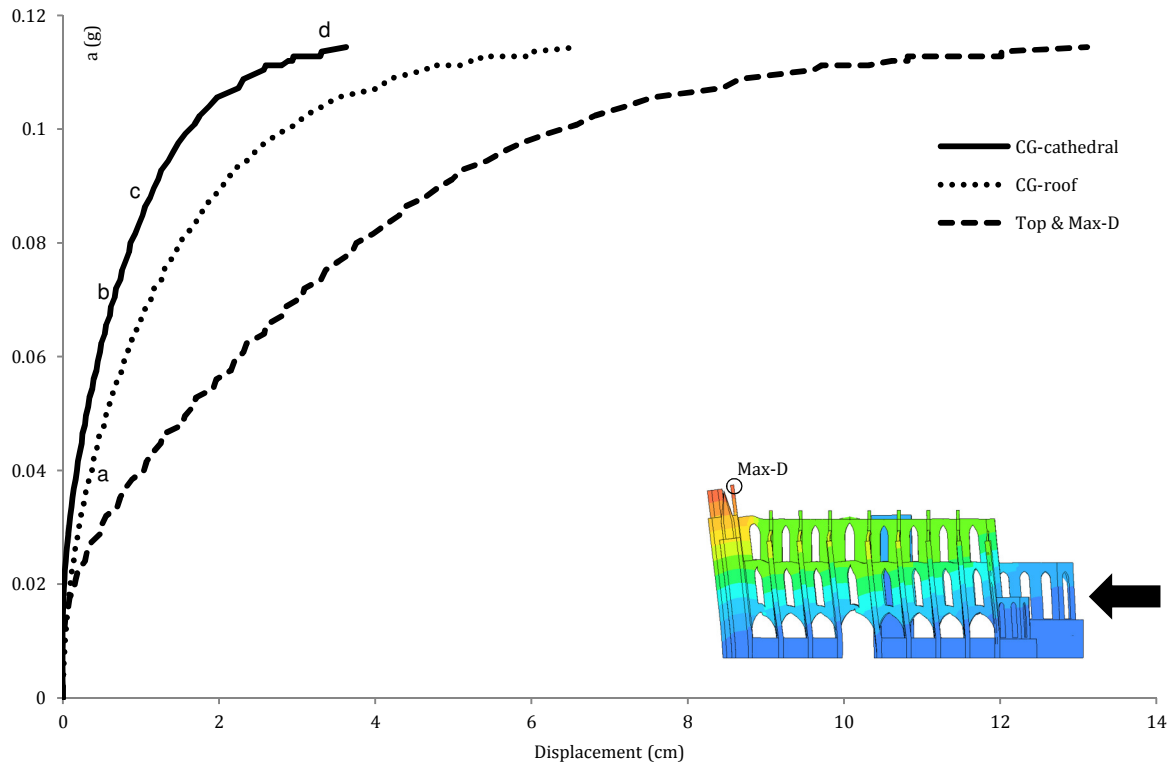
Figure 17. Capacity curve for the seismic analysis in (+X) direction. The control point (Max-D) is shown in circle.

The obtained capacity curve for the analysis in +X direction is presented in Figure 17. The point Top was found to be also the one with the highest displacement. From the capacity curve, it was observed that the behavior was linear up to a load value of about 0,040g and the collapse occurred at 0,114g. Four different points on the curve are points (a) to (d) are selected to follow the collapse progression.

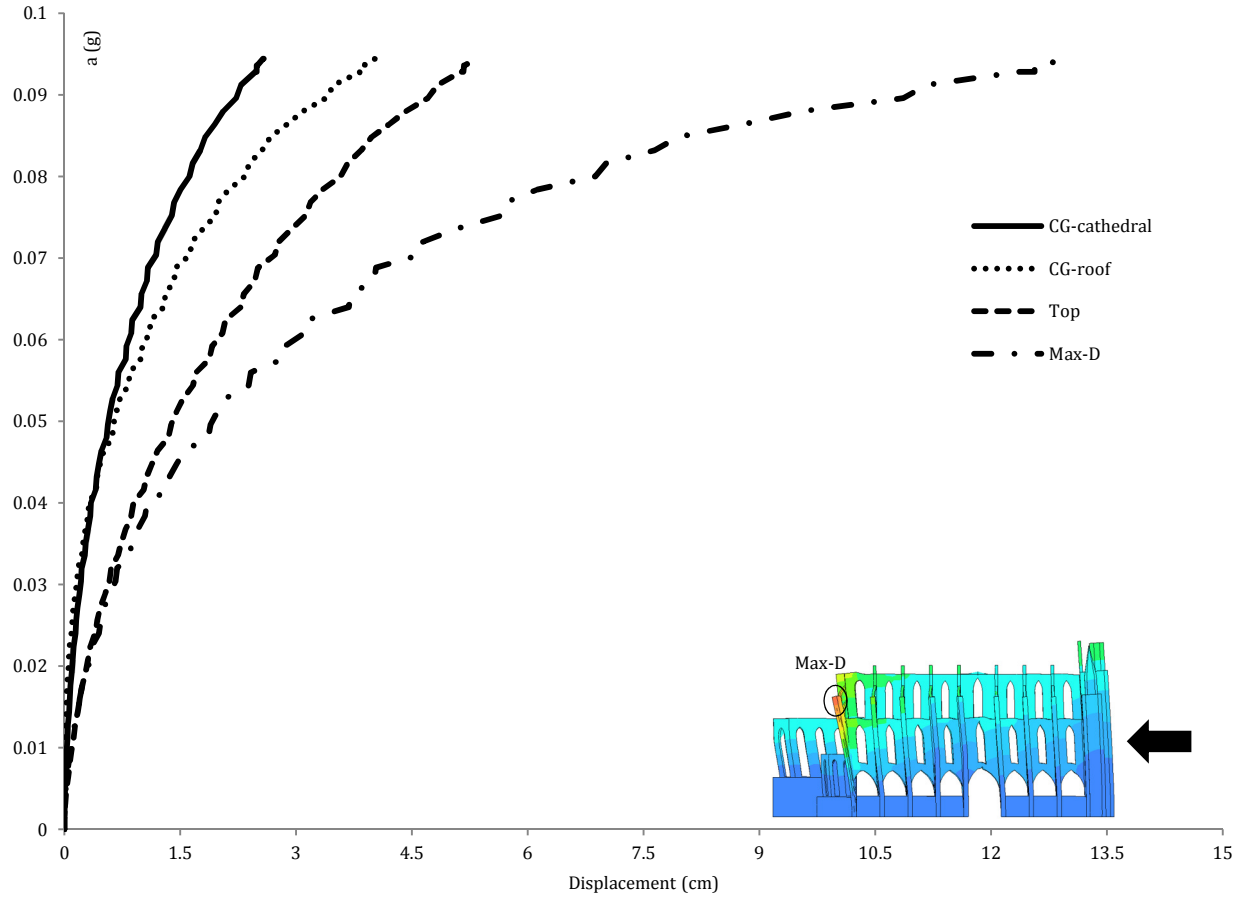
Figure 19. Capacity curve for the seismic analysis in (-X) direction. The control point (Max-D) is shown in circle.

The -X direction showed the lowest capacity among the four considered directions. The attained capacity was only 0,095g. Figure 19 shows the different capacity curves for the considered control points. The point Max-D was observed to be at the top of the most north buttress. The cracking process started like the case of +X at about 0,04g. At 0,095g the collapse occurred due to the overturning of the east façade after separation from the rest of the cathedral. The lower clerestory walls were diagonally cracked above and below windows' openings. The same was noticed for the first and the last bays of the upper clerestory walls. After being cracked at their top, the columns lost their connections with the upper clerestory walls.

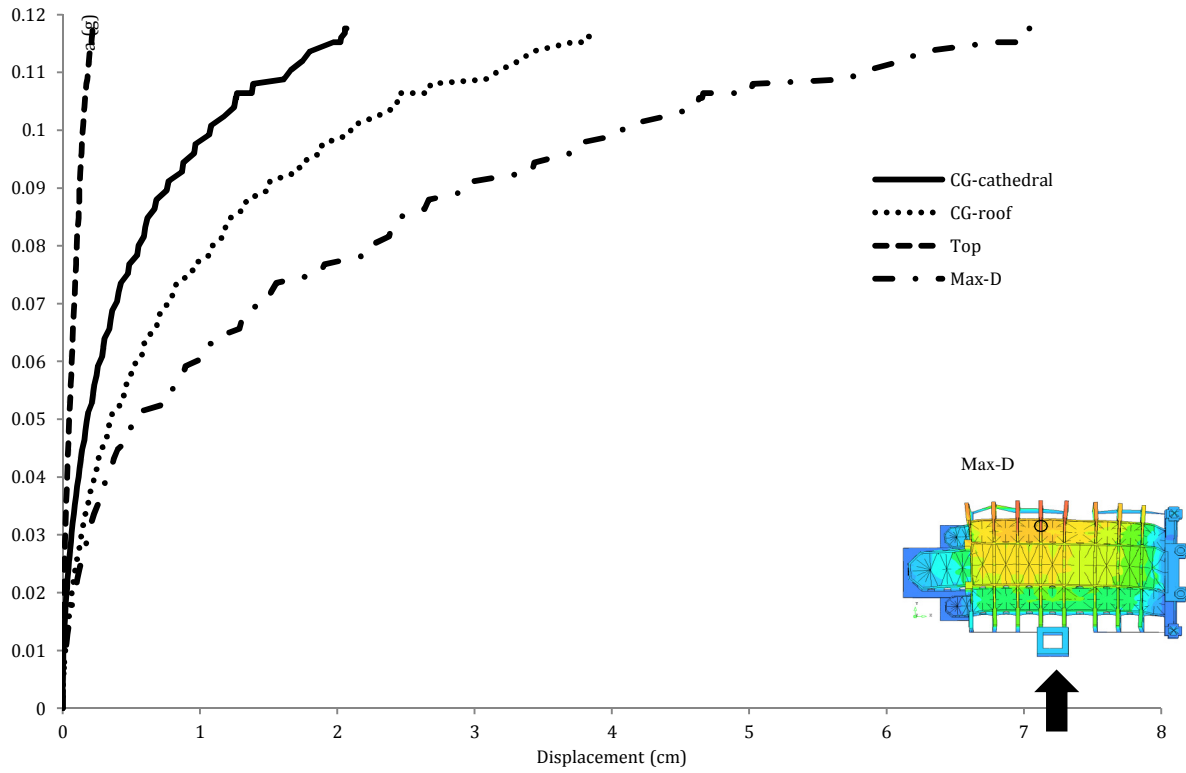
Figure 20. Capacity curve for the seismic analysis in (+Y) direction. The control point (Max-D) is shown in plan.

In the +Y direction the cathedral showed a higher capacity (0,118g) than that in the longitudinal direction. Figure 20 shows the capacity curves. The point Max-D was found to be at the top of the fifth flying arch counting from the west façade. As expected in masonry structures composed of arches, a series of disconnections (hinges) between structural parts could be noticed with the increase in the applied lateral load until reaching collapse. This process of cracking is shown in Figure 21. The hinge mechanism process started at a seismic load of 0,075g (crack 1) with the arising of four cracks at the top of the column, the upper flying arch, the top of the lateral nave's vault and the connection of the buttress with the longitudinal wall, being the largest damaged area at the flying arch. The following group of cracks started at 0,093g (crack 2) at the top of the lower flying arch, the bottom of the lateral nave's vault and the base of the buttress. One crack only initiated at 0,099g (crack 3) at the bottom of the lower north flying arch. At 0,102g a new crack appeared (crack 4) in the main nave vault followed by another one at the base of the buttress at 0,104g (crack 5). The followed crack initiated at 0,106g (crack 6) at the top of the vault of the north lateral nave. Four cracks opened at the load factor of 0,109g (crack

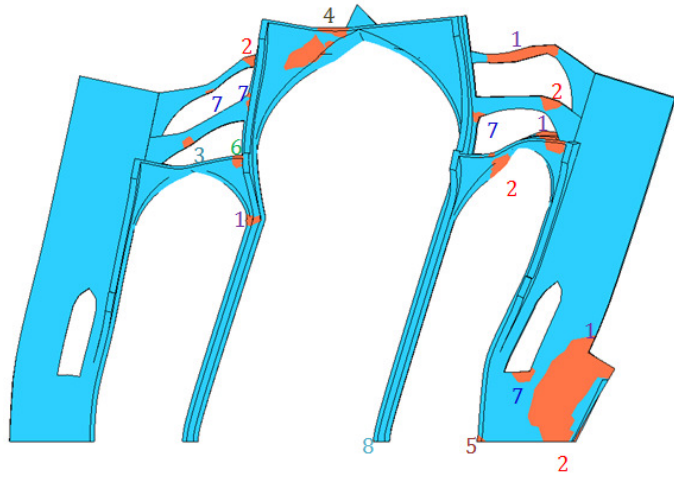
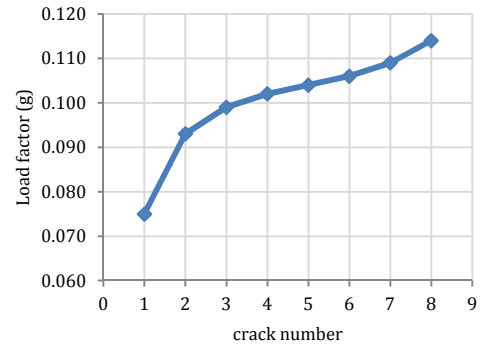
Figure 21. Cracking pattern at collapse with sequence of cracking (left); and the seismic load factor of initiation of each crack (right).

7), two at the north part of the bay, in specific, at the bottom of the upper flying arch and the connection of the lower flying arch with the main nave vault, the other two were at the south part at the connection of the lower flying arch with the main nave vault and just below the buttress window. Very near to collapse, at 0,114g, the base of the column was cracked (crack 8).

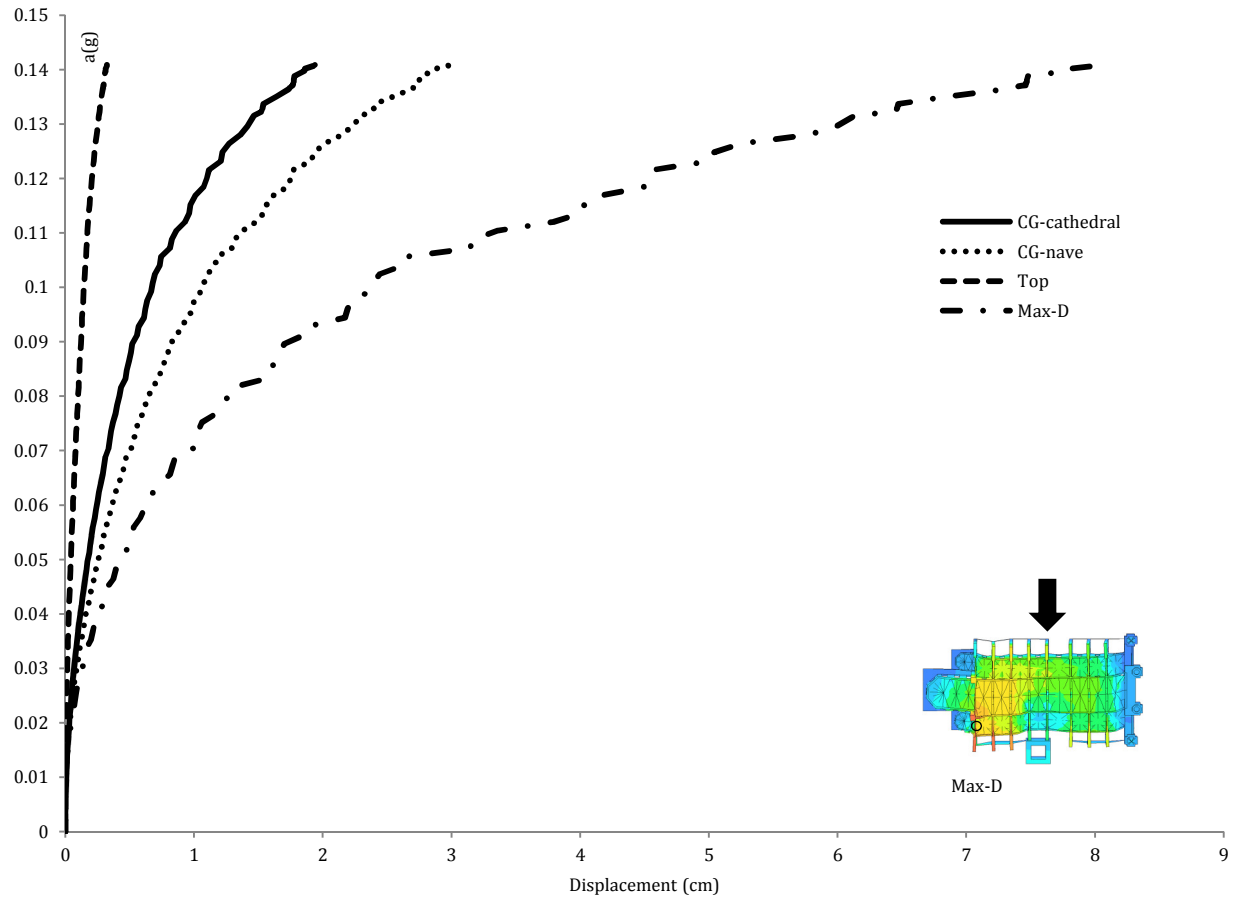
Figure 22. Capacity curve for the seismic analysis in (-Y) direction. The control point (Max-D) is shown in circle.

In $-Y$ direction the resistance was the highest among all directions as can be seen in the capacity curve (Figure 22). In this figure the point Max-D was located at the top of the northern flying arch of the east façade. The capacity was 0,141g which was about 20% more than $+Y$ direction. The existence of the tower as a strong support near the middle of the structure was the reason for the higher capacity. Comparing this case with the previous case of $+Y$, it was noticed that a near sequence of structural elements' cracking was found. At first, the top of the column, the upper battery of flying arches, the extrados of lateral nave's vaults and the base of the buttress, and at last, the bases of the columns and the buttresses. In between, the lower battery of the flying arches, the extrados and the intrados of the lateral naves' vault cracked. An important difference between the two cases was the capability of the typical bay to resist after the initiation of the first crack in the case of $-Y$ over a wider range of seismic loads from 0,094g to 0,135g. The collapse occurred at 0,141g, whereas in the case of $+Y$, a rapid cracking took place in a narrow range from 0,099g to 0,114g as previously mentioned.

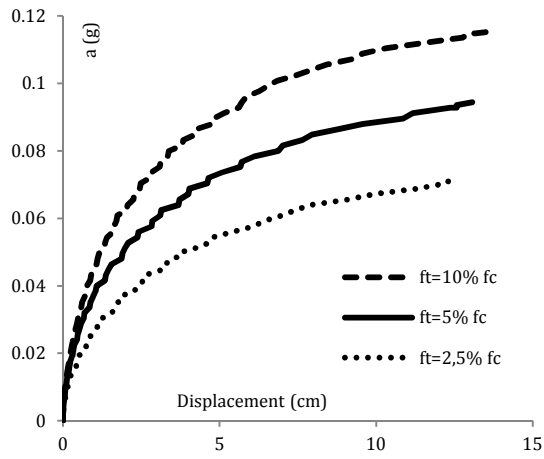
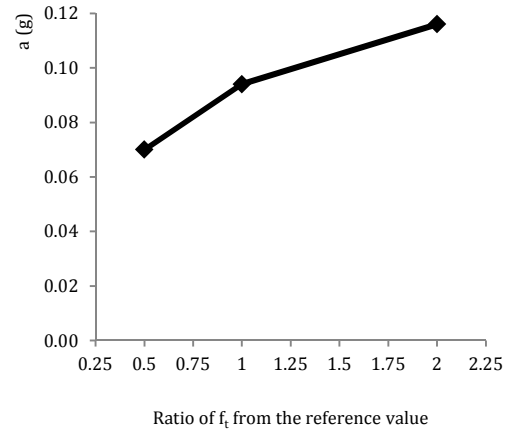
Figure 23. Capacity curves varying f_t (left); and change of the capacity with the change of f_t ratio from the reference value (right).

As can be noticed in Figure 23 (left), a remarkable change in the capacity was associated with the change of the tensile strength. A reduction of about 24% was obtained when reducing the strength to the half of its reference value. An increase of about 23% was obtained when increasing the strength to the double of its reference value. Within the examined values, a linear trend between tensile strength and capacity could be noticed (Figure 23, right). Since the collapse was governed by the tensile cracking, this result was expected. For the examined values, the change in final displacement was not significant and the collapse mechanism remained the same.

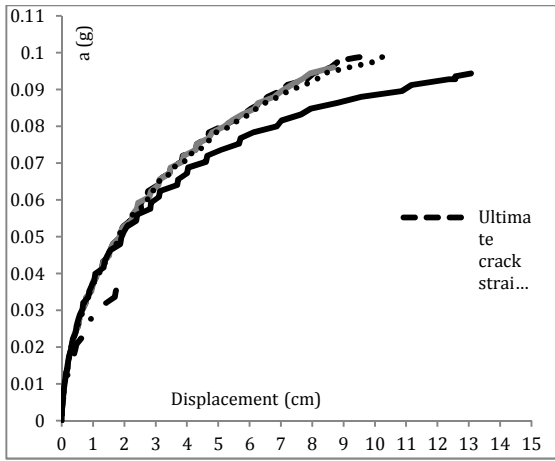
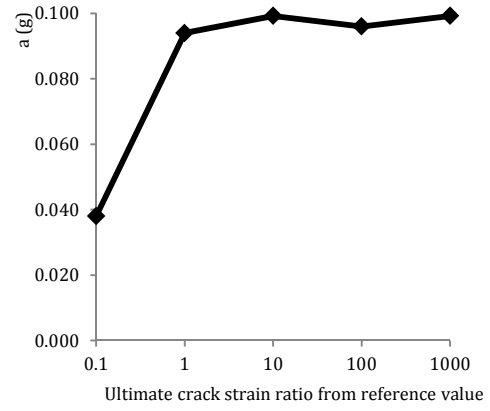
Figure 25. Capacity curves varying ϵ_u^{cr} (left); and change of the capacity with the change of ϵ_u^{cr} ratio from the reference value (right).

Figure 25 (left) shows the obtained capacity curves when varying the ultimate crack strain. It can be seen that reducing this parameter by one order of magnitude resulted in a significant reduction in the capacity (about 60%) and the behavior was brittle. On the other side, the increase by one to three orders of magnitudes had slight influence on the capacity with an increase of about 4% only because increasing the ultimate crack strain led the material behavior to be like an elastic-perfect plastic behavior and no gain in the capacity was found Figure 25(right).

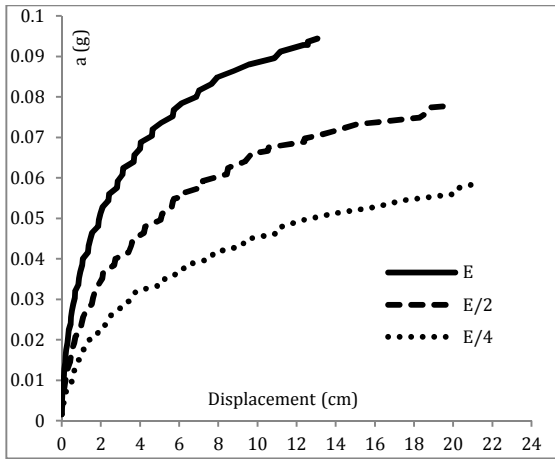
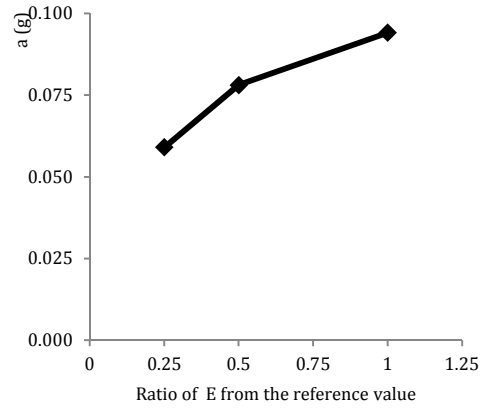
Figure 26. Capacity curves varying the modulus of elasticity E (left); and change of the capacity with the change of E ratio from the reference value (right).

Two values of the elastic modulus were examined: $E/2$ and $E/4$. Reductions in the capacity about 17% and 37% were found when reducing E to one half and one quarter of its reference value, respectively, Figure 26. In addition, the nonlinear behavior started earlier when reducing E . In the reference case it started at about 0,04g, while it starts for less than 0,03g at $E/2$ and for about 0,02g for $E/4$. The influence of E is attributed to the nonlinear geometric effects linked to the slenderness of the piers and other members of the structure.

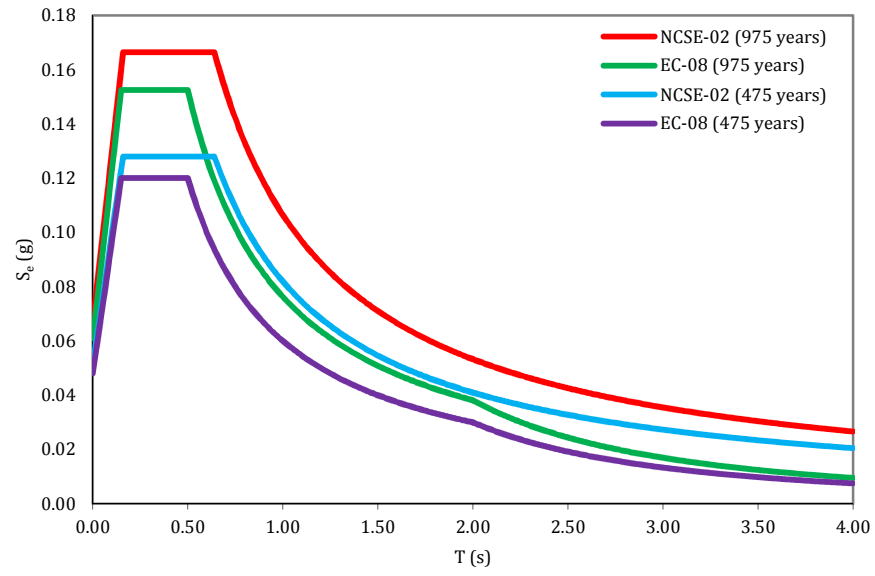
Figure 27. The elastic response spectrum S_e (g) using the Eurocode 8 (EC8) and the Spanish code NCSE-02.

In Table 7 the obtained results for the performance load multiplier (LM_p) and the performance displacement (D_p) are reported. It was always observed that the lowest and the highest D_p and LM_p were attributed to the cases of EC-08 with return period of 475 years and NCSE-02 with return period of 975 years, respectively. Near values for D_p and LM_p were obtained for the other two cases of EC-08 (return period of 975) and NCSE-02 (return period of 475 years) because the descending branch of these two spectra were near to each other (Figure 27).

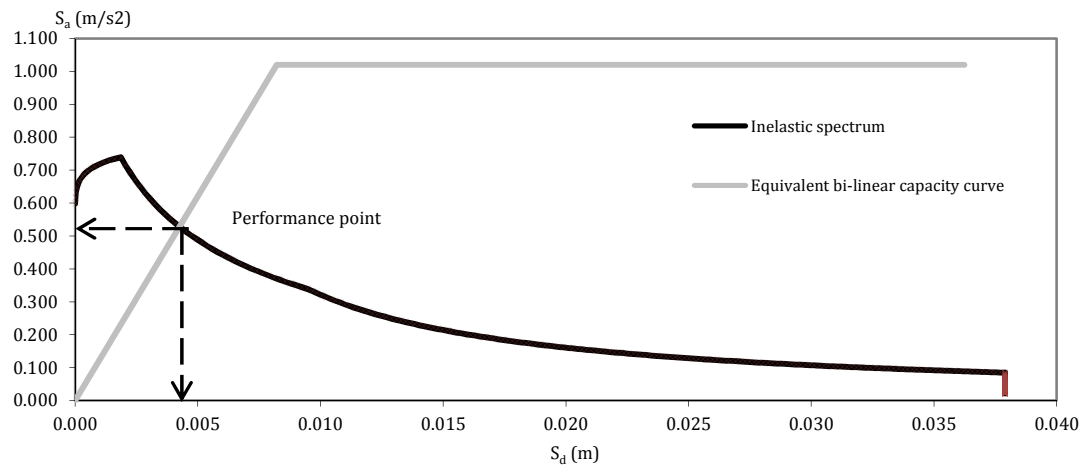
Figure 28. Application of the N2 method to the control point of CG-cathedral (case of +X direction) and EC-08 (return period of 975 years) to find the performance point.

seismic analysis \times 4 control points \times 2 codes \times 2 return periods. Figure 28 shows, as an example, the application of the method to the evaluation of the seismic performance in +X direction considering the control point CG-cathedral and the Eurocode 8 with a return period of 975 years. The found values were $0,53 \text{ m/s}^2$ (0,053g) and 0,004m for the performance load multiplier (LM_p) and the performance displacement (D_p), respectively.
