Seismic Safety Assessment of Historical Structures Using Updated Numerical Models: the Case of Mallorca Cathedral in Spain

Abstract

2 MALLORCA CATHEDRAL

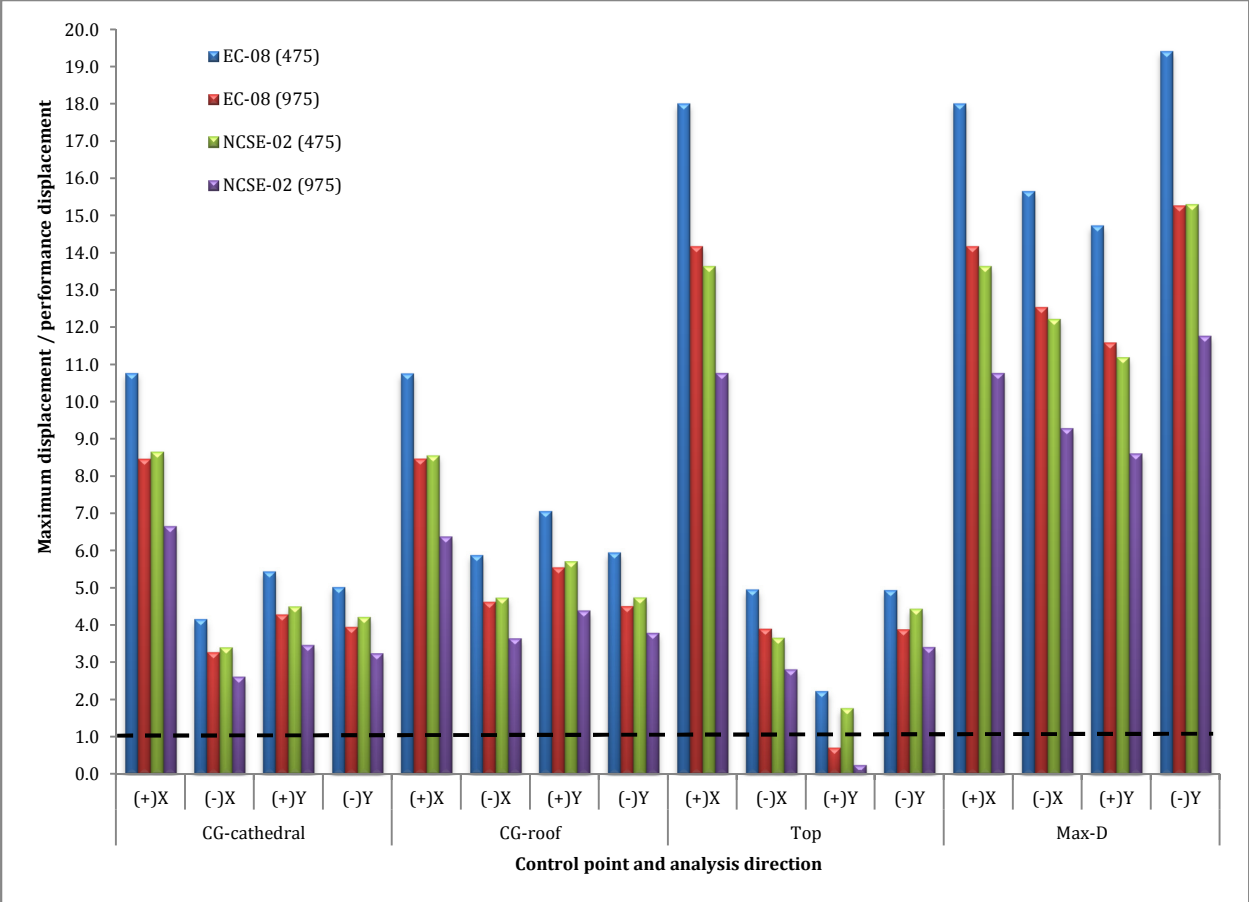
Figure 29. Evaluation of seismic safety in terms of displacements: ratios between maximum displacements and performance displacements.

To highlight the effect of the control point choice on the evaluation of the cathedral seismic safety, the ratios between the maximum displacements and the D_p are shown in Figure 29. In this figure, it is clear that the highest ratios were found (for any of the analysis directions) when using the point Max-D. The two control points CG-cathedral and CG-roof showed near ratios and lesser ones than those of Max-D point. As expected, the point Top presented larger displacements (higher than CG-cathedral and CG-roof and lesser than Max-D) only for the case of +X direction. In the -X direction, the ratios were near to those of CG-cathedral and CG-roof. In the $\pm Y$ directions, the ratios were small. Recalling that the point Top was located on the top of the west façade gable, it seemed that using it for the case of +X direction (the west façade is pushed outside its plane) is appropriate and representative choice. However, using it for the other directions seemed to be inadequate to represent the displacement capacity of the cathedral.

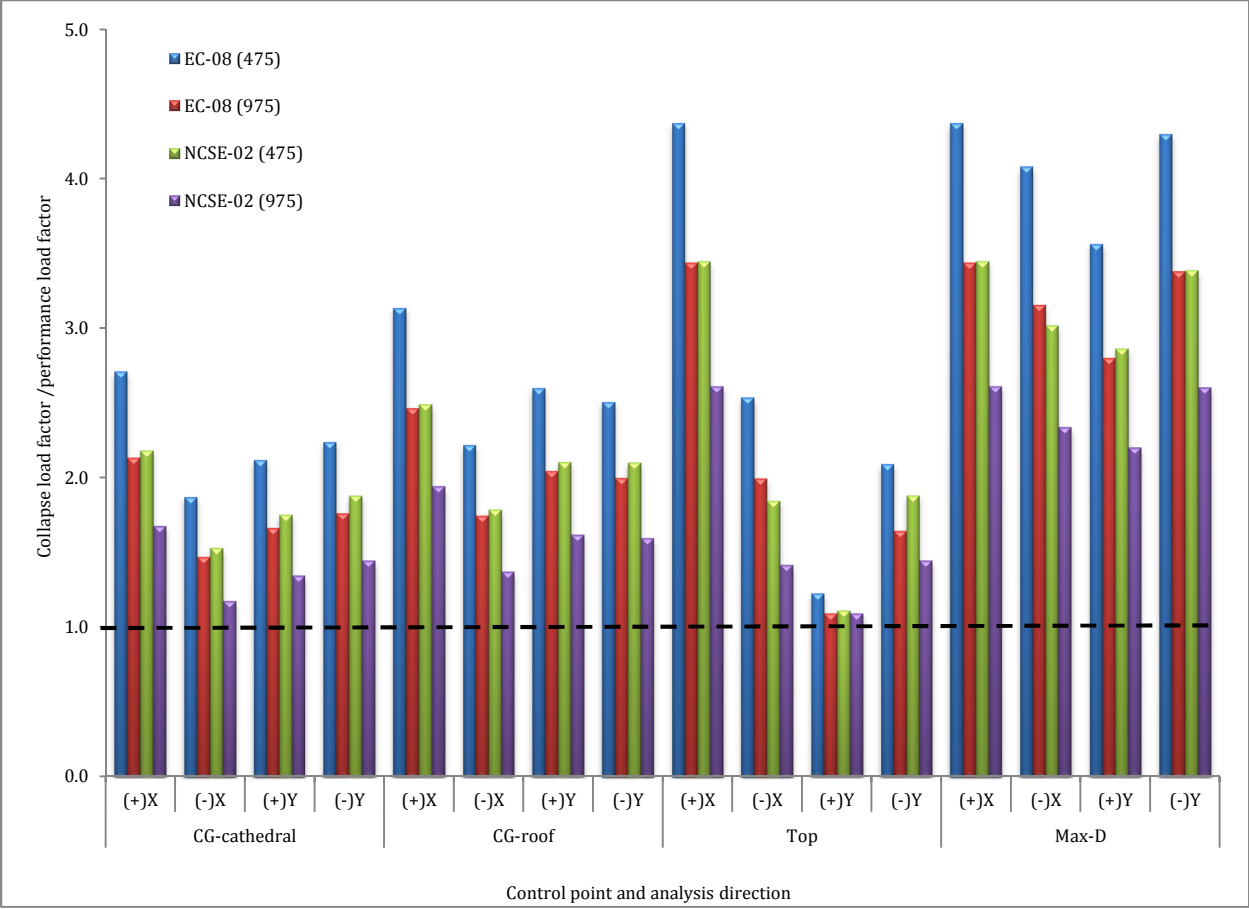
Figure 30. Evaluation of seismic safety in terms of load multipliers: ratios between collapse load multipliers and performance load multipliers.

Similarly, the ratios between the collapse load multiplier and the LM_p are shown in Figure 30. The same comments mentioned on the displacements comparison, can be mentioned again on the load multiplier comparison. It was found that the point Max-D gave the highest ratios and the point Top did not give reasonable values for all directions except the +X one. Slightly higher ratios were obtained for the point CG-roof than those obtained for CG-cathedral. For any combination of demand spectrum, return period, analysis direction and control point, no ratio less than one was found. This is an indicator of the sufficient seismic capacity of the cathedral.
