# Water Quality Monitoring Project for Demonstration of Canal Remediation Methods Florida Keys- Report of activities: September 7th, 2016

# WATER QUALITY MONITORING PROJECT FOR DEMONSTRATION OF CANAL REMEDIATION METHODS FLORIDA KEYS

**Report of activities: September 7th, 2016**

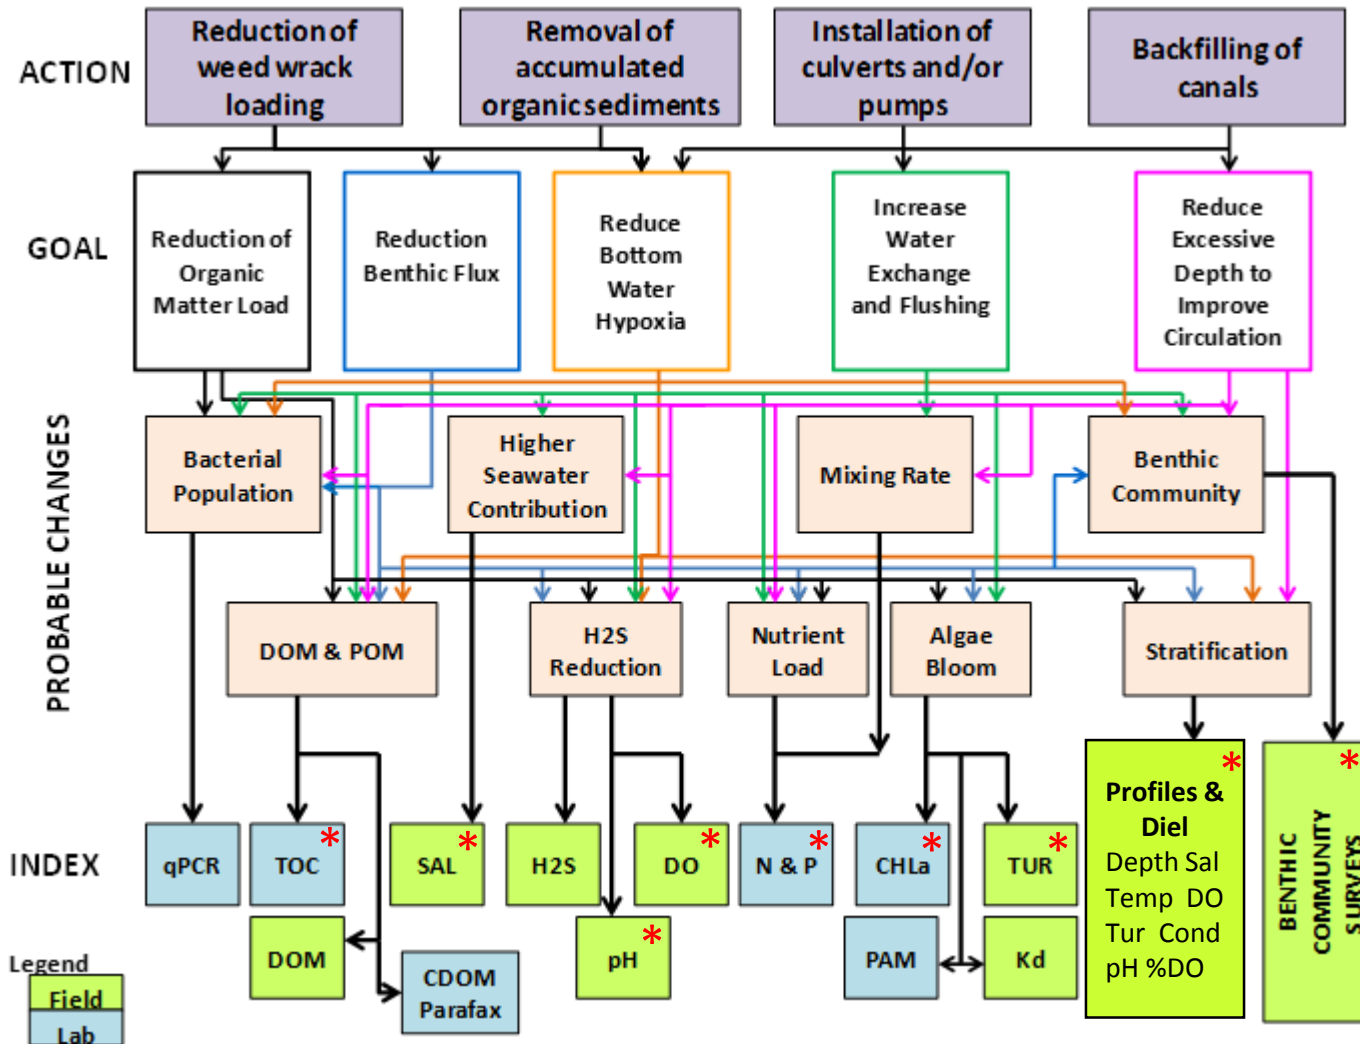
## Conceptual Model

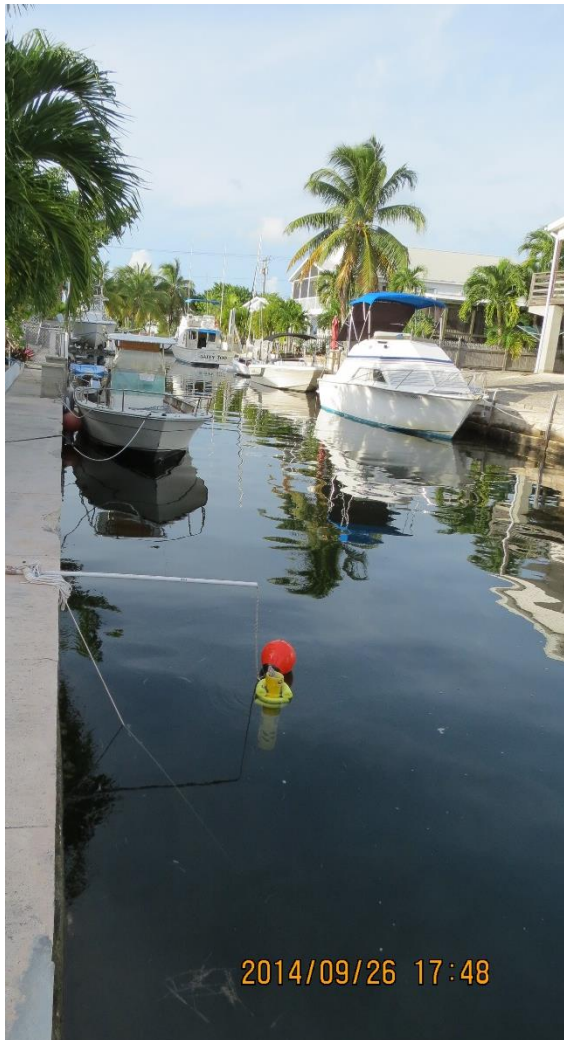
## Demonstration canals included in this report

- **First project:** Backfilling at Canal #29 in Sexton Cove in Key Largo. Completed in July 2015.
- **Second project:** Culvert Installation to connect Canals #472 and #470, on Geiger Key. Initially completed in April 2015, was later closed until May 2016.
- **Third project:** Combined Organic Removal and Air Curtain Installation on Canal #266 at Drs. Arm and Avenue J in Big Pine Key. Completed in May 2016.

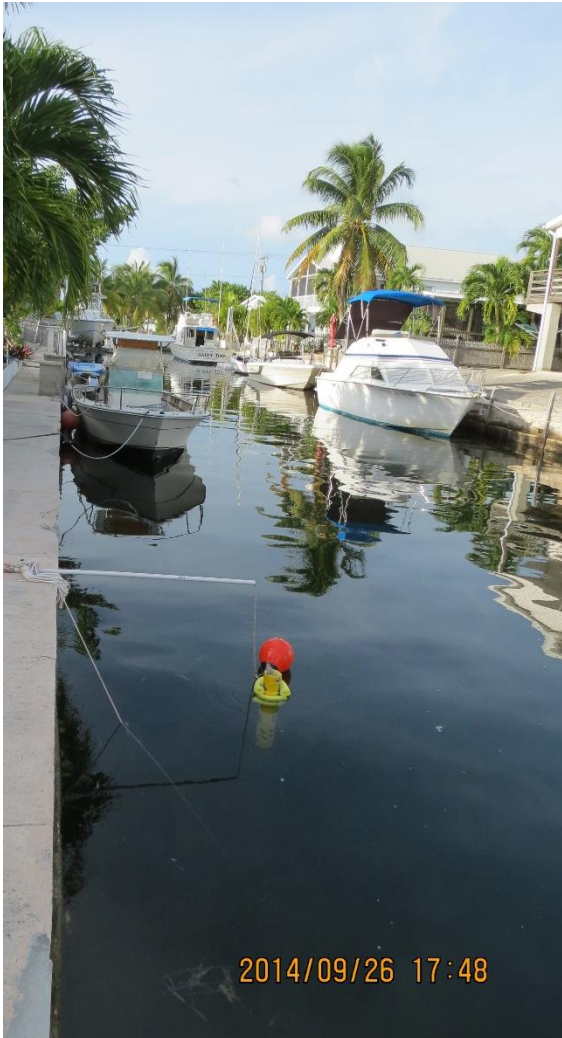
## Demonstration canals included in this report

- **Fourth project:** Organic Muck Removal Project on Canal #290 Avenue I on Big Pine Key. Completed in March 2016.
- **Fifth project:** Installation of a culvert under a roadway and private property connected two portions of Canal #277. Completed in May 2016.
- **Sixth project:** Air Curtain Weed Gate Installation for Canal #287 in Atlantic Estates on Big Pine Key. Completed June 2016.
