# Visibilia ex invisibilibus: seeing at the nanoscale for improved preservation of parchment

A Bartoletti, M Odlyha, S Hudziak, K Mühlen Axelsson, J de Groot and L Bozec

*This paper describes the application of atomic force microscopy (AFM) for the imaging of collagen denaturation as observed in parchment. Parchment is prepared from processed animal skin and collagen is the main component. Large collections in national archives, libraries and religious institutions contain numerous documents written on parchment. Their preservation presents an unsolved problem for conservators. The main challenge is to assess the state of collagen and to detect what conservators refer to as the pre-gelatinised state, which can cause surface cracking resulting in a loss of text and can increase the vulnerability of parchment to aqueous cleaning agents. Atomic force microscopy (AFM) was first used within the Improved Damage Assessment of Parchment (IDAP) project, enabling the characterisation of the collagen structure within parchment at the nanoscale. Damage categories were also established based on the extent of the ordered collagen structure that was observed in the AFM images. This paper descri

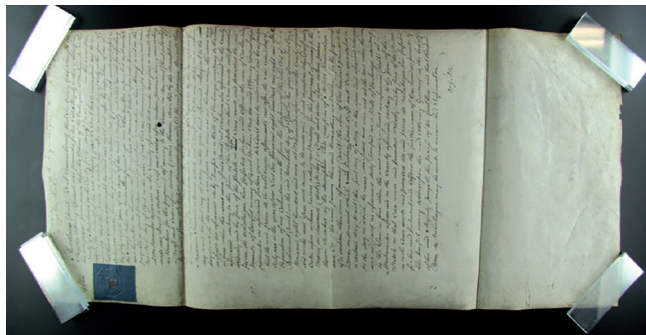
Figure 1. Image of the recto of the 18th century document written on parchment provided by The National Archives UK for this study

The parchment samples analysed in this study included two new calfskin hides bought from different tanneries (Z H De Groot in The Netherlands and Pergamena in the USA), dehaired in Ca(OH)<sub>2</sub> with the addition of sodium sulphide to speed up the dehairing process, and a historical parchment document dating back to the reign of King George the Third (18th century) from The National Archives, UK (Kew, London) (see Figure 1). The document is folded in three parts and written on the recto with carbon ink. Viewing with the naked eye, it appears to be in a good state of conservation and the surface is covered by a ‘patina’ (layer of superficial dirt).

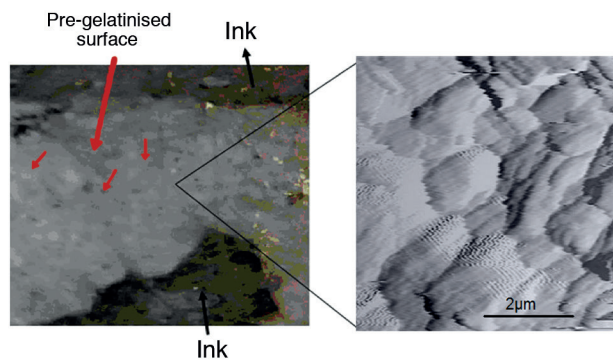
Figure 11. The handheld digital image USB microscope (Supereyes B008) shows the parchment surface in the area raster-scanned with AFM: the related image (on the left, magnification 50 $\times$ ) shows an area on the parchment between two letters, characterised by a pre-gelatinised state. This is confirmed by the related AFM image (on the right, scan size 5  $\mu\text{m}$ ) where the collagen scaffold is characterised by a complete loss of its typical structure, similar to Figure 7(c)
