SAN PAWL MILQI , BURMARRAD , MALTA – PRESENTATION OF A MULTI-CULTURAL SITE IN A CHANGING LANDSCAPE

Faculty of Architecture and Civil Engineering, University of Malta

Institute for Masonry and Construction Research, University of Malta

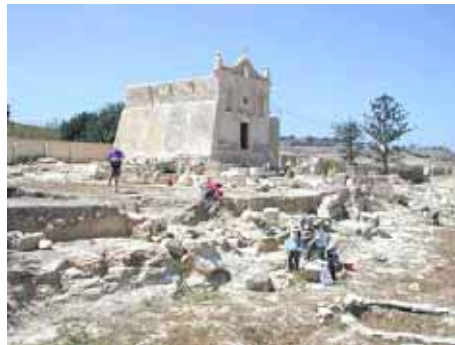
Figure 2 View of the Baroque church and its relationship to the archaeological site.

In such a landscape, San Pawl Milqi is to be found in a position of control, situated on a wide natural terrace that breaks the North-Eastern slope of Gebel Ghawzara. The Baroque church that dominates the archaeological site (Figure 2) stands as a real landmark, visible from all over the area – from the North, South, East and West, and above all for all who approached the coast from North to East. In this dominating position, the archaeological area is exposed to often strong winds from the North East and from the North West which often batter the church and the archaeological remains.

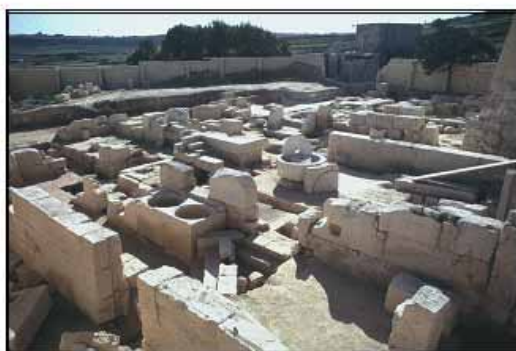
Figure 4 View of part of the site showing the boundary wall which surrounds only part of the remaining archaeological structures.

During the 1960s, a boundary wall was built which incorporates an area of approximately 4000 m² (Figure 4). Unfortunately the boundary wall does not include all the archaeological structures: some of these are found behind the church, on the other side of a small country-road that deeply cuts the rock in the North-West part of the archaeological area, exposing the soft yellowish layers of Globigerina Limestone and even cutting through some of the archaeological features.

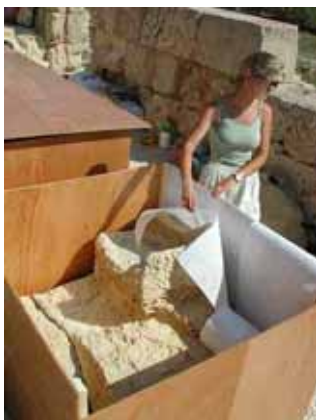
Figure 5 Measures being taken to protect one of the friable oil vat found on site.

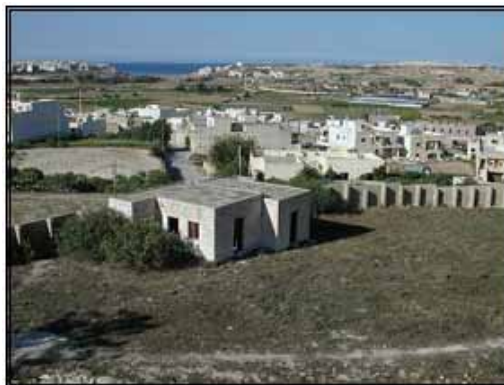
Figure 6 Store rooms built during the 1960s and the encroaching village of Burmarrad.

Situated on the plateau, above the location just mentioned for the visitors' center, there exist rooms built during the 1960s as store rooms (Figure 6). These rooms are not in a good state of repair and hence it would be ideal to demolish them so as to eliminate the negative impact on the skyline

due to their proximity to the archaeological site and the church. The concrete flooring of these rooms, which would create a scar on the landscape were it removed, could be retained and refurbished to house information panels explaining the archaeological site.
