## Wilket Creek: urbanization, geomorphology, policy, and design

Danielle Barr

A thesis submitted in partial fulfillment of the requirements for the degree in Master of Science

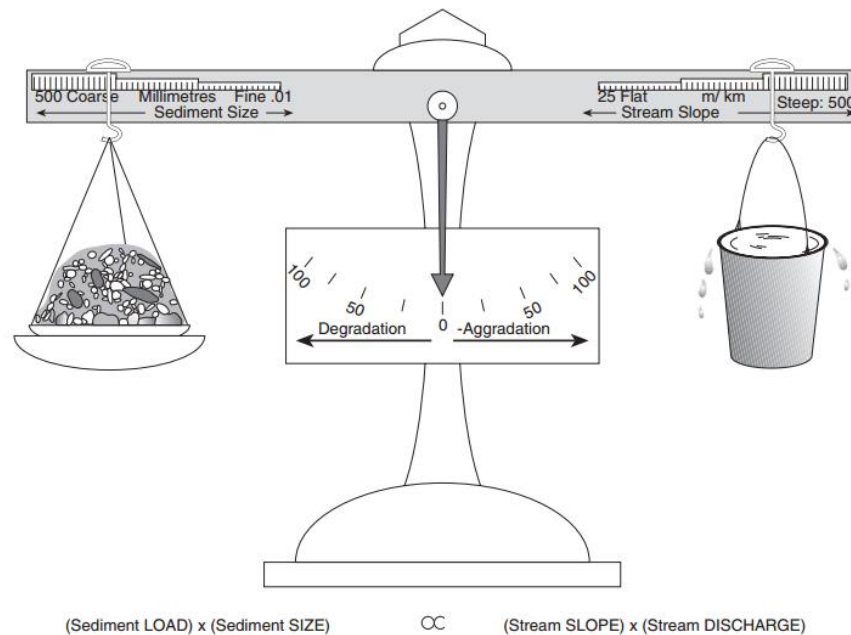
**Figure 2.1: Illustration of the Lane balance between stream power (stream slope x discharge) and sediment supply (sediment load x sediment supply) (Charlton, 2008).**

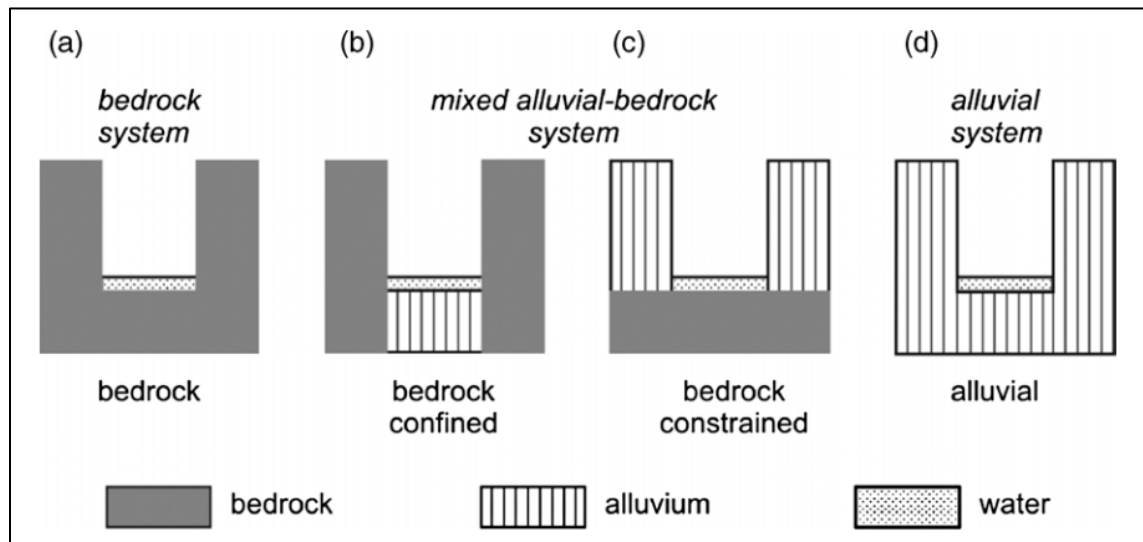
**Figure 2.2: The variation of channel types (Hrytsak (2012) based on Meshkova et al., (2012)).**

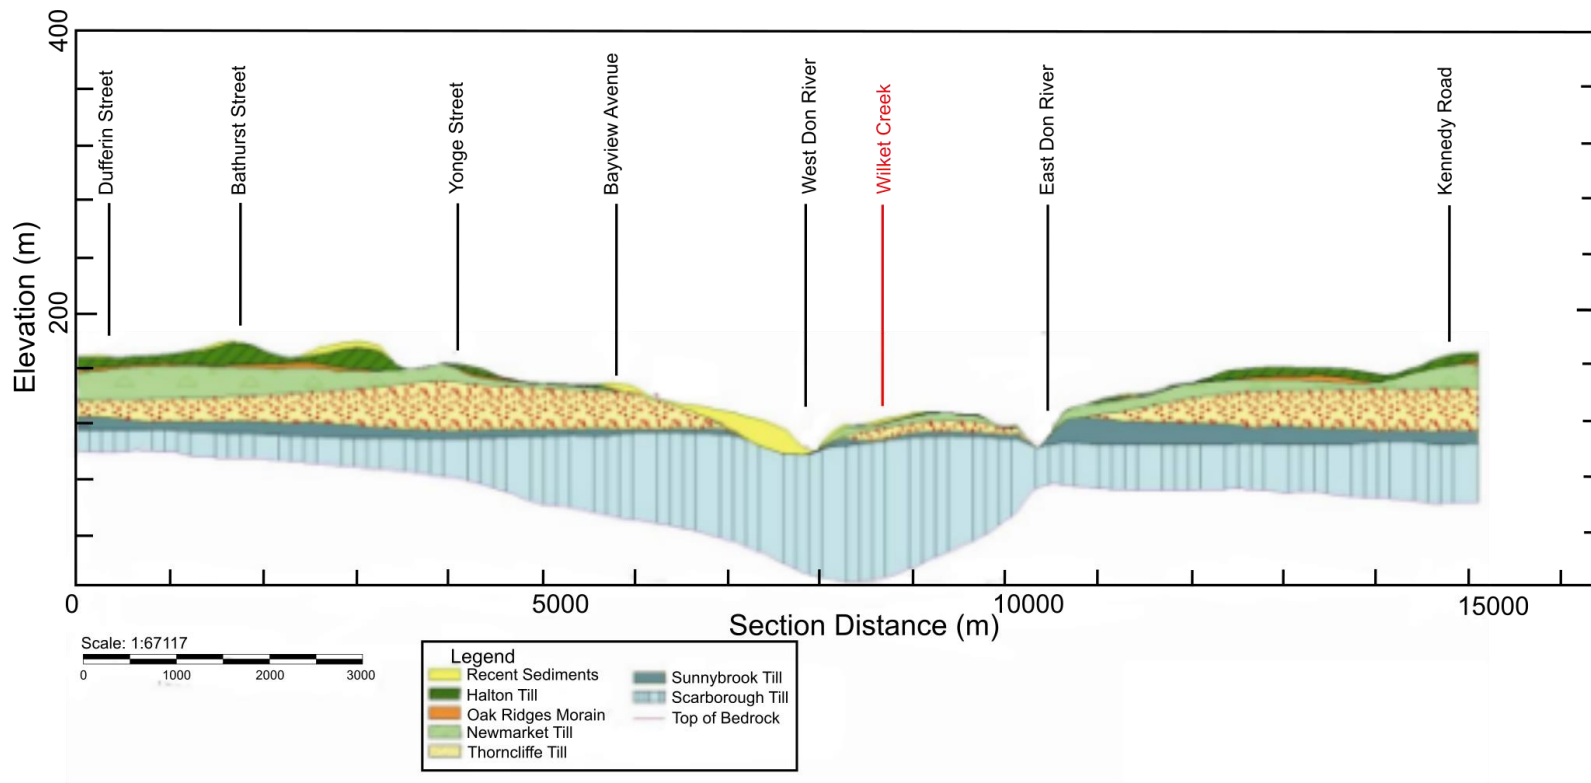
**Figure 3.6: A west-east cross section of the geology in Toronto. Based on the approximate location of Wilket Creek, it features recent sediments, and Halton Till. Wilket Creek flows into the West Don River, so it may also features some Thorncliffe Till and Sunnybrook Till(modified from Toronto and Region Conservation Authority, 2009).**

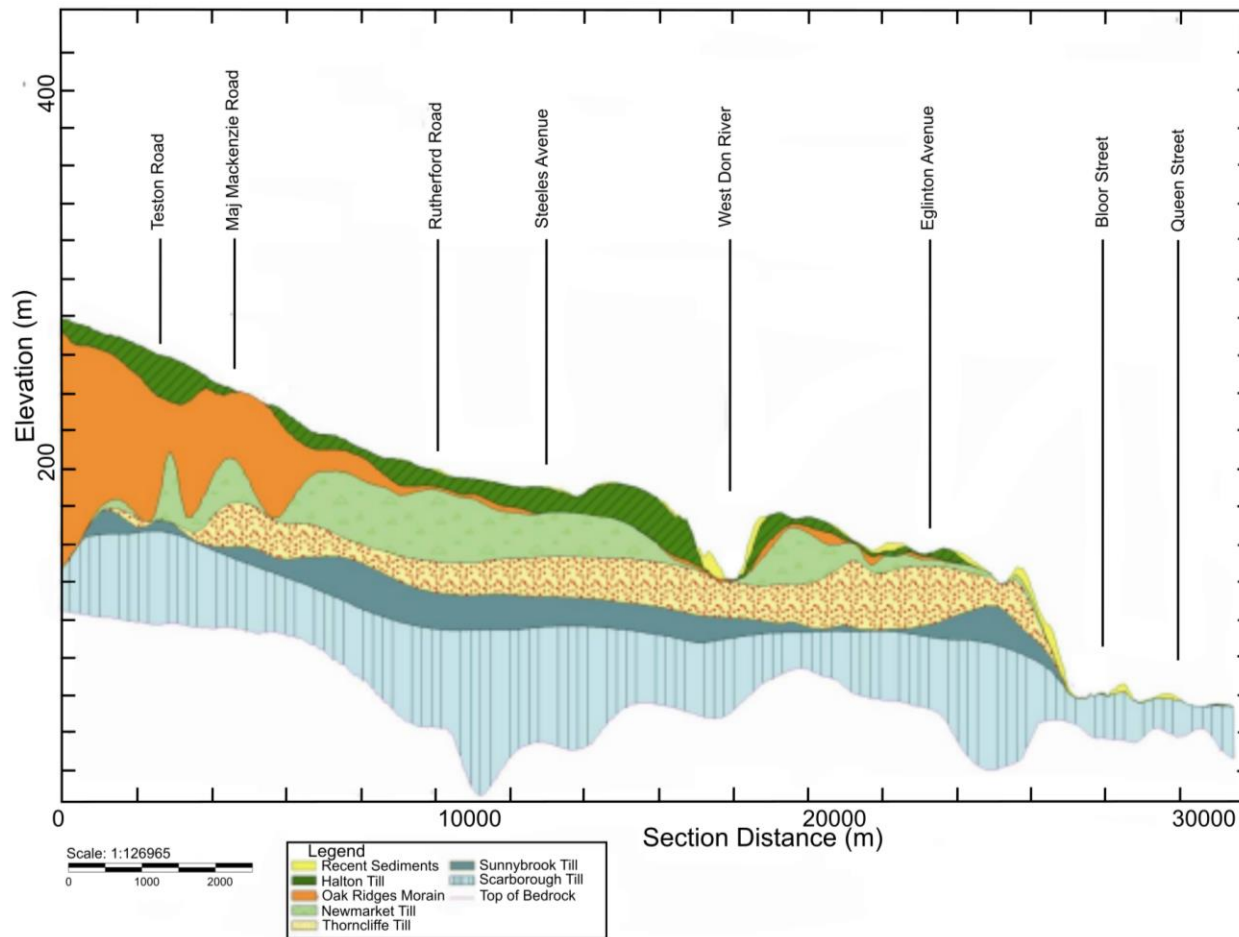
**Figure 3.7: A north-south cross section of the geology located west of Wilket Creek. The West Don River, into which Wilket Creek flows, features some recent sediments, Halton Till, and possibly some Thorncliffe Till. Wilket Creek likely follows a similar pattern, at least at its confluence (modified from Toronto and Region Conservation Authority, 2009).**

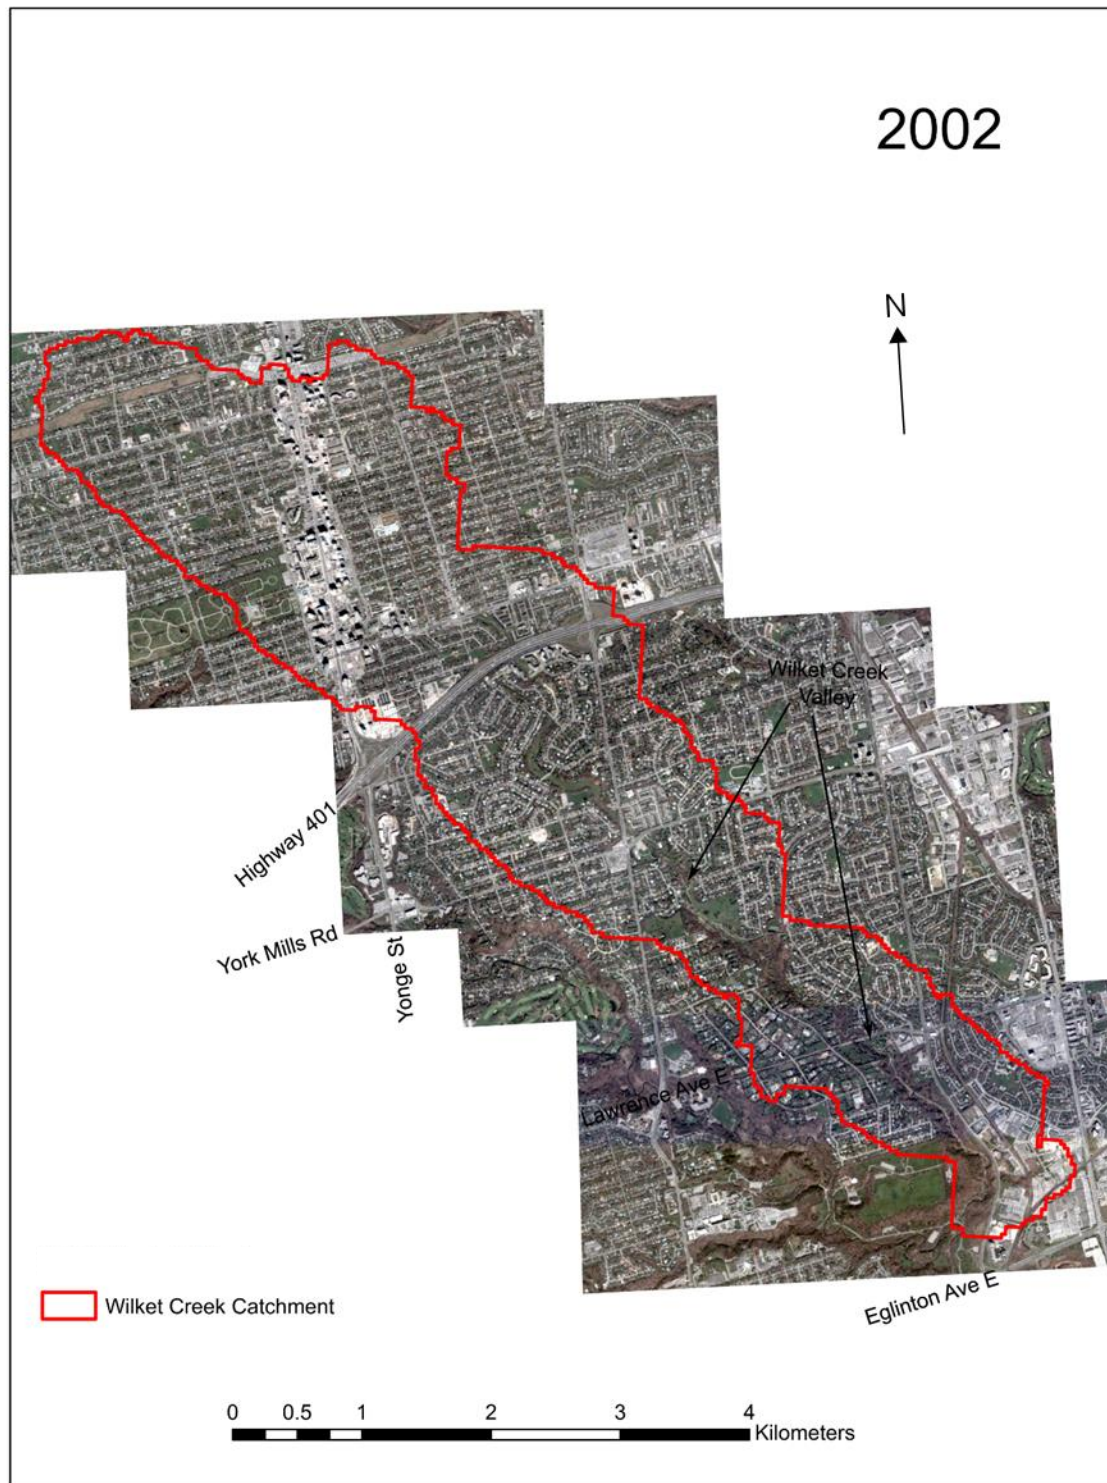
**Figure 3.16:** These satellite photos from 2002 show that the land use in the catchment continues to evolve. It is hard to see the channel in these photos due to the riparian coverage, while the footpath running between Eglinton Ave E and north to Lawrence Ave E is easily visible.

The evolution of development in the catchment continues through 1992 (Figure 3.15), and the catchment as a whole remains fully urbanized through 2002 (Figure 3.16) and 2016 (Figure 3.17). In the upper catchment, Yonge Street has more numerous high rises. The

The historical air photos (Figure 3.9 - Figure 3.17), show extensive changes in land use and creek from 1942-2016. The catchment changed from agricultural with a small percentage of residential land use to being fully urbanized with residential, commercial, and industrial land use. The channel also changed from open channel to buried storm sewer downstream of York Mills Rd in the middle reach, leaving the only open channel in the lower catchment. Because of the intense urbanization in the catchment and the resulting hydrology change, the channel itself also changed in geomorphology. In order to protect the surrounding infrastructure, stream corridor policies, land acquisition, and reconstruction and reengineering of the channel began as early as the 1960s and the preservation of this corridor is apparent in the historical aerial photographs. This will be discussed further in Chapter 4.

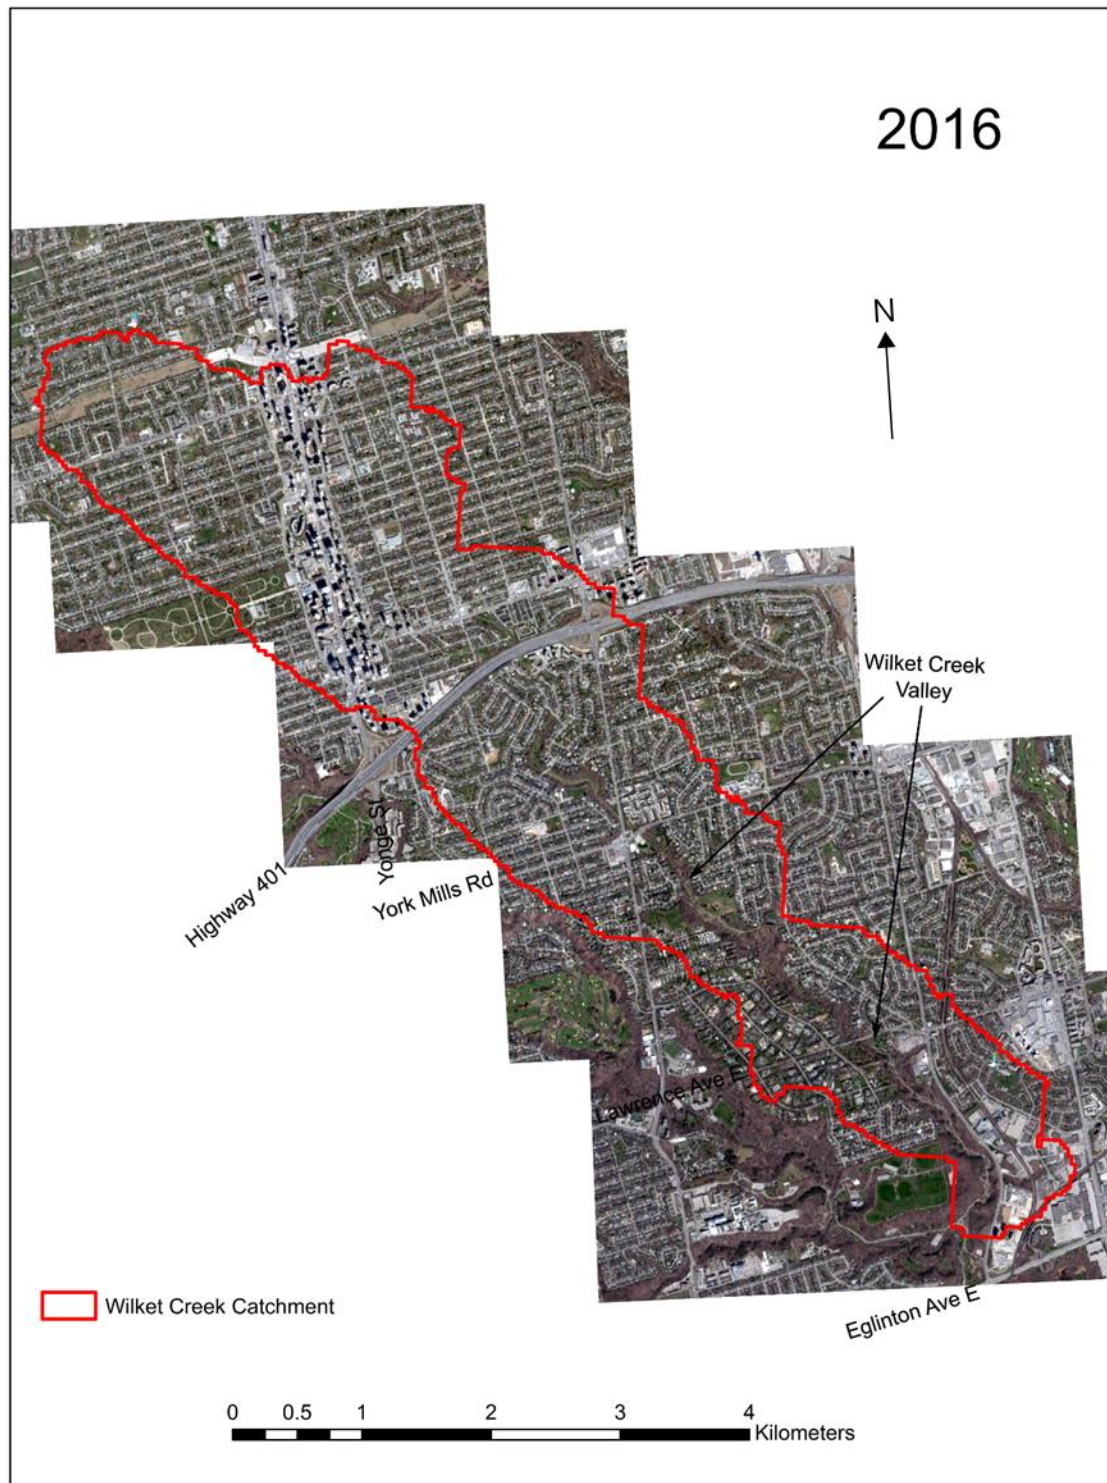
**Figure 3.17:** These aerial photos from 2016 show the fully urbanized catchment, in which the land use is still evolving. Some areas of the channel are visible.

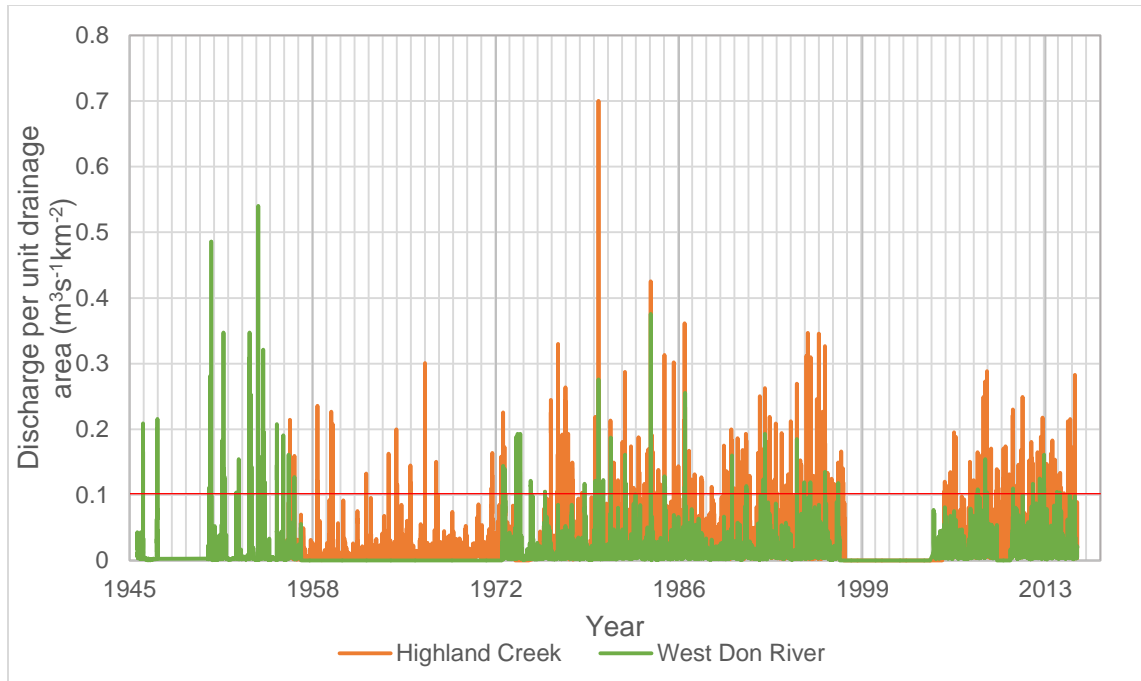
**Figure 3.18: The discharge per unit drainage area ( $\text{m}^3\text{s}^{-1}\text{km}^{-2}$ ) of the West Don River and Highland Creek catchments upstream of York Mills/Ellesmere Roads. These gauges are located approximately due east and west of where Wilket Creek appears on the surface (south of York Mills Rd), and can be used to approximate the timing of large flood events in Wilket Creek. Prominent flood years include 1954, 1980, and 1984; these floods will be more closely examined in Figure 3.21. As part of the NSERC Strategic Project Grant, gauging on Wilket Creek began in 2013 through to current day, with several gauges in both restored and unrestored sections of the channel. There are two gauges located upstream of Lawrence Ave E, while three more are located downstream of Lawrence Ave E. The longest record is from the gauge that was installed on September 13, 2013, and is used here. Figure 3.19 shows the comparison between flood events which were identified in the West Don River and Highland Creek and those that occurred in Wilket Creek based on flow level (stage).**

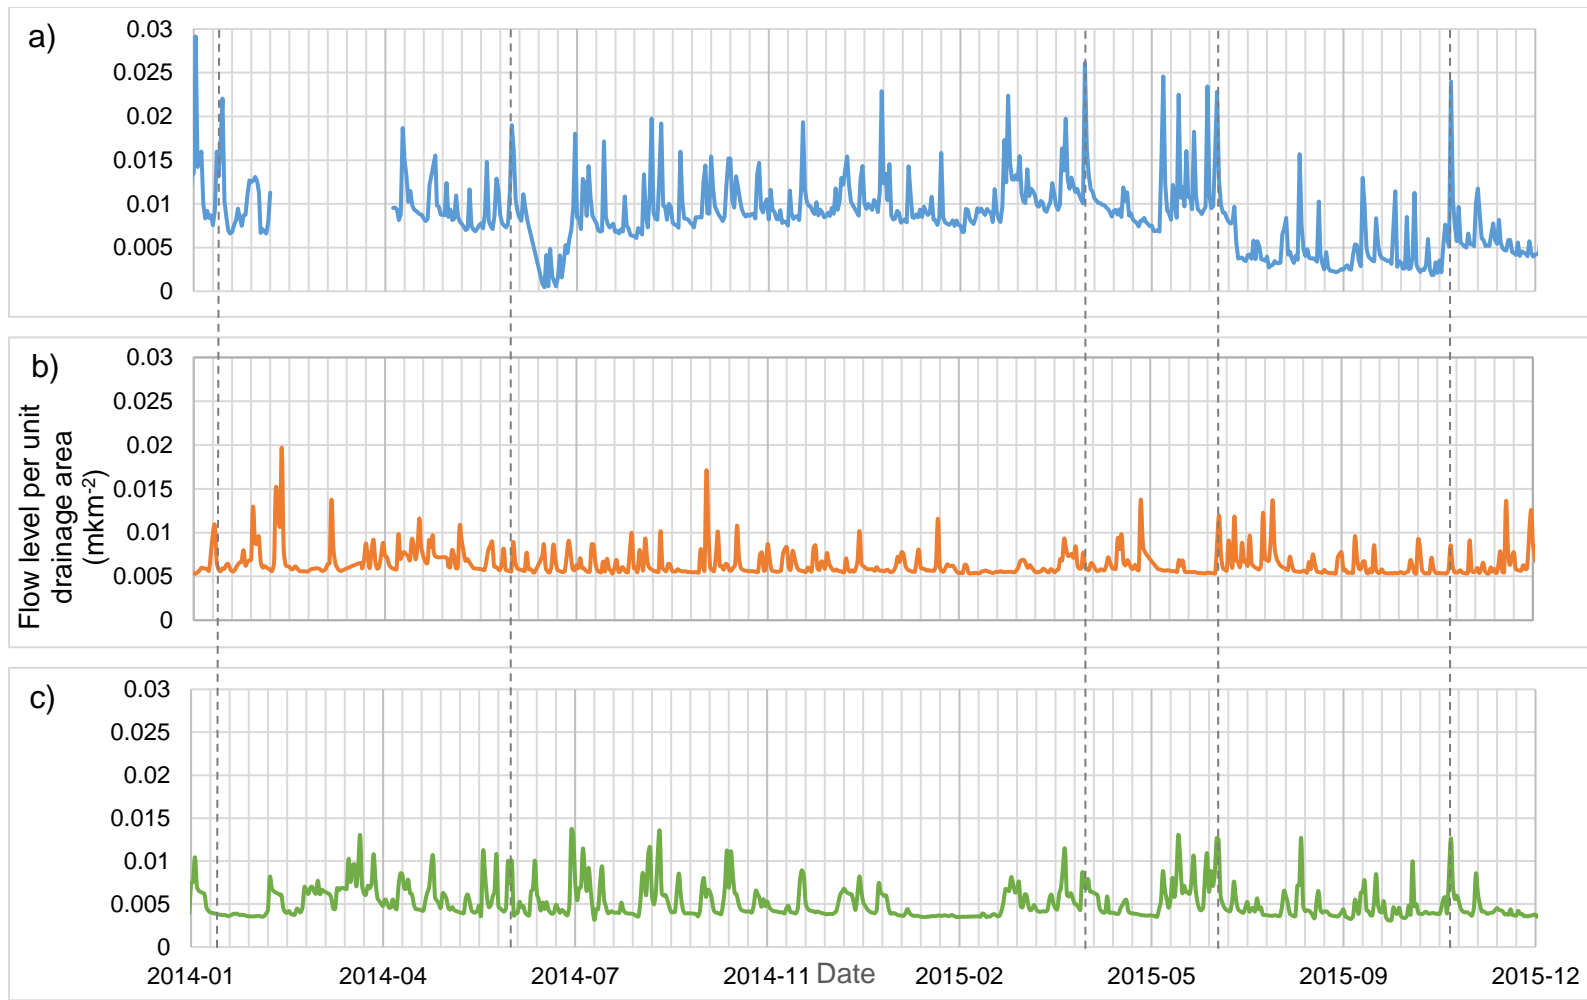
**Figure 3.19: A comparison of flow level per unit drainage area ( $\text{mkm}^{-2}$ ) between a) Wilket Creek, b) Highland Creek near Westhill, and c) the Don River at York Mills. The flow level in Wilket Creek is far greater than those seen in the**

While Figure 3.19 and Figure 3.21 show the peak events which may have occurred in Wilket Creek due to the proximity of the catchments, catchment size, and physiographic conditions, the overall trends in discharge should be examined. Gauging of the Don River at York Mills began in 1945, with a few gaps in data 1999 and 2006. While this gauge shows the flooding caused by Hurricane Hazel in 1954 (Figure 3.22), there are also several large flood events at other times in the late 1940s and early 1950s. Neither of the gauges on the other neighbouring catchments date back to this time period so there is limited information on whether these events also occurred in Wilket Creek. Highland Creek near Westhill began in 1956, although continuous gauging did not begin until 1958, and there is a large gap in the data between 1999 and 2006. Finally, the gauge on Black Creek at Weston began in 1966, and has no gaps in the data.

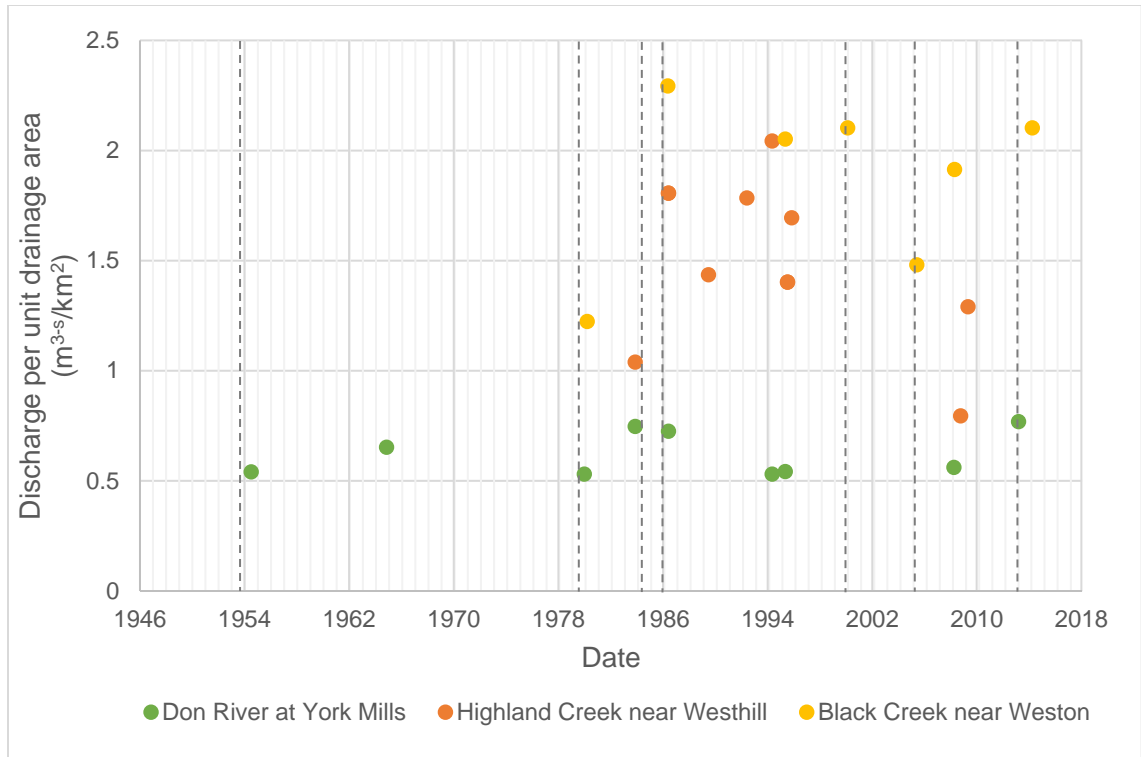
**Figure 3.21: The peak flow events in three neighbouring catchments to Wilket Creek. There is a large range of discharges between the three catchments; based on the above information, Wilket Creek would have also experienced these events, most likely within this range of discharges. These are the most extreme events in each of the catchments; it is expected that for each of these years (1954, 1980, 1984, 1986, 2000, 2005, and 2013) there would be an extreme event in Wilket Creek as well.**

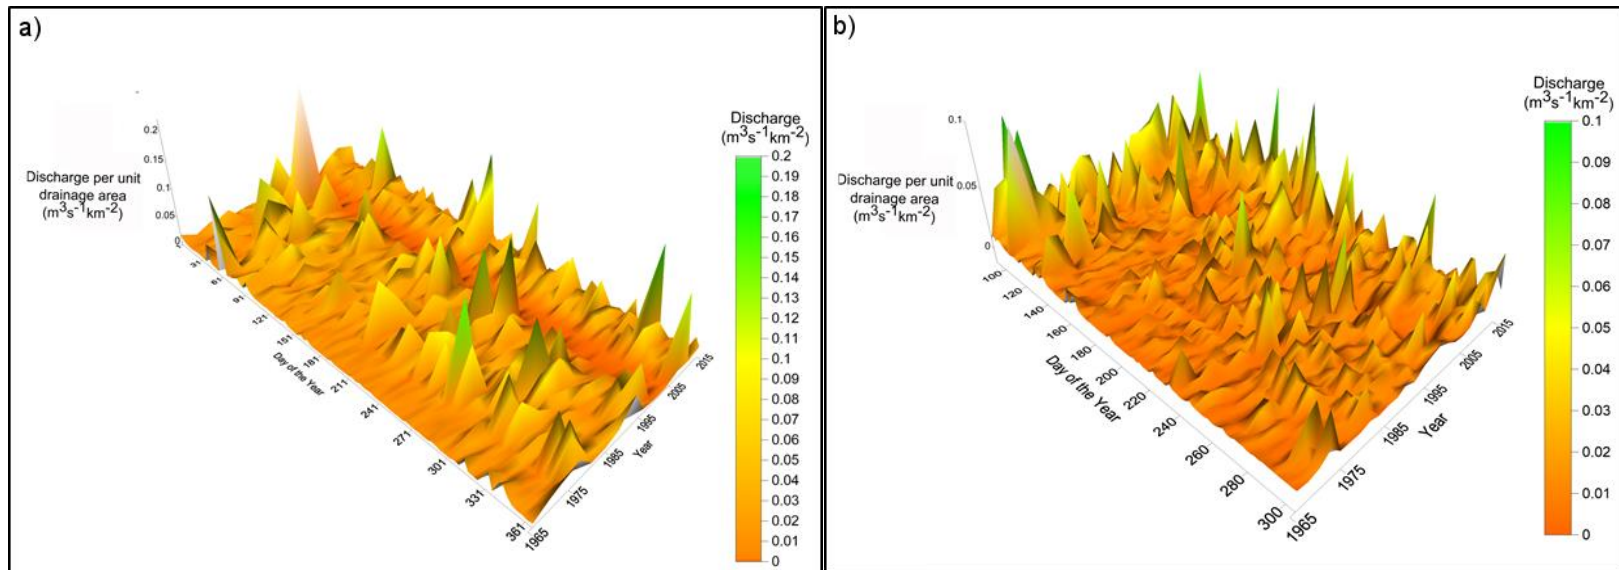
**Figure 3.24: The daily discharge per unit drainage area ( $\text{m}^3\text{s}^{-1}/\text{km}^2$ ) of Black Creek at Weston starting in 1966. a) shows the entire year while b) shows the summer months between April 1 and October 31. The winter snowmelt flows have depleted from 1966 to 2015. Flashy summer flows have already begun at the start of gauging in this catchment however, over time there is an increase in the frequency and magnitude of the flashy flows, presumably with the increase of urbanization.**

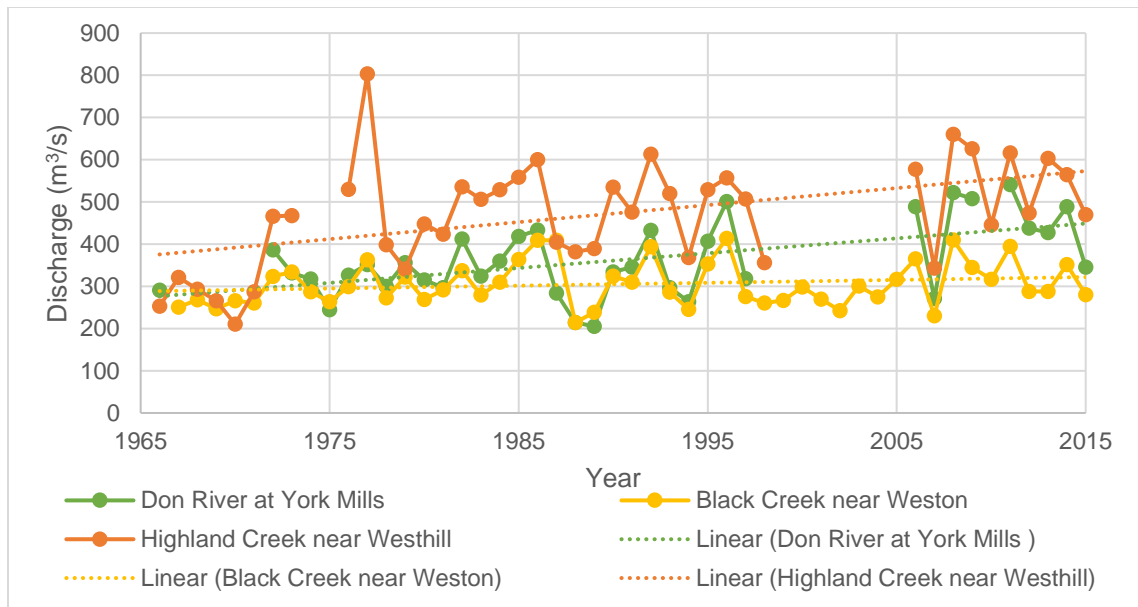
**Figure 3.25: The total annual discharge of the three neighbouring catchments; Don River at York Mills, Highland Creek near Westhill, and Black Creek at Weston. While there are gaps in records for both Don River at York Mills and Highland Creek near Westhill, the overall trend is an increase in annual discharge over time. This can be linked to the increase in urbanization in each of the catchments. As these catchments share similar urbanization histories, physiographic characteristics, and catchments sizes, it can be assumed that Wilket Creek would have also experienced this trend.**

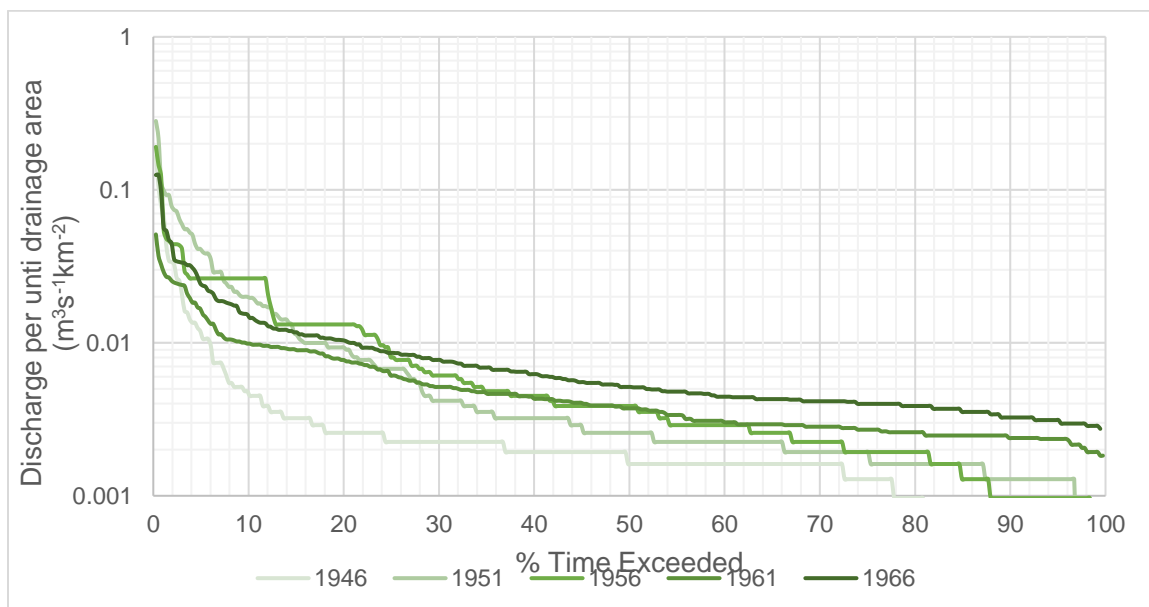
**Figure 3.26: The flow duration curve for the West Don River between 1946 and 1966.**

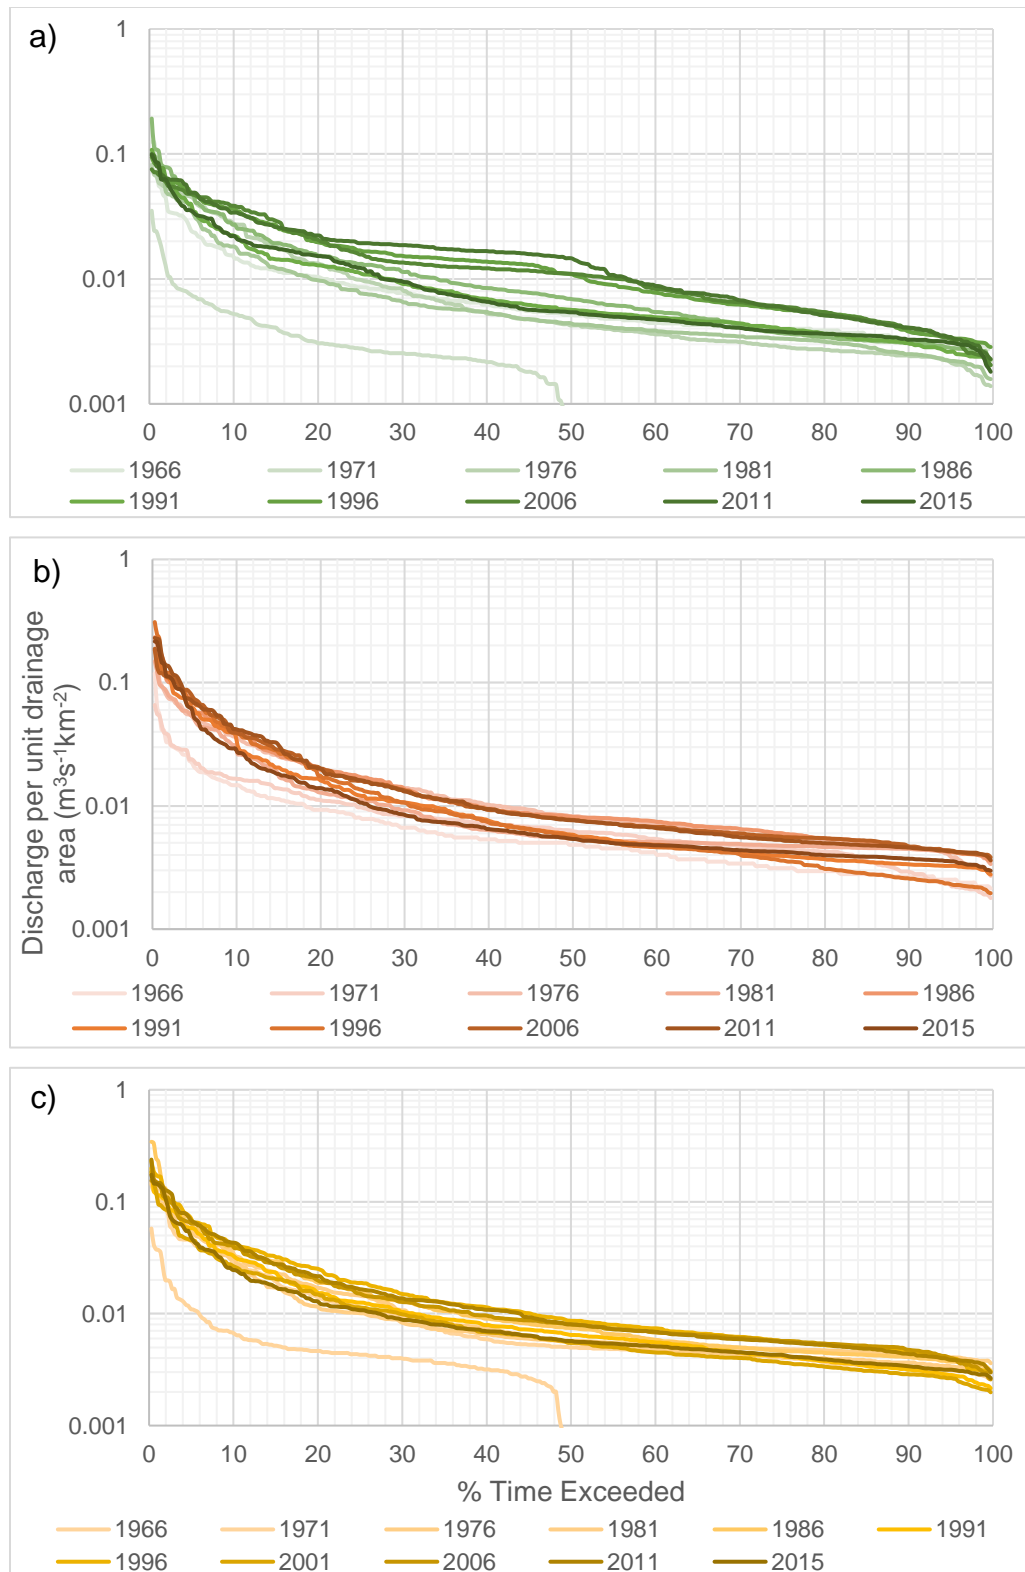
**Figure 3.27: Flow duration curves for a) the Don River at York Mills, b) Highland Creek at Westhill, and c) Black Creek near Weston.**

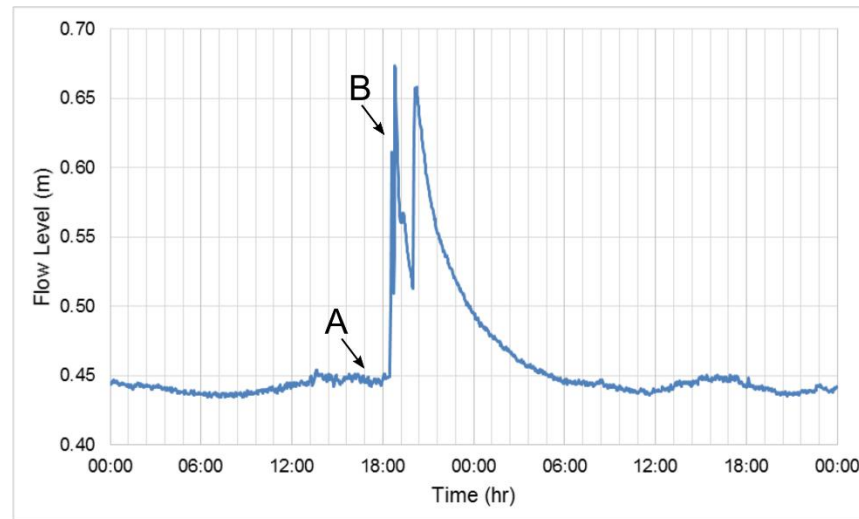
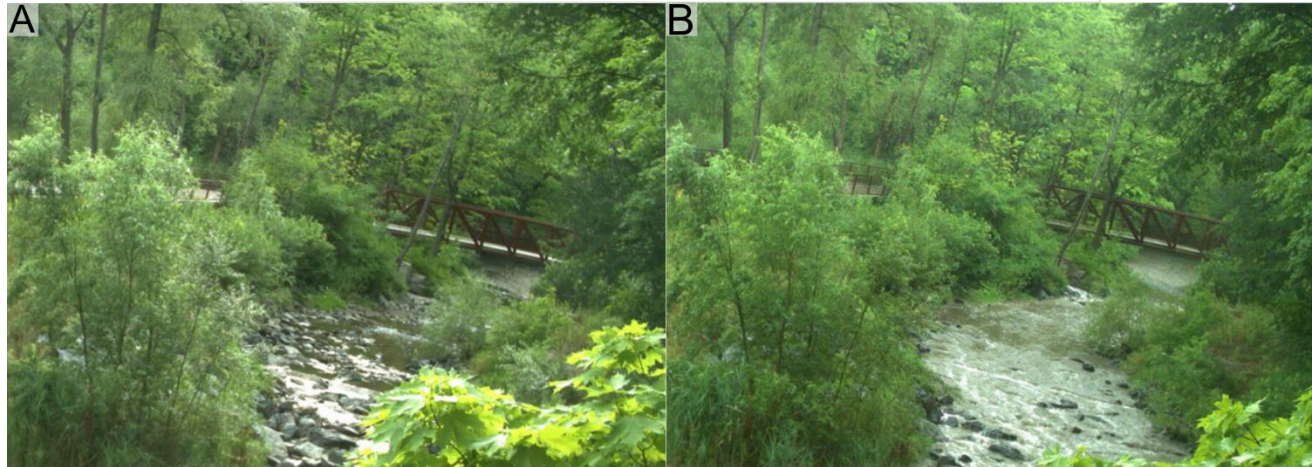
**Figure 3.28:** The rise and fall of a peak flow event in Wilket Creek above base flow during a 48 hour flood period. The letters, A and B, correspond to the photographs showing the base flow and peak flow of this event. These photographs were taken slightly downstream of the gauge noted in the previous figures. The morphological history of Wilket Creek

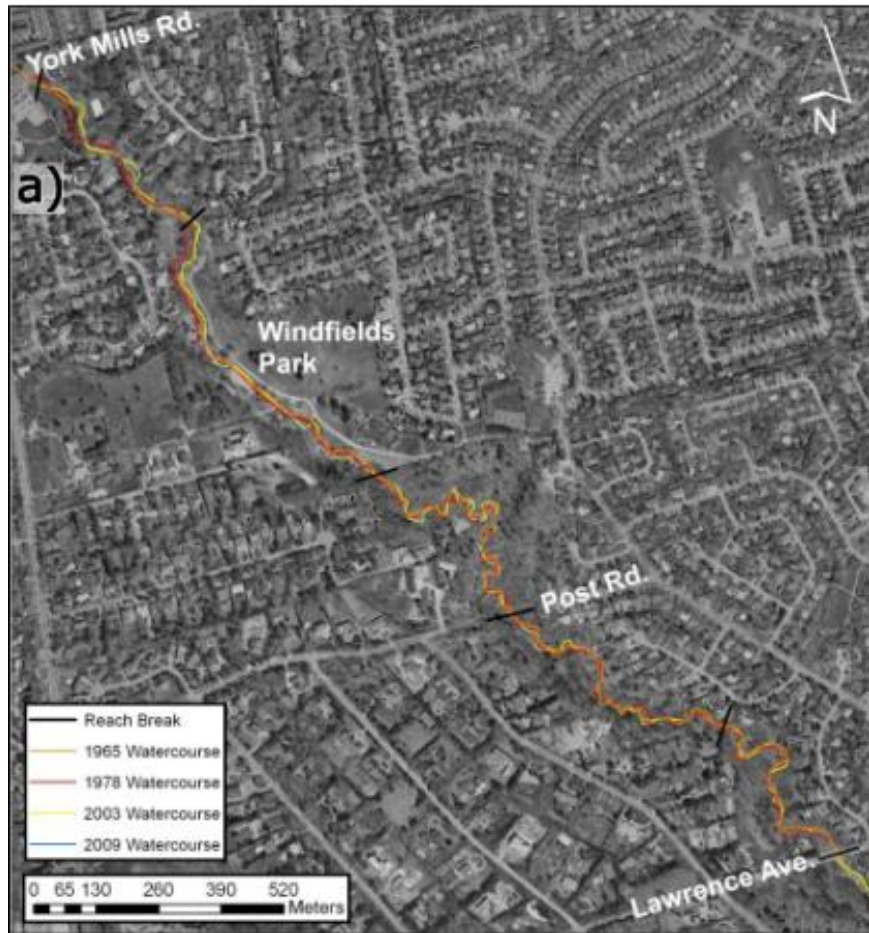
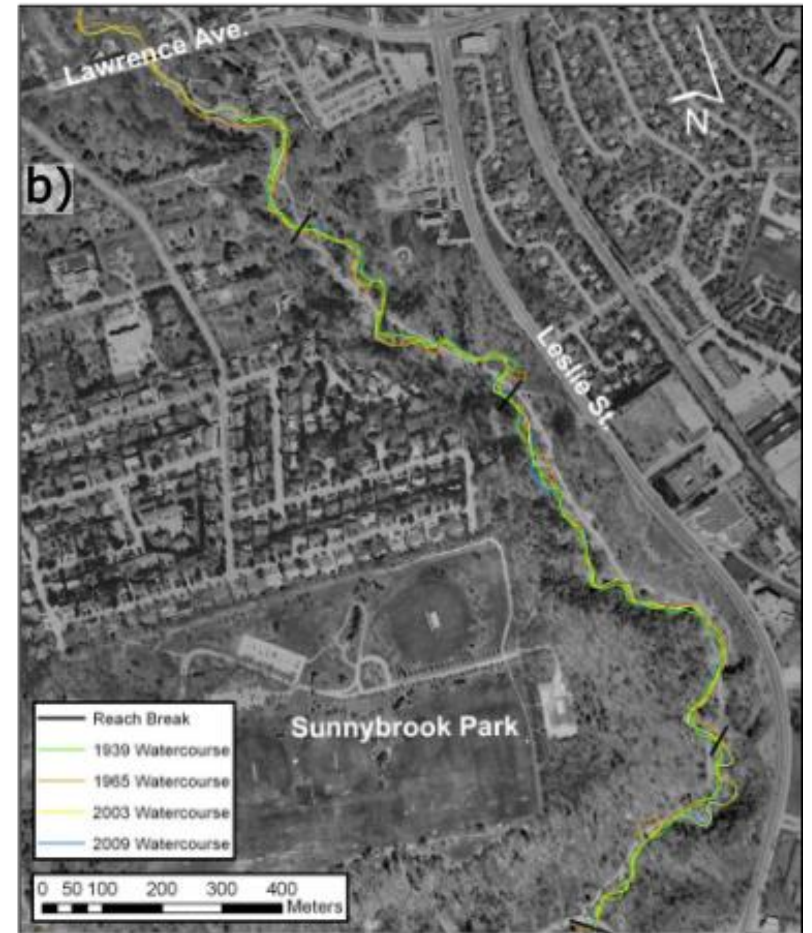
**Figure 3.29: The planform alignment of a) the upstream reach and b) the downstream reach of Wilket Creek. The planform in b) begins before the beginning of urbanization while the planform in a) begins during urbanization. The greatest change in planform morphology is between 2009 and 2013. This may be due to further reconstruction after a flood event in 2005 (modified from Parish Aquatic Services, 2013).**

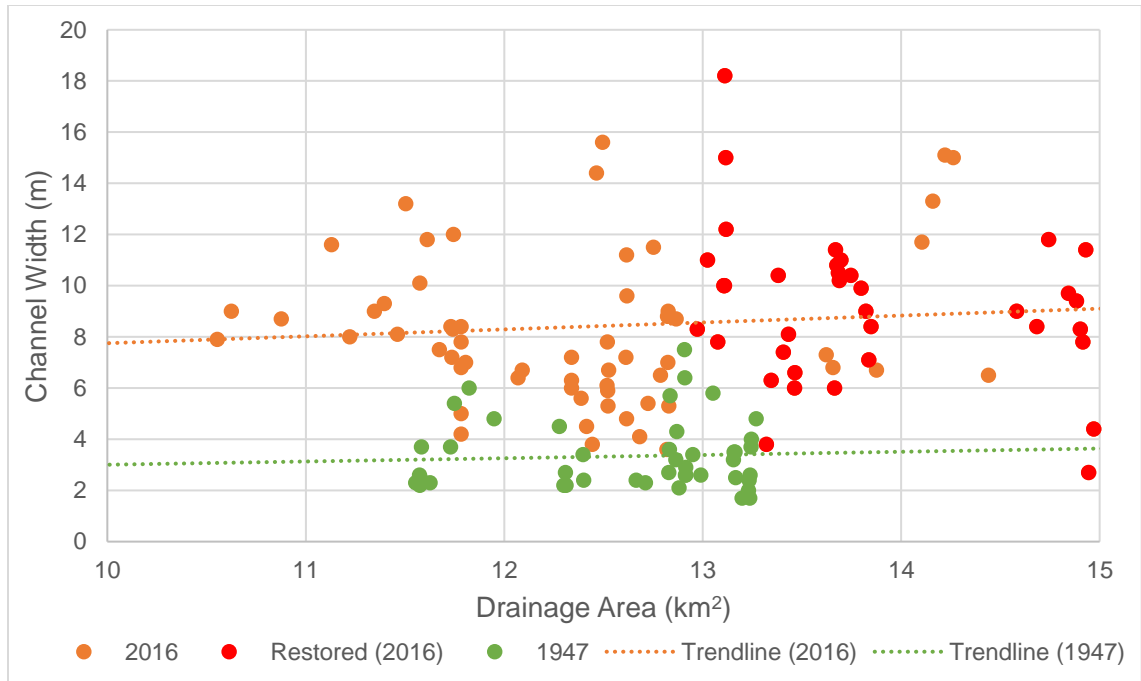
**Figure 3.30: The widening of Wilket Creek between 1947 and 2016. The widths from 1947 are less than half of those in 2016. The distribution also shows the widths of the restored sections channel which fall within the distribution of widths from 2016. It is likely that widening is the result of increased discharge but direct confirmation is difficult.**

photographs. The aerial photograph from 1947 covers a limited length of the channel, however overall the channel has widened between these two time periods. In 1947, the channel width averaged between 3m and 8m, while in 2016 the channel width averaged between 4m and 16m. This finding is consistent with many previous papers on the effects of urbanization on river morphology (i.e. Arnold et al., 1982; Chin & Gregory, 2001; Wolman, 1967). With that in mind, it must also be noted that there have been processes or events occurring within the catchment other than urbanization that could affect the morphology of the channel. Some of these processes or events include the rainstorm events noted in Section 3.3, and the reengineering/reconstruction, which will be discussed in Chapter 4.

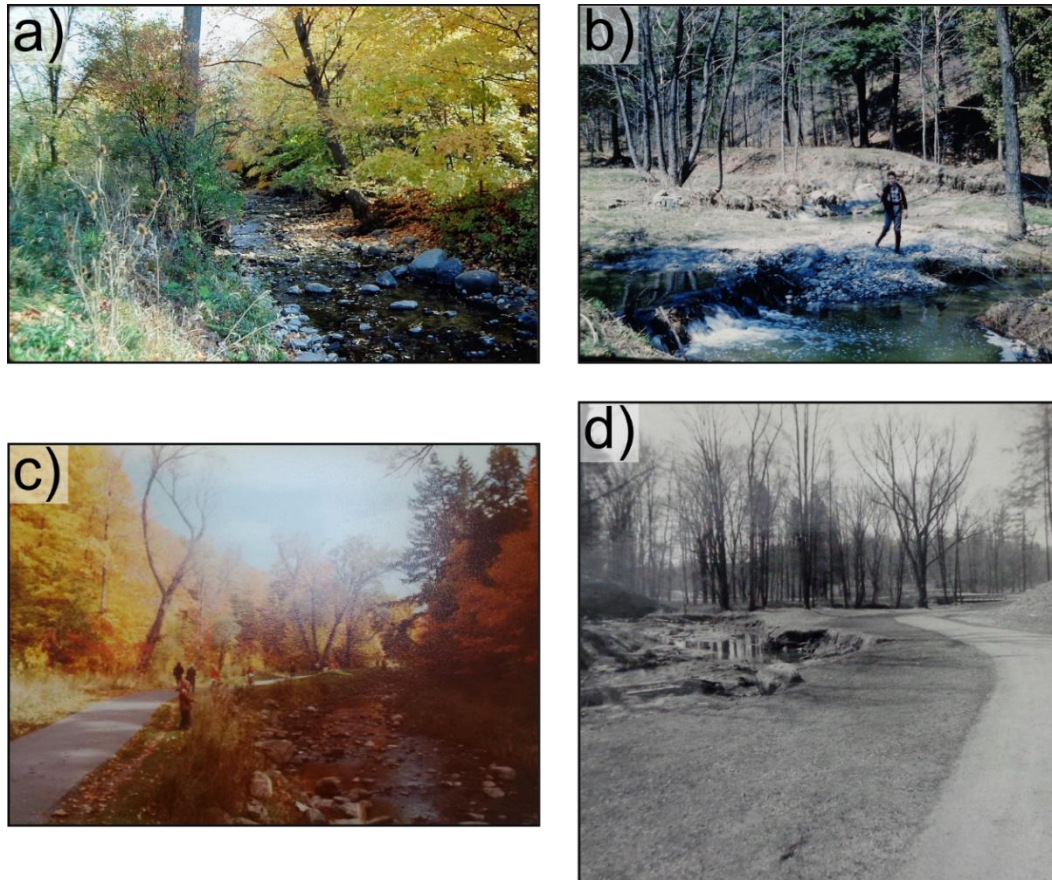
**Figure 3.31: Historical ground photos of Wilket Creek from the early 1960s. While the locations of each of these ground photos is not known, each photo demonstrates what the mid-urbanization channel may have looked like. Each of these photos show a) a section of channel less than half a meter in depth and a width of approximately 1-2 meters; b) a section of channel varying in depth and with a varying channel width; c) a larger section of channel with a small boy for scale: this section is less than 0.5m in depth with a width of less than 2m; d) a section of channel exhibiting the beginning of erosion (Toronto Archives, 1965). Below, Figure 3.39, shows photographs of the current channel for comparison.**

Ground photographs of the channel itself show the morphological changes between the 1960s and 2016. Figure 3.31 shows ground photos from the early 1960s and indicates that the channel is shallow in depth and not very wide. Unfortunately, there is no way to accurately measure these as there is no given or known scale. The grain size, which will be discussed below in Section 3.5.2 and 3.5.3, seems to range from sand to cobbles. As seen in several figures below, including Figure 3.37 and Figure 3.43, the depth of the channel has increased since the ground photos in Figure 3.31 were taken. In Figure 3.31 the depth seems to be less than 0.5m, while based on bank profiles in Section 3.5.3, the depth is now over 1.5m in many locations, showing the degree of incision in the channel, a common channel response to increased discharge from urbanization (Leopold, 1968; Brown, 2001; Chin & Gregory, 2001; Walsh et al., 2001).

Figure 3.43 shows two left bank profiles from the upstream end and the middle of the downstream reach. The depth of these bank profiles also shows the degree to which the channel has incised, especially when looked at compared to Figure 3.31. The profiles are similar; b) and g) are lag layers that appear to be from the bed of a previous channel. Based on the position of this layer in the stratigraphy, this layer is most likely from Wilket Creek's channel pre-urbanization. This layer was investigated for its grain size distribution, which was then compared to the grain size distribution of the adjacent channel bed. Above this layer, a) and f), appears to be overbank fines or post-settlement alluvium. This layer may be sediment that was washed down the channel in the 1950s and 1960s, from the erosion during the development and construction boom in the catchment. It is also possible that this layer is even earlier from previous land clearance for agriculture (e.g. Crawford et al., 1998). The two bank profiles differ below the lag layers; beneath lag layer in the profile on the left of Figure 3.44 is a well sorted fine to medium sand layer with clear flow structures, while under the lag layer in the profile on the right of Figure 3.44 there is layered diamict.

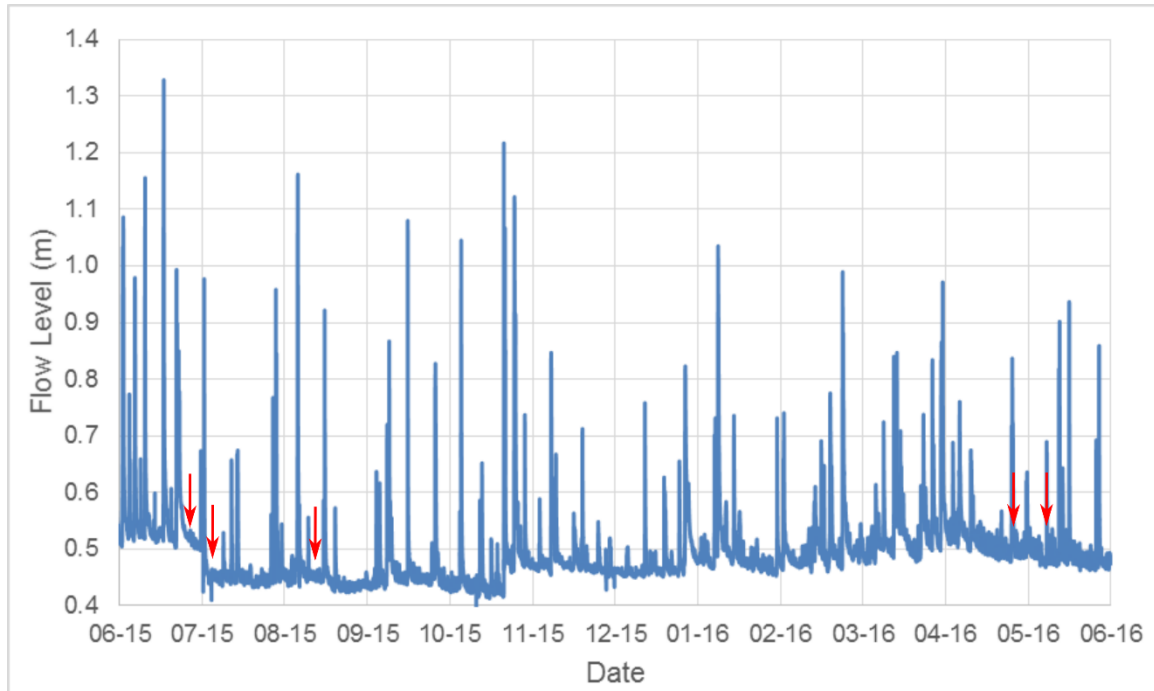
**Figure 3.34: The flow level (above base flow) of Wilket Creek, with the field visit highlighted by red arrows. Three of the five dates were single days (the first and the last two), while the middle two visits were four days in length. Between each of the five different field visits there is at least one peak flow. The stream flow data (from Section 3.3) is from a gauge located in TRCA defined Reach 3 as part of the larger research project.** The glacial sediment which is exposed in this reach is relatively smooth, containing small gravel clasts within it. This material is highly erodible and mainly exposed in deep pools in this reach. Downstream of these areas, clasts of the material are present, both in the channel and on bars (Figure 3.35). These clasts are presumably eroded during high flow events.
