## Wilket Creek: urbanization, geomorphology, policy, and design

Danielle Barr

A thesis submitted in partial fulfillment of the requirements for the degree in Master of Science

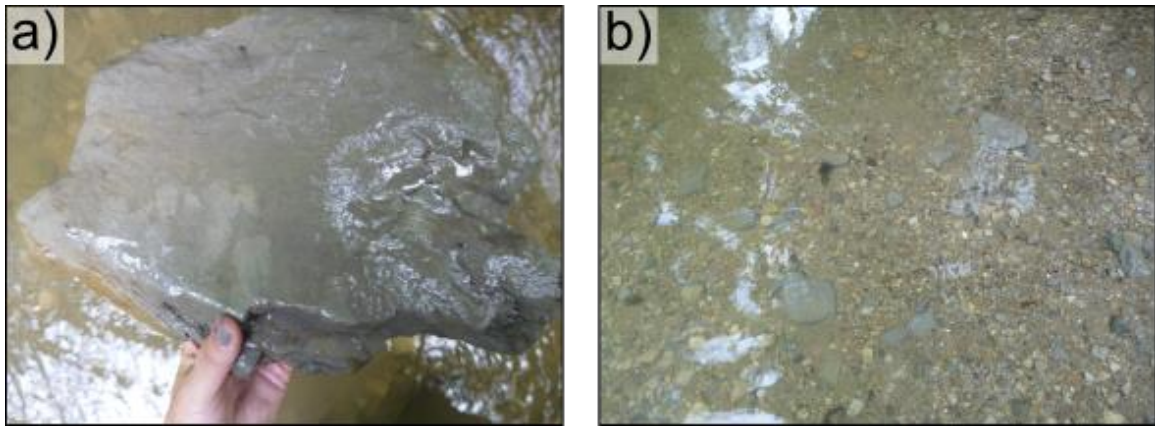
**Figure 3.35: Glacial diamict clasts located in the upstream reach of Wilket Creek. On the left, a) a close up photo of a till clast, and on the right b) depositional area of till clasts from upstream erosion. The till in this reach is smooth with few small clasts in it.**

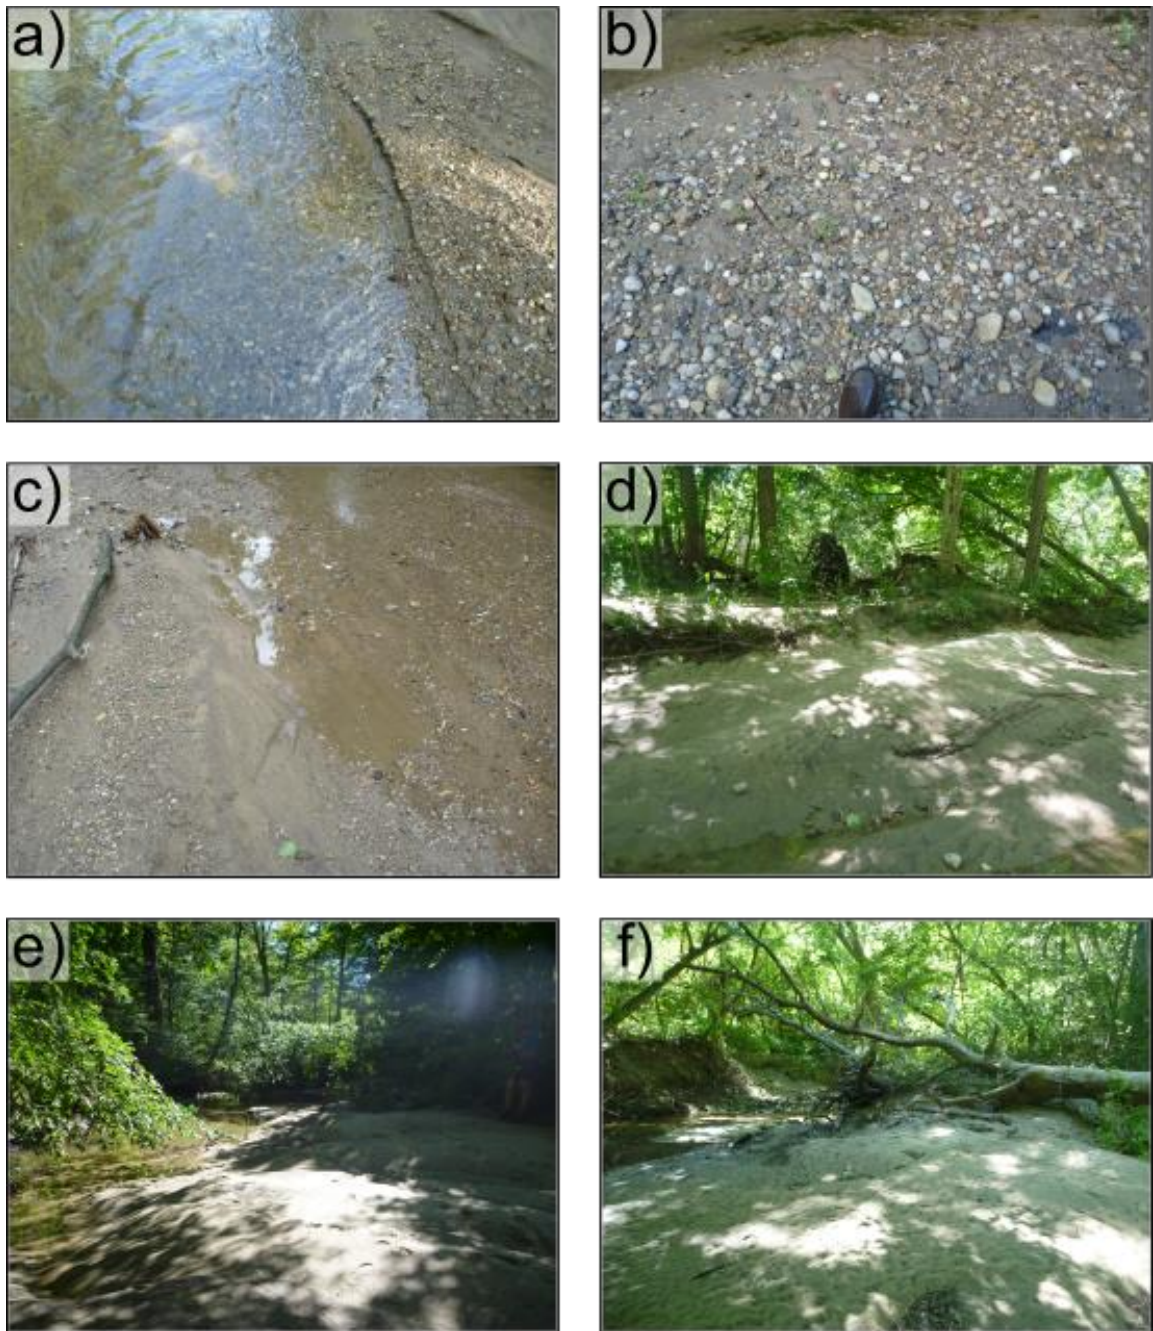
**Figure 3.36: The upstream reach channel bed showing sand and gravel areas, gravel dominated areas, and sand dominated areas. In a) a sand and gravel point bar, b) a gravel and sand bar, c) a sand and fine gravel bar, d) a sand bar on the inside of a meander bend, e) a sand bar on the outside of a meander bend, f) a sand bar created by woody debris downstream. The sand point bars are extensive, both laterally and vertically. Other areas of alluvial cover are gravel and sand and gravels areas lying in thin layers overlying Halton till.**

The woody debris in the channel frequently extends from the banks of the channel as fallen trees (Figure 3.36). These trees span the channel width, and line the channel banks along with roots and vegetation. Generally, the root exposure is due to channel widening, undercutting trees, or erosion of the channel sides indicating active meandering. This destabilization leads to bank failure, which increases the sediment input to the channel. This could lead to the deposition of the aforementioned sand point bars, or it could lead to erosion of the downstream banks.

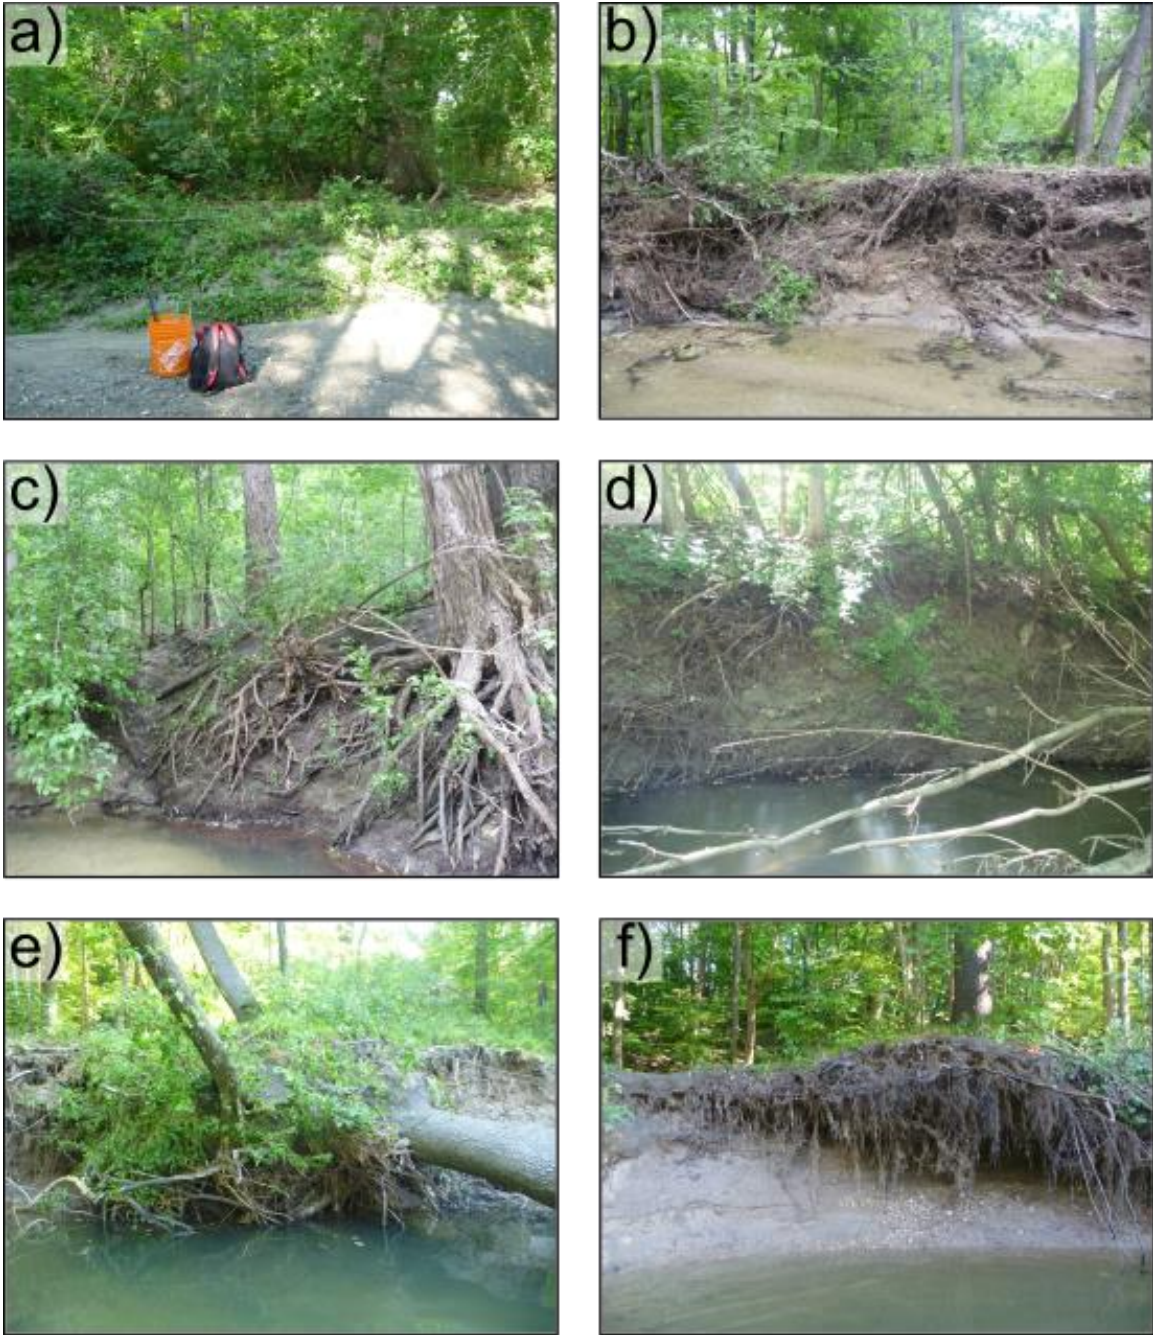
**Figure 3.37: Pictures of the upstream reach left and right banks. In a) a low bank with some vegetation cover, b) an eroded bank with roots of varying sizes helping with bank stability, c) an eroded bank with larger root mass helping with the stability of the bank, d) a bank with bar sediment at the base and roots and vegetation at the top, e) a group of trees which fell due to erosion undercutting the bank, and f) a bank eroding and undercutting a large tree. The tree in f) fell into the channel over the following winter months.**

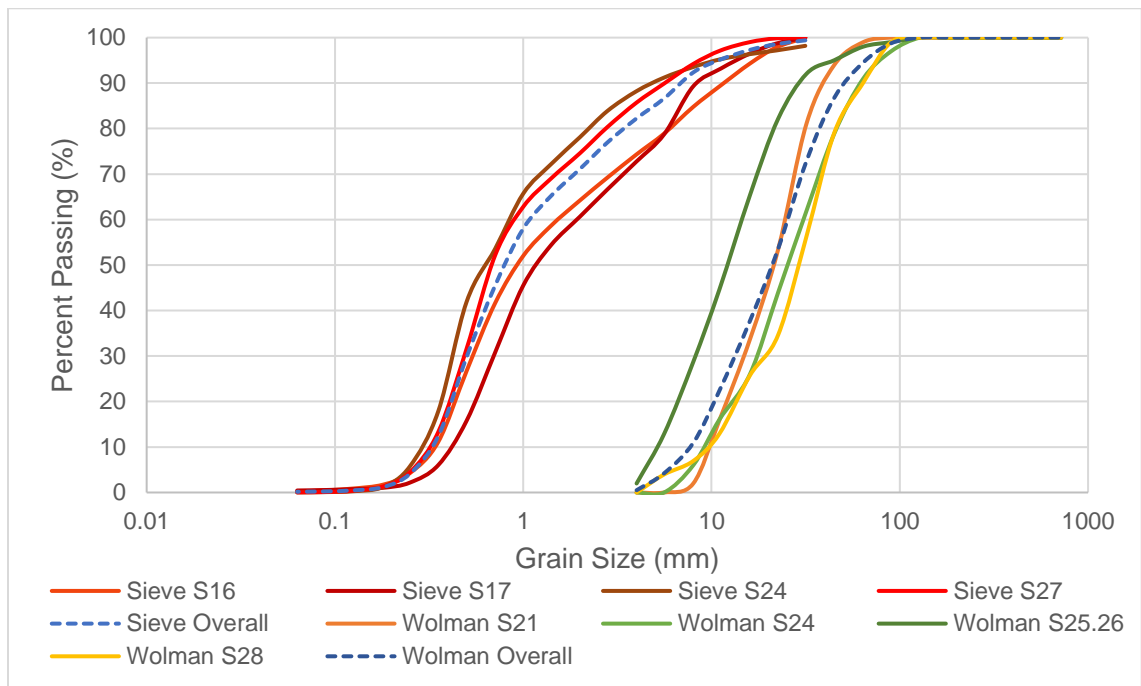
**Figure 3.38: The grain size distribution of the upstream reach obtained through four Wolman Walks (gravel fraction), sediment collection and sieving (sand and fine gravel).**

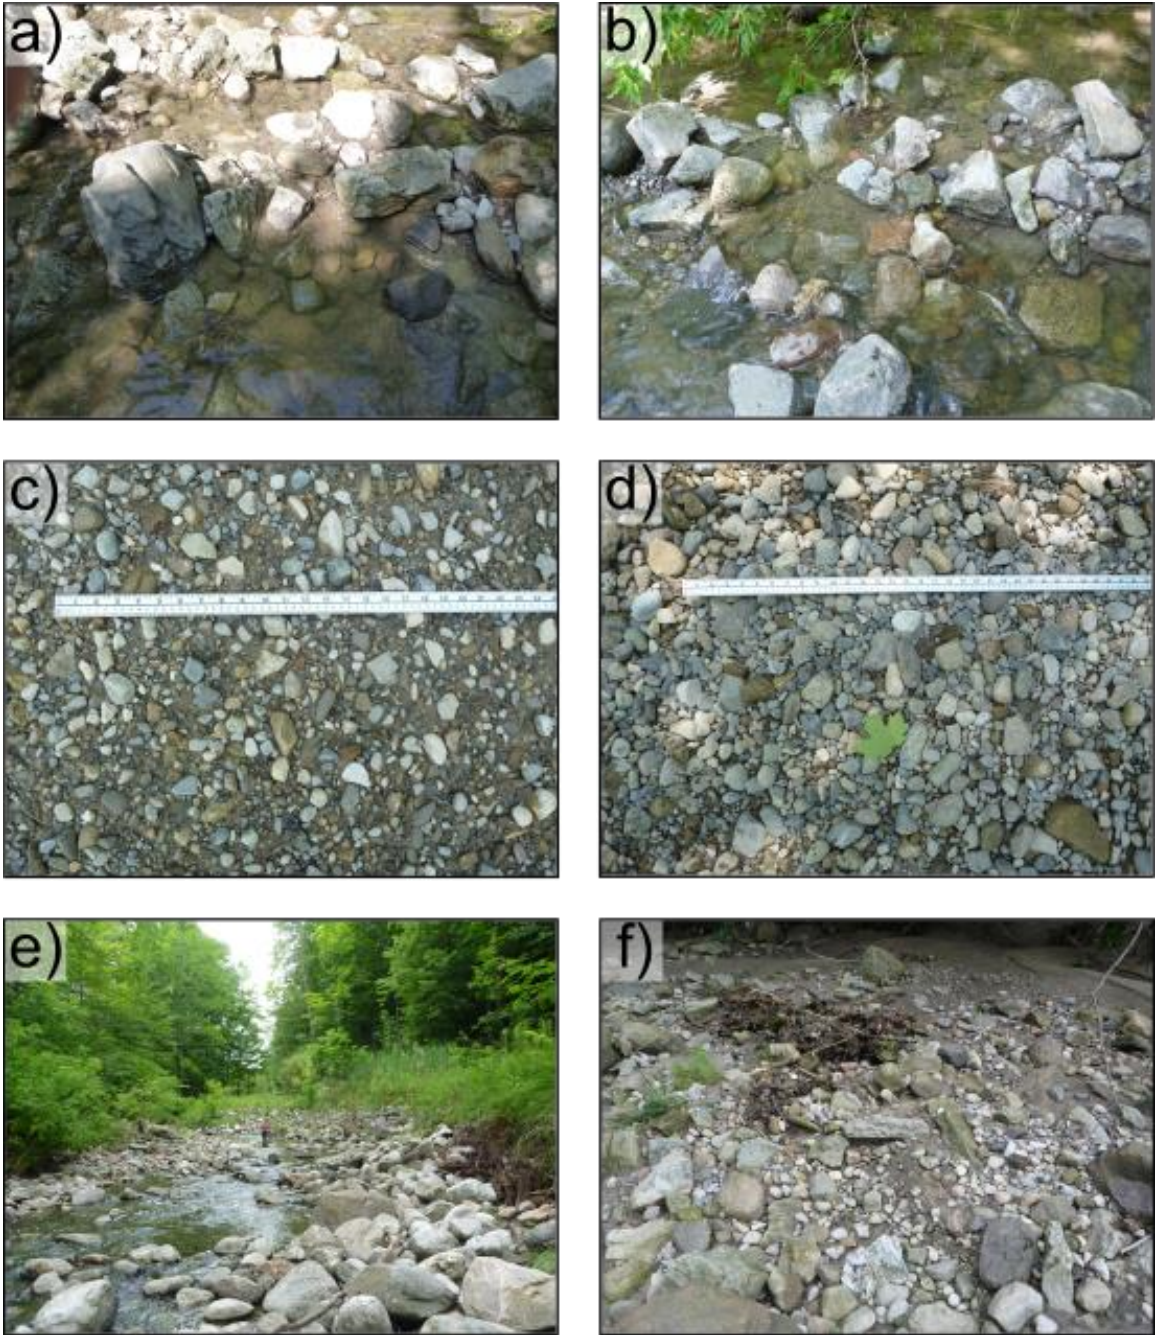
**Figure 3.39: Examples of grain size of the channel bed in the downstream reach. There is a larger range of grain size in this reach; a) natural cobbles and boulders, b) natural gravel, cobbles, and boulders ; c) natural gravel and sand; d) natural gravel; e) natural and/or historical reconstructed cobbles and boulders; f) natural sand to boulders along with woody debris.**

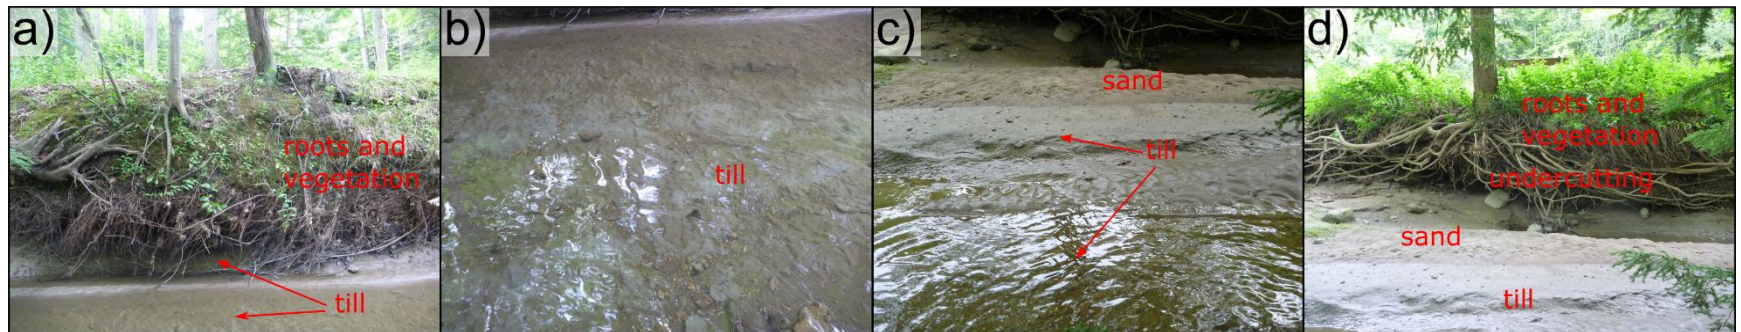
**Figure 3.41: A full view of a cross section in the downstream reach. Starting from a) the right bank featuring vegetation and roots on top of diamict (till) in the bank which extends downwards into the channel bed; b) blocky till in the channel bed abutting the right bank with minimal to no alluvial cover; c) till channel bed abutting the left bank featuring a silty/clay bar; d) the eroded right bank with roots and vegetation. The point bar featured in c) was used for the depth of alluvial cover in Figure 26.**

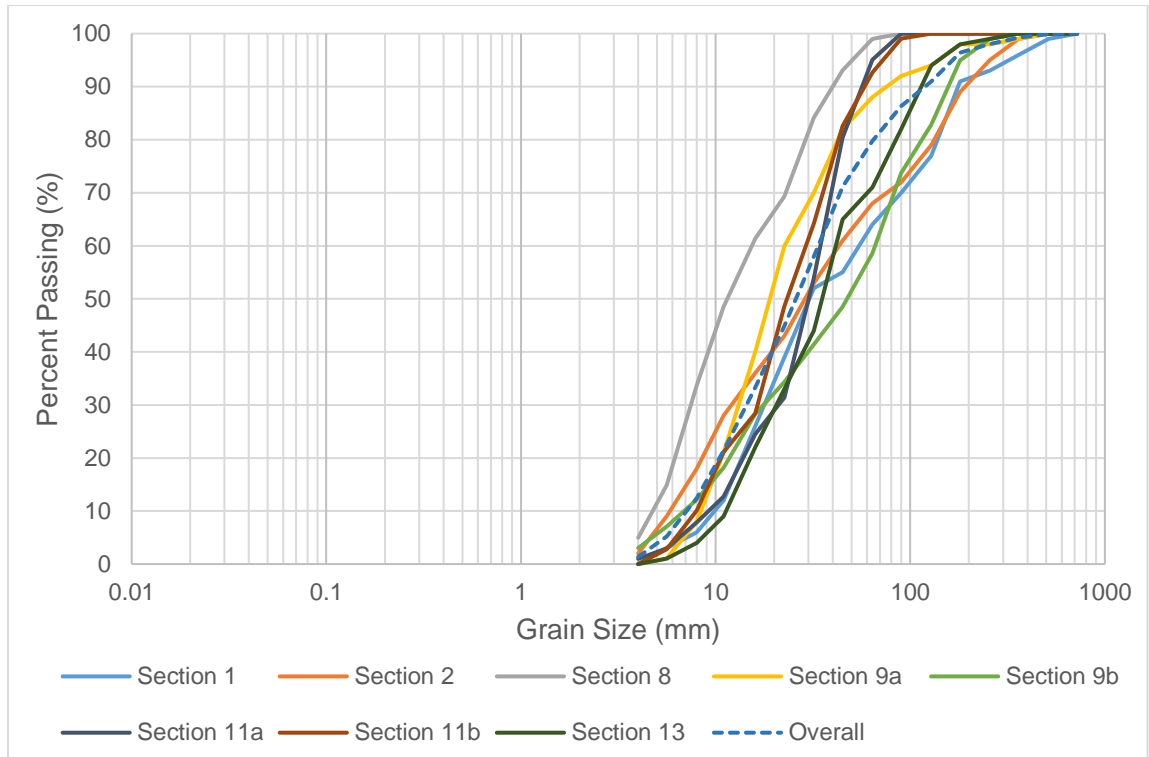
**Figure 3.42: The grain size distribution of the downstream reach obtained through Wolman Walks (Wolman, 1967).**

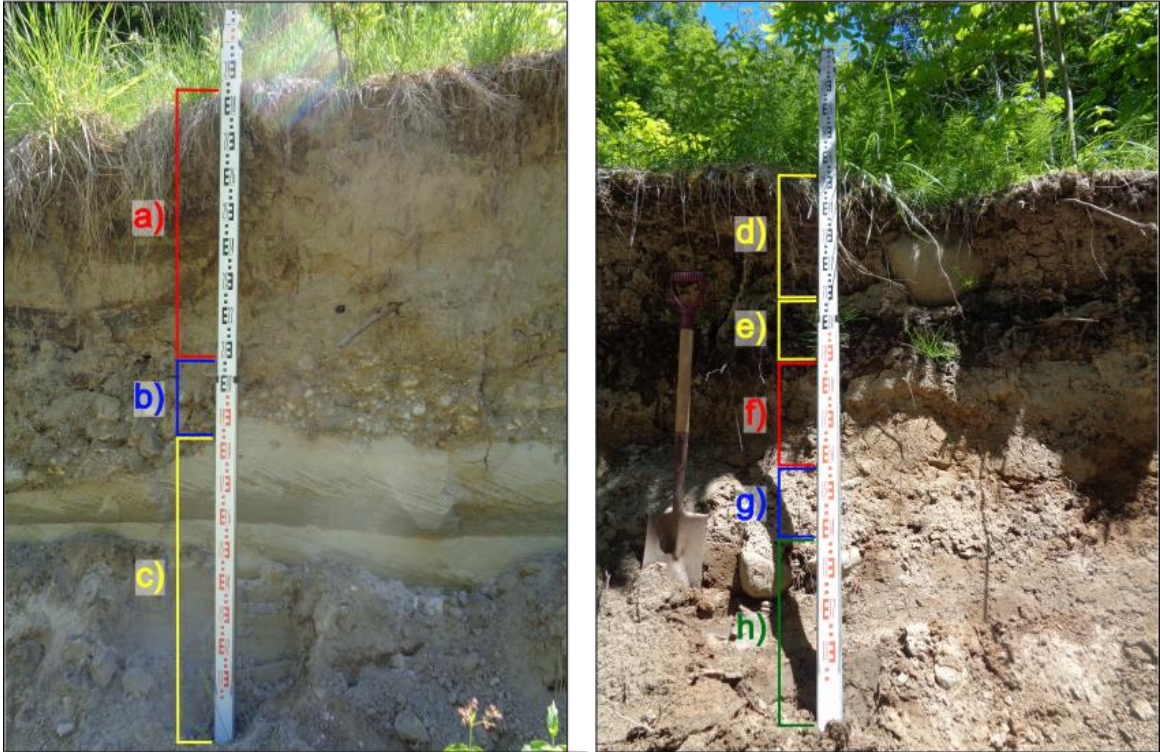
**Figure 3.43: Two left bank profiles in the downstream reach. Sampling each section revealed several layers with similar layers labelled in coordinating colours; a) a massive fine sand layer with organics and iron irregular layers intermixed, b) alluvial gravel layer with slight grading to smaller pieces; c) well sorted fine to medium sand with clear flow structures; d) post settlement layer; e) paleo soil; f) coarse sand fining upwards to medium to fine sand; g) gravel lag layer; h) layered diamict.**

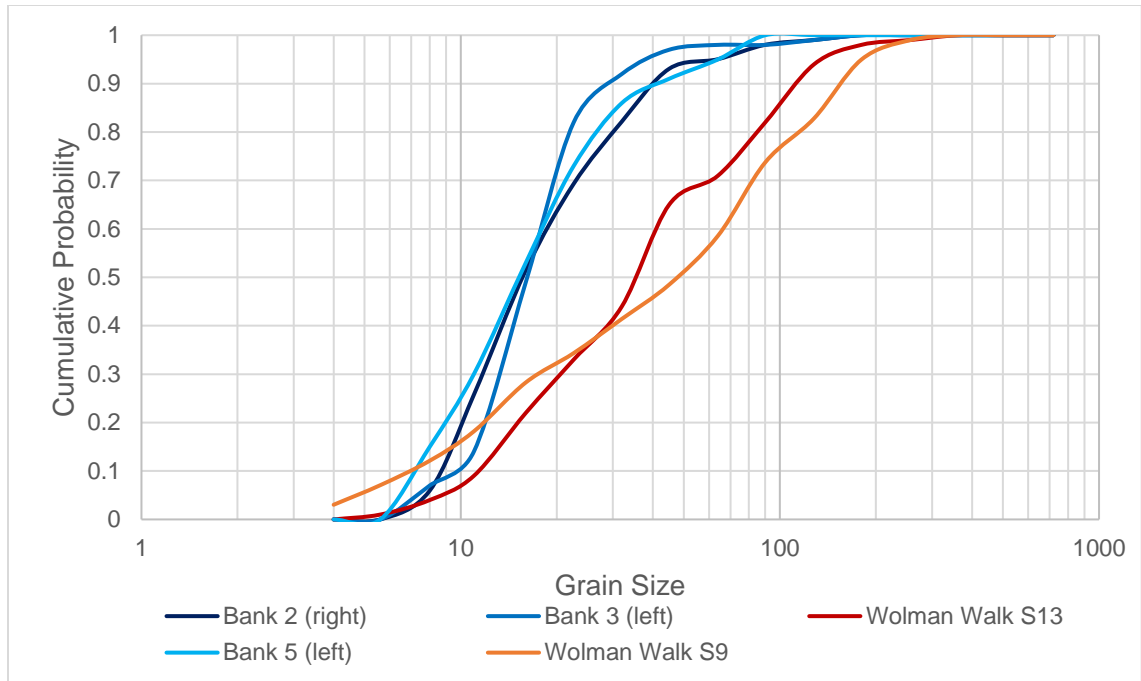
**Figure 3.44: The grain size distribution of the bank and its adjacent channel bed in the downstream reach. There is a clear difference between the two distributions; the channel bed Wolman Walks show a much coarser distribution. This addition of coarse sediment may be due to the reconstruction occurring in the channel (Chapter 4).**

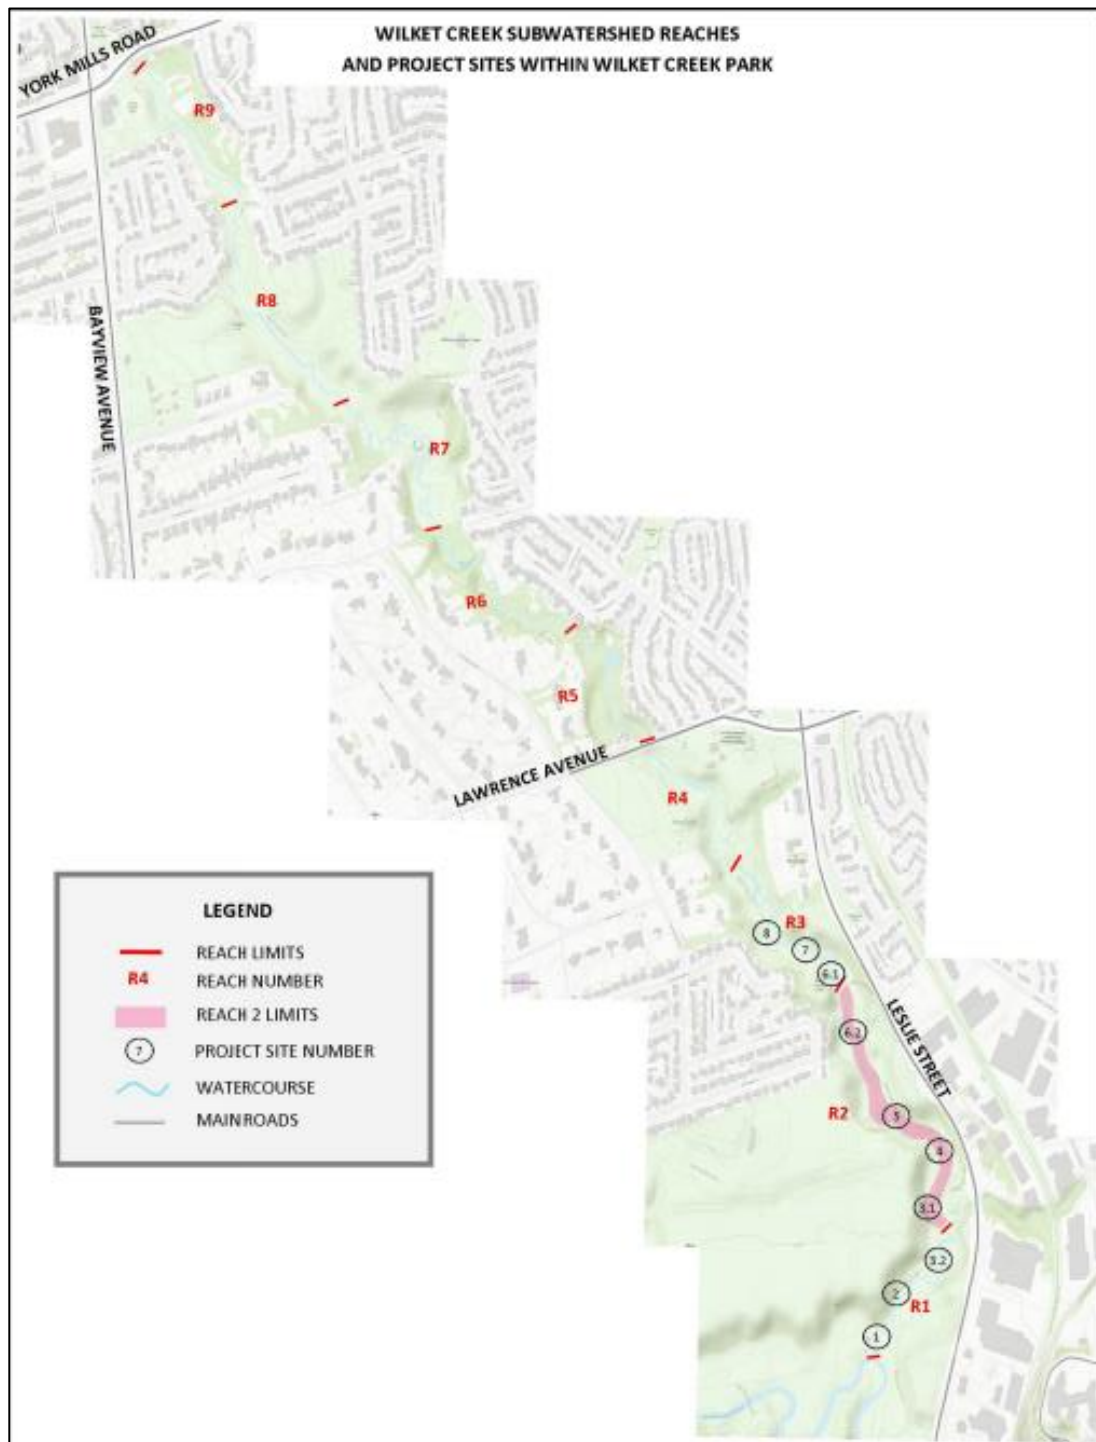
**Figure 4.4: The restoration sites as defined by the Wilket Creek Channel within Wilket Creek Park Rehabilitation Study and Geomorphic Systems and Habitat Study. Emergency works to reconstruct the channel and protect surrounding infrastructure at project sites 2, 3.1, 3.2, and 7 was completed between April 2011 and fall 2015. The two reaches highlighted are the two discussed above in Section 3.5 (modified from Parish Aquatic Services, 2014)**

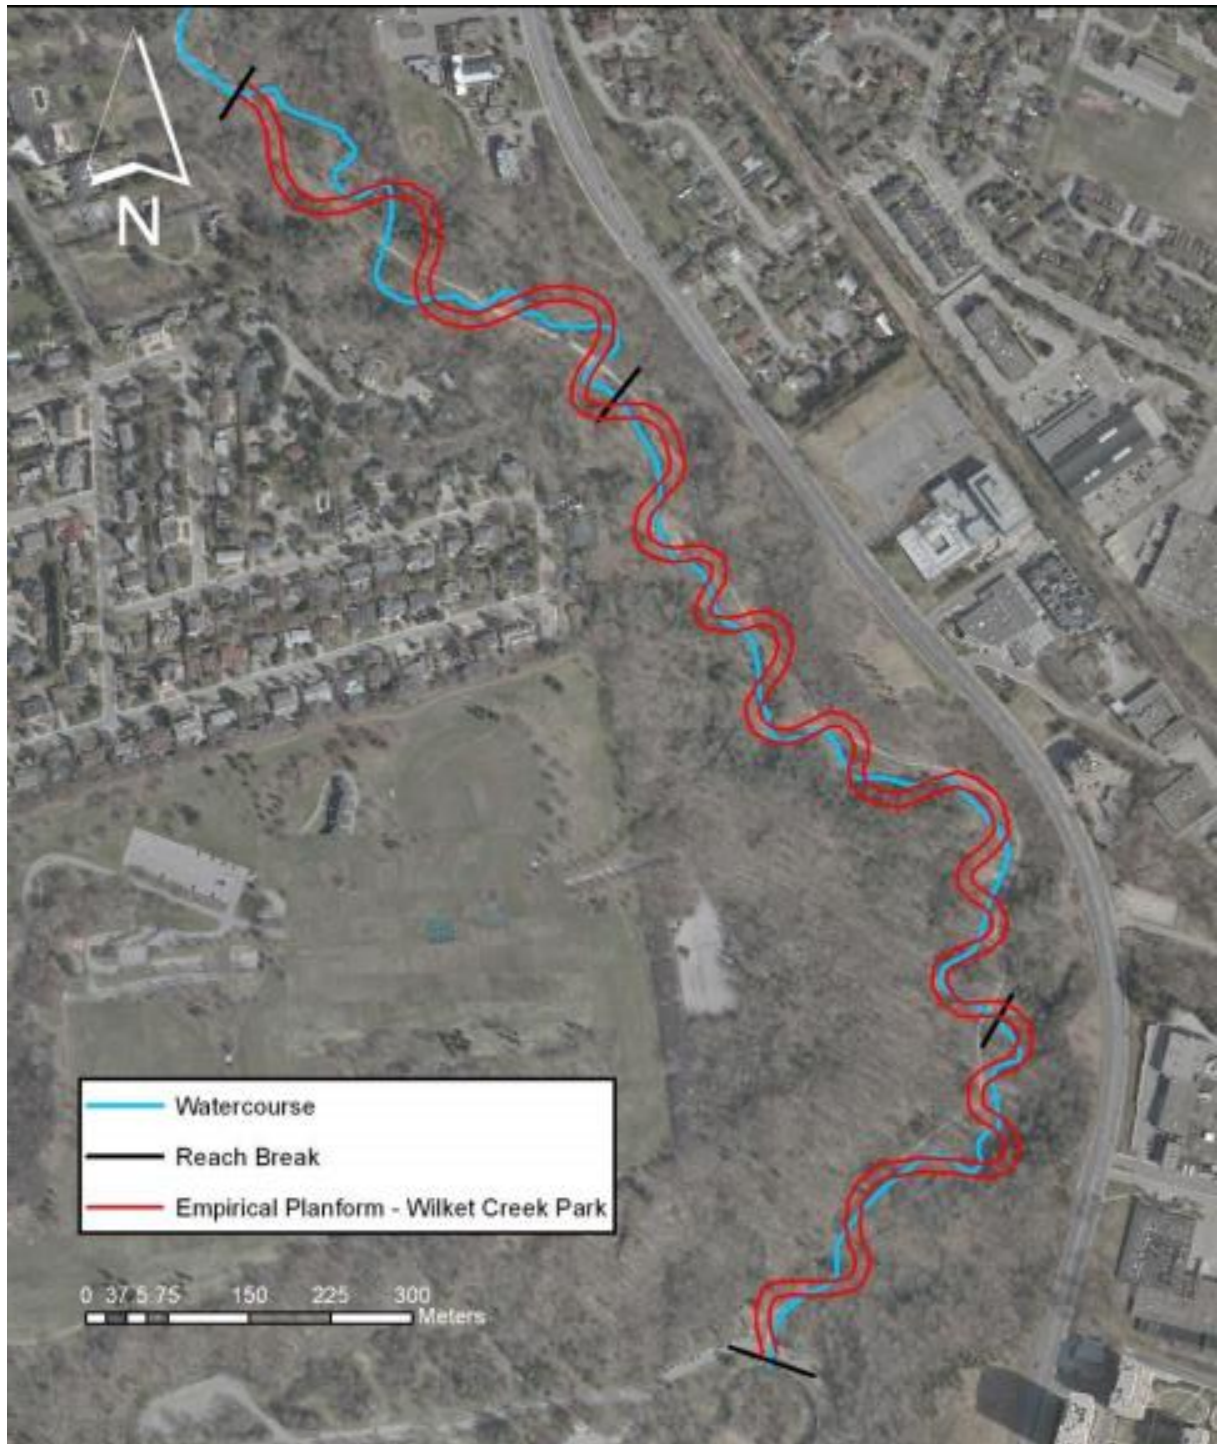
**Figure 4.5: The current planform of Wilket Creek's watercourse (blue) south of Lawrence Ave E. This is compared to the empirically designed proposed planform**

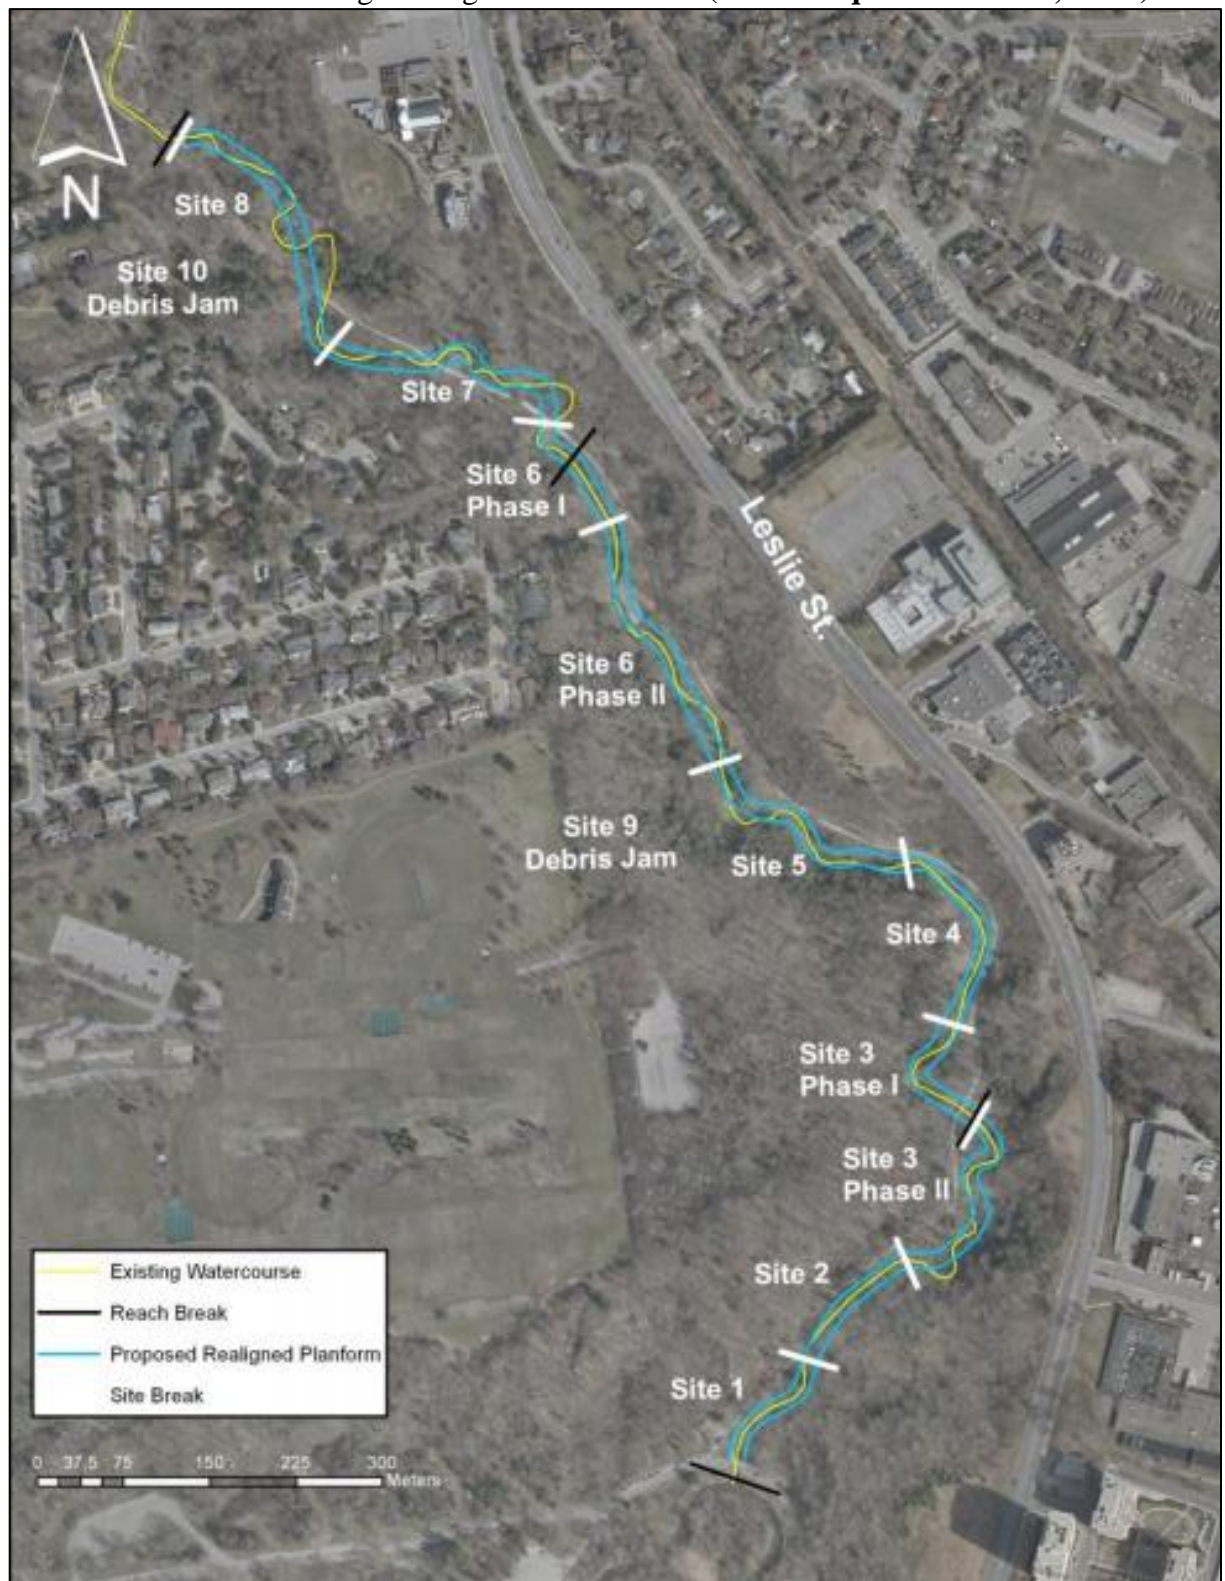
**Figure 4.6: The proposed realigned planform of Wilket Creek south of Lawrence Ave E. This planform design helps stabilize the channel while accommodating the infrastructure in the valley (Parish Aquatic Services, 2014).**

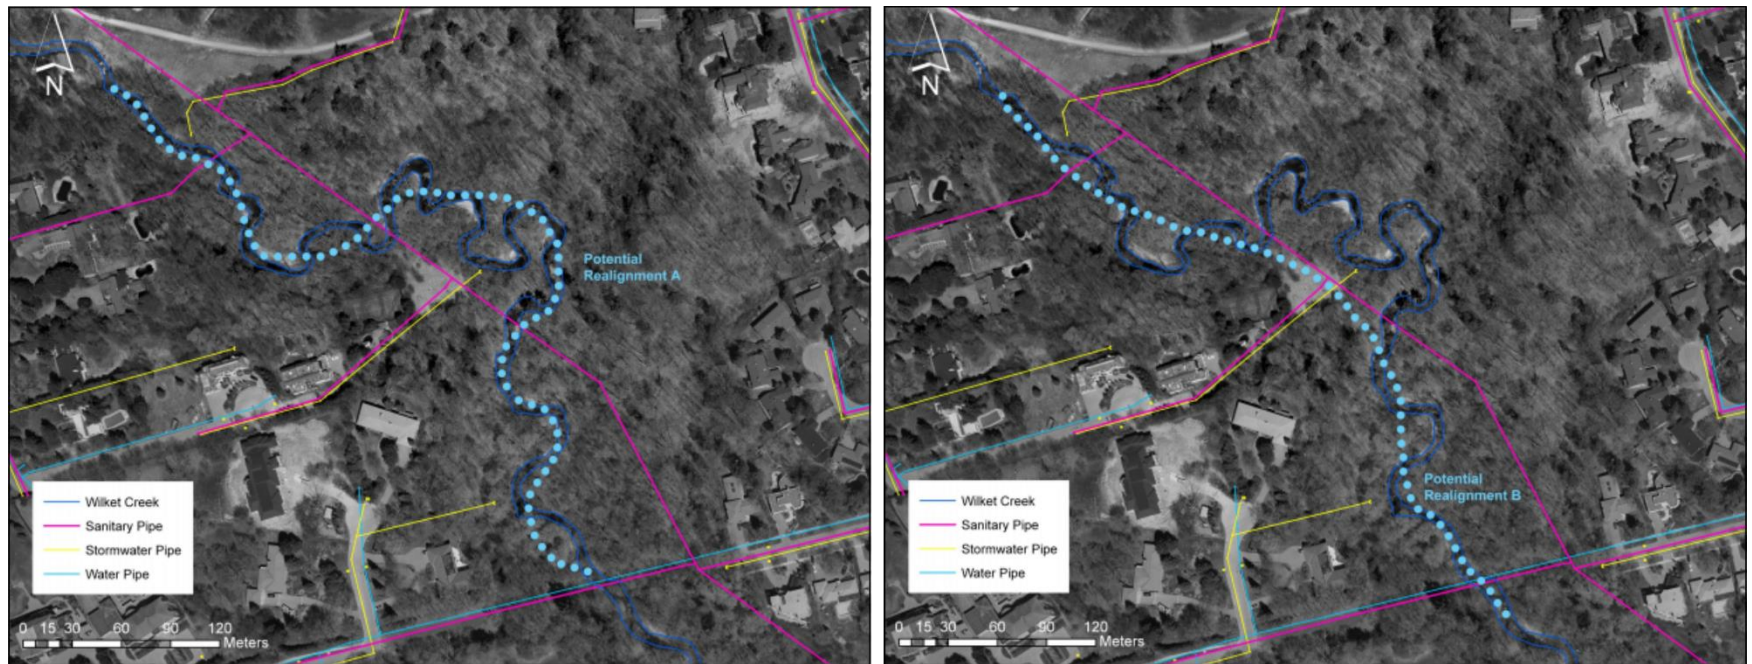
**Figure 4.7: The two proposed planform designs for TRCA defined Reach 7. The high sinuosity of the channel combined with the new urbanized hydrology has led to an unstable channel; the proposed planform designs aims to stabilize this section of Wilket Creek (Toronto and Region Conservation Authority & City of Toronto, 2013).**

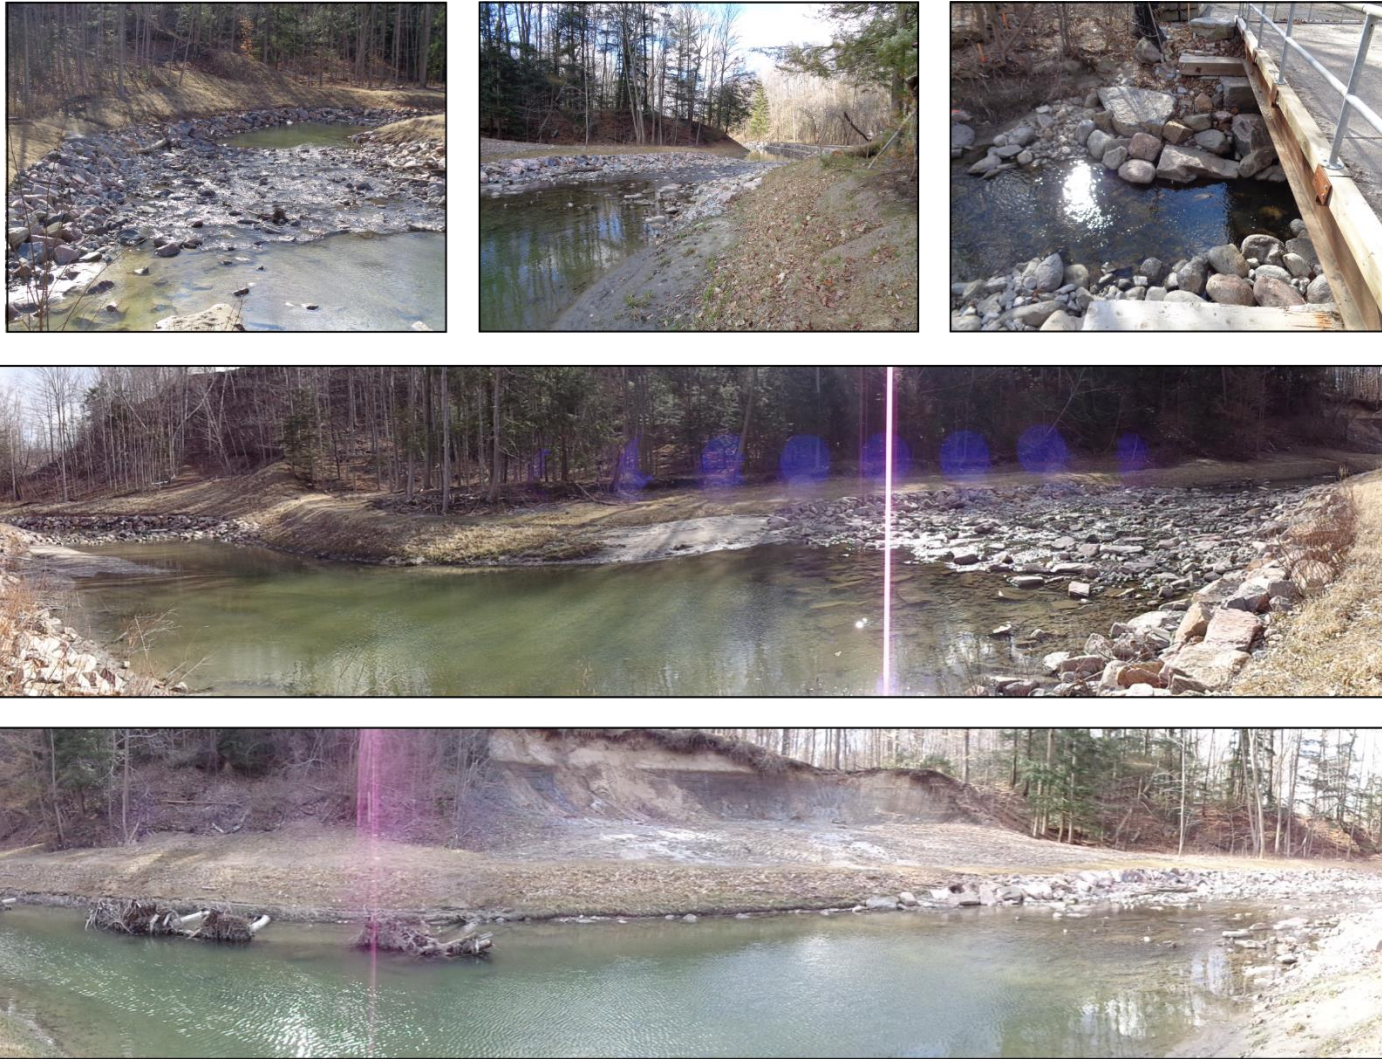
**Figure 4.14: Photographs of the completed reconstruction of Wilket Creek in March 2016.**

While the designs for Site 3 Phase II stabilized the channel, there may continue to be some adjustment to natural flows. Some adjustments of sediment transport from reaches upstream, siltation in pools ‘flushed’ during bankfull and higher flows, subtle planform adjustments, and some bar formation are anticipated. Photographs of the finished site from March 2016 can be seen in (Figure 4.14).
