Slide Correction Case Study: SR 105 in Huntington County

John Langmaid, INDOT

Jennifer Goins, P.E., HNTB

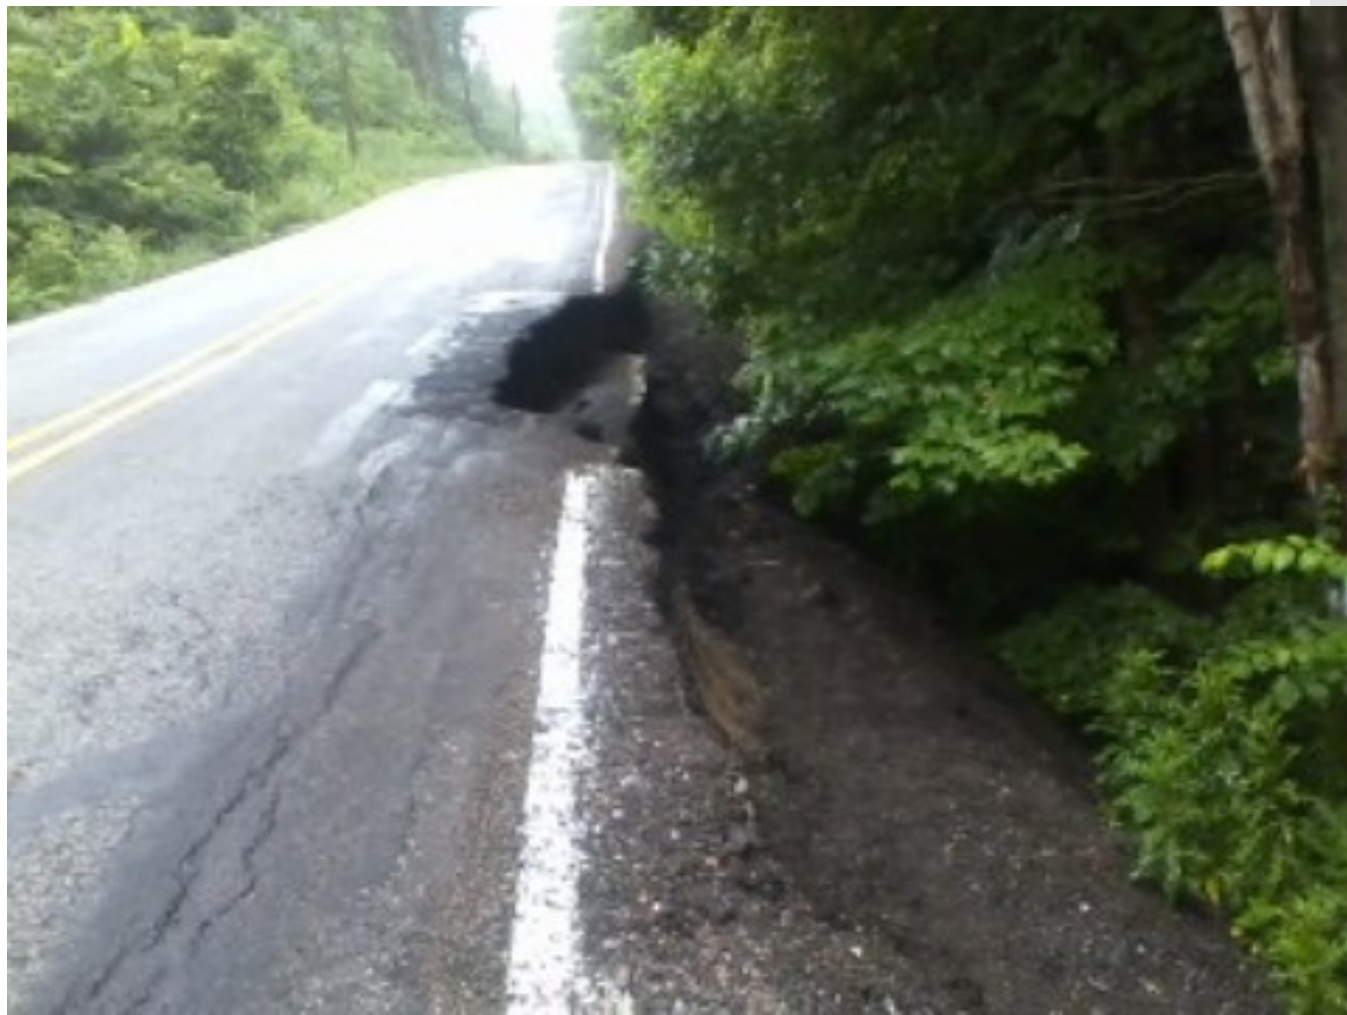
View of Slide

June 2015

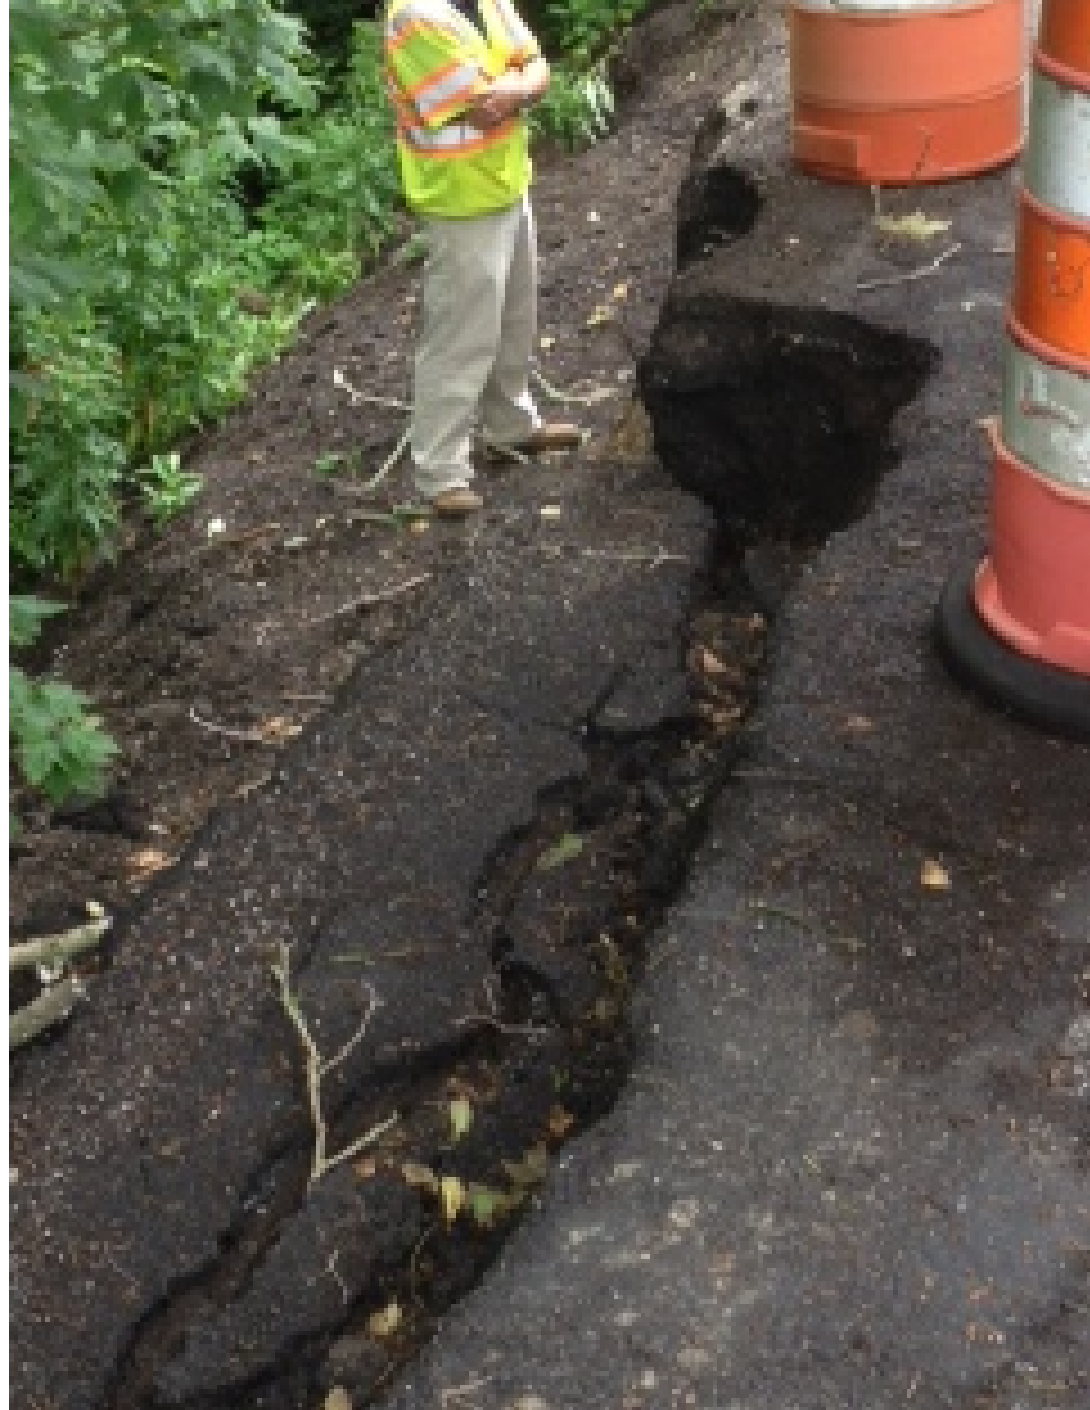
Pavement Step Down

June 2015

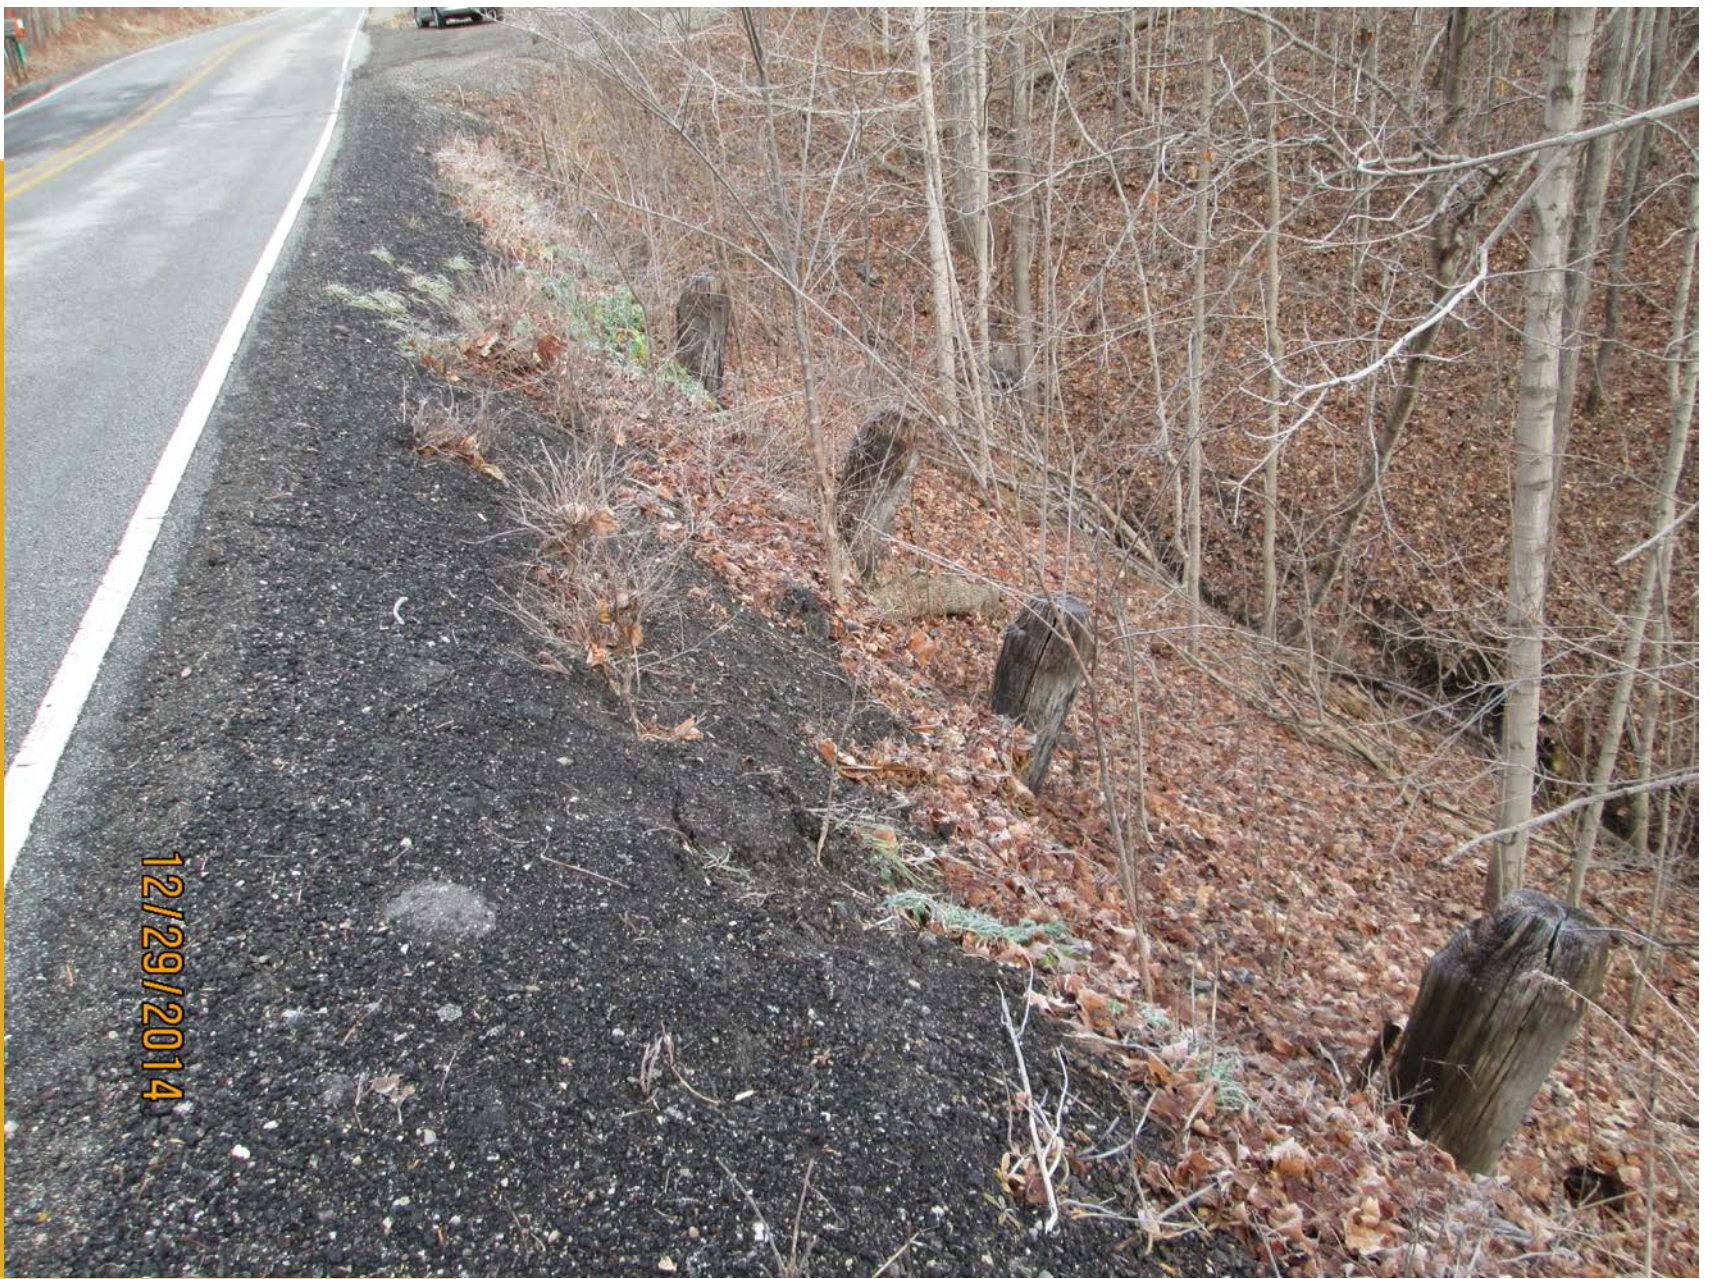
Skewed Cross Section at Existing Pipe

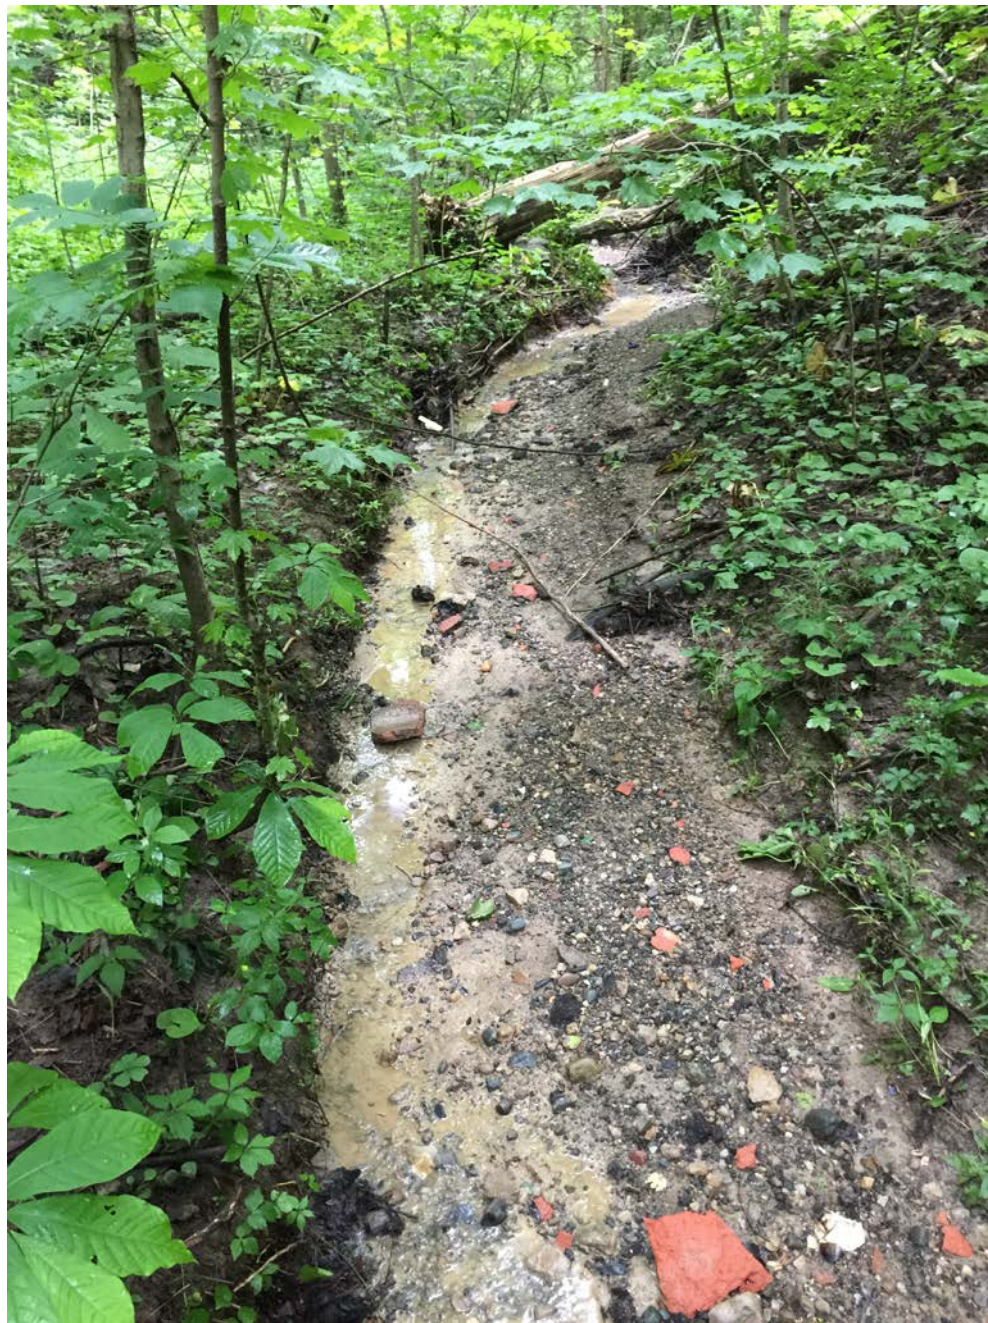
Downstream
m of Pipe
June 2015

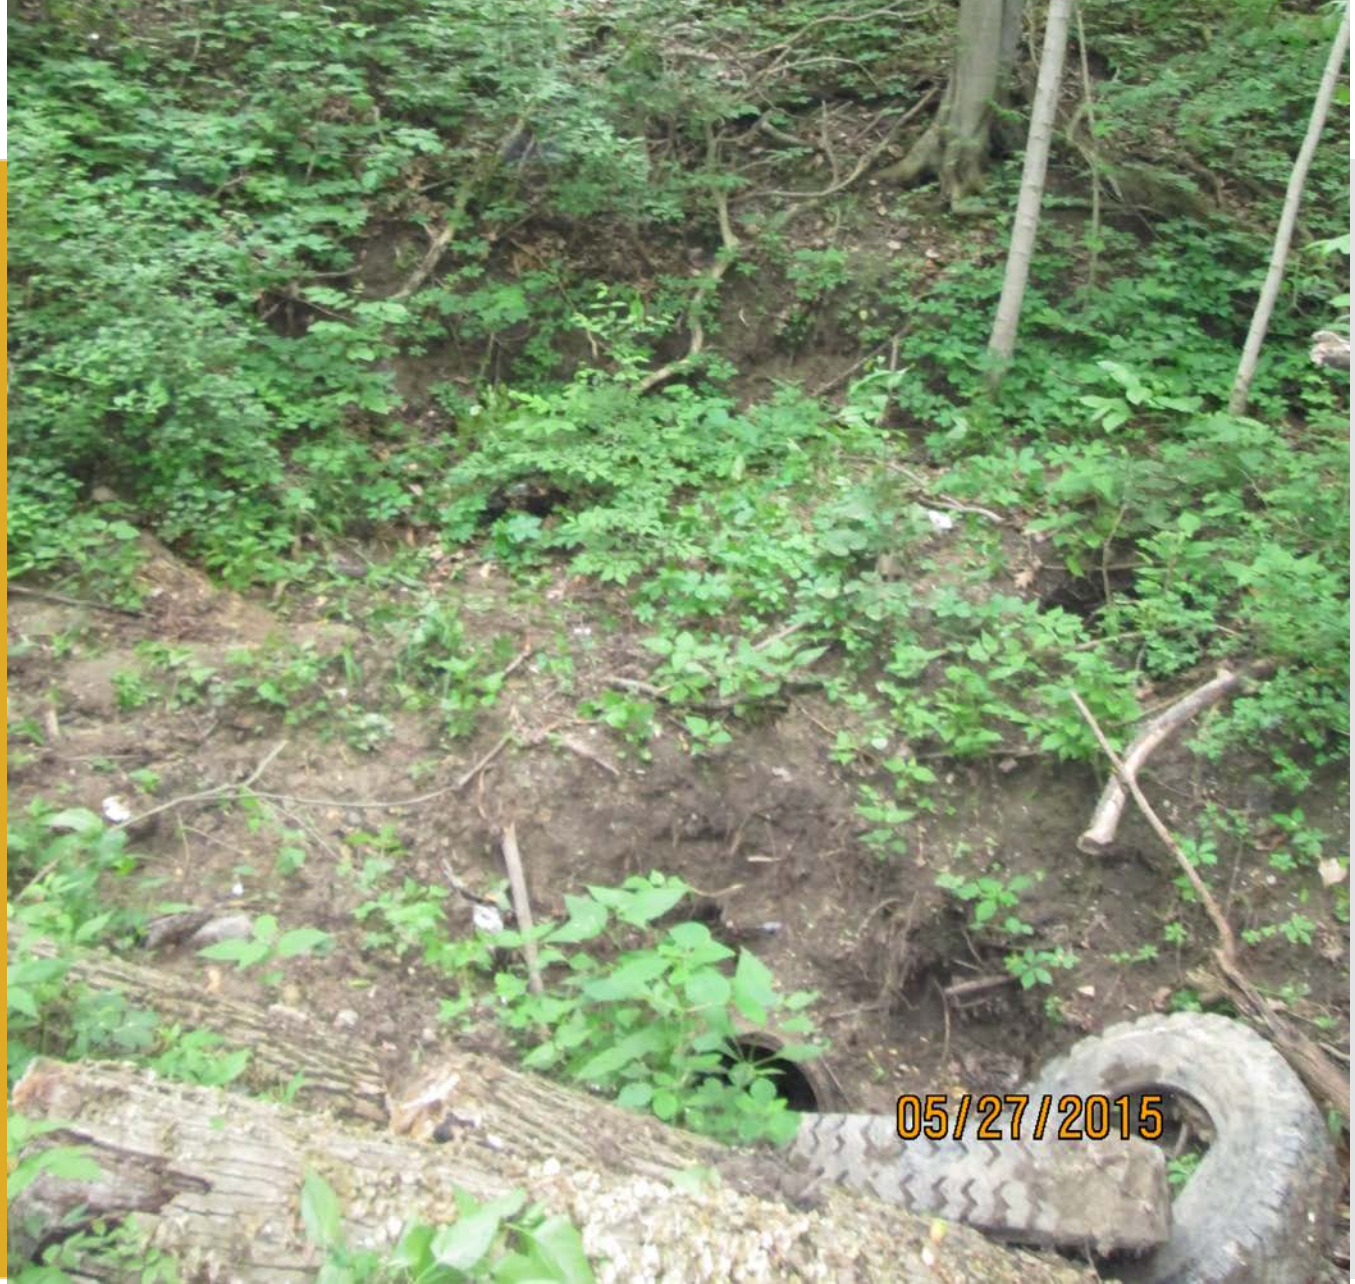
Inlet of Existing Pipe

May 2015

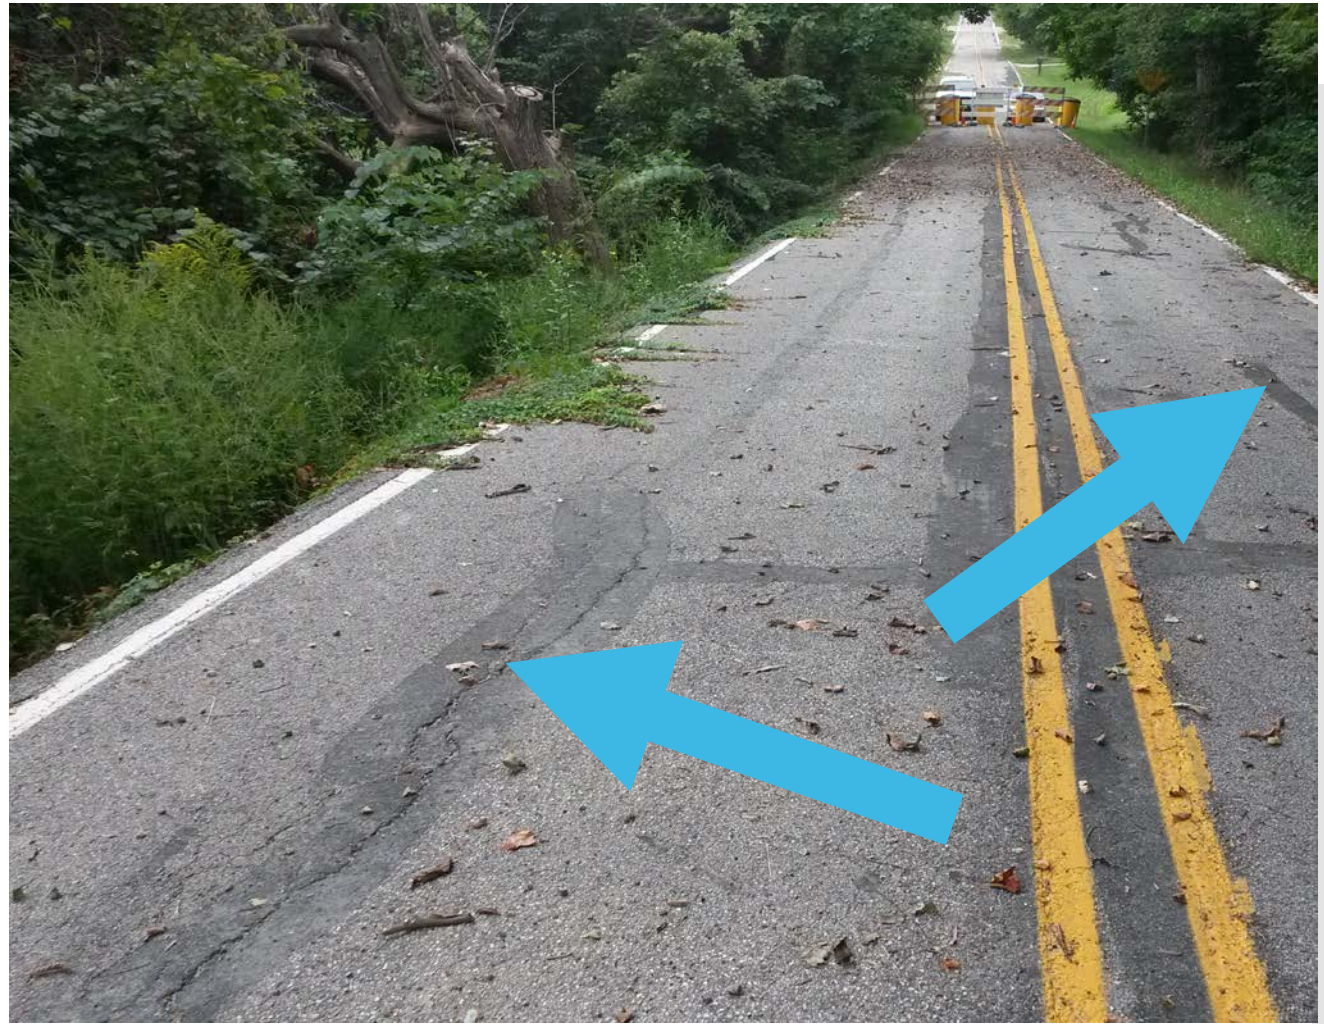
Preventing A Future Slide

Picture looking South – Crack along EOPs

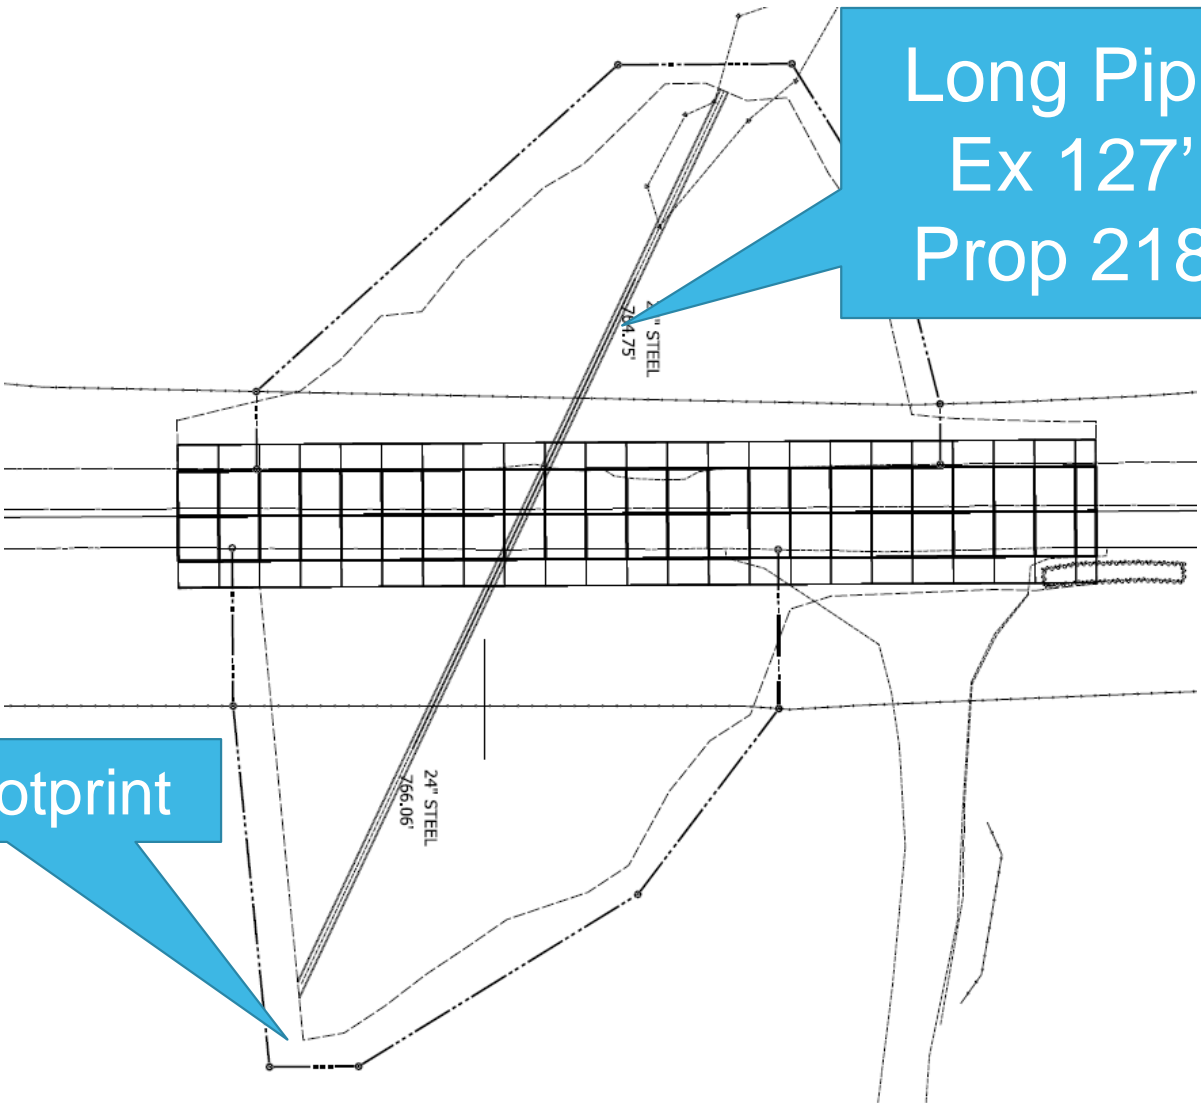
Option 1 – 3:1 Fill Slopes

Long Pipe
Ex 127'
Prop 218'

Wide Footprint

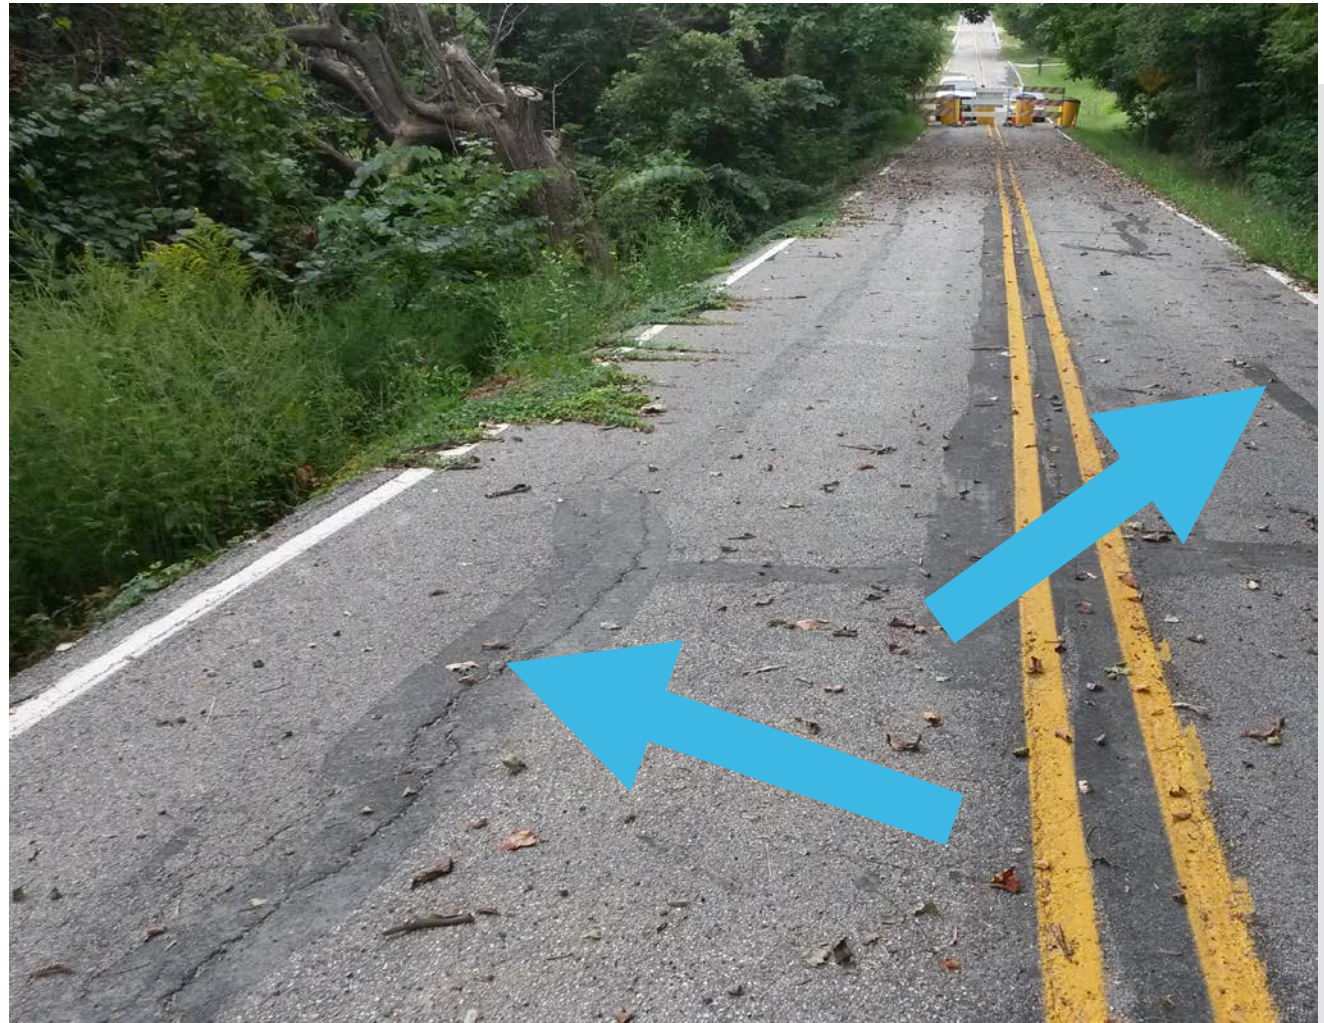
Preventing A Future Slide

Picture looking South – Crack along EOPs

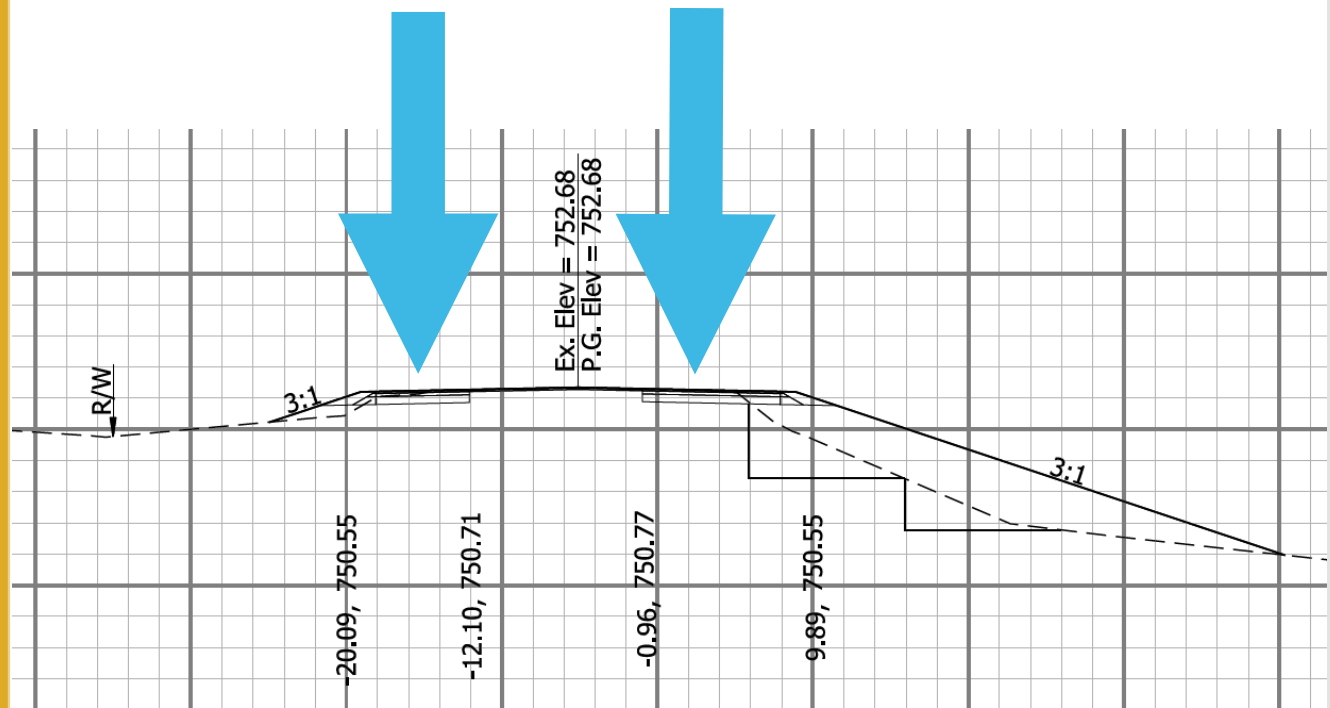
Cross Section looking North
Longitudinal Cracks along
Both EOP

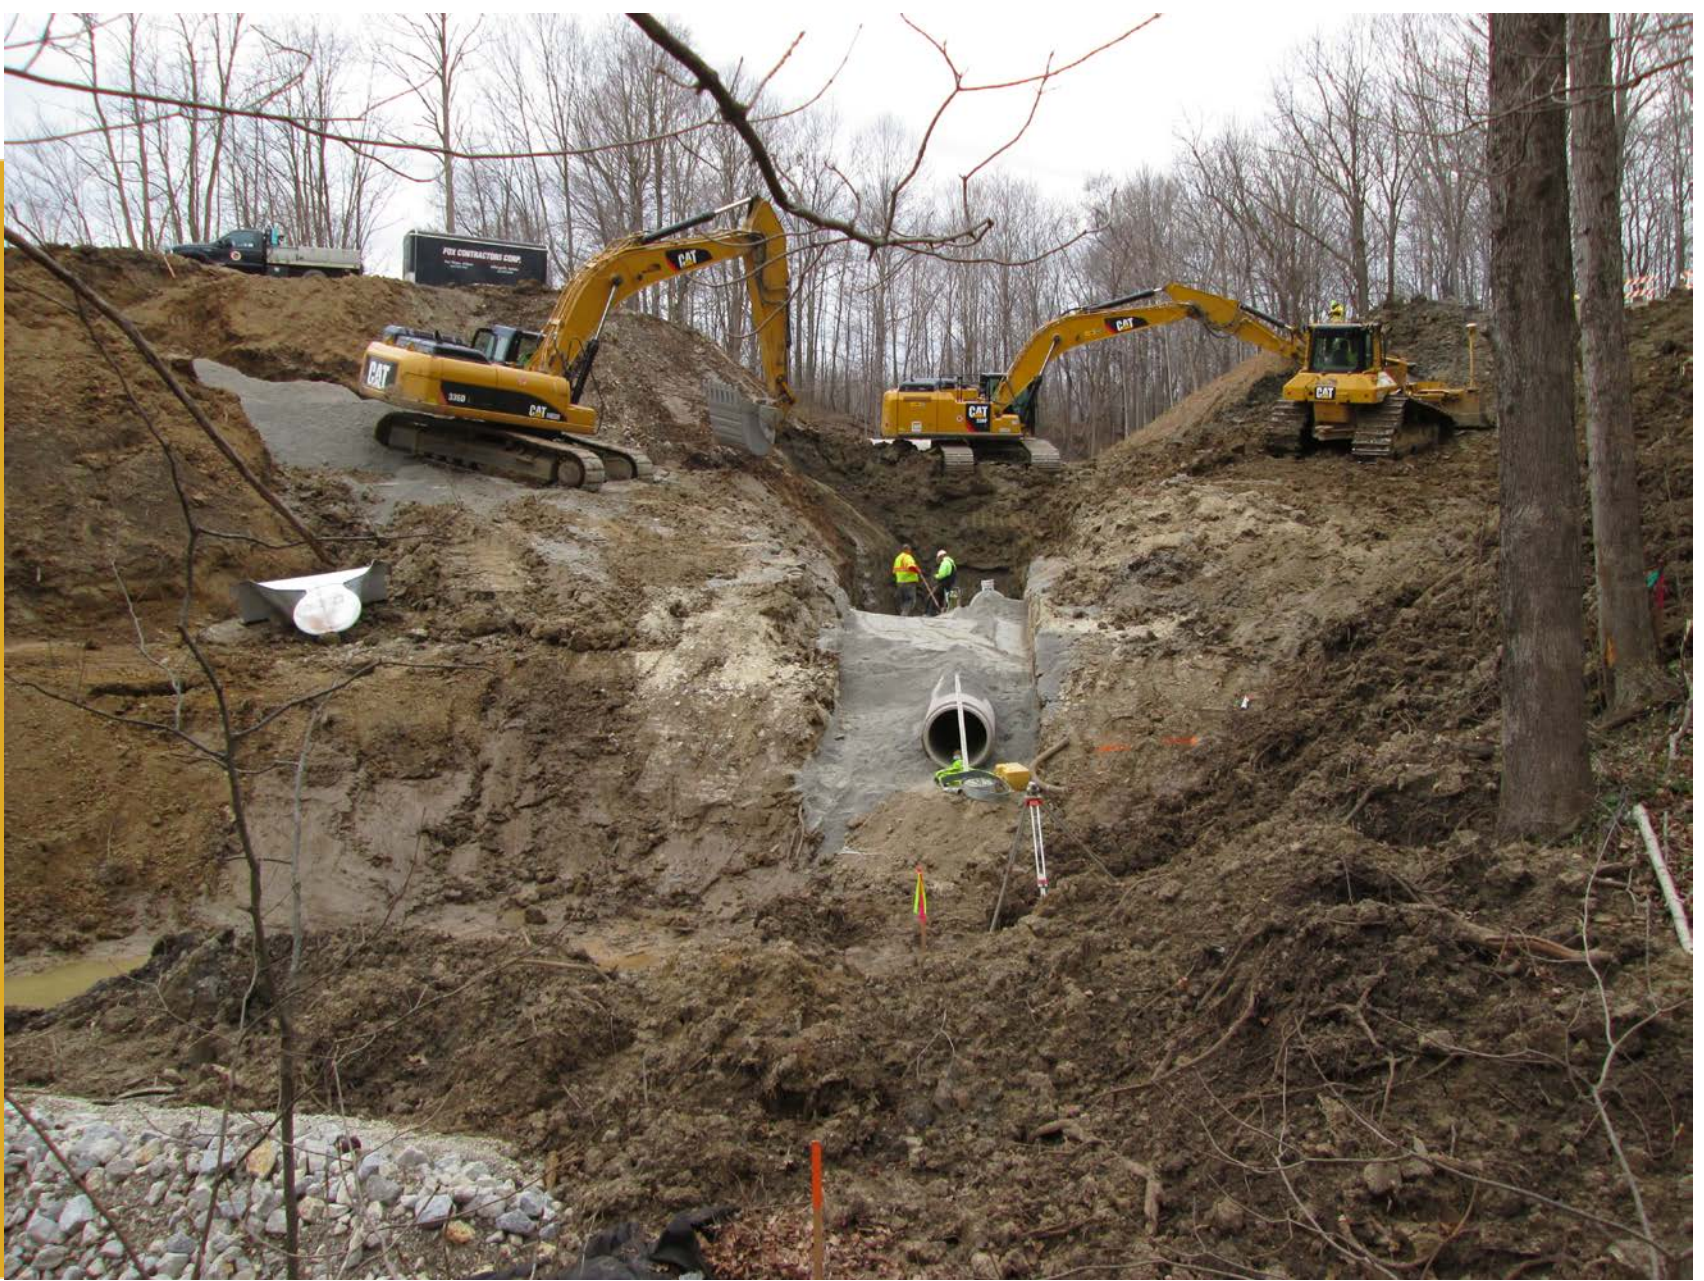
Excavation of Slide Area

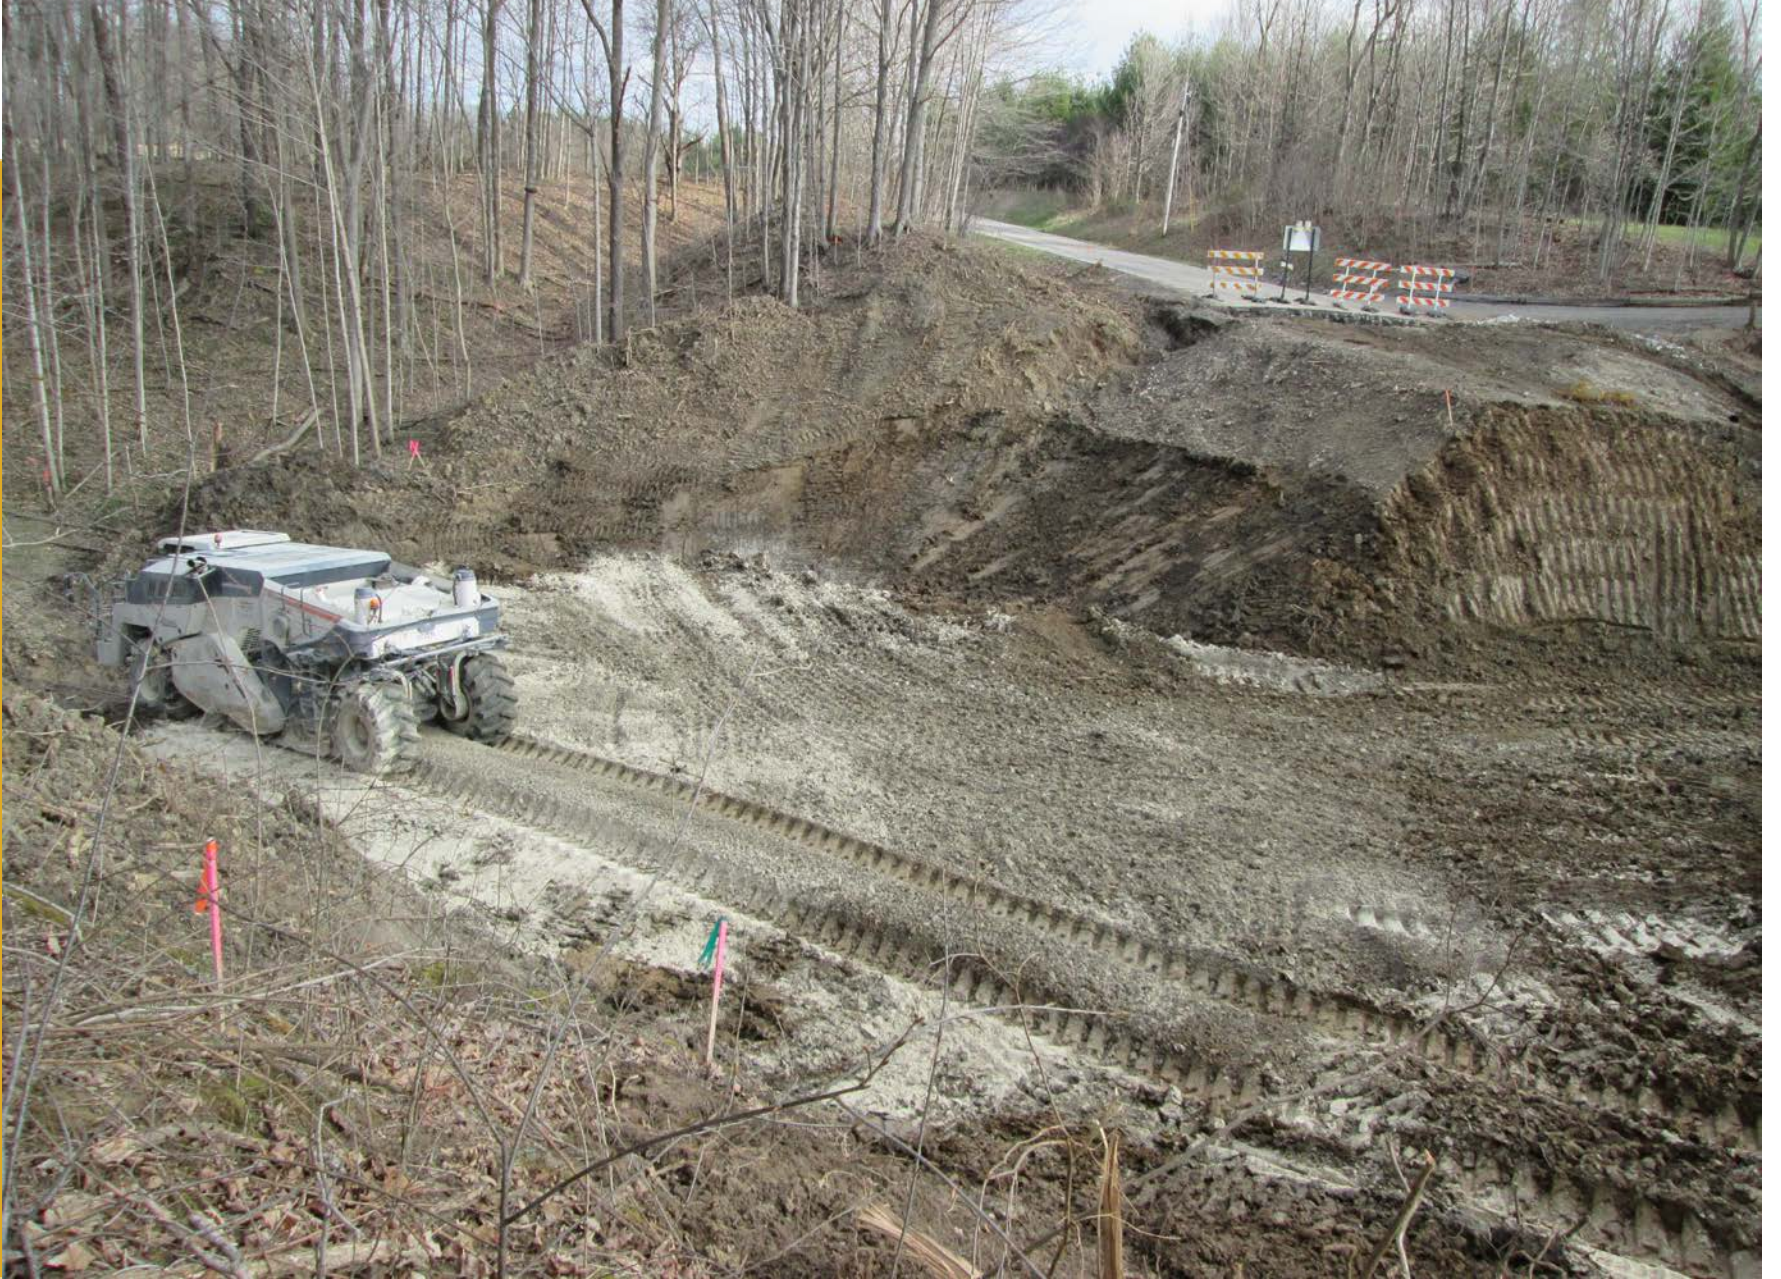
Drying On-site Borrow with Lime = Major Reduction in Downtime

- Property Owner Meetings
- Kickoff meeting with R/W Appraiser, Review Appraiser, & Buyer
- Right of entries
- Addition of lime to help dry soil
- Change Orders
 - One on resurface project
 - Zero on slide project
- Partnership & Cooperation of the Entire Agency

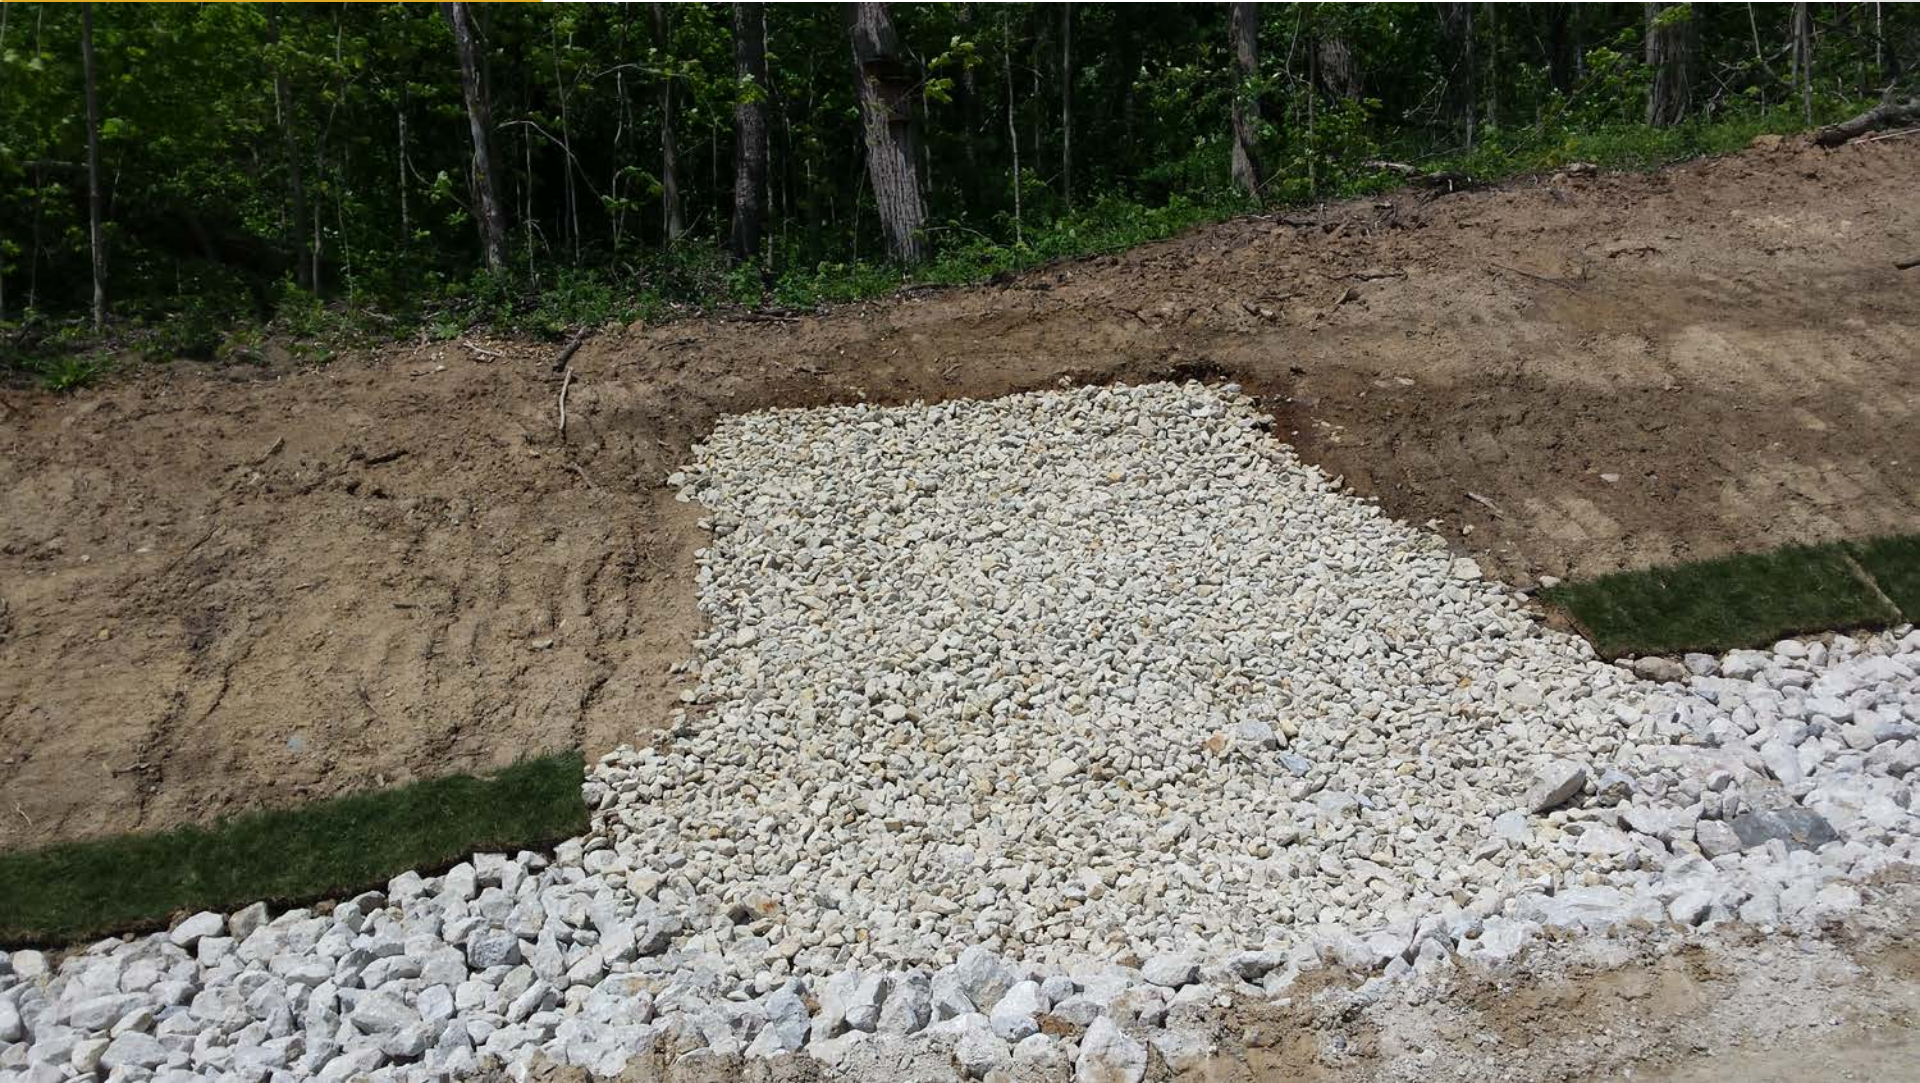
Dealing with shelf of
trapped water
