# Fluvial Erosion Impacts on Infrastructure Along Indiana Rivers and Streams

Siavash Beik, Robert Barr, Brian Meunier

2017 Purdue Road School

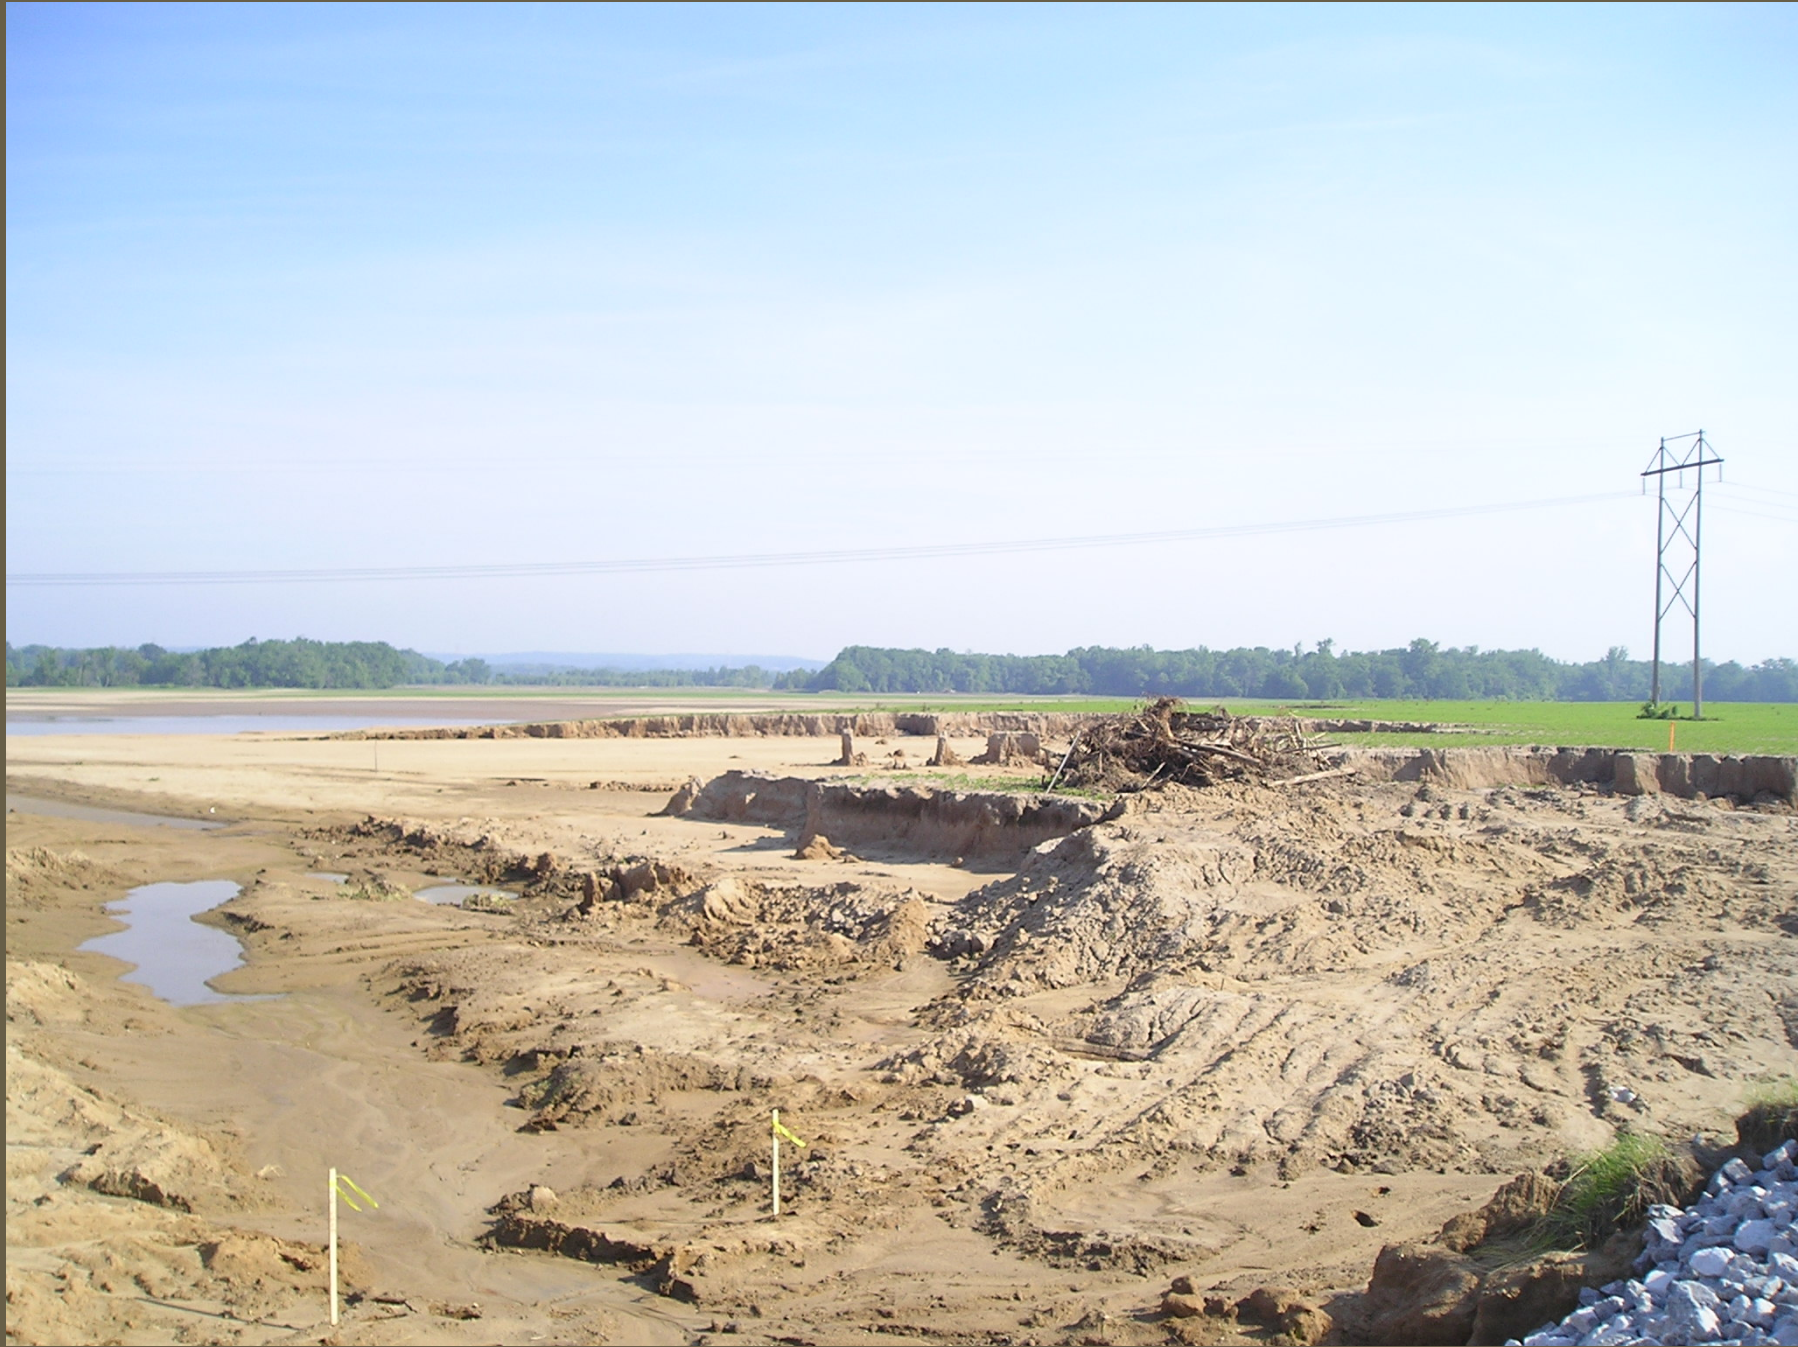
White River, Morgan County, IN

June, 2008

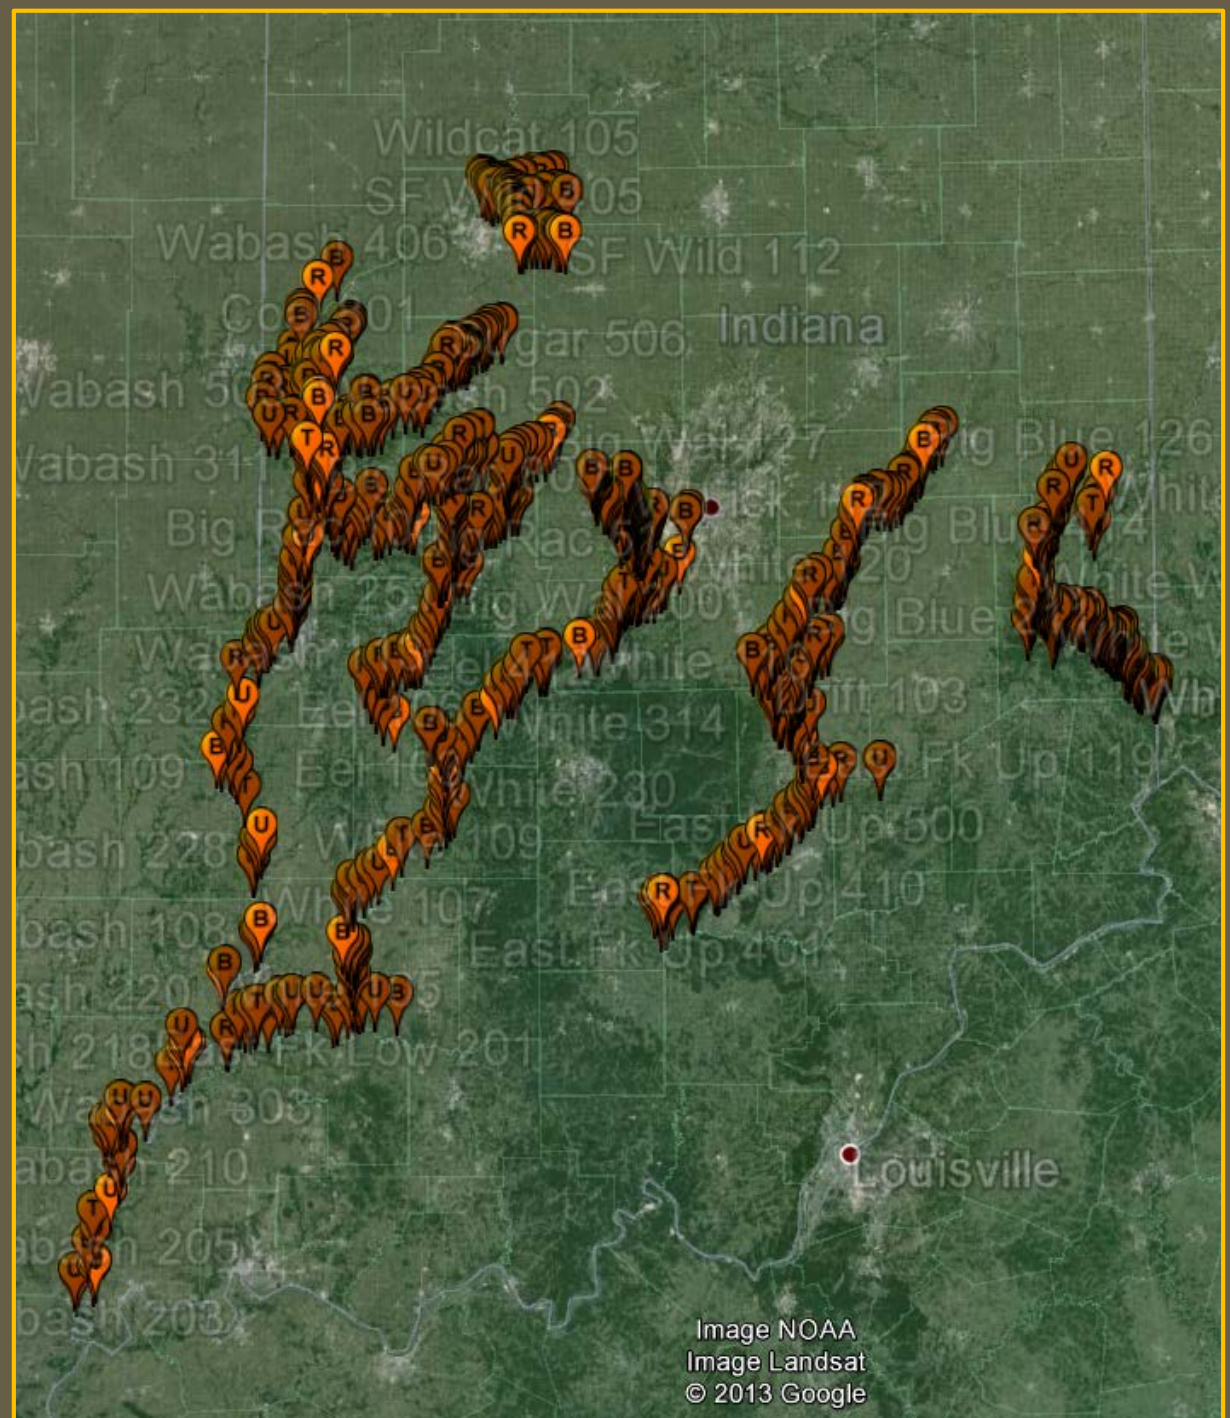
# Buried Pipelines

(Natural Gas & Oil)

## Actively Migrating Streams

(16)

141 Crossings

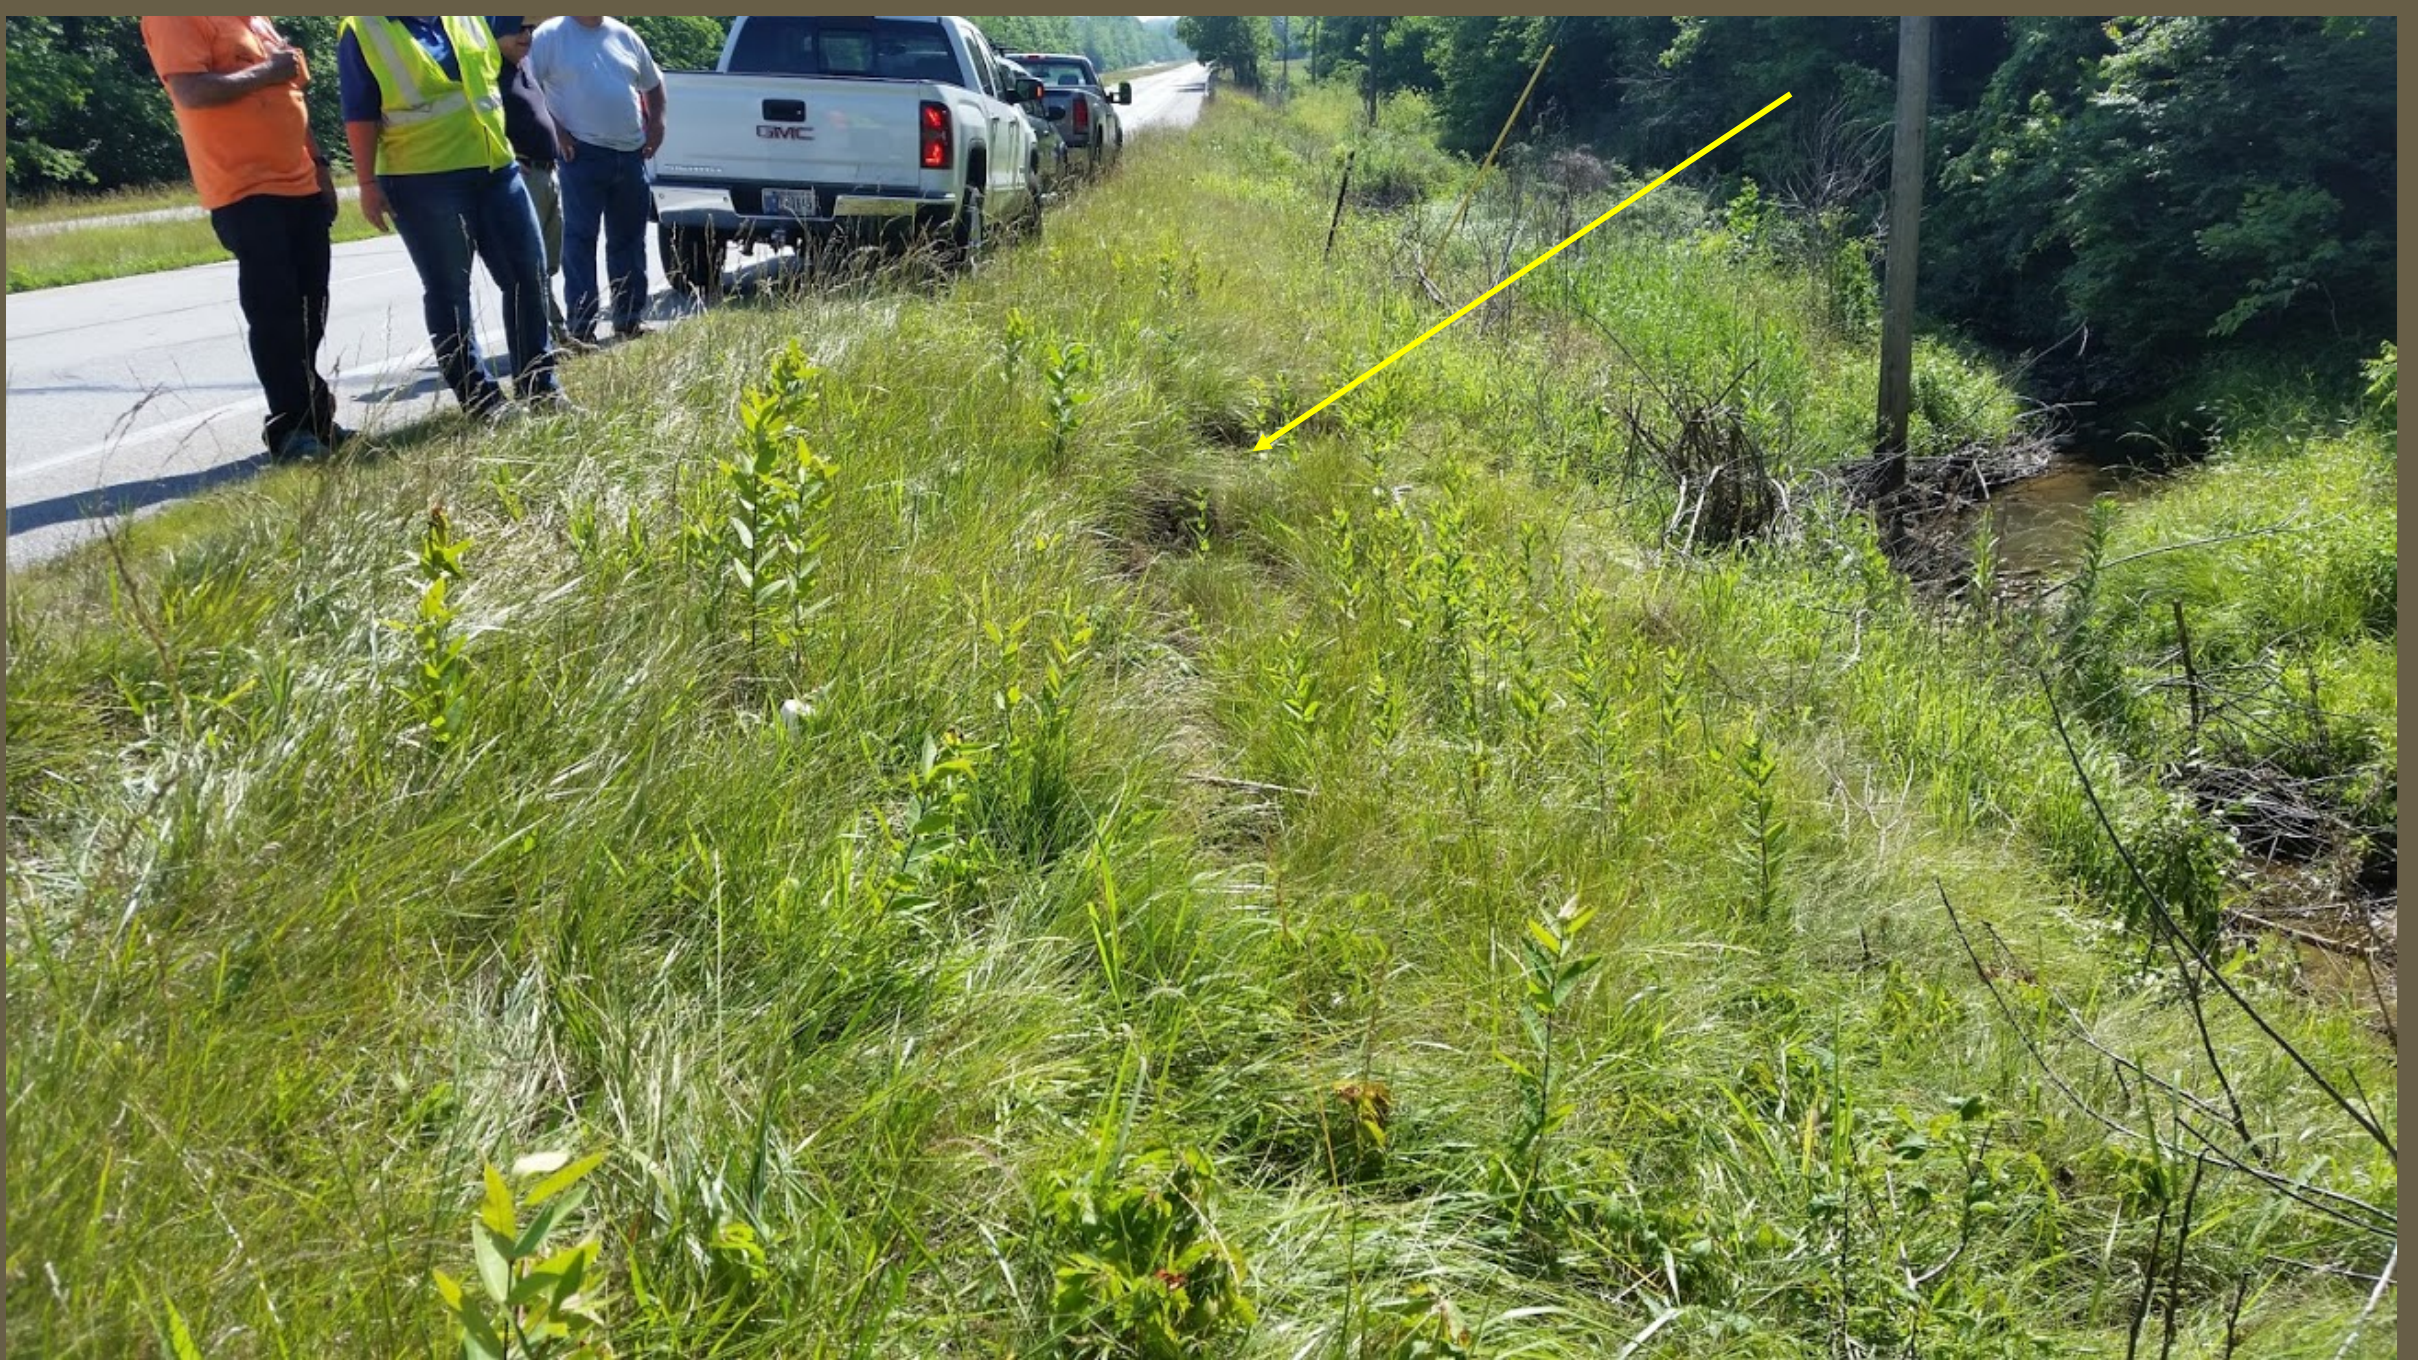
Beacon Run at US 40, near Brazil, Putnam County, Indiana

Note rotational slump (yellow arrow)

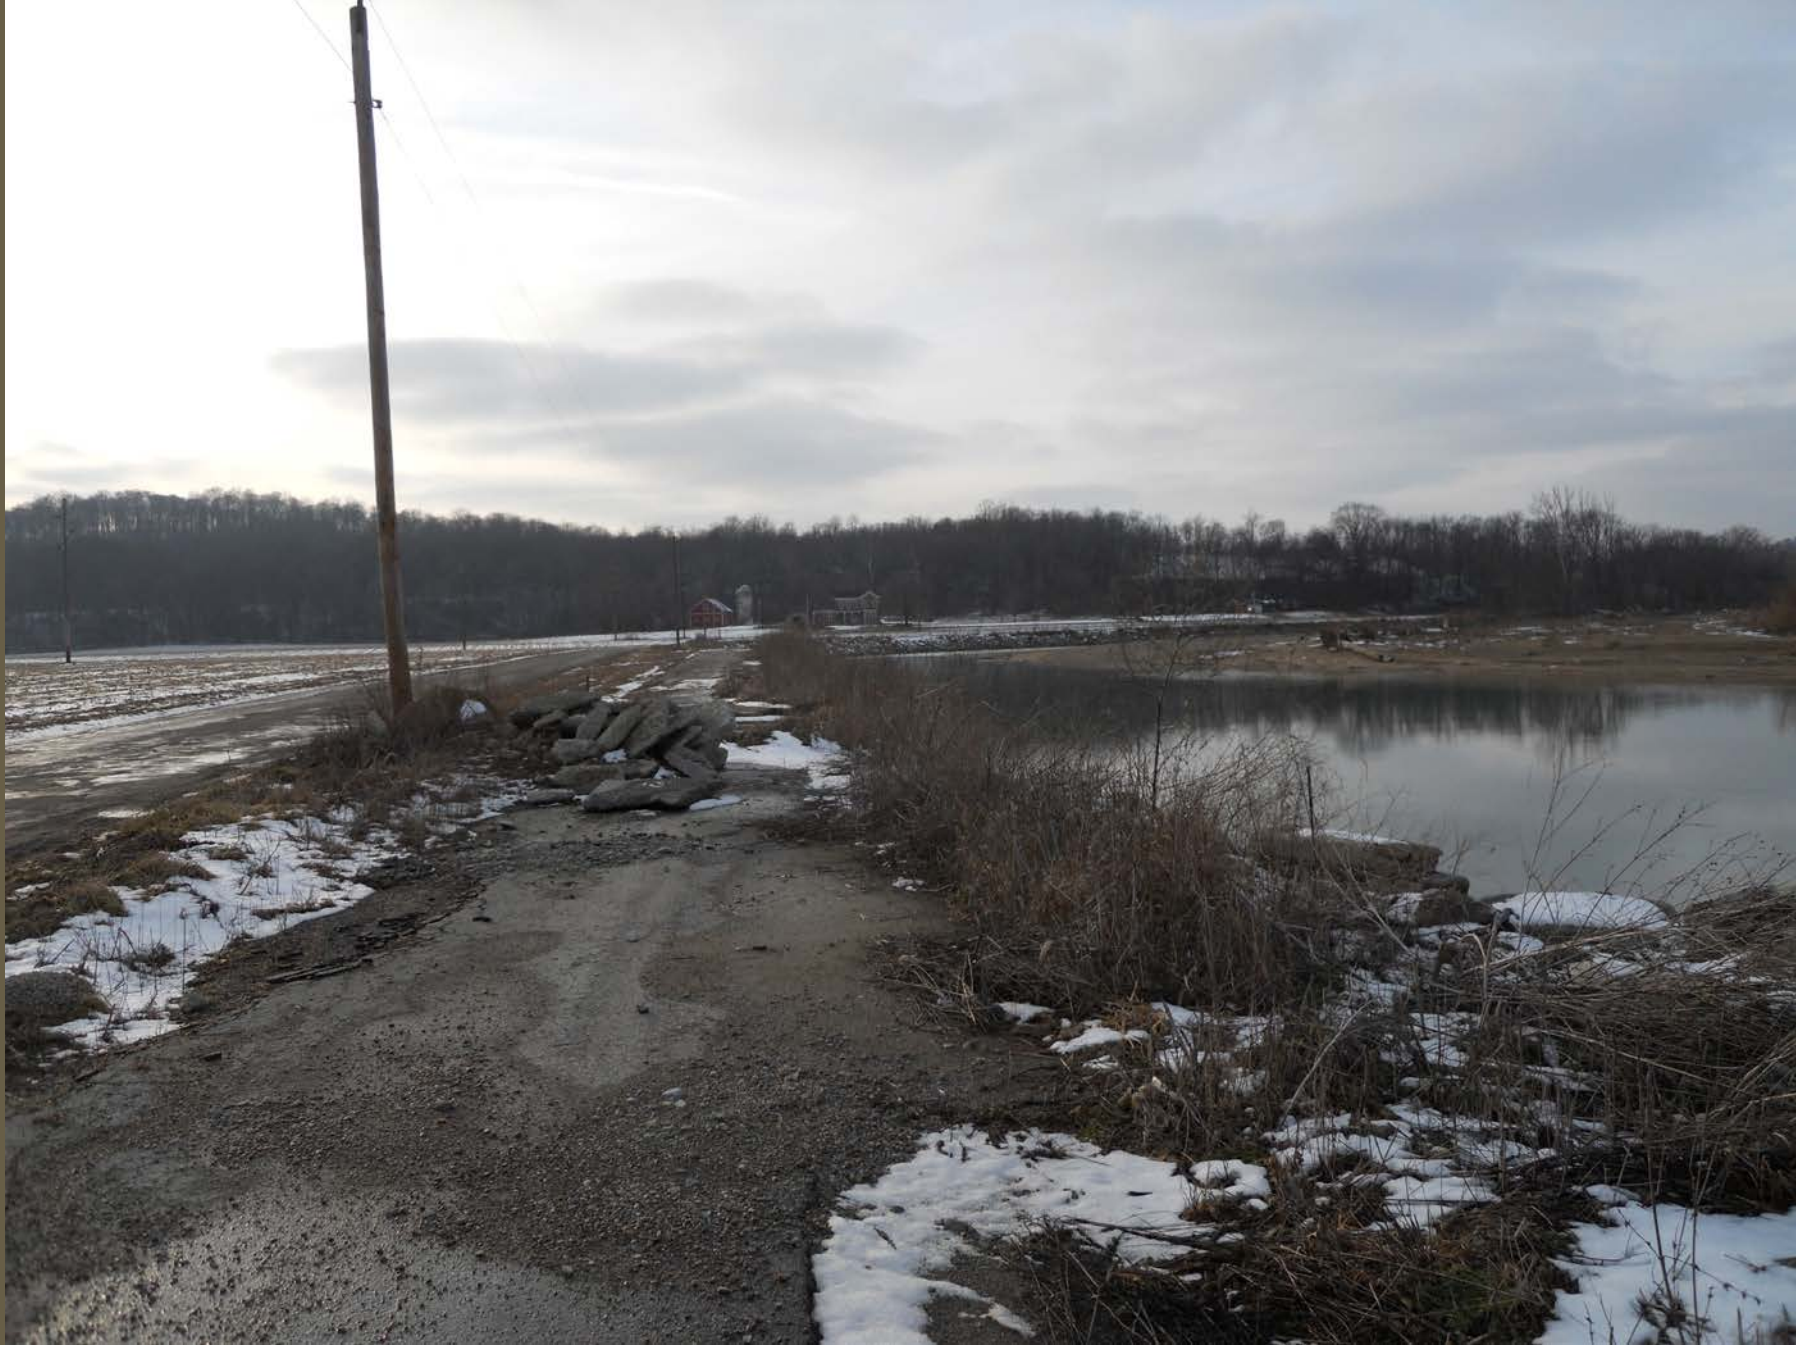
Whitewater River at Levee Road, near Brookville, Franklin County, Indiana

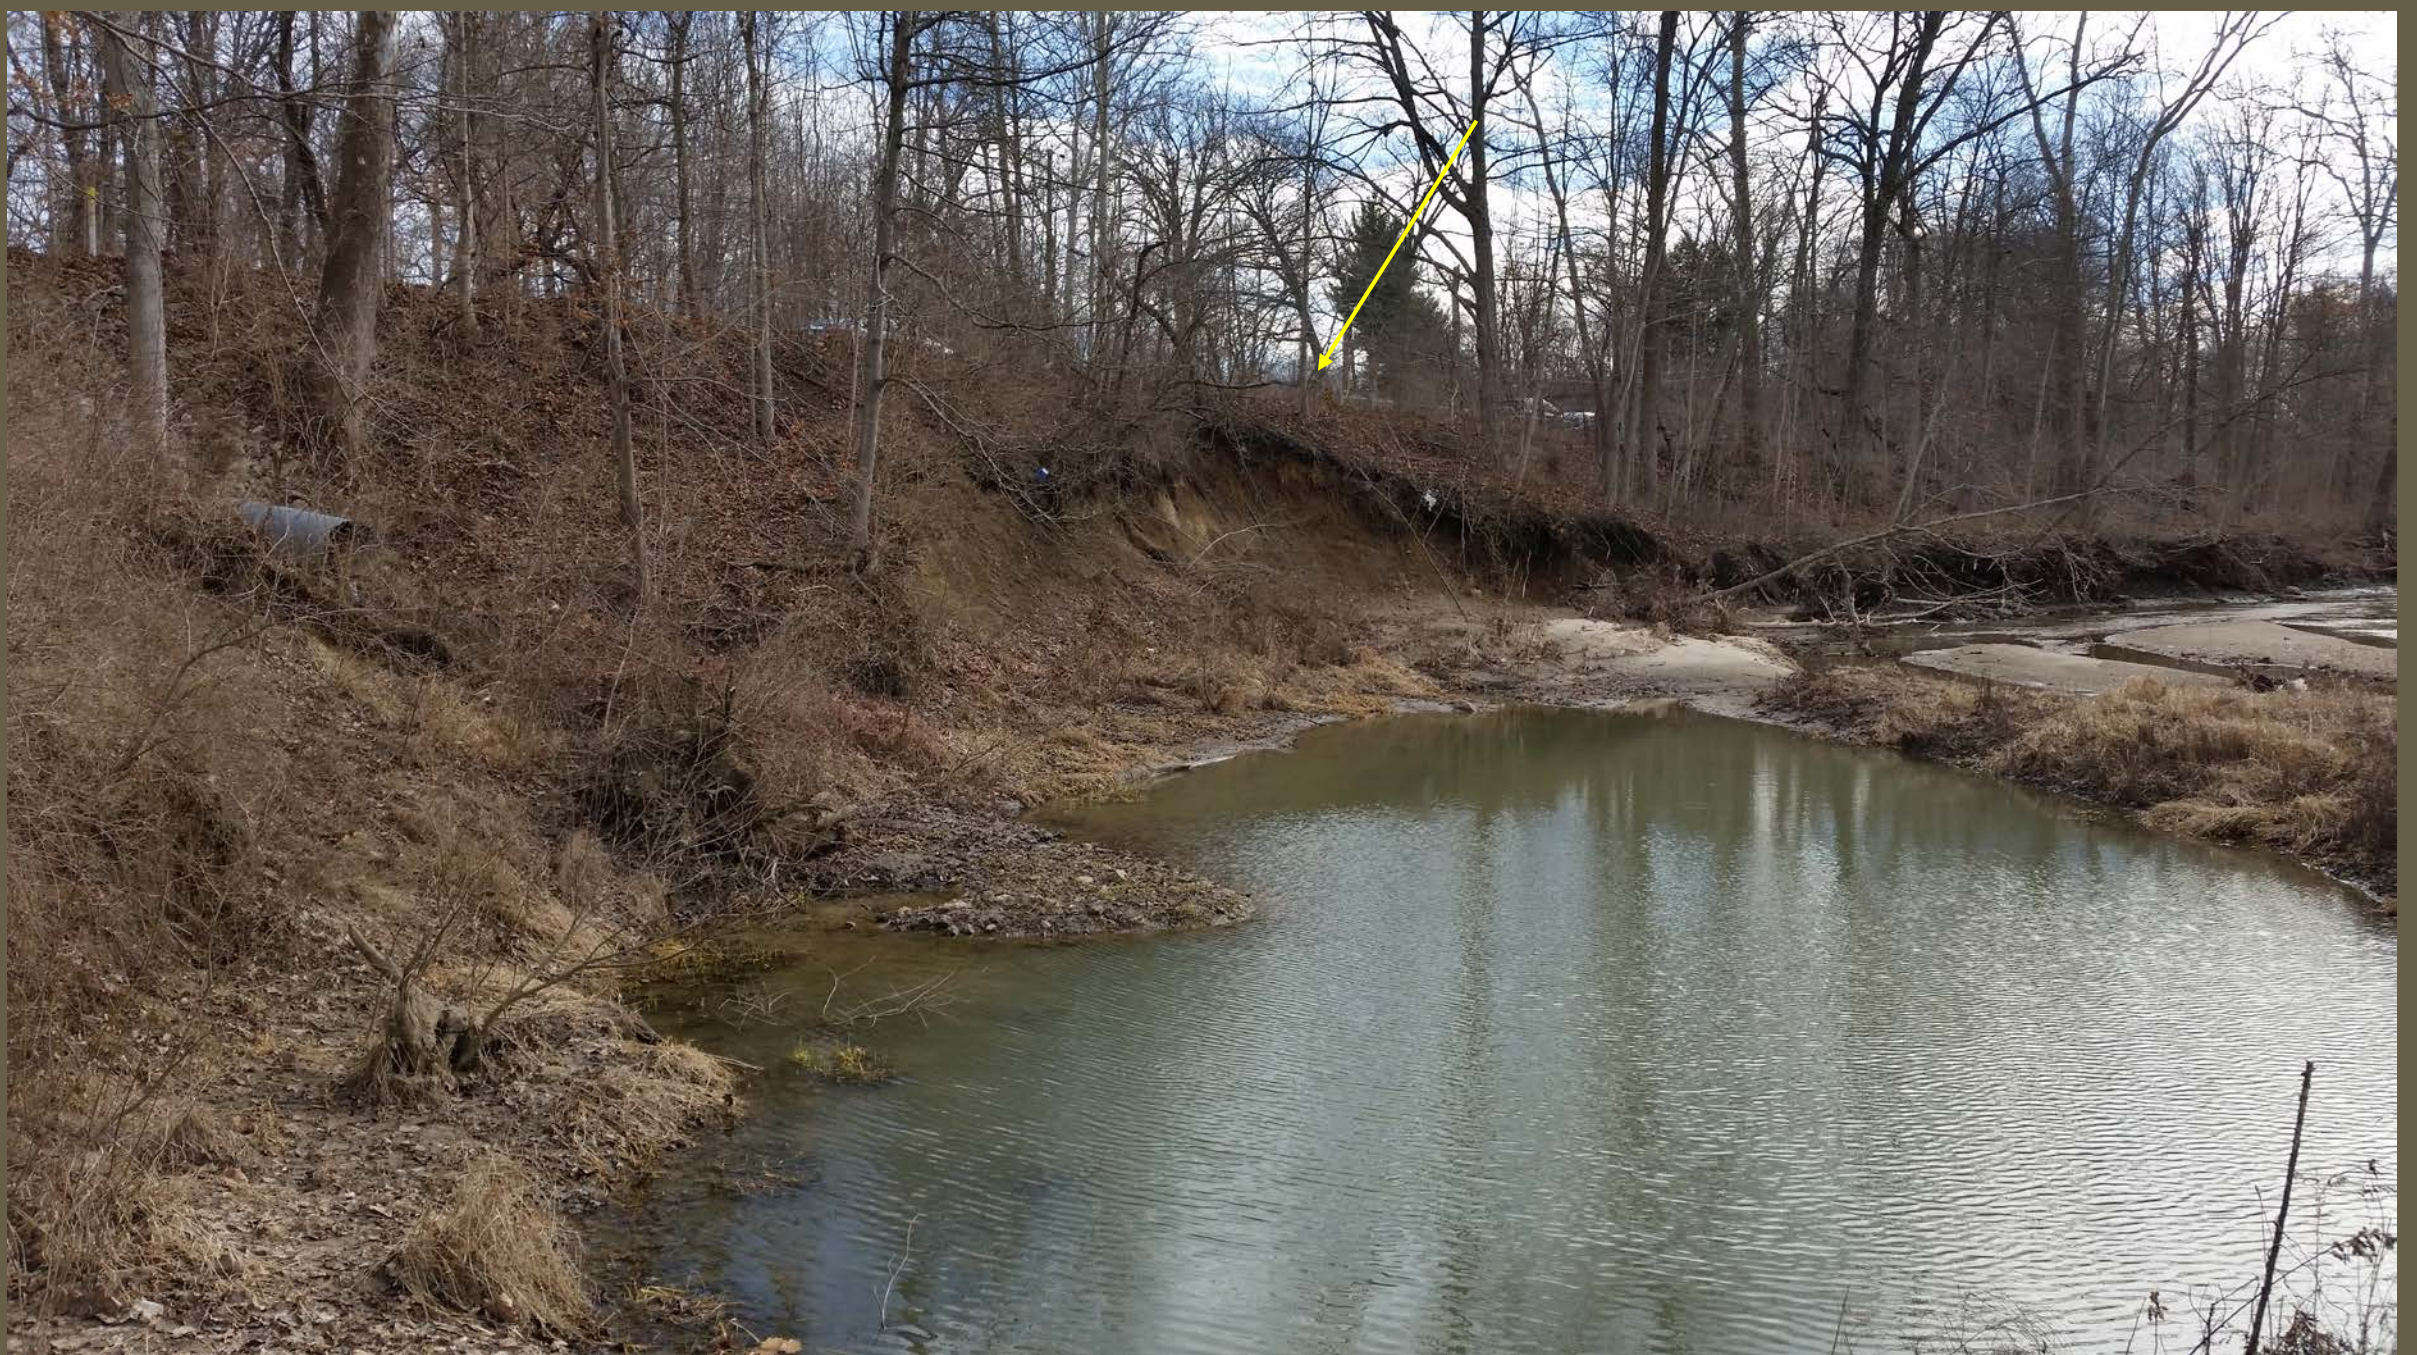
White Lick Creek at SR 267, near Plainfield, Indiana (39.6550, -86.3843) left bank, yellow arrow indicates SR 267

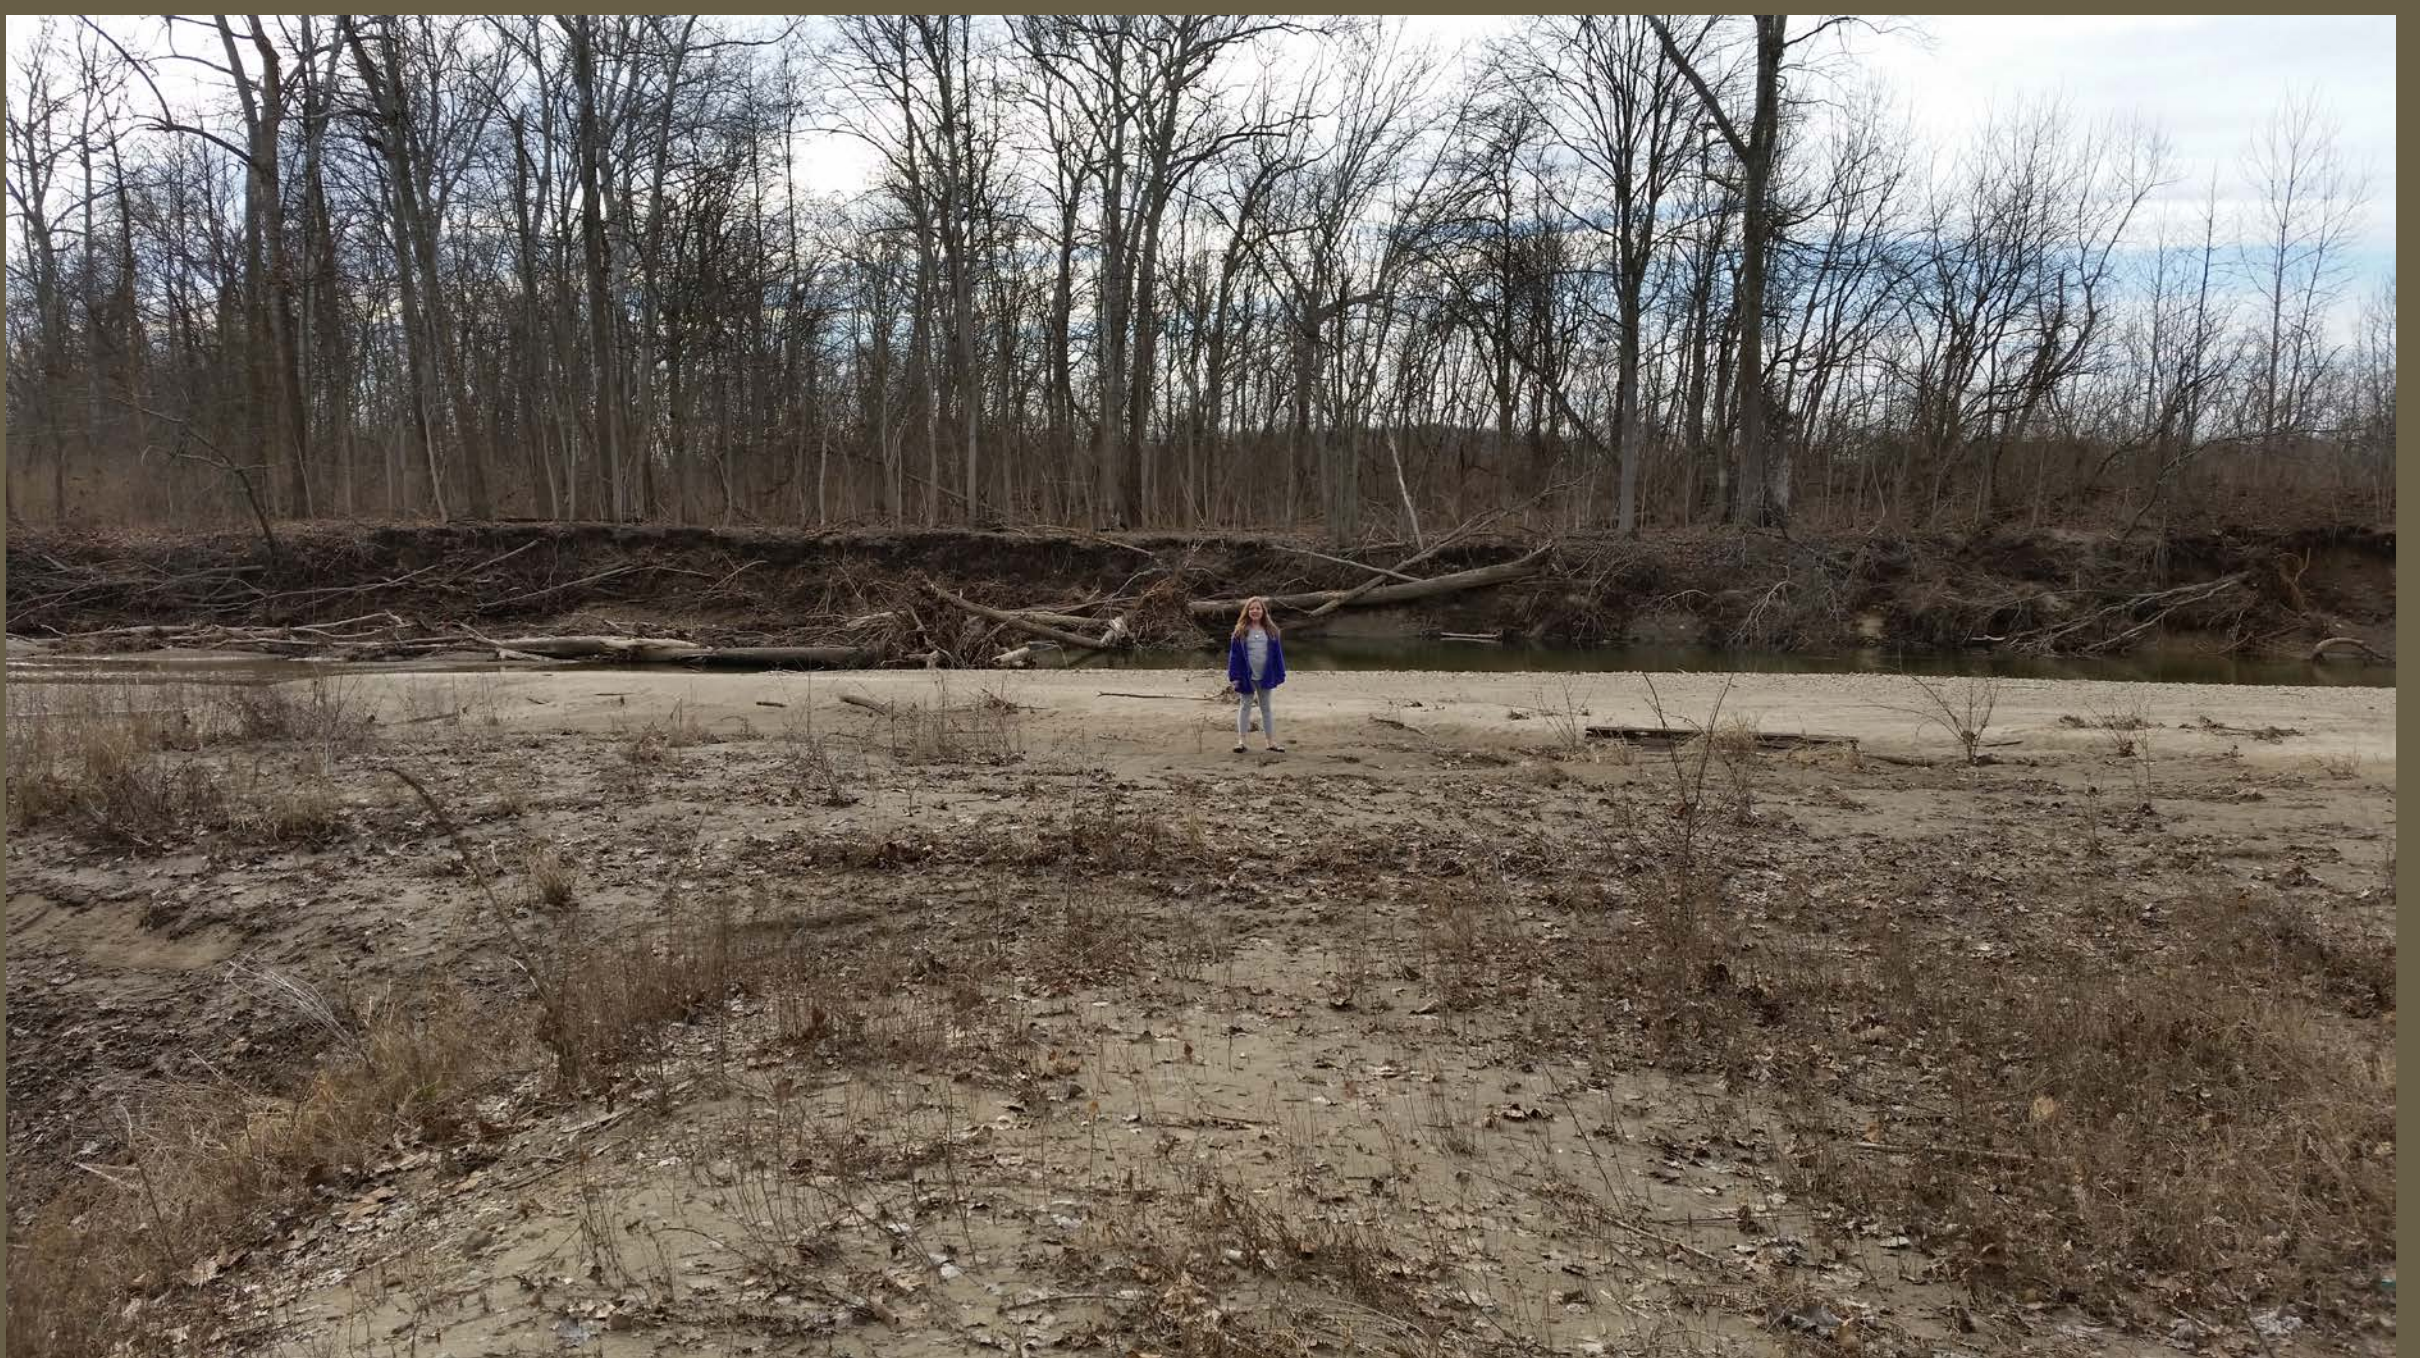
White Lick Creek at SR 267, near Plainfield, Indiana (39.6550, -86.3843) right bank

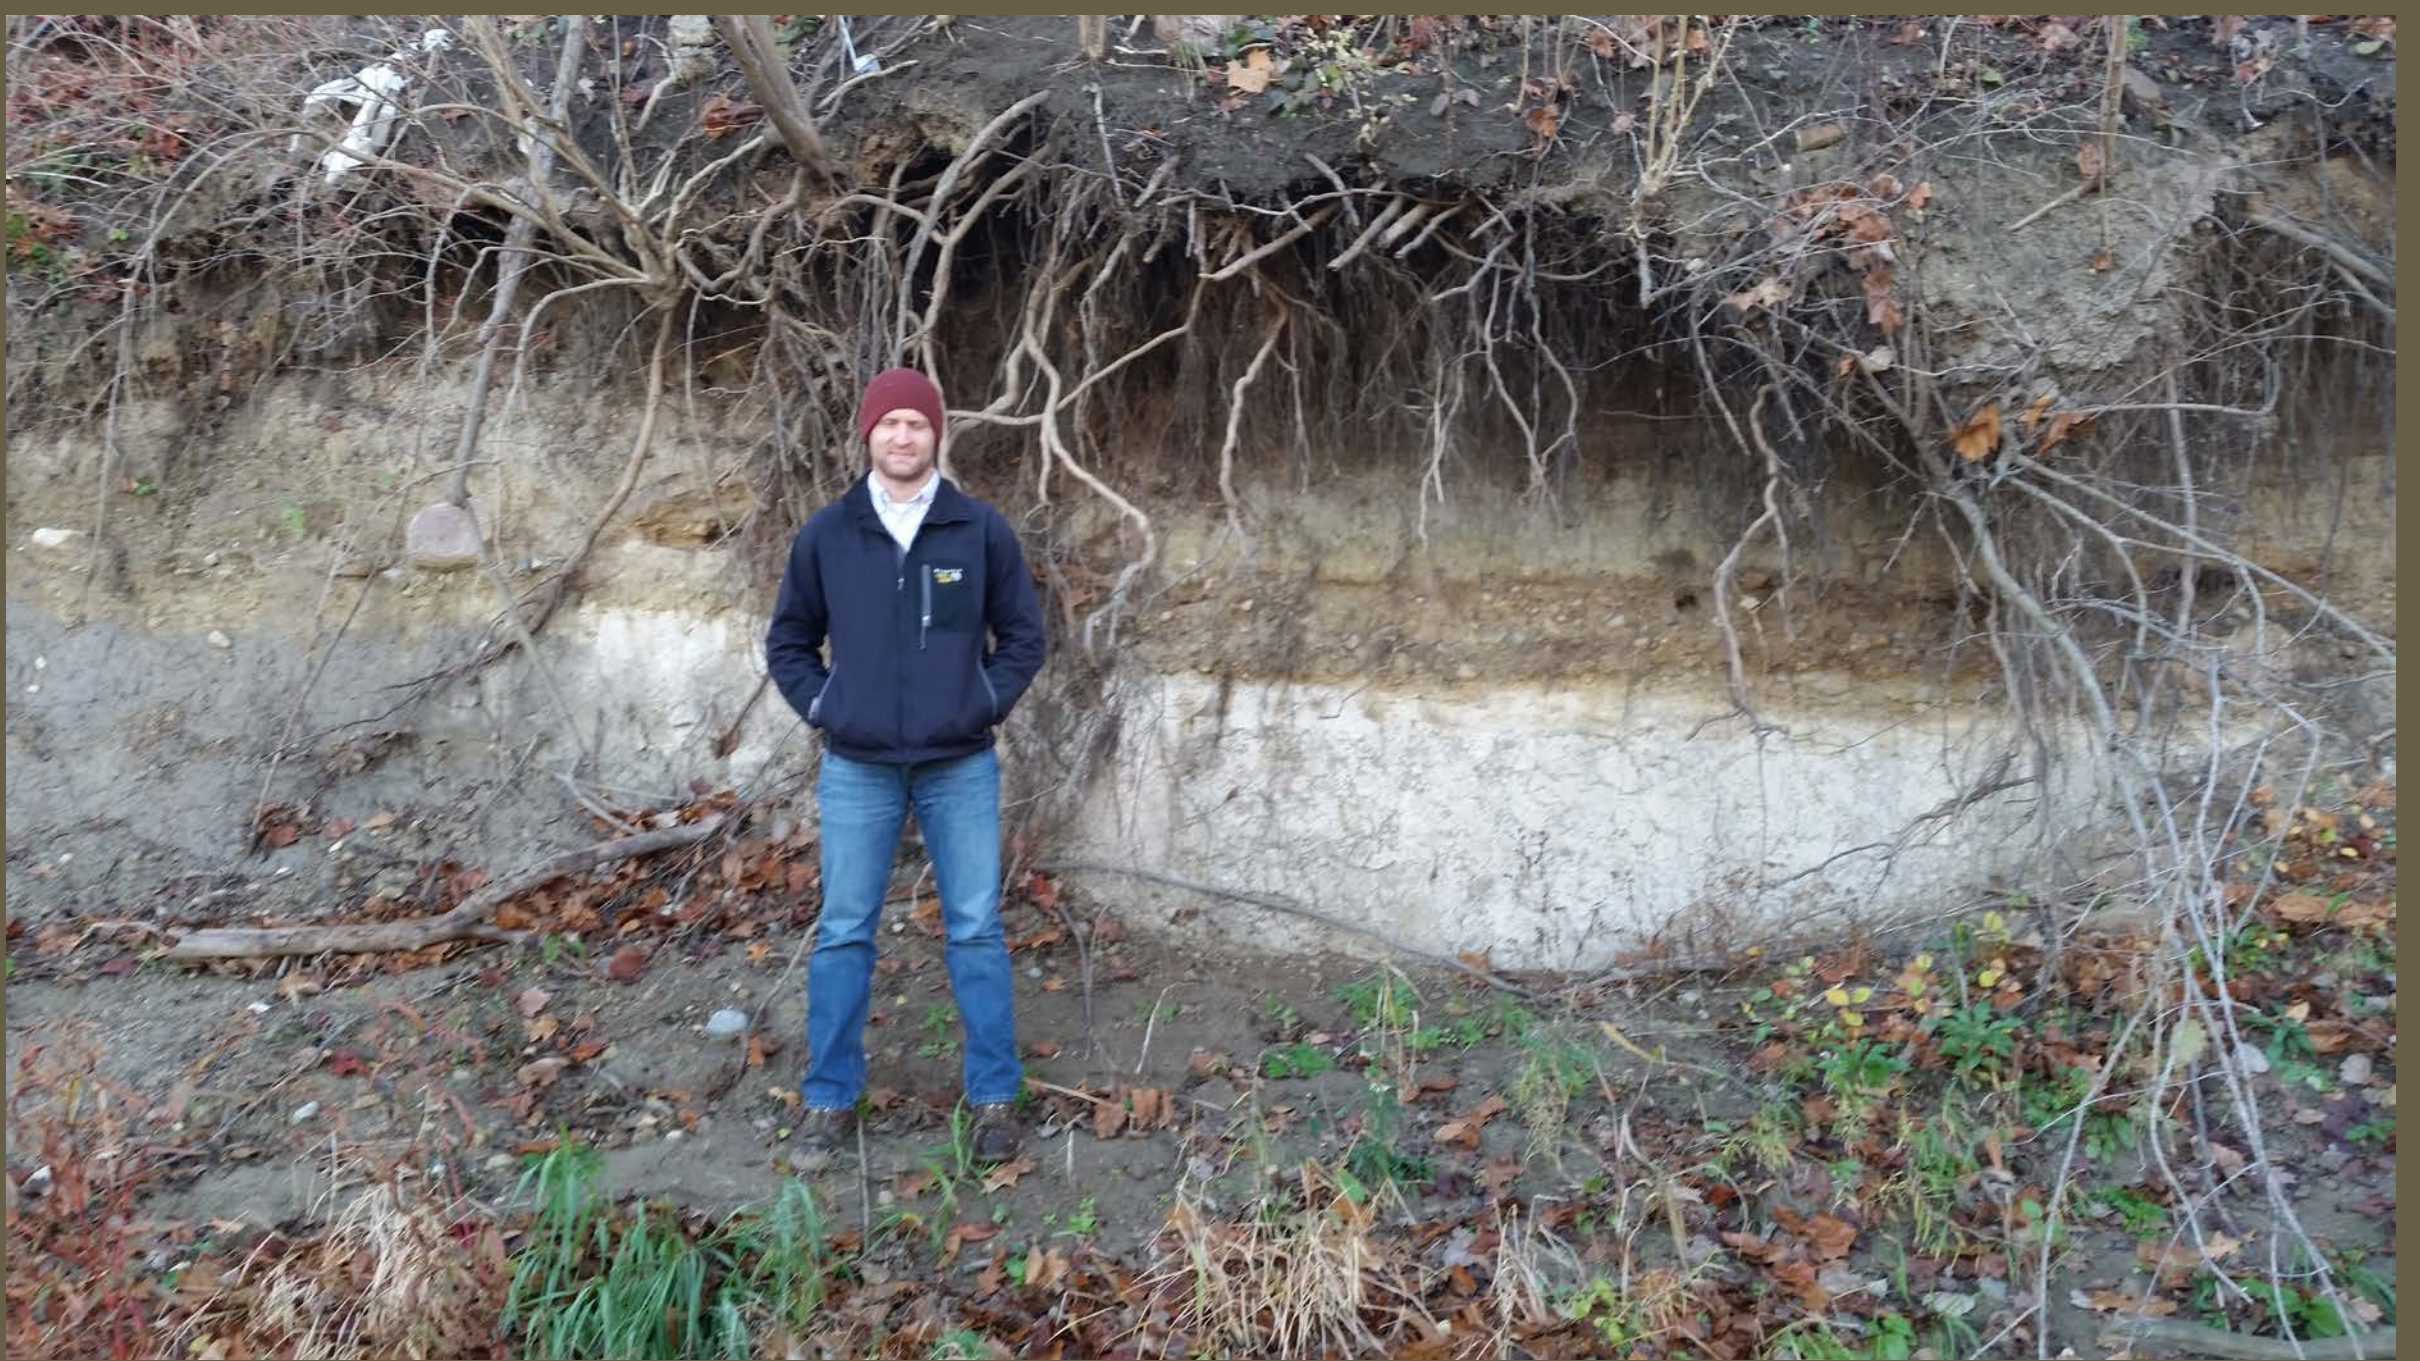
White Lick Creek at SR 267, near Plainfield, Indiana (39.6550, -86.3843) left bank, bank sediment stratigraphy

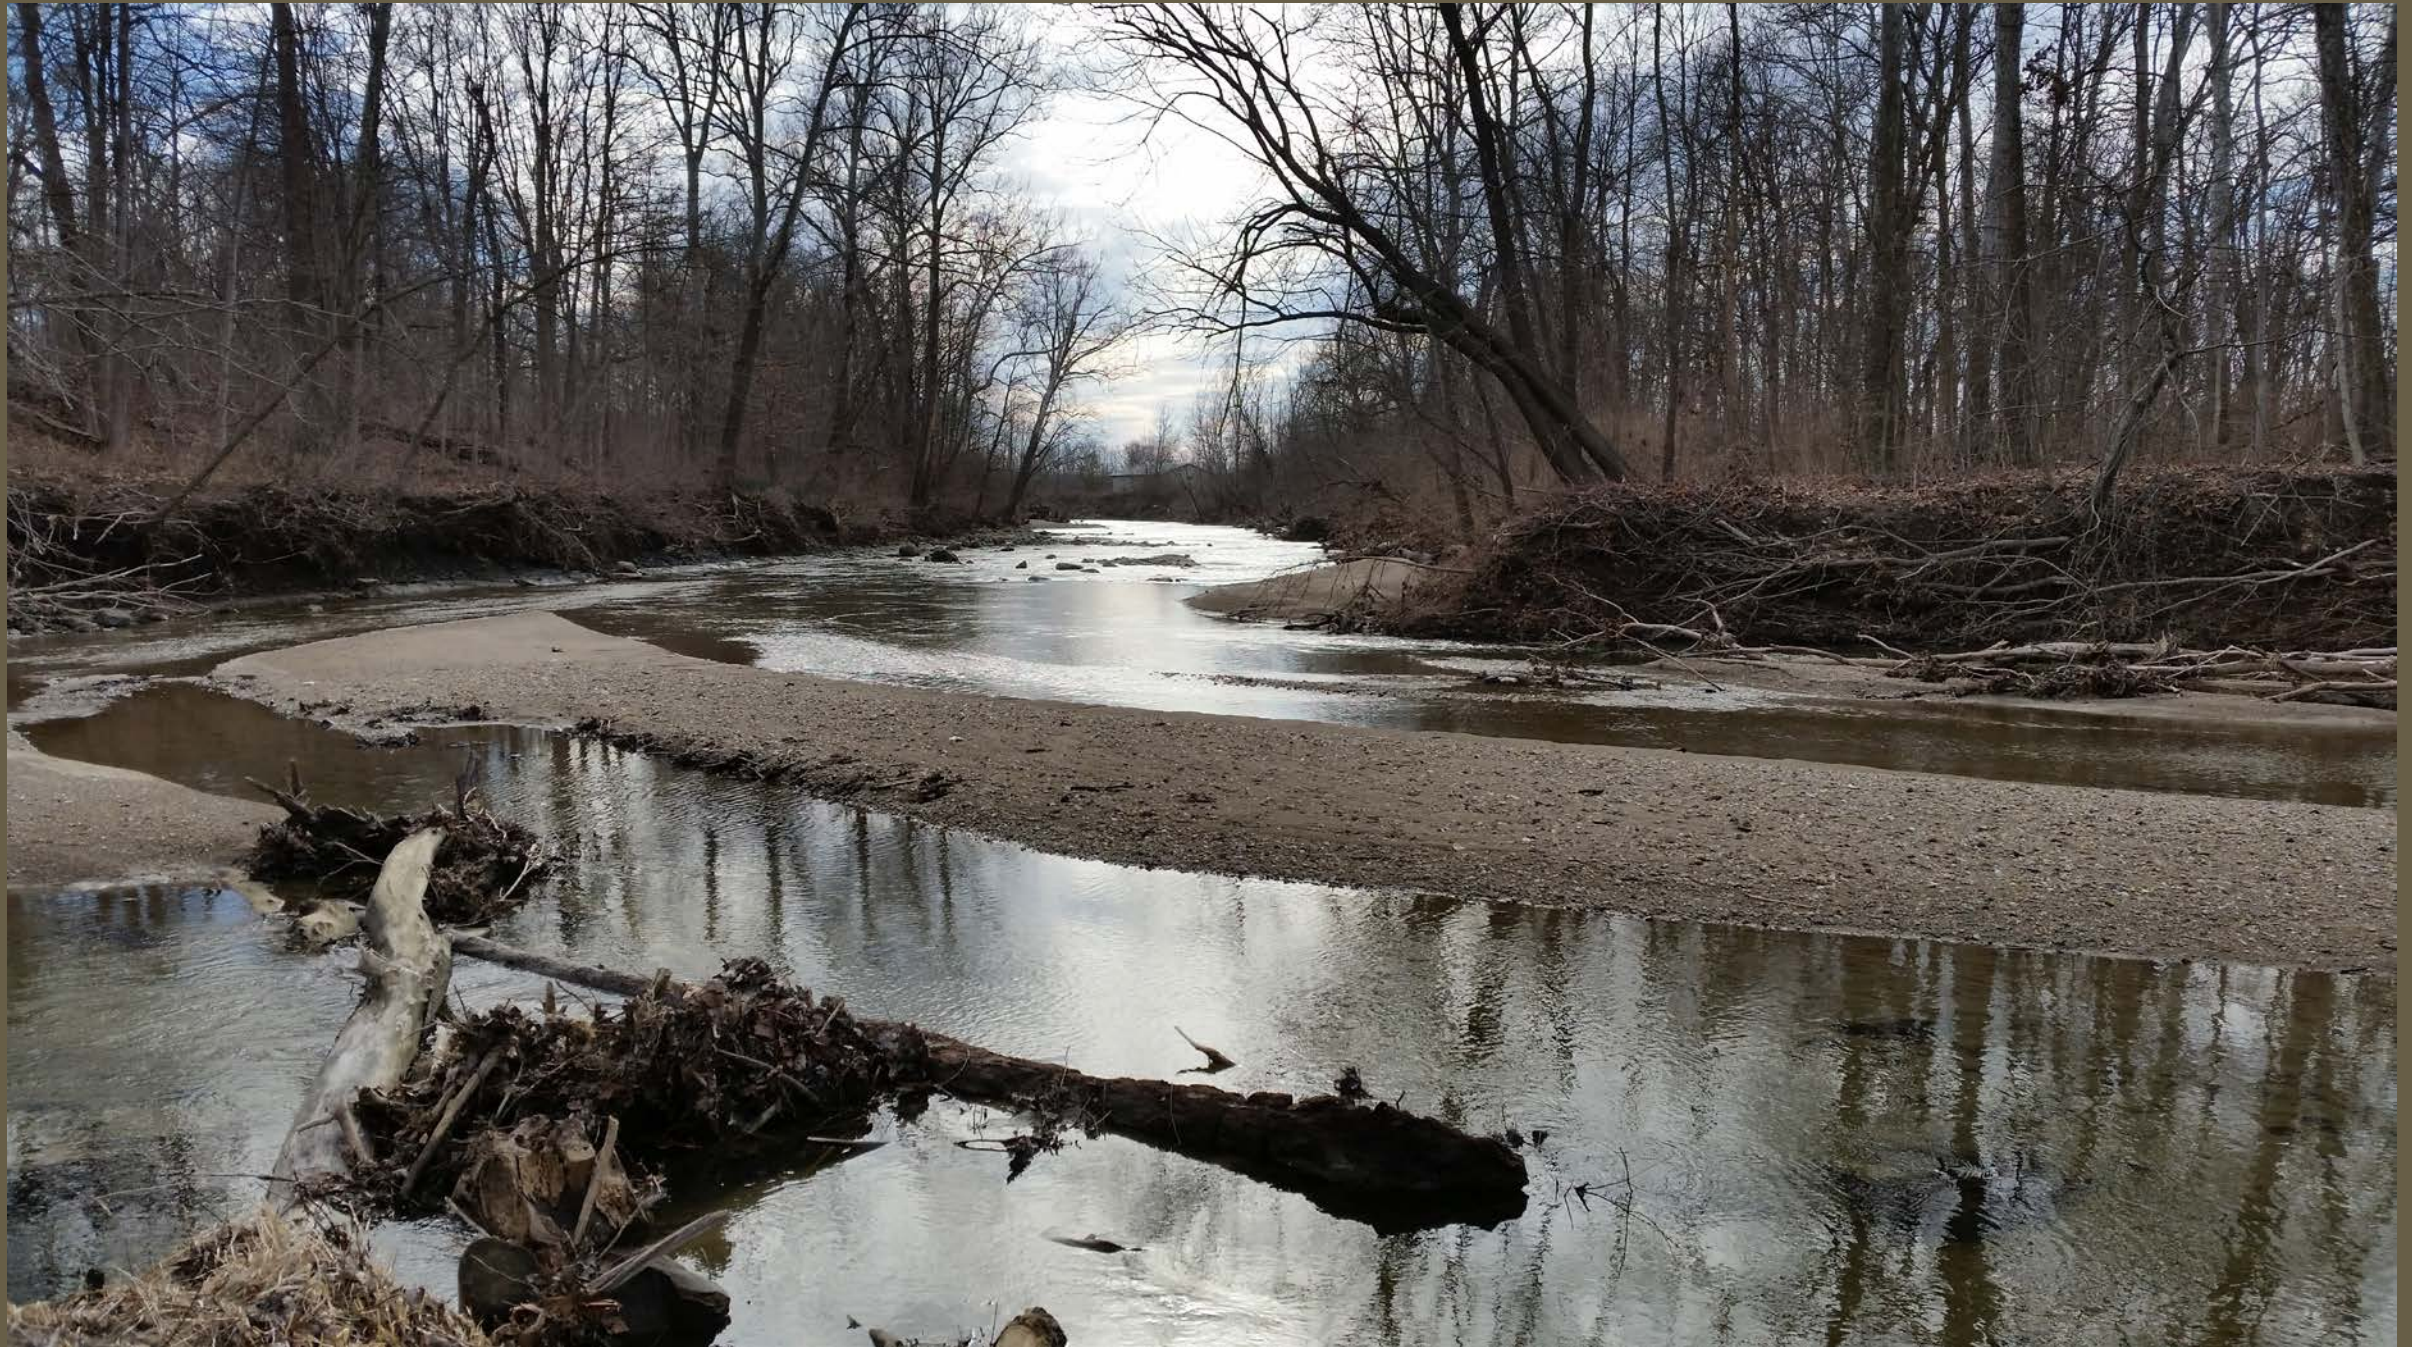
White Lick Creek at SR 267, near Plainfield, Indiana (39.6550, -86.3843) downstream
