# Fluvial Erosion Impacts on Infrastructure Along Indiana Rivers and Streams

Siavash Beik, Robert Barr, Brian Meunier

2017 Purdue Road School

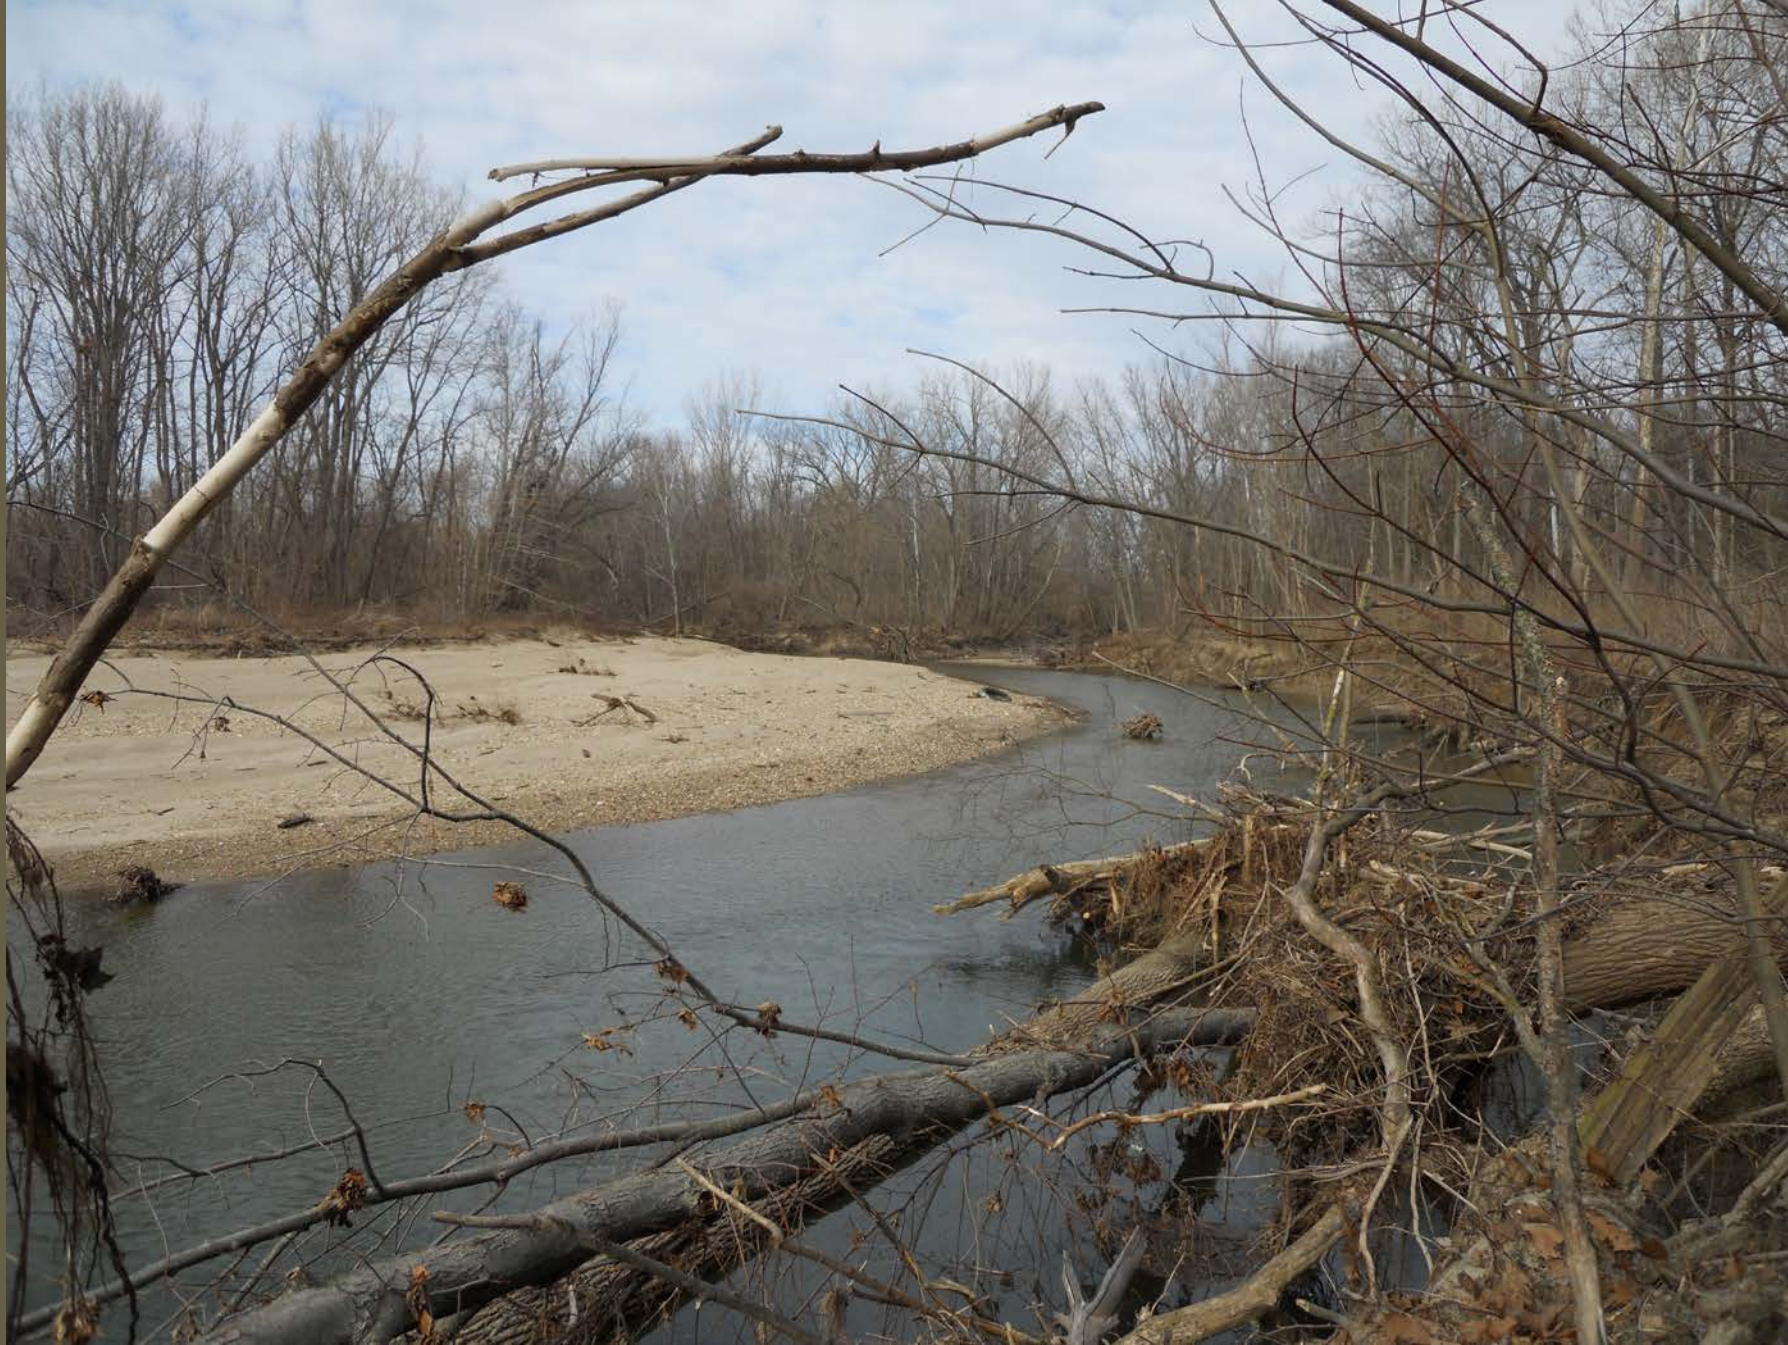
White Lick Creek at SR 267, near Plainfield, Indiana (39.6550, -86.3843) upstream
