POLLACK PERIODICA  
An International Journal for Engineering and Information Sciences  
DOI: 10.1556/606.2017.12.1.10  
Vol. 12, No. 1, pp. 123–133 (2017)  
[www.akademiai.com](http://www.akademiai.com)

## EXPERIMENTAL STUDY OF THE OUT OF PLANE BEHAVIOR OF MASONRY INFILL WALLS WITH EXTERIOR INSULATION SYSTEMS

**Abstract:** The objective of this study is to evaluate the out of plane behavior of a masonry infill wall provided with an exterior thermal insulation system. For this purpose there were constructed two 1:1 scale specimens of masonry infill walls in order to compare a simple wall with one having already applied an exterior thermal insulation system composed by a polystyrene insulation and a protection layer of plaster and a glass fiber mesh. The load was applied through a horizontal force, acting at the mid height of the wall. Both specimens were tested in displacement control, using alternate force with 3 cycles per loading step. As it was expected, an increased stiffness and out of plane resistance was observed for the wall provided with the insulation system. Various observations were noticed related to the technology and overall behavior of the infill masonry wall.

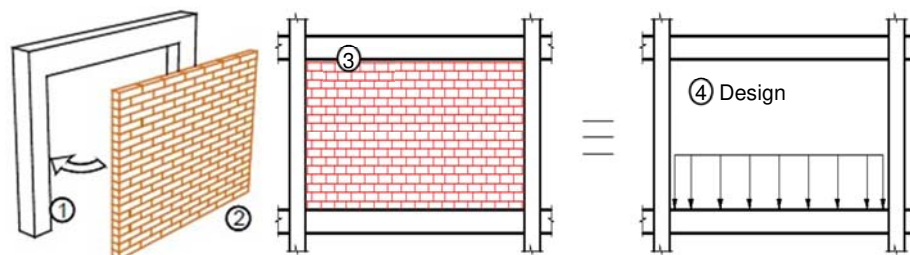
*Fig. 1.* Construction sequence of masonry infill walls

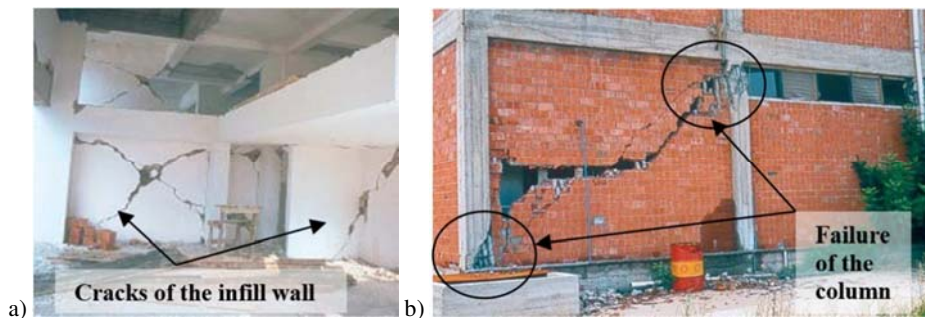
*Fig. 2.* In-plane damages, a) Cracking of the infill wall, Izmit earthquake; b) Local failure of reinforced concrete column, Adana-Ceyhan earthquake (after Bachmann 2002)

Having a nature difficult to predict, earthquakes affect everyday activities and all man-made constructions. The masonry infill panels from reinforced concrete frame buildings are prone to in-plane and out of plane damages. Consequently, these damages can cause the loss of building functionality, impacting everyday life at an economic and social level. Current design codes fail to provide proper regulations for these infill walls and can ultimately cause the loss of human life [6]. In order to increase the stiffness of reinforced concrete frame structures, masonry walls are introduced between the frame elements. Combining materials with different mechanical characteristics can cause an unpredictable behavior of the overall structure [7]. From this association of materials, the following scenarios can emerge: strong frame and weak infill, weak frame and strong infill, strong frame and strong infill, and weak frame with weak infill. Given the existing recordings in literature, this paper focuses on the first two scenarios. The result of the first scenario can be observed in *Fig. 2a* as diagonal cracking of the infill panels,

and for the second scenario *Fig. 2b* illustrates the failure of the reinforced concrete column, as well as severe cracking of the infill wall. Overturning of the masonry infill represents the most dangerous out of plane failure. Due to the high seismic forces occurring in the non-structural elements, the masonry infill can fail out of plane, as it can be seen in *Fig. 3a* and *Fig. 3c*, highlighting poor conformation to the structural frames [8]. Driven by the desire to ensure a good correction of thermal bridges in a building, veneer walls were placed over the reinforced concrete frame structure [9]. As a result of the seismic action and poor connection to the frame, failure of this veneer can be seen in *Fig. 3b*.

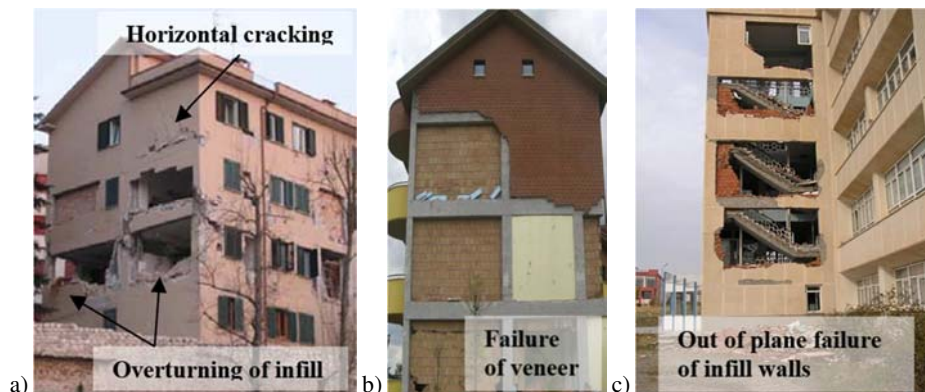
*Fig. 3.* Out of plane overturning of masonry infill, a) Abruzzo earthquake (after Morandi et al. 2013); b) Failure of veneer, Abruzzo (after Vicente et al. 2010); c) Van earthquake [10]

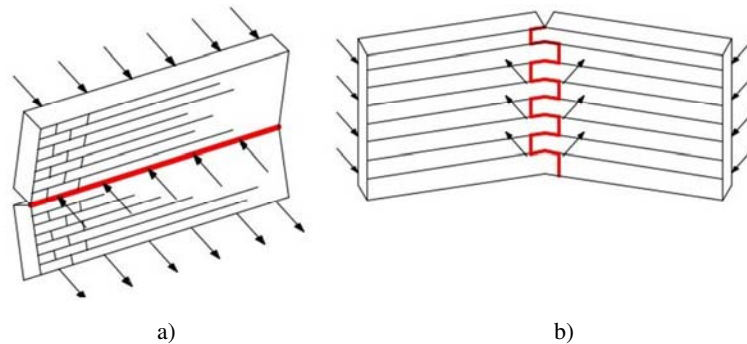
*Fig. 4.* Out-of-plane failure modes for masonry infill walls, a) parallel with the horizontal joints; b) perpendicular on the horizontal joints

provisions given in design codes, and together with poor workmanship, the resistance of these walls is reduced when subjected to out of plane loads. The Romanian seismic design code [11] accounts the interaction of reinforced concrete frame and masonry infill, only if a set of compressed diagonals are identified in the masonry panel. Due to uncertainties from the execution phase and together with the collaboration between structural and non-structural elements make this identification difficult. Two out of plane failure modes are identified by the Romanian masonry design code [12], one parallel and one perpendicular to the mortar joint, as it can be seen in *Fig. 4a* and *Fig. 4b*.

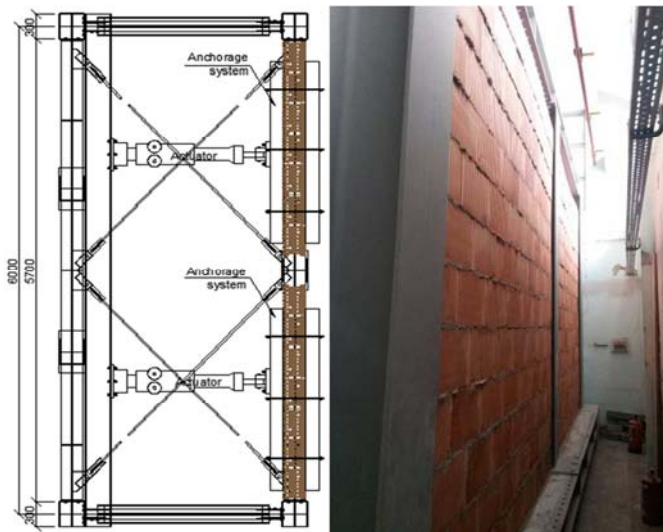
*Fig. 5.* Plan view of the test setup and construction stage of infill specimens

Two infill wall panels were constructed at a scale 1:1. The first constructed specimen (MW1) was the reference one, in order to establish a comparison. The second constructed specimen (MW2) had a 10 cm exterior thermal insulation system applied, composed of polystyrene panels fixed with adhesive to the infill wall surface and an exterior reinforced plaster with a glass fiber mesh. The infill panels had a dimension of 2.65 m width and a height of 3.50 m. In order to construct these specimens, clay blocks with vertical holes of dimensions 375x250x238 mm (length/width/height) and a 53% volume of holes were used together with general purpose M5 mortar. The compressive strength of a clay unit was given by the producer and had a value of 10 N/mm<sup>2</sup>, while the mortar had a resistance of 5 N/mm<sup>2</sup>. Material characterization tests were performed

and reported in a design guideline for structural systems with clay blocks with vertical holes [16]. In both cases, the infill panels were simply supported on a concrete beam at the bottom side, while at the top, wooden wedges and mortar was placed between the top side of the wall and the elements of the experimental set-up, representing the current practice from Romania. No interaction was provided with the adjacent columns of the experimental stand, in order to test the infill panels only to one way vertical bending. Both wall specimens were subjected to a cyclic load applied at mid height, through a steel anchoring system composed of angle profiles and steel rods passing through the wall. A layer of rubber was placed between the angle profiles and the surface of the masonry, in order to avoid local crushing of the masonry. The test setup of the experiment can be observed in *Fig. 5*. The loading protocol was performed in displacement control up to a value of 45 mm. Three cycles were applied at each loading step in both pushing and pulling state, as it can be seen in *Fig. 6* [17].

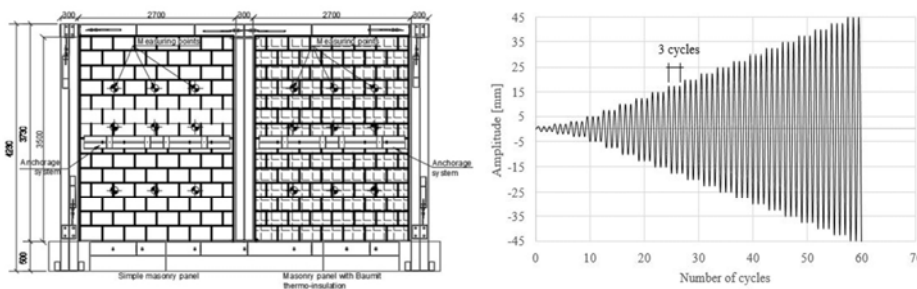
*Fig. 6.* Measuring points of out of plane displacement and loading protocol

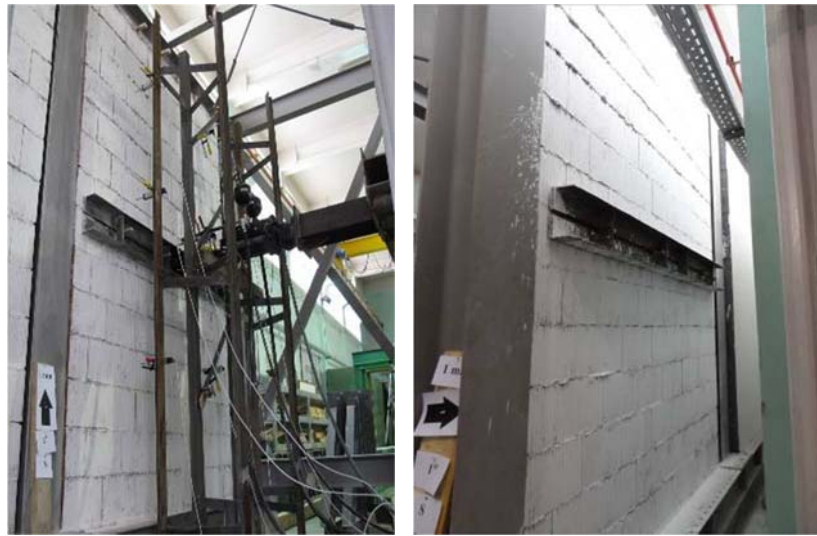
*Fig. 7.* Experimental setup for MW1

The experimental setup for infill specimen MW1 can be observed in *Fig. 7*. At a displacement of 10 mm, a horizontal crack appeared in the horizontal mortar layer, followed by horizontal cracks at the bottom part and top part of the masonry wall. Increasing the displacement, the crack in the middle part of the wall opened as much as 8 mm, as it can be seen in *Fig. 8*. Using a hydraulic actuator to apply pressure on the infill wall, the displacement was monitored in the central part and the force displacement curve obtained for MW1 can be observed in *Fig. 9*. The maximum recorded force was 56.6 kN for an out of plane displacement at 45 mm representing an inter-story drift of 1.28%, larger than the value of 0.7% given in the Romanian seismic codes [11]. Larger displacements were not able to be recorded due to the limitations of the laboratory equipment.

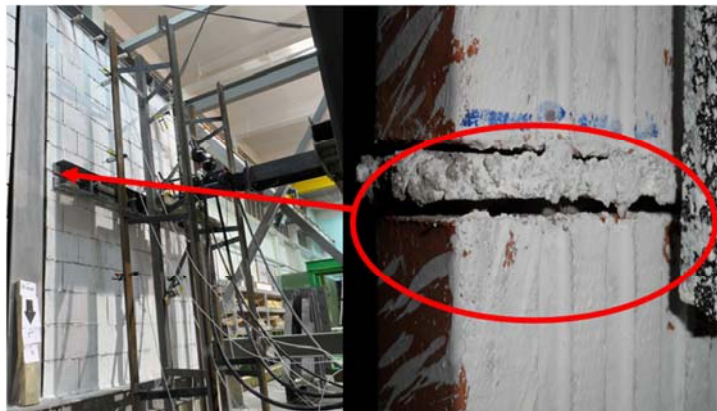
*Fig. 8.* Opening of horizontal crack in MW1

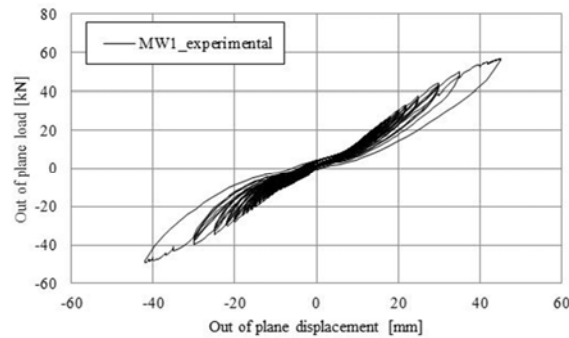
Fig. 9. Force-displacement diagram for MW1

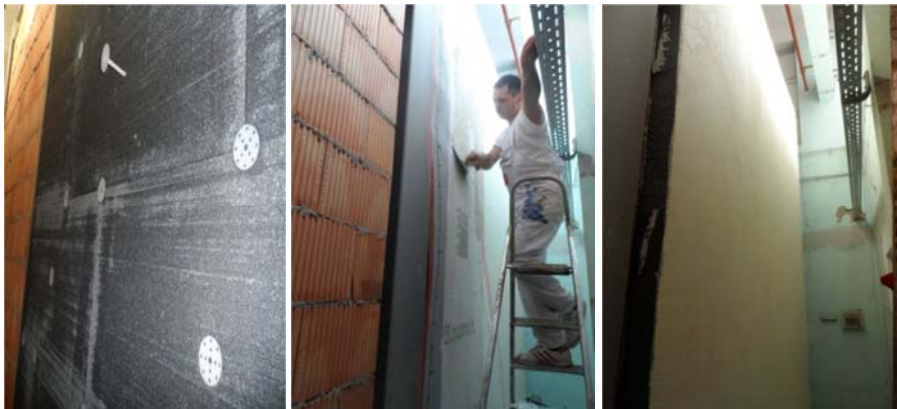
Fig. 10. Construction process of infill specimen MW2

The construction process of the infill wall specimen MW2 having a layer of thermal insulation applied can be seen in Fig. 10 and was performed as per producers requirements. The application of the insulation system on one part of the wall simulates the current trend of thermal proofing of existing and new buildings.

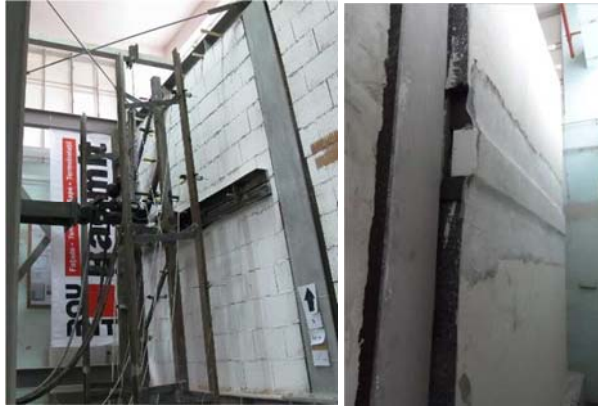
*Fig. 11.* Experimental setup for MW2

Plastic dowels at the corners and in the middle of every polystyrene panel were provided and a reinforced plaster with glass fiber mesh was provided over the polystyrene. The tensile strength of the glass fiber mesh had a value of 1750 N/50mm, as provided by the producer. An adjustment was made in order to allow for the application of the cyclic load without damaging the polystyrene, as it can be seen in Fig. 11. An overlapping of the glass fiber mesh of 40 cm was provided in this area.

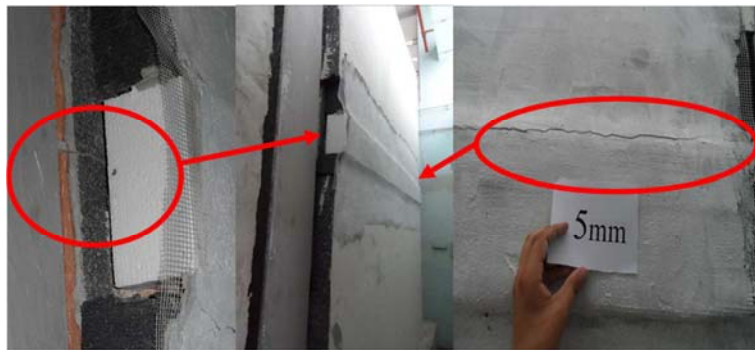
*Fig. 12.* Experimental setup for MW2

First superficial cracks appeared in line with the steel anchoring system, as expected, at a displacement of 5 mm, while the first crack in the horizontal joint occurred at a displacement of 7.5 mm, as it can be seen in Fig. 12. The maximum recorded force was reached at a displacement of 42.5 mm and had a value of 60.44 kN, while at 45 mm a slight decrease of force was recorded, reaching only 58.9 kN. The force displacement

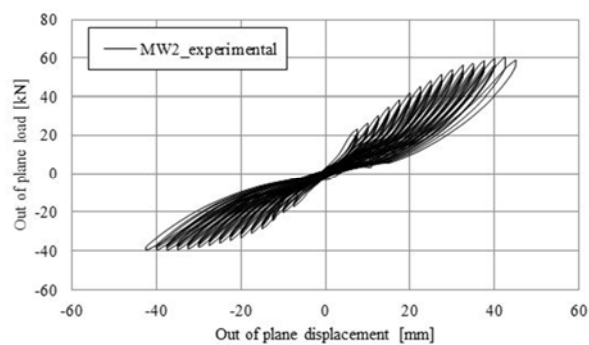
*Fig. 13.* Force displacement diagram for MW2

diagram for infill wall specimen MW2 can be observed in *Fig. 13*. Analytical calculations performed according to Mosoarca et al. [15] can yield a good correlation with these results.

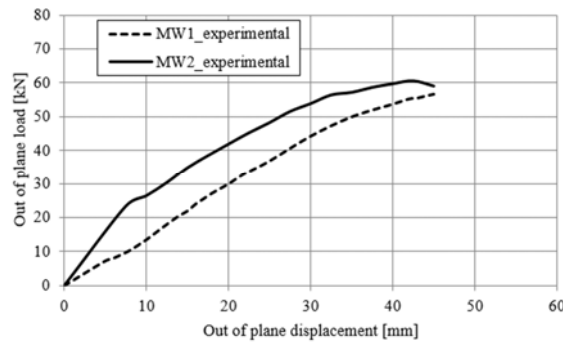
*Fig. 14.* Pushing state backbone curves for MW1 and MW2

In order to better understand the effect of the thermal insulation system on the out of plane behavior of masonry infill walls, *Fig. 14* presents in comparison the backbone curves of the analyzed infill specimens MW1 and MW2, in terms of resisting force and out of plane displacement. It can be seen that at the ultimate displacement of 45 mm, the bearing capacity of MW2 had a slight increase of 6%. On the other hand, an increased stiffness as well as enhanced energy dissipation can be observed for MW2, which can be translated to a better response to seismic action. *Table I* presents comparative values of the forces recorded at the moment in which the first crack appeared in the horizontal joint. It is clear that the external insulation system protects the infill wall confining it and providing a more stable response until the ultimate point of behavior. *Fig. 15* presents the displacement measured on the height of both infill walls. It can be observed that a smaller displacement is recorded in the adjacent points of MW2.

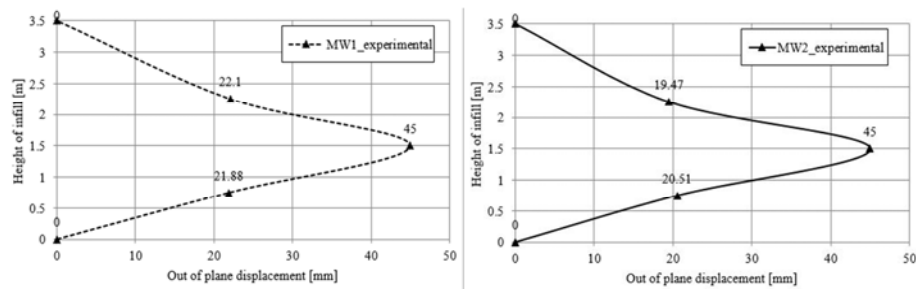
Fig. 15. Ultimate out of plane displacement for MW1 and MW2 versus the height of the infill
