## REPORT AND PRELIMINARY RESULTS OF R/V POSEIDON CRUISE POS472

NORGEOTECH

GEOTECHNICAL IN SITU INVESTIGATION OF SLOPE STABILITY IN  
NORWAY

TRONDHEIM (NORWAY) – TROMSØ (NORWAY)  
27.07.2014 – 12.08.2014

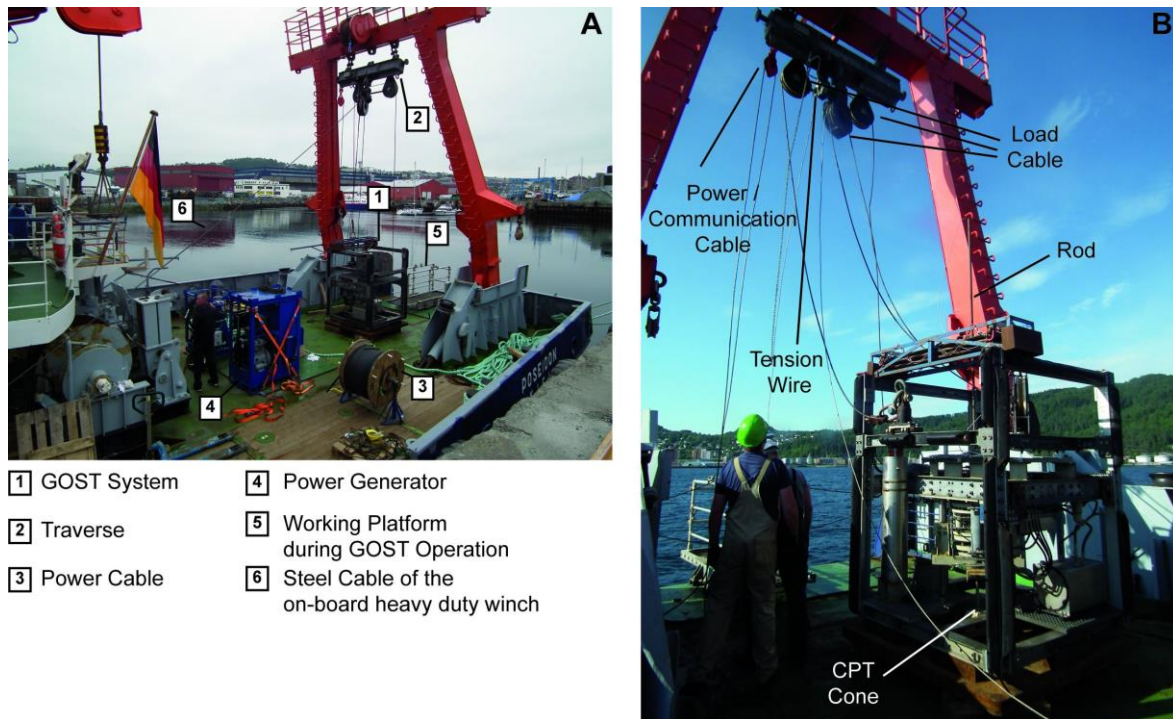
**Figure 8** Setup of the GOST system on R/V Poseidon

water column (Figure 8). During POS472 the length of the mounted rod was 20 m, which defined the maximum penetration depth. In the course of operation the rod was held upright by a constant-tension winch from the ship (Figure 8). When GOST reached the seafloor the CPTu probe is pushed quasi-statically into the soil with a penetration velocity of 2 cm/s in increments of 25 cm.

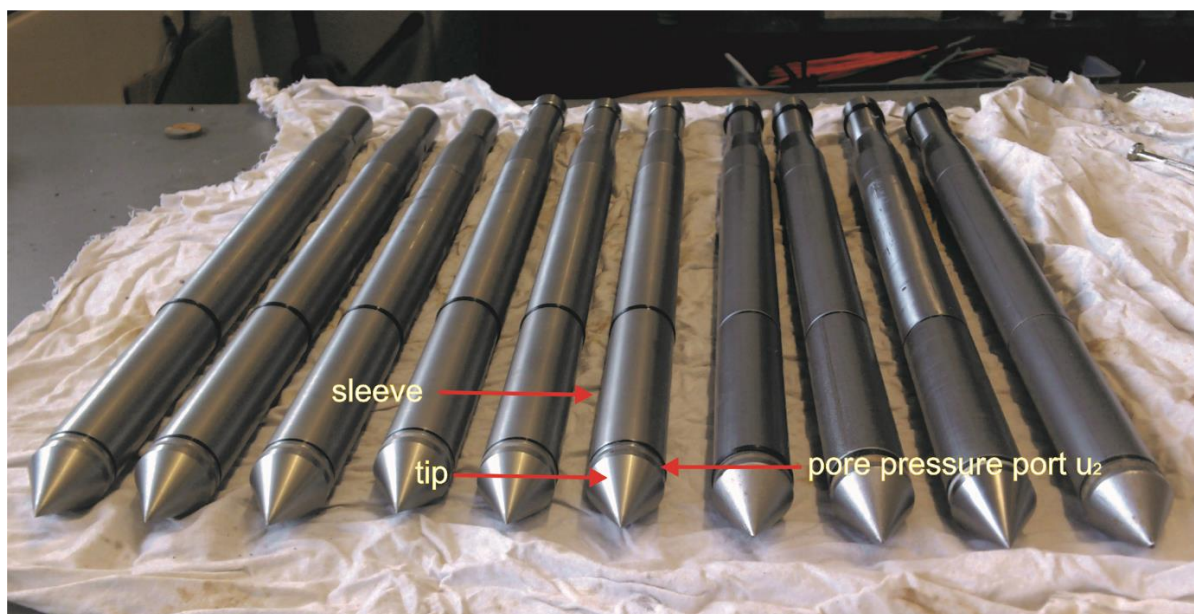
**Figure 9** Digital pressure-compensated compression CPTu cones, as installed in the GOST system.

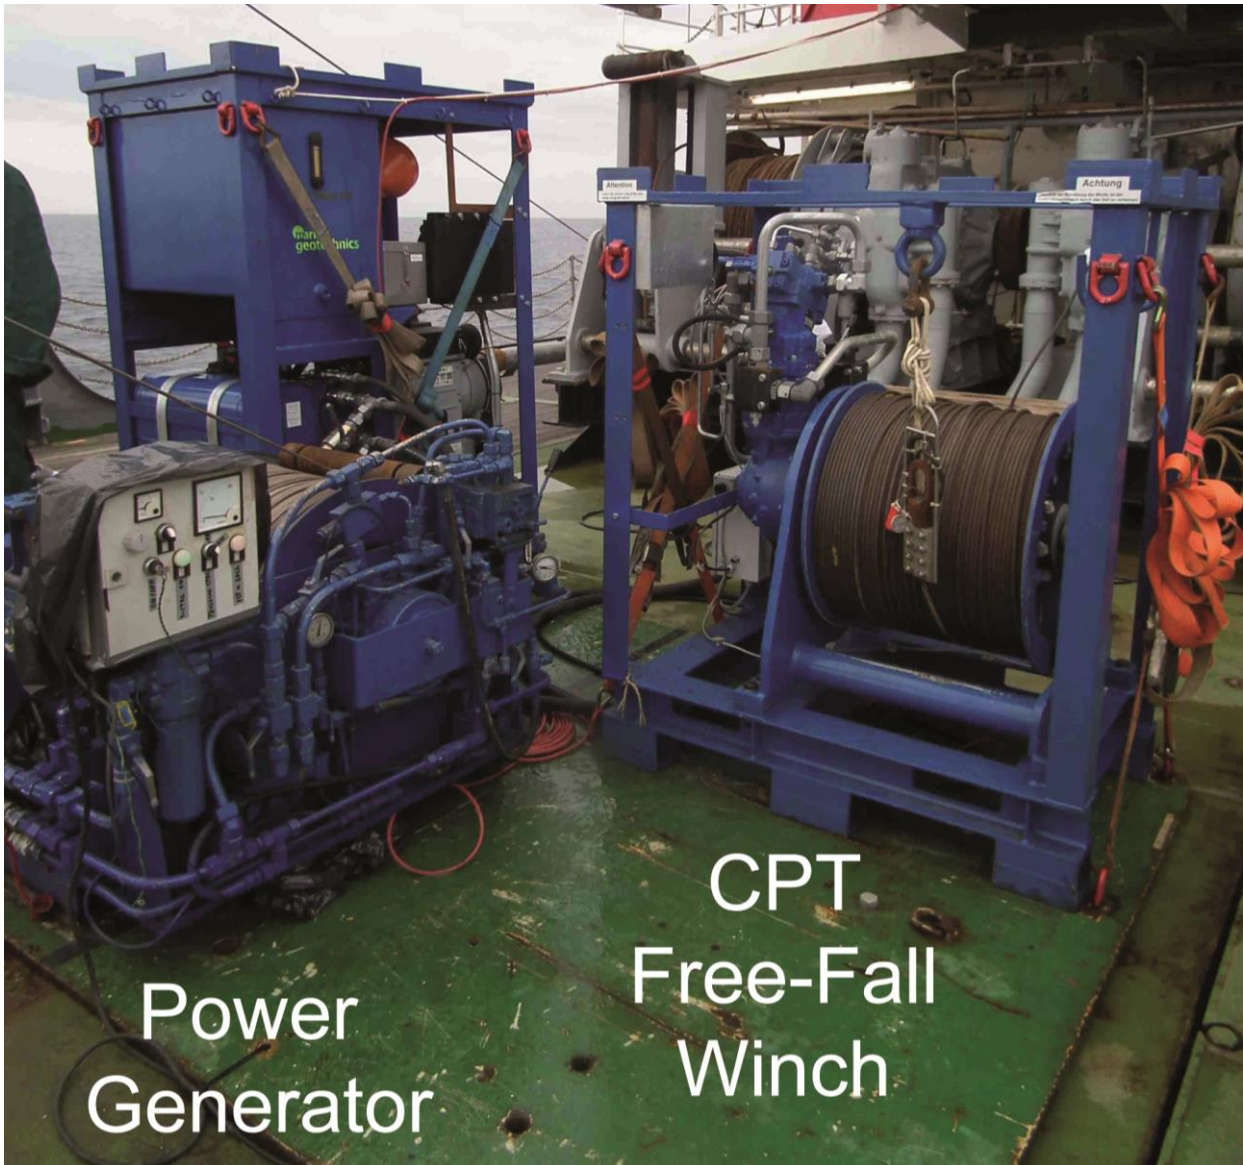
**Figure 12** New MARUM FF-CPTu-Winch 200 m (left) and entire assembly together with hydraulic aggregate (right).

The winch as well as the aggregate is designed with a footprint of a standard Euro-palette, and the winch itself can be put either next to the aggregate, or on top of it (see Figure 12). The frame is equipped with leashing points, where the winch was fixed on the working deck of RV POSEIDON. Electrical power was provided by the aggregate of the GOST system.

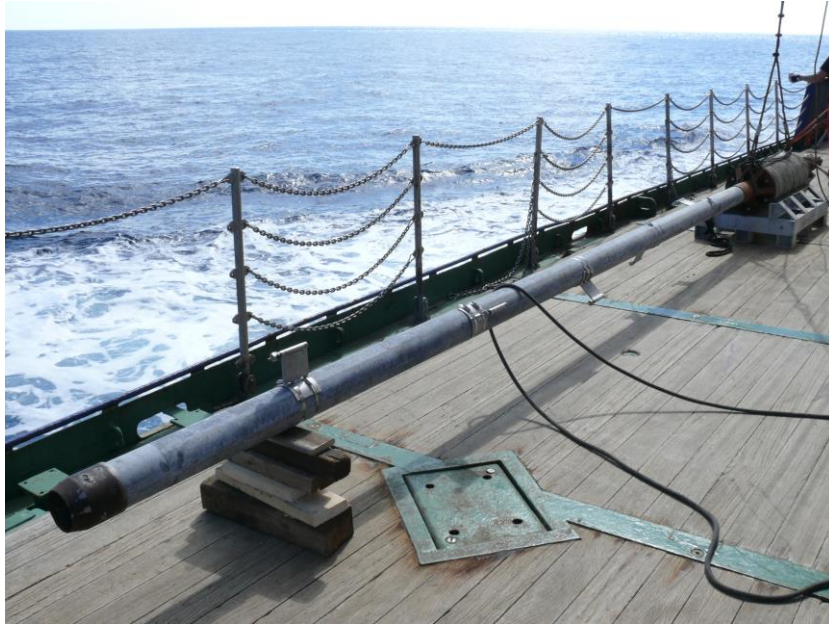
Figure 13 Gravity corer on board RV Poseidon.

A gravity corer with tube lengths of 6 m and a weight of approximately 1.5 tons was used during cruise POS472 (Figure 13). Plastic liners were marked lengthwise with a straight line in order to retain the orientation of the core and then placed inside the steel tube of the gravity corer.

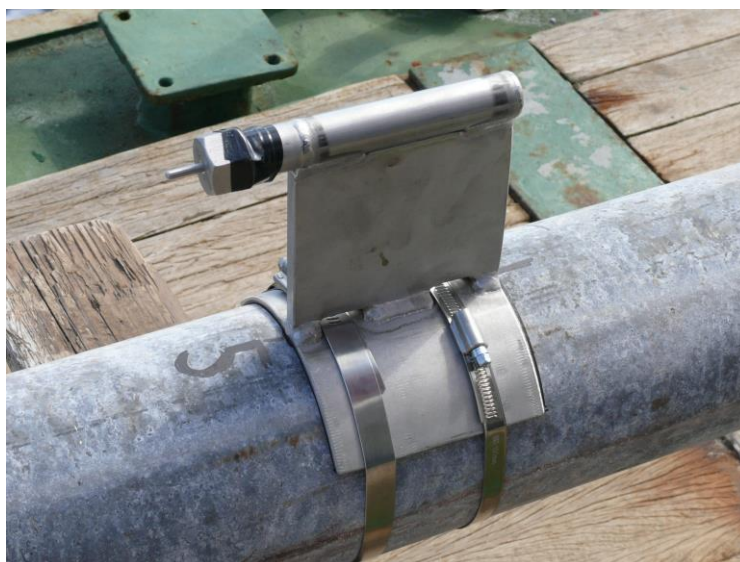
**Figure 21** MTL mounted on the gravity corer on cruise P472. The pointy end with the thermistor is facing downward.

The *in situ* temperature gradients within the superficial portion of sediments were measured routinely when gravity cores were taken using autonomous **Miniature Temperature Loggers (MTLs)**. For technical specifications and detailed information, refer to Pfender & Villinger (2002). Measurement of temperature within the sediments (seafloor penetration) was realised by mounting the MTLs to the gravity core barrel using fins and receptacles and get gradient at the chosen spacing as well as reference temperature in the water column (Figure 21). The probe remains in the seafloor sediment for 5 mins to allow for some dissipation of artificial frictional heat from inserting the gravity corer. The sampling rate of the logger is 1sec. For each depth temperature is plotted as a function of time. The data are available in the open-source data base PANGEA ([www.pangea.de](http://www.pangea.de))

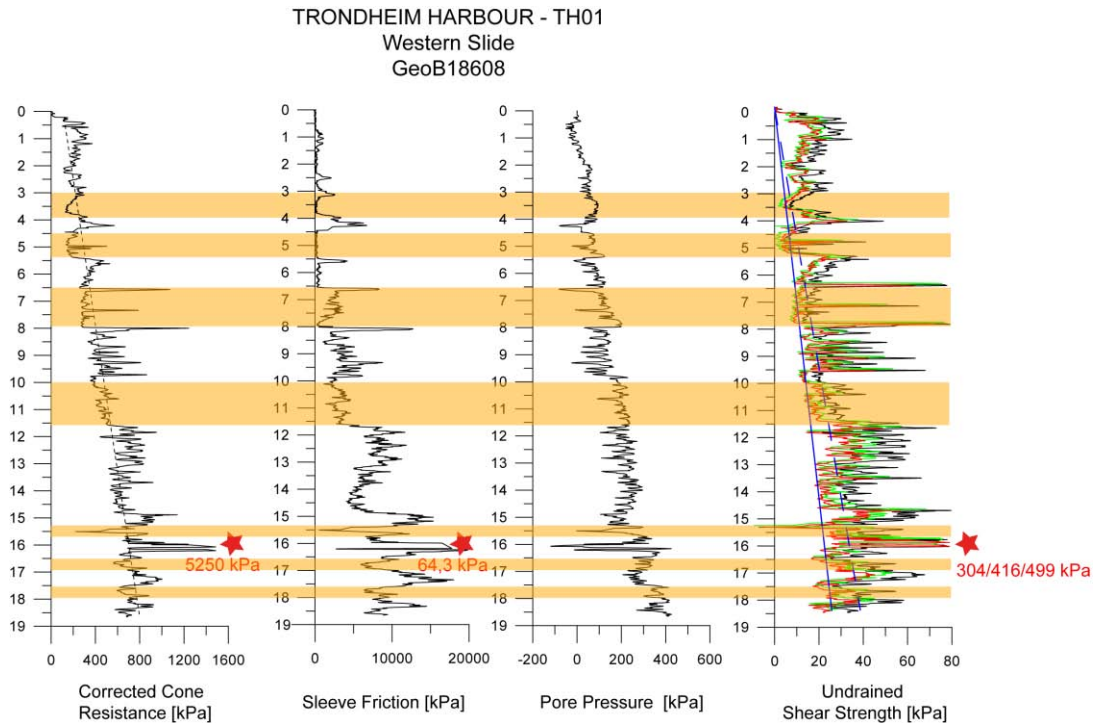
**Figure 24** Data plot of the static CPTu profile GeoB18608. Red-coloured stars mark data peaks, which have been clipped for better illustration. The number specify the value of the peak. Blue lines indicate the ratio of undrained shear strength over the depth of the profile (continuous line:  $s_u$  ratio = 0.2; dashed line:  $s_u$  ratio = 0.3, see Chapter 6.1.1))

The CPTu profile GeoB18608 at site TH01 characterises the non-failed portion behind the W'Slope on the plateau in between the Nidelva channel system (Fig. 23). The corrected cone resistance  $q_t$  reflects well interbedded strata comprising i) the background sediment, which increases linearly up to ~800 kPa at 19.5 mbsf, ii) stiff layers with  $q_t$ -values up to 5.25 MPa, and iii) material, where  $q_t$  decreases relatively and indicates a certain loss of sediment-mechanical strength. In accordance to  $q_t$ , these portions reveals low values of sleeve friction  $f_s$  (Figure 24). These portions are highlighted by orange-colored corridors in the plot (Figure 24). Pore pressure measurement indicates no zone of overpressure. High values of  $q_t$  coincides with significant loss of pore pressure. This is the typical signal for dilative shearing behaviour when the CPTu penetrates coarser-grained or overconsolidated sediment.

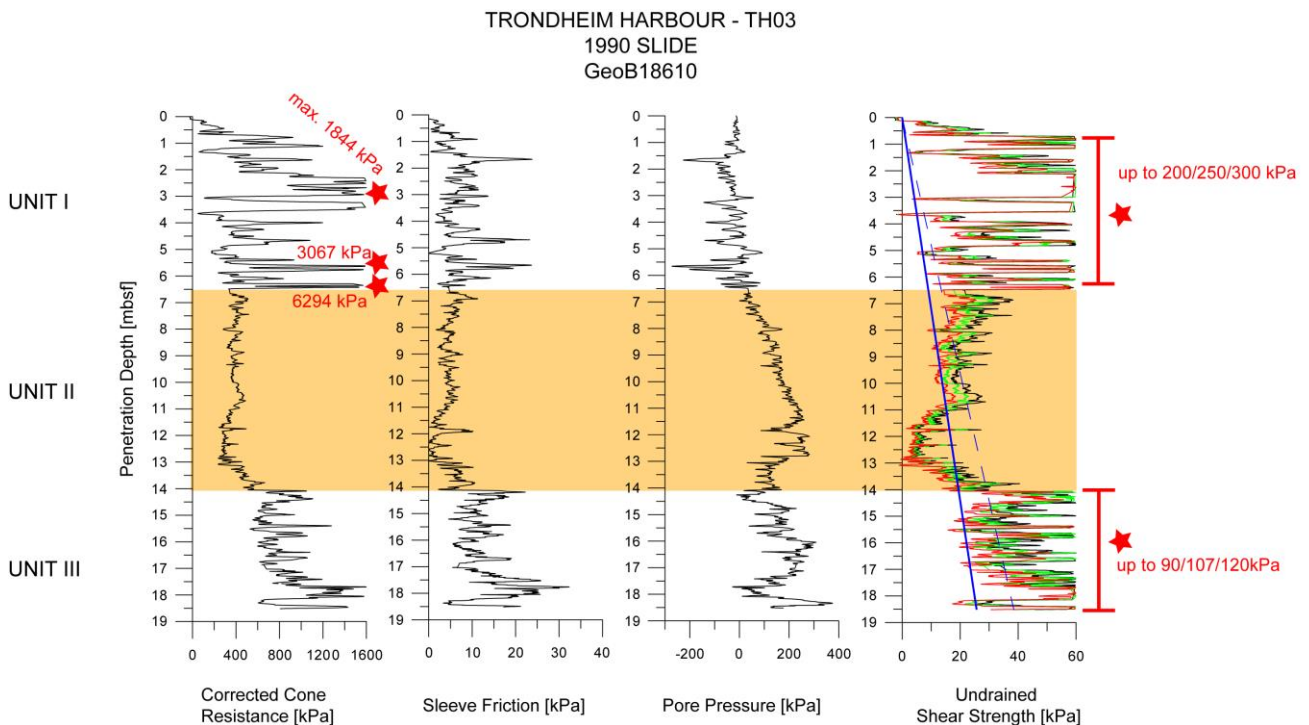
**Figure 25** Data plot of the static CPTu profile GeoB18610. Red-coloured stars mark data peaks, which have been clipped for better illustration. The number specify the value of the peak. Blue lines indicate the ratio of undrained shear strength over the depth of the profile (continuous line:  $s_u$  ratio = 0.2; dashed line:  $s_u$  ratio = 0.3, see Chapter 6.1.1))

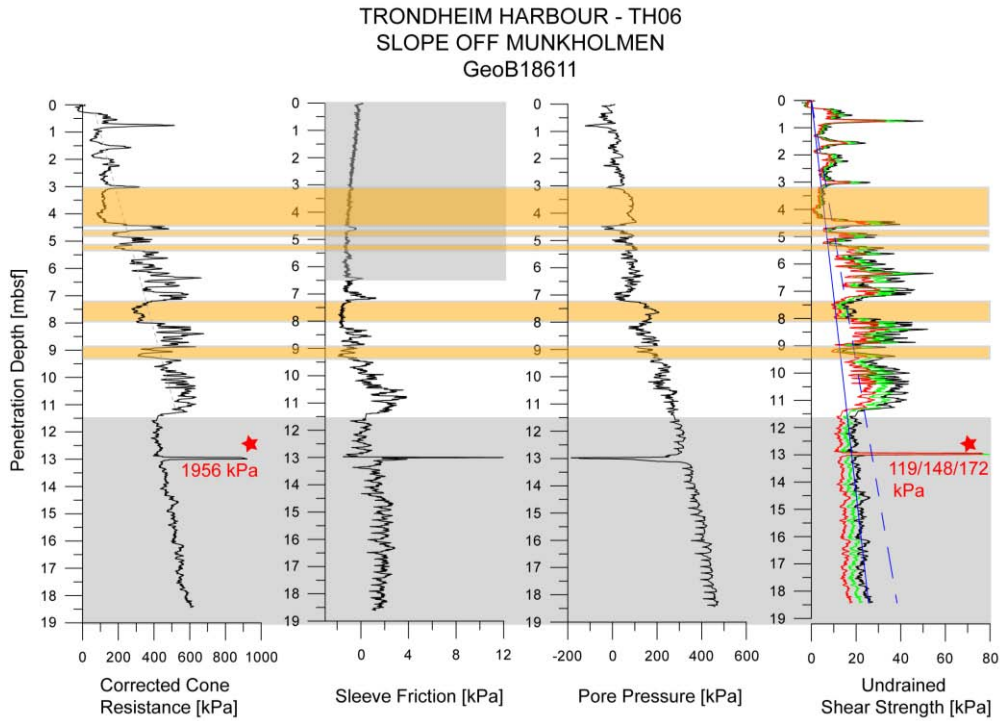
**Figure 26** Data plot of the static CPTu profile GeoB18611. Red-coloured stars mark data peaks, which have been clipped for better illustration. The number specify the value of the peak. Blue lines indicate the ratio of undrained shear strength over the depth of the profile (continuous line:  $s_u$  ratio = 0.2; dashed line:  $s_u$  ratio = 0.3, see Chapter 6.1.1))

CPTu profile GeoB18611 is located on a submarine terrace between the western flank of the Island Munkholmen and the Nidelva channel in the East (see Figure 23). Penetration depth was 18.5 mbsf. Penetration depth was 18.5 mbsf. Quality of the GeoB18611 data is limited: i) The tiltmeter recorded an inclination up to  $90^\circ$  in the upper section (up to 10 mbsf). But no bending or breaking of the rods has been observed. ii)  $q_t$ ,  $f_s$  as well as  $u$  show no reliable data underneath 10 mbsf (Figure 26). Cause for this data is not reproducible, as the GOST system worked well after recovery.

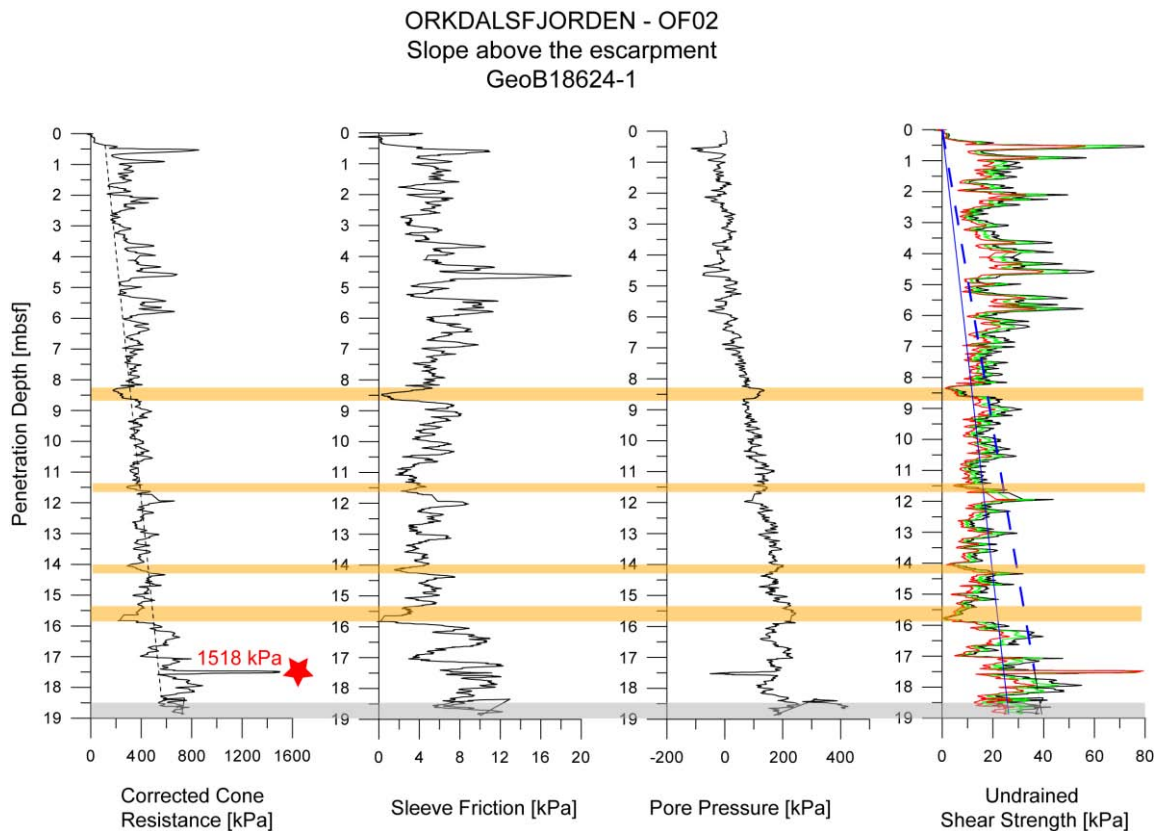
**Figure 30** Data plot of the static CPTu profile GeoB18624-1. Red-coloured stars mark data peaks, which have been clipped for better illustration. The number specify the value of the peak. Blue lines indicate the ratio of undrained shear strength over the depth of the profile (continuous line:  $s_u$  ratio = 0.2; dashed line:  $s_u$  ratio = 0.3, see Chapter 6.1.1). Orange-coloured bar represents mechanically relative weaker layers defined by decreasing  $q_t$ .

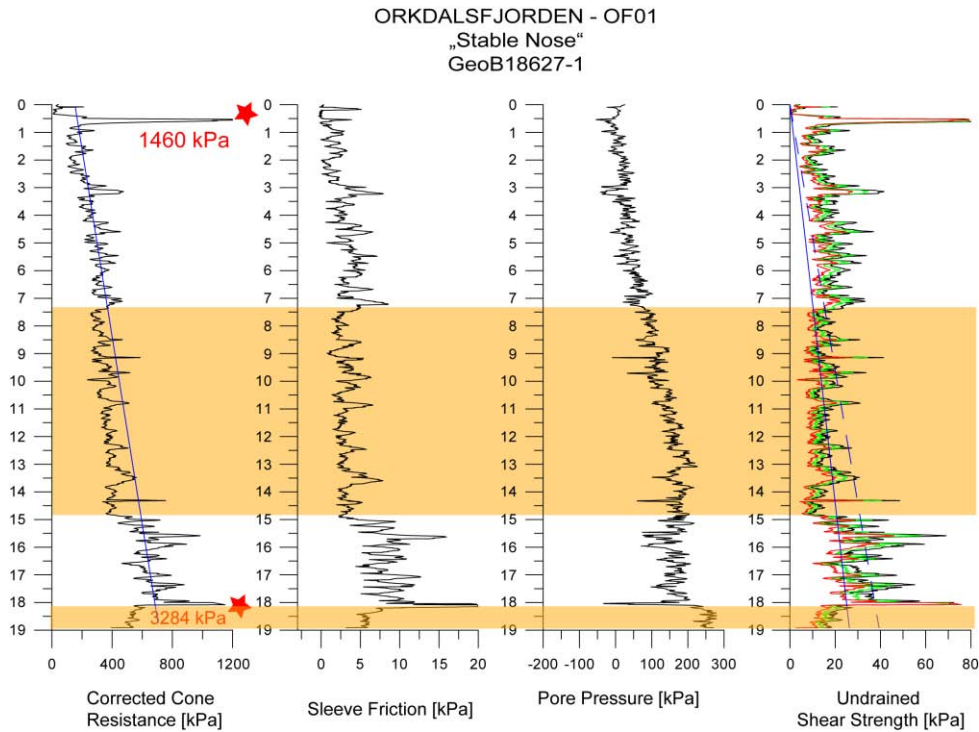
**Figure 31** Data plot of the static CPTu profile GeoB18627-1. Red-coloured stars mark data peaks, which have been clipped for better illustration. The number specify the value of the peak. Blue lines indicate the ratio of undrained shear strength over the depth of the profile (continuous line:  $s_u$  ratio = 0.2; dashed line:  $s_u$  ratio = 0.3, see Chapter 6.1.1)). Orange-coloured bar represents mechanically relative weaker layers defined by decreasing  $q_t$ .

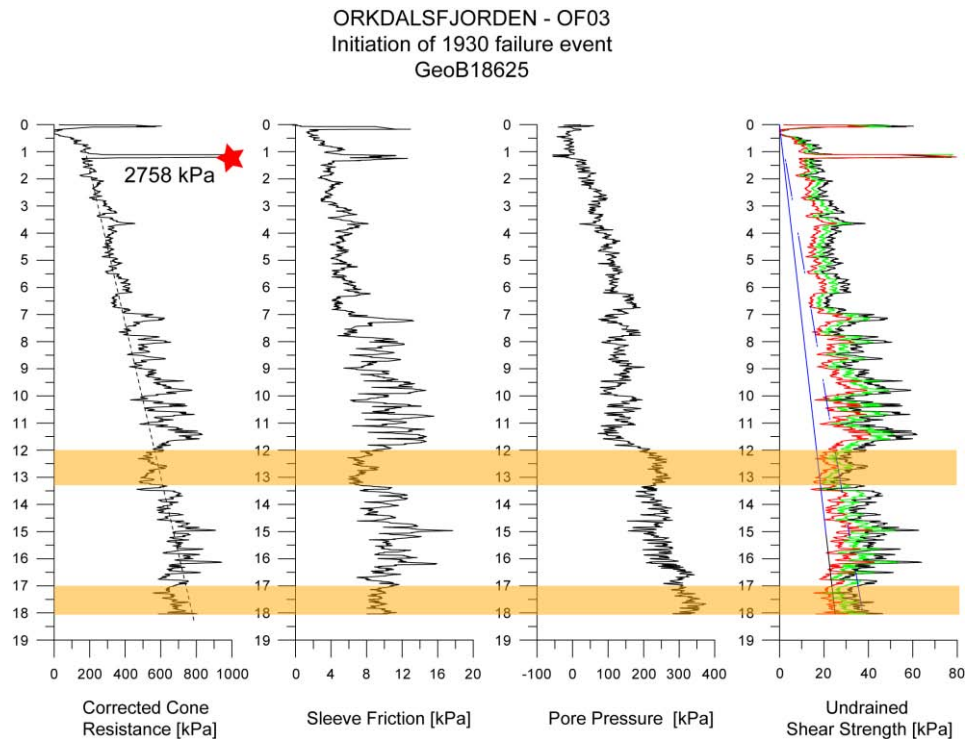
**Figure 32** Data plot of the static CPTu profile GeoB18625. Red-coloured stars mark data peaks, which have been clipped for better illustration. The number specify the value of the peak. Blue lines indicate the ratio of undrained shear strength over the depth of the profile (continuous line:  $s_u$  ratio = 0.2; dashed line:  $s_u$  ratio = 0.3, see Chapter 6.1.1)). Orange-coloured bar represents mechanically weaker layers defined by decreasing  $q_t$ .

Profile 18625 is located at OF3, where the initial failure occurred and sediments were mobilised (see Figure 29 and L'Heureux et al. 2014). Here, we reached a sedimentary portion of sediment underneath the sliding surface with a thickness of 8 m (Figure 32). Pore pressure can be used to distinguish between different units (Figure 32). In the upper 12 mbsf pore pressure increased slightly or remained constant. In deeper strata the general trend of pore pressure increased significantly (Figure 32).

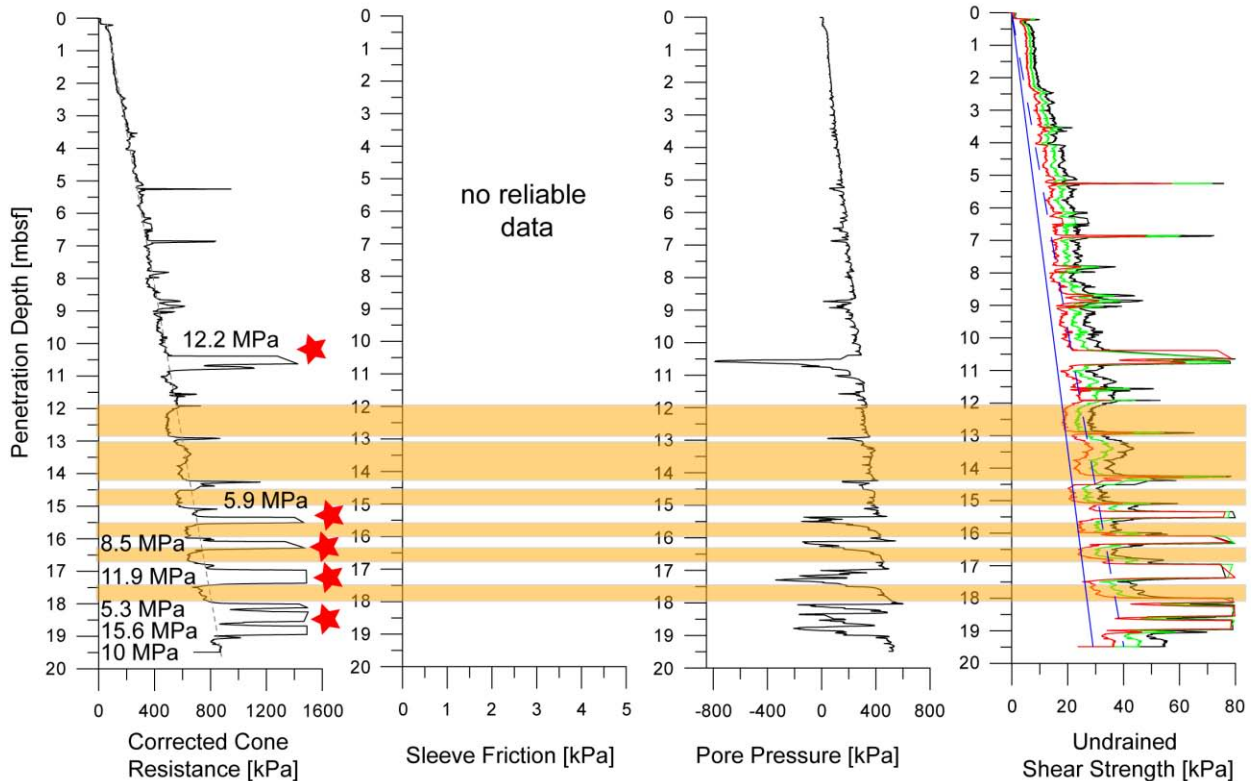
**Figure 36** Data plot of the static CPTu profile GeoB18638. Red-coloured stars mark data peaks, which have been clipped for better illustration. The number specify the value of the peak. Blue lines indicate the ratio of undrained shear strength over the depth of the profile (continuous line:  $s_u$  ratio = 0.2; dashed line:  $s_u$  ratio = 0.3, see Chapter 6.1.1))
