Stone weathering under Mediterranean semiarid climate in the fortress of Nueva Tabarca island (Spain)

To appear in: *Building and Environment*

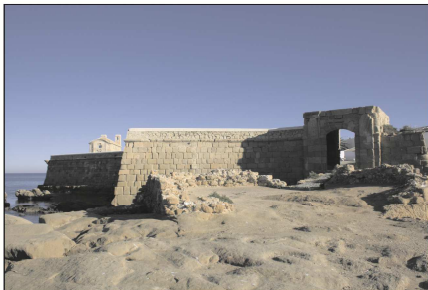
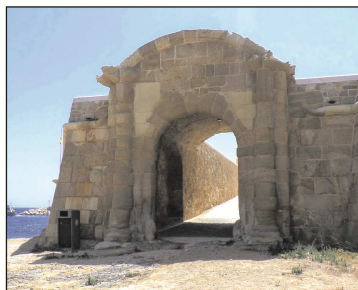
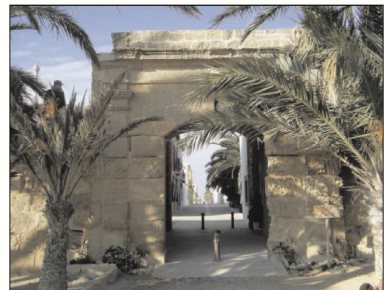
Western entrance
San Gabriel city-wall door

Northern entrance
San Miguel city-wall door

Eastern entrance
San Rafael city-wall door
