# Failure mechanisms in sensitive volcanic soils in the Tauranga Region, New Zealand

A thesis submitted in partial fulfilment  
of the requirements for the degree

**Master of Science (Earth Sciences)**

**Philippa Mills**

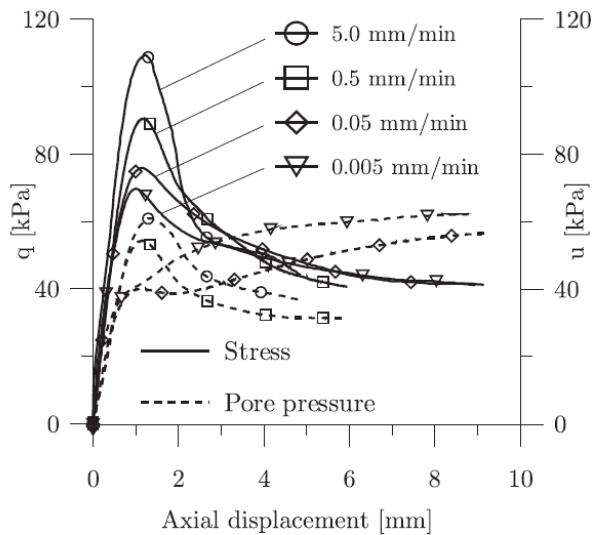
**Figure 2.14.** Results from the base-sled testing show that for increased displacement rate, the peak shear strength is higher and the softening response is greater (Gylland *et al.* 2014).

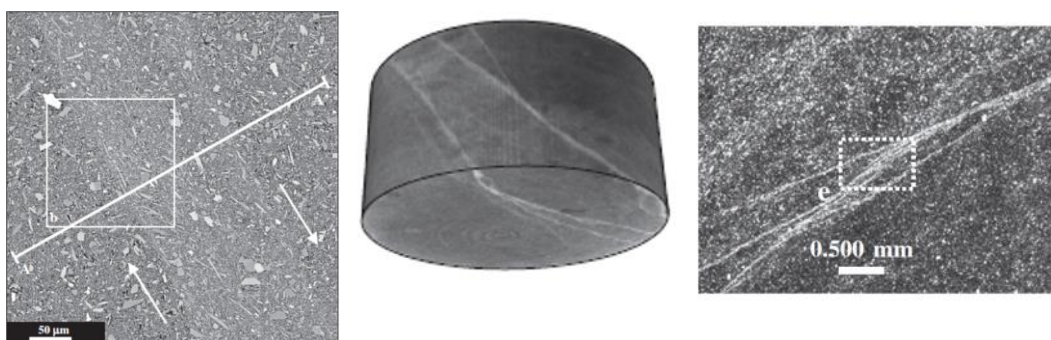
**Figure 2.15.** (a) (left) shows reoriented materials locally in the shear zone and (b) (middle & right) shows densification of material locally in a shear zone (Gylland *et al.* 2013a, b).

Microstructural analysis using thin section and micro-CT (Gylland *et al.* 2013b, c) techniques gave strong evidence that strain softening and progressive shear band formation is governed by excess pore pressure. Micro-CT scans showed that material contracted locally within shear bands (shown by densified clay regions in **Figure 2.15b**), meaning pore pressure must have been released from densified pores (**Figure 2.15b**) and (**Figure 2.15a**) grains were reoriented along the shear bands, providing a preferential pathway for excess pore pressure to drain along.

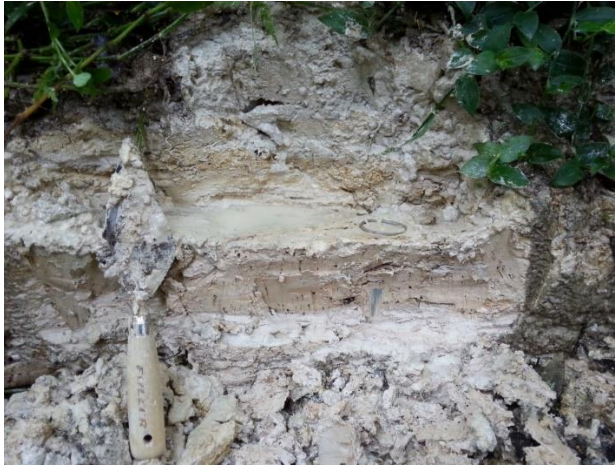
**Figure 3.1.** An example of a bench dug into a sensitive layer. Triaxial and bulk density push tubes were gently hammered into the profile from a vertical direction.

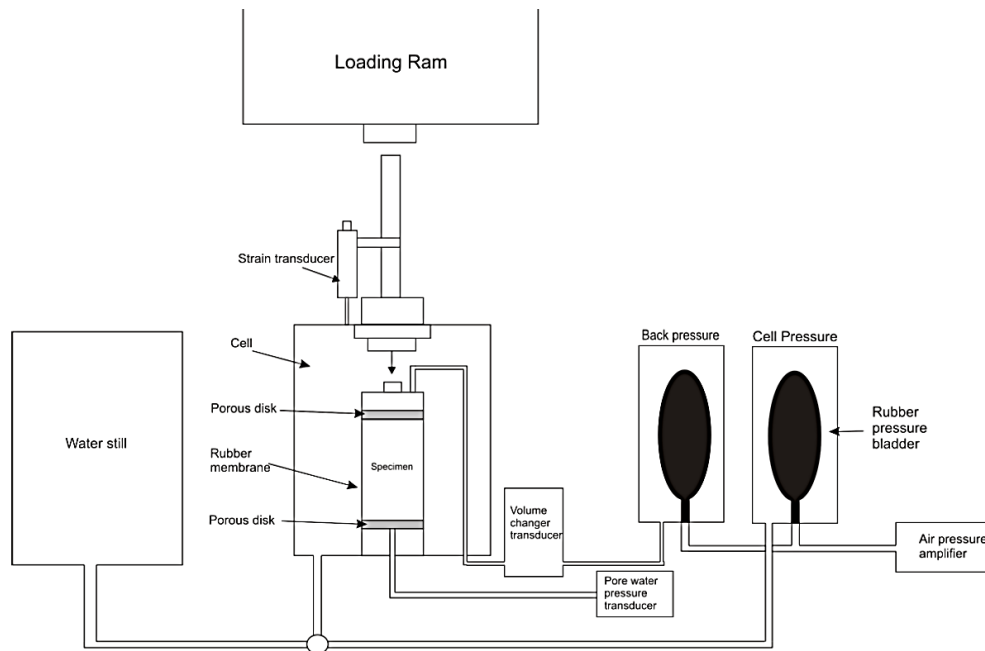
**Figure 3.2.** A simplified view of the triaxial set-up. Figure: Cunningham, 2012.

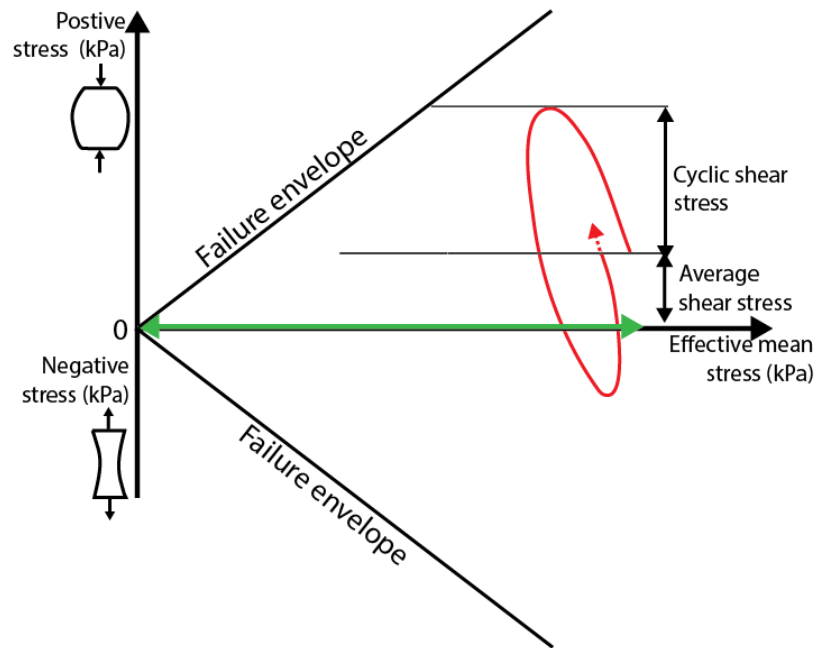
**Figure 3.5.** A schematic of the stress path plot of deviator stress vs effective stress ( $p'$ - $q'$ ) for a cyclic triaxial test with small average shear stress application and slightly larger cyclic shear stress application. Eventually the cycles move to the left as effective stress is lost and the failure envelope is reached. Figure adapted from Anderson, 2015.

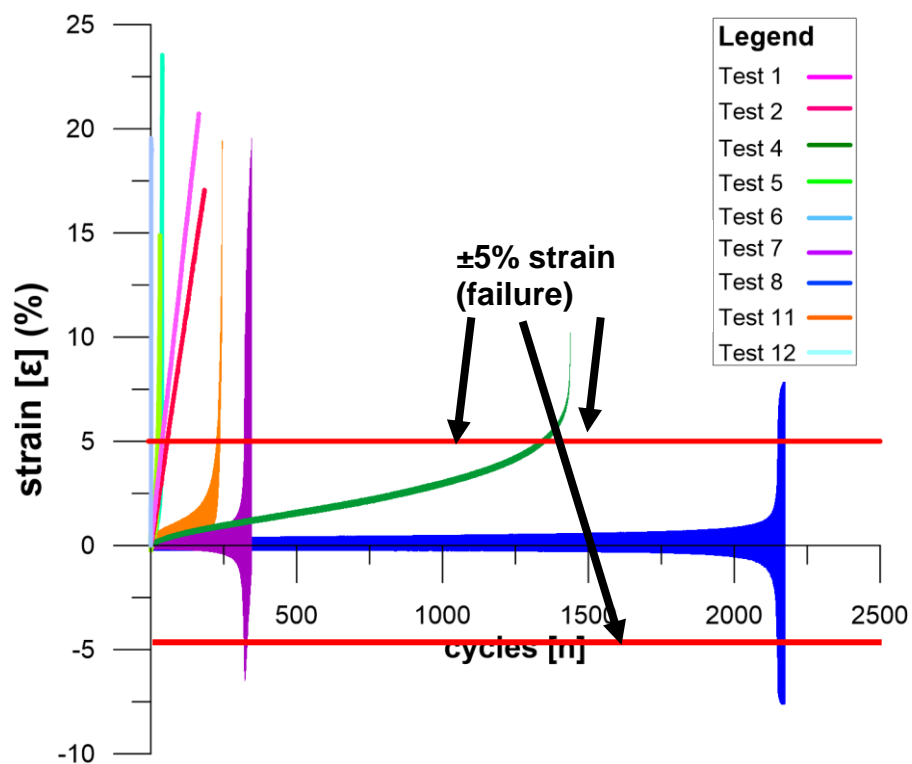
**Figure 3.6.** Strain vs cycles for all valid tests in this thesis. Failure is defined as 5% for all tests.

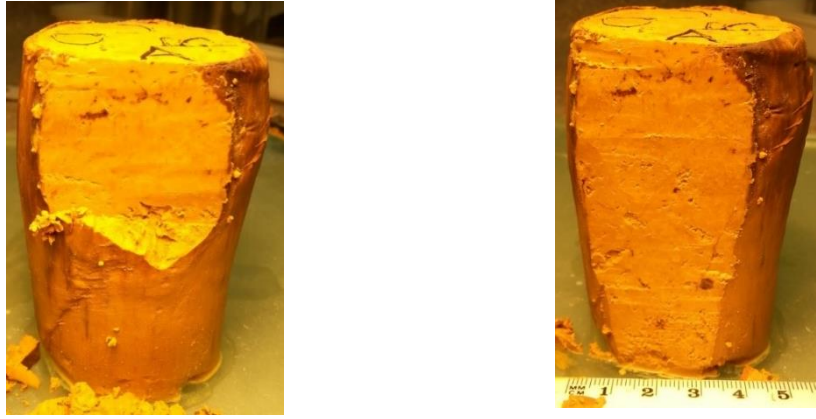
**Figure 3.8.** Omokoroa (240 kPa) post-failure, showing the cut failure surface exposing the shear zone.

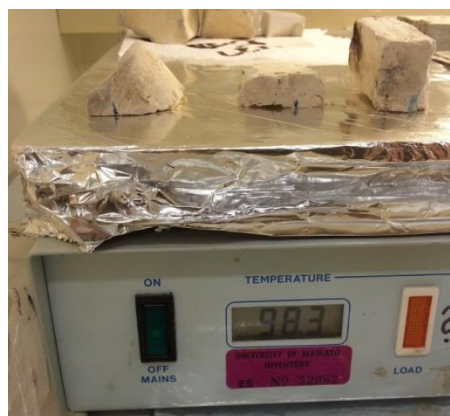
**Figure 3.9.** The dried block heating up on the hot plate prior to impregnation of resin. Heat allows the resin to permeate deeper into the sample.

- a) Dried blocks were very carefully placed on aluminium foil on a hot plate at 60 - 70° so that the soil could heat up to allow the resin to easily impregnate (**Figure 3.9**).
- b) Nuplex KI36 hardener and resin was used as it was low enough viscosity to impregnate the sample surface. 2 parts resin by 1 part hardener was slowly mixed on a hot plate to avoid entrapping air (**Figure 3.10**). Once a homogeneous colour was achieved, the mixture was deemed ready to begin applying.
- c) The resin was applied to the failure surface evenly with a wooden spatula. It was also applied to the sides of the specimen in order to preserve the quality of the dried specimen. Care was taken to ensure the surface was topped up with resin. Once the resin stopped absorbing into the sample, excess resin was wiped off the surface.
- d) The resin was then left to cure overnight at 60° on the hot plate;

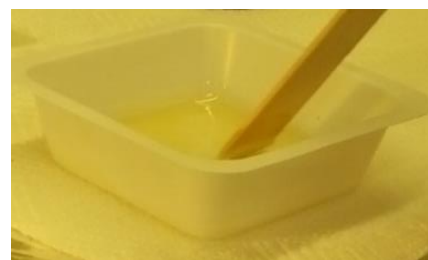
**Figure 3.10.** The hardener and resin mixture was applied to the failure surface.

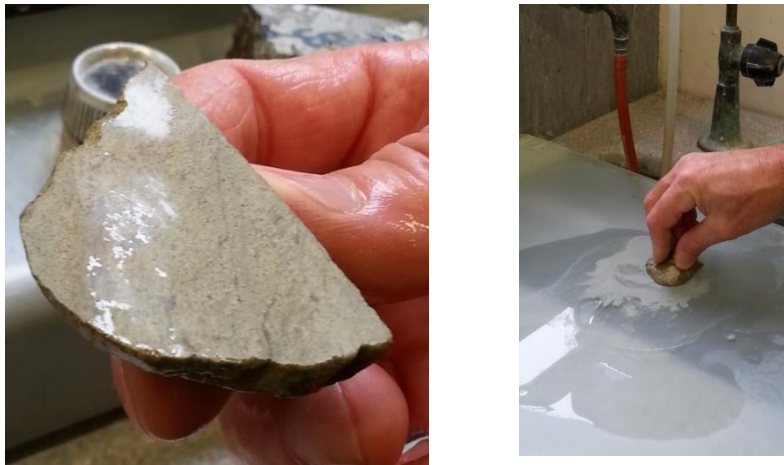
**Figure 3.11.** Excess resin is ground off using a slurry of grinding powder and water, so that an even coating of resin is visible on the surface.

- a) The surface coating of resin on the failure surface was removed by grinding it face down in a slurry of grinding powder and water on a glass plate (**Figure 3.11**). The sample was checked every 30 seconds to a minute by running the sample under water, drying it, and checking under light to see if resin still remained. Grinding continued until a matte surface was achieved and no resin was on the sample surface;

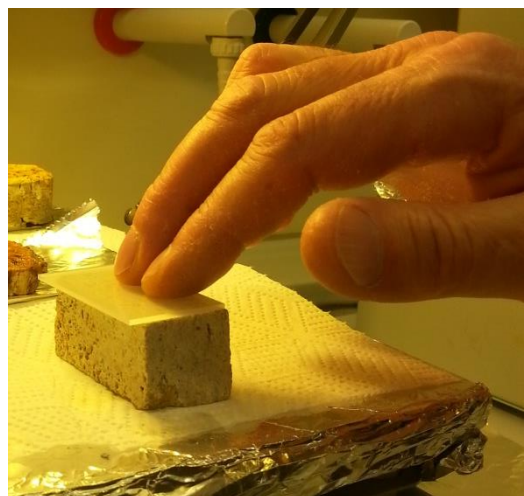
**Figure 3.12.** The frosted slide was out face down and moved in a circular motion to remove air bubbles between the sample and the slide.

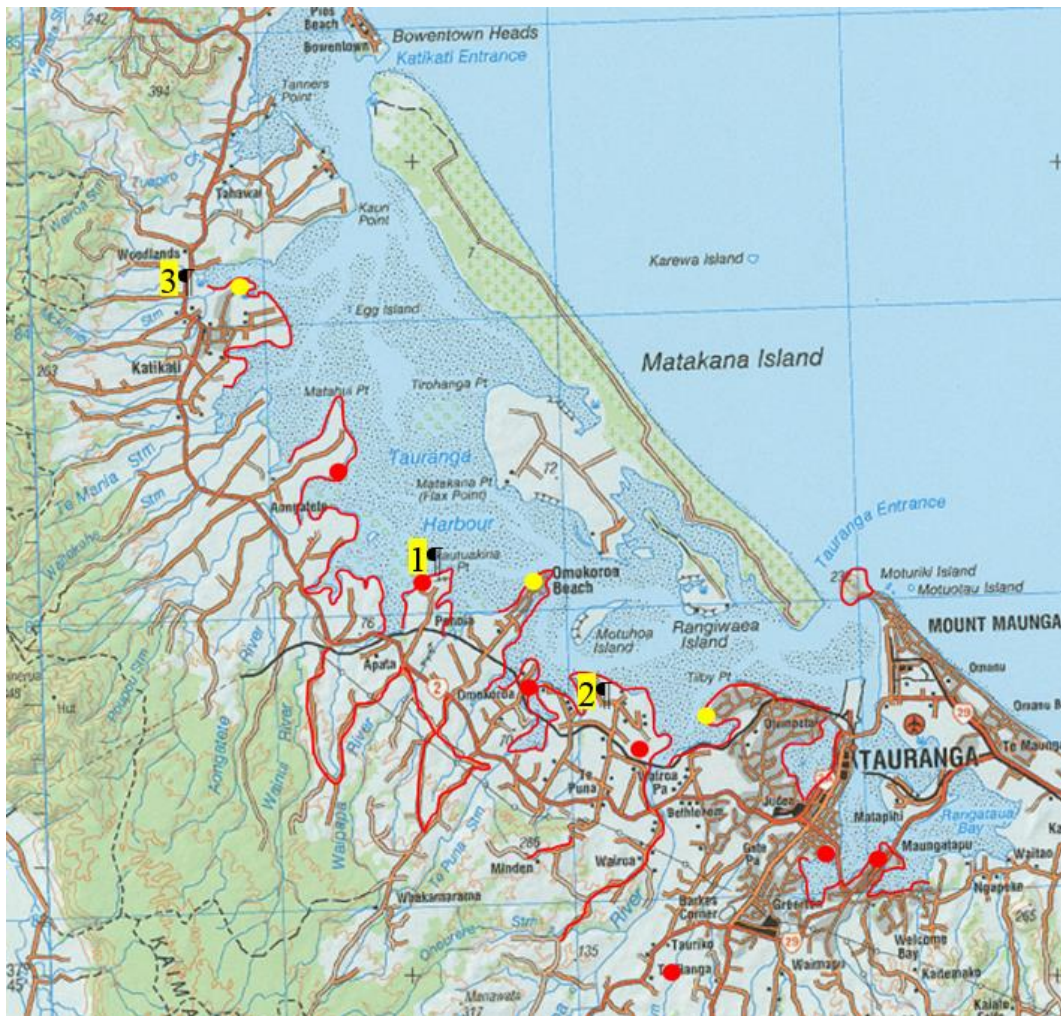
**Figure 4.1.** Sites explored in the Tauranga Region. Outlined red indicates peninsulas which were walked around. Red dots include face exposures tested with a shear vane. Yellow dots are the three sites chosen: Katikati (3) Omokoroa (1), and Matua (2).

exposures. Peninsulas explored are outlined in red in **Figure 4.1**, and included Maungatapu, Matua, Tauranga CBD, Te Puna, Plummers Point, Omokoroa, Pahoia, and exposures at the end of Turner Road, Prestidge Road, Walker Road, Sharp Road, Matahui Road, Park Road, Beach Road, Whakamarama Road, Youngson Road, Waipapa Block Road, Esdaile Road, and Plummer Road.

Three sites were chosen on the criteria suitability of each site. These were Bramley Drive at Omokoroa, (37°37'48.11"S 176° 2'43.99"E) Rewarewa Place at Matua (37°40'20.84"S 176° 6'57.28"E), and the public reserve at the end of Park Road in Katikati (37°32'14.45"S 175°56'2.24"E) (**Figure 4.1**). Field investigations at site three were carried out, but no geomechanical tests were done because it was not a landslide site. Site investigation information is presented in **Appendix 4.2**.

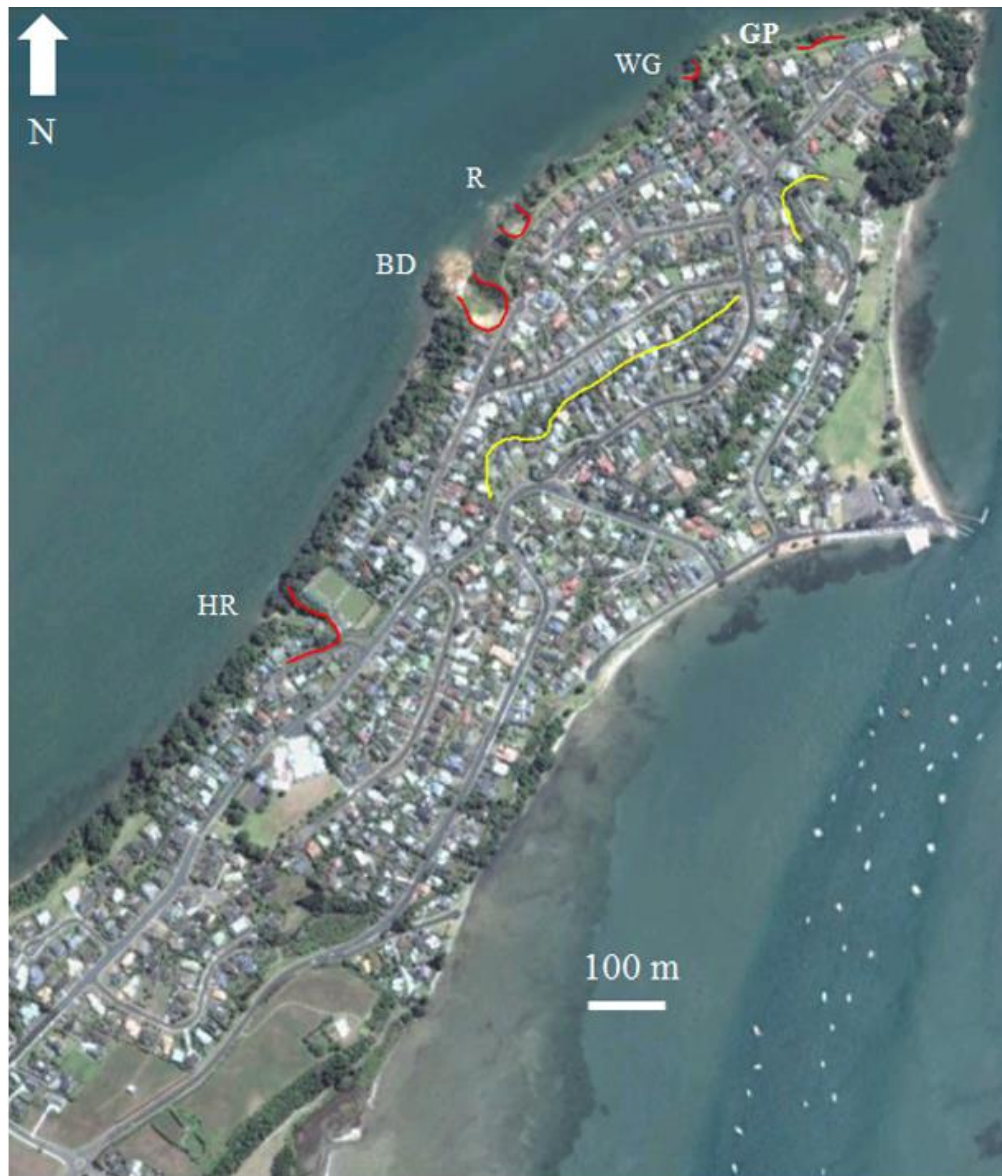
**Figure 4.2.** An aerial view of Omokoroa (2015, GoogleEarth), and respective landslide scarp locations. Historic landslides, including Bramley Drive (BD), Ruamoana Place (R), Hamurana Place (HP), Walnut Grove (WG), and Gerard Place (GP) are outlined in red. Inferred relict landslip scarps are outlined in yellow, after Christophers (2015).

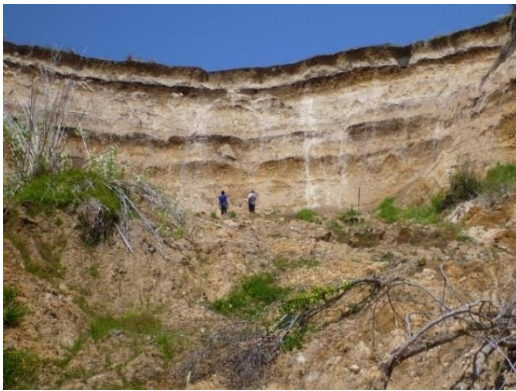
**Figure 4.4.** The exposed back scarp following the 2011-2012 events. Photo: Vicki Moon.

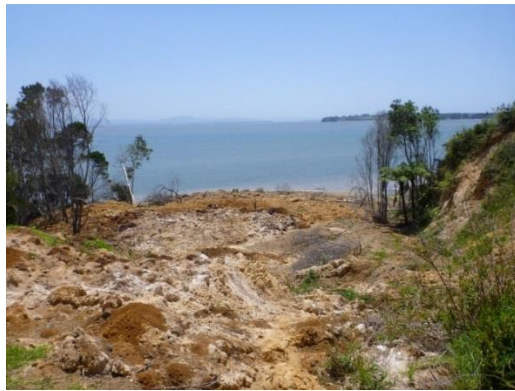
**Figure 4.5.** The remoulded debris lobe from the 2011-2012 events. Photo: Vicki Moon.

the headscarp (Tonkin and Taylor, 2011) (**Figure 4.5**). The landslide is classified as a sensitive clay rotational slide (Hungry *et al.* 2014). Features created that indicate slumping include the bowl shaped scar in the cliff, and the largely intact “block” of material overlying the sensitive remoulded debris. Geomorphic indications of sensitivity included the exceedingly long (150 m) runout distance of the sensitive material (Gulliver & Houghton, 1980). Sensitivities of up to 140 were measured during the geotechnical investigation following the slide (Gulliver & Houghton, 1980).

Approximately 3500 m<sup>3</sup> of remoulded material from both events inundated the bowl of the landslip, covering most of the original remoulded material, with the exception of a vegetated area of original 1979 remoulded material on the south side (**Figure 4.5**). The reworked nature and deposition of material at a distance approximately 100 m from the cliff edge shows that sensitive materials have contributed to flowsliding, however to a lesser degree than the 1979 event (Moon *et al.* 2013). The 2011-2012 landslips exposed a bench around 25 m depth which is believed to be the weakly – non welded Te Puna Ignimbrite (**Figure 4.7**).

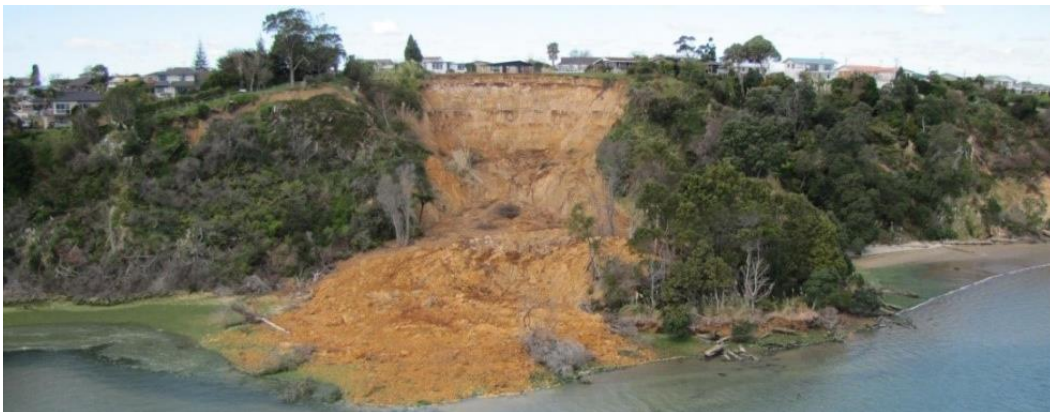
**Figure 4.6.** Bramley Drive failure viewed from the Harbour. Photo: Peter Clarke.

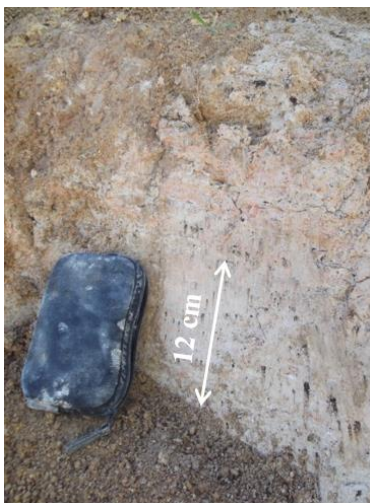
**Figure 4.8.** The Silty CLAY Pahoia Tephra tested at SS1, with a small digital camera bag for scale.

OM2 is defined as a Silty CLAY, with low plasticity, minor manganese inclusions and moderate weathering, as indicated by limonite staining in **Figure 4.8**. Shear vane results confirmed the soil was in the sensitive range (5 - 8) according to NZGS (2005) (**Appendix 4.3.3**). The soil also smeared and hands were left slightly damp upon remoulding between fingers. However, when gently hammering in metal triaxial cores, it was found that the soil fractured. The soil was therefore

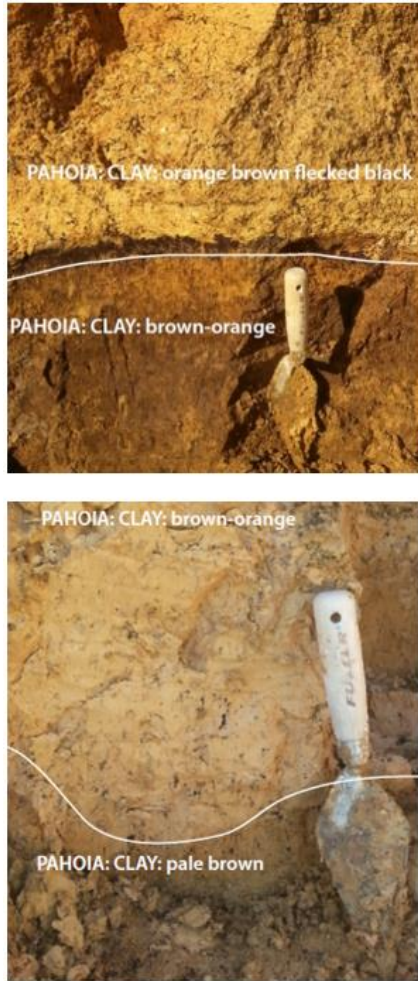
Graphic log	Depth (m)	Unit description	Consistency	Moisture condition	Vane shear (kPa)
					<small>⊙ Remoulded</small> <small>⊗ Peak</small>
	0.5	PAHOIA: CLAY: high plasticity, orange-brown flecked black, with some fine grained sand, sensitive, minor manganese inclusions.  0.795 m: high concentration manganese layer 0.005 m thick	St	Moist	
	1.0	PAHOIA: CLAY: high plasticity, brown-orange, sensitive, minor manganese inclusions.			
	2.0	PAHOIA: CLAY: high plasticity, pale brown, sensitive.

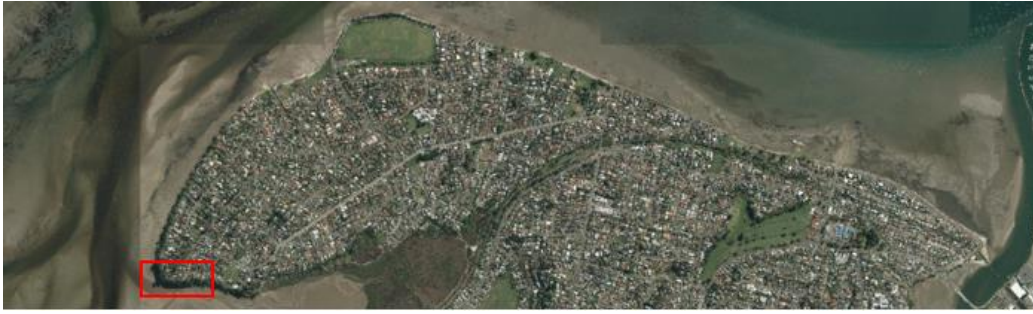
**Figure 4.11.** Matua Peninsula aerial 2015. The area investigated is outlined in red and shown below in Figure 4.12 Photo: <http://gismob.tauranga.govt.nz>

Matua Peninsula is a marine terrace within the Tauranga City margins (Briggs *et al.* 1996) (**Figure 4.11**), with a gently undulating surficial gradient, which abruptly transitions into steep coastal cliffs, which wrap around the peninsula. These coastal cliffs range from 10 – 20 m high. The site investigated is on the southern side of Matua peninsula, where the cliff height ranges between 18-20 m (**Figure 4.11**). The site lies to the south of a peak at 23 m (**Figure 4.12**).

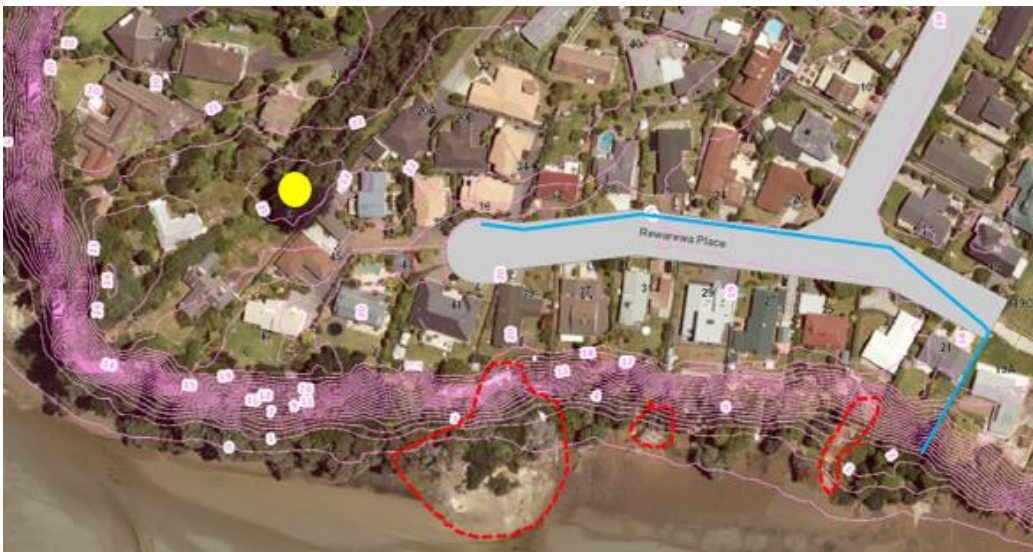
**Figure 4.12.** Aerial photo taken in 2015 of the south side of Matua Peninsula, with overlain 1 m contours. Several landslides occurred following heavy rainfall in 2012 (red outline), including the largest one studied in this thesis. Storm water drains at the eastern end of Rewarewa Place, as outlined in blue. The yellow circle indicates the peak at 23 m. Photo: <http://gismob.tauranga.govt.nz/>

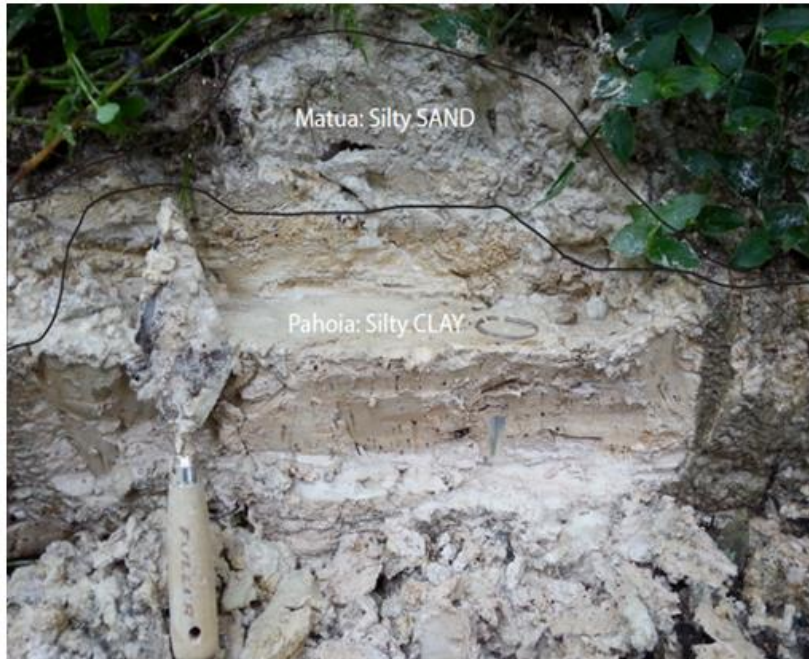
Graphic log	Depth (m)	Unit description	Consistency	Moisture condition	Vane shear (kPa)		
					1	2	3
	0.0 - 0.35	Silty SAND: fine - coarse grained, grey-white  0.35 m: becoming grey-white-orange	loose	saturated	10	10	10
	0.35 - 1.0	Silty CLAY: low - medium plasticity, pale pink-white-grey, with minor fine - coarse sand, with some manganese inclusions (5 - 50%), with minor fine rootlets, sensitive.	firm-stiff		10	10	10

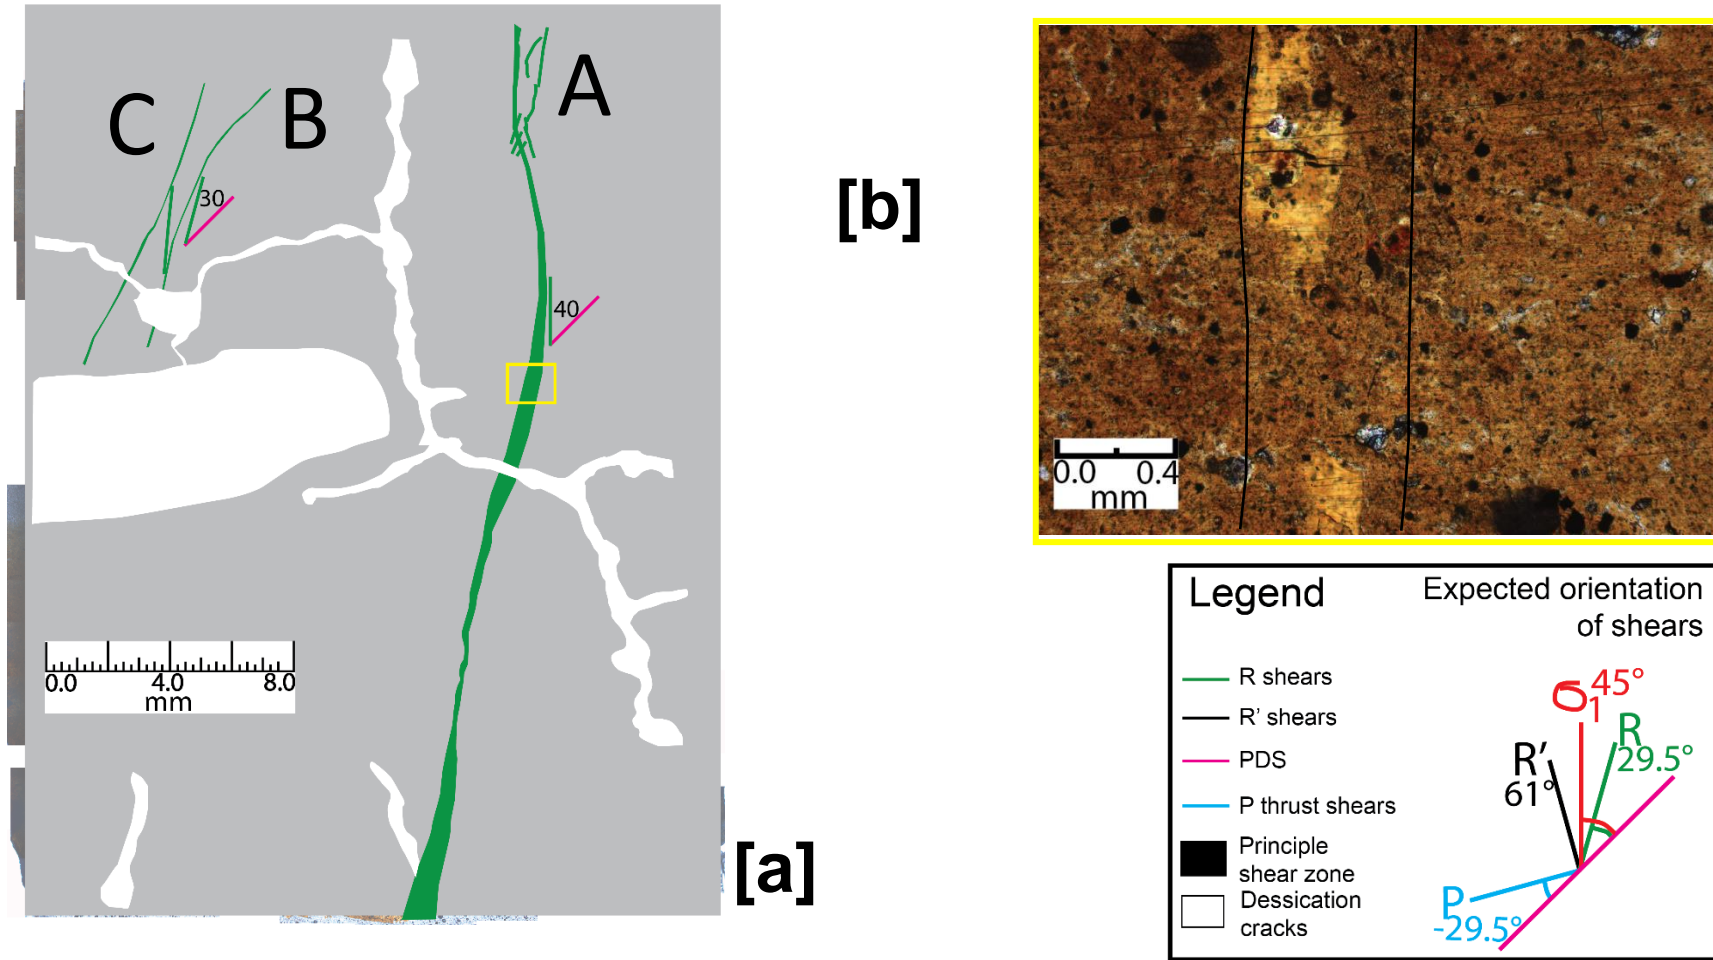
**Figure 6.10.** [a] Shears observed in thin section 4 (top of OM1b3) and their measured orientations, compared with expected orientations (outlined in the legend). The three PSZ's are outlined as A, B and C. Figure 6.10 [b] shows where shear zone A has sheared a clay coated mineral.

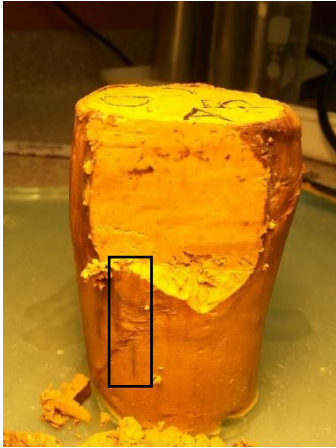
**Figure 6.19.** The location of the sub-sample of the failure surface for OM1b3.

The location of the sub sample of the shear zone in OM1b3 captured by the hollow plastic tube for micro-CT scanning is shown in **Figure 6.19**. The soil was classed into four density zones as outlined in **Figure 6.21**; the densest material are particles suspended in a less dense matrix. Within this matrix are denser regions including the shear zones (dark blue), and less dense clay matrix (dark green and light green).

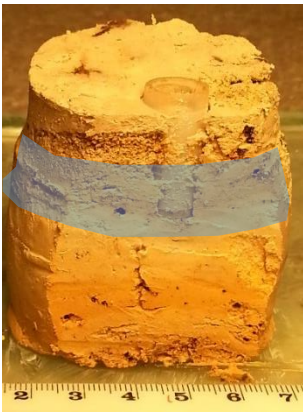
**Figure 6.28.** Location of the sub sample in M1d, with the PSZ shaded dark blue.

The location of the sub-sample taken from the sample is presented in **Figure 6.28**. Ring artifacts and poisson noise were also present in M1 scans. The material was comprised of material of four different densities. The densest particles (Class 1, **Figure 6.29**) were angular to subangular and sometimes platy, 25 – 250  $\mu\text{m}$ , and made up approximately 1% of the material. The distribution of these particles was much less consistent than dense particles in OM1. Evidence of weathering of these particles includes the gradation between more dense in the centre (bright pink) to less dense on the exterior of some particles, and in other particles the lack of dense material in the centre i.e. only the outer shell of the particle has been preserved.

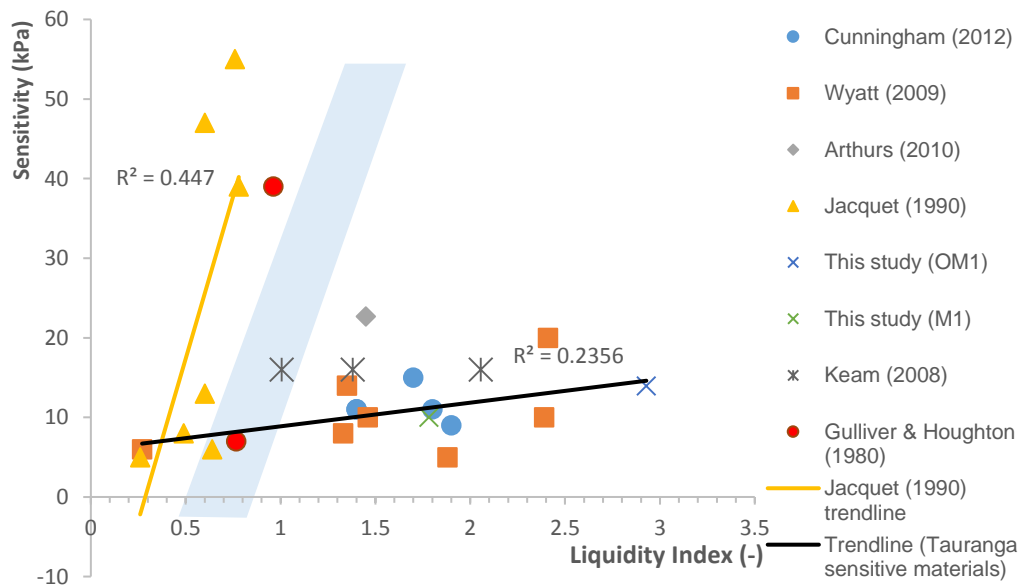
**Figure 8.4.** The relationship between sensitivity and liquidity index for both sensitive volcanic soils from NZ and Norwegian sensitive soils (shaded blue area) adapted from Rankka *et al.* (2004). A much sharper increase in liquidity indices with sensitivity occurs in Norwegian soils in comparison to most NZ sensitive soils. Four outliers of the trend from NZ are soils from Huntly and Taranaki, from Jacquet (1990), and one sample from Omokoroa (Gulliver & Houghton, 1980).
