Carbonation of indoor concrete : measurements of depths and degrees of carbonation

Fridh, Katja; Lagerblad, Björn

Carbonation of indoor concrete

Measurements of depths and degrees of carbonation

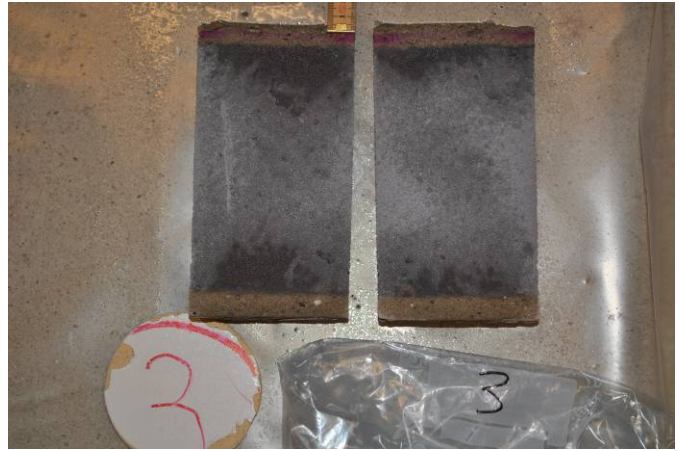
The wall thickness is 100 mm. This wall turned out to be of aerated concrete with mortar on the surface. The mortar was painted on one side and ceramic tiles were the surface material on the other side, figure 2.4.

Figure 2.3. Core 3: Inner wall.

The core was split just before applying the phenolphthalein. Only a thin line was seen 3-4 mm from the painted surface. The material seems completely carbonated from the other surface (with ceramic tiles). There is no documentation regarding if the tiles were applied directly after completion of the wall but it is believed that the tiles was applied a long time after the wall was built.

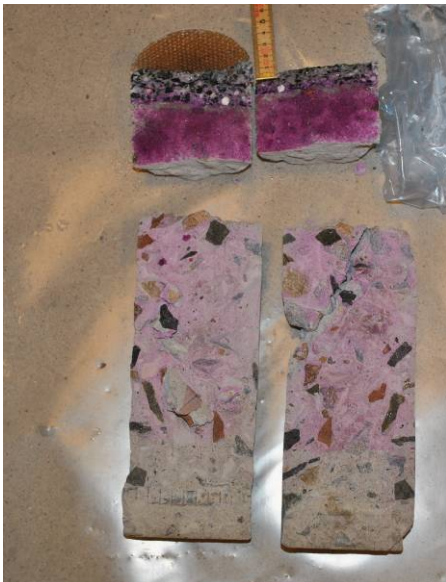
The construction component was 200 mm thick. The different layers were linoleum carpet, a concrete layer with smaller aggregates, and a layer with even smaller aggregates followed by more regular concrete and paint on the roof side, figure 2.8.

Figure 2.8. Core 6: Intermediate floor.

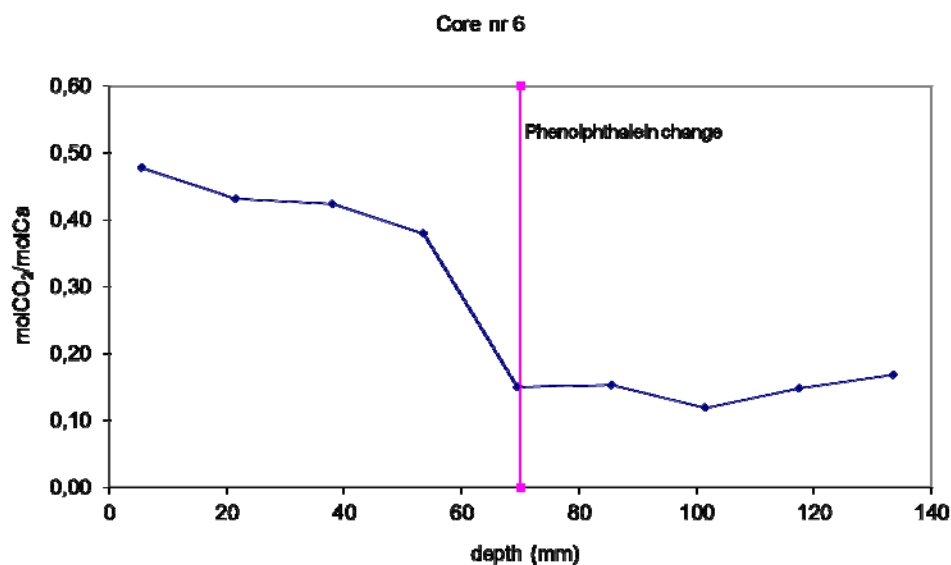
To investigate the degree of carbonation nine slices (11 mm each) were sawed from the concrete covered by paint on the roof side, figure 2.9.

Figure 2.9. Core 6: Degree of carbonation at different depths. Depth defined as the centre of each slice. From the painted surface and upwards towards the floor. The concrete contains some carbonate aggregate particles giving an apparent higher degree of carbonation.

The pH-change coincide with the drop in degree of carbonation just as (Möller, 1994) also found. For the first 60 mm is the degree of carbonation decreasing slowly from 0.49 to 0.40 and thereafter drop to 0.15 in just 11 mm. The degree of carbonation is fairly constant after that. One must however consider that the concrete contain some small carbonate aggregates and that this gives a higher degree of carbonation. Presumably the degree of carbonation in the interior of the concrete is close to 0 %. Thus the degree of carbonation at the surface is closer to 40 than 50 %.

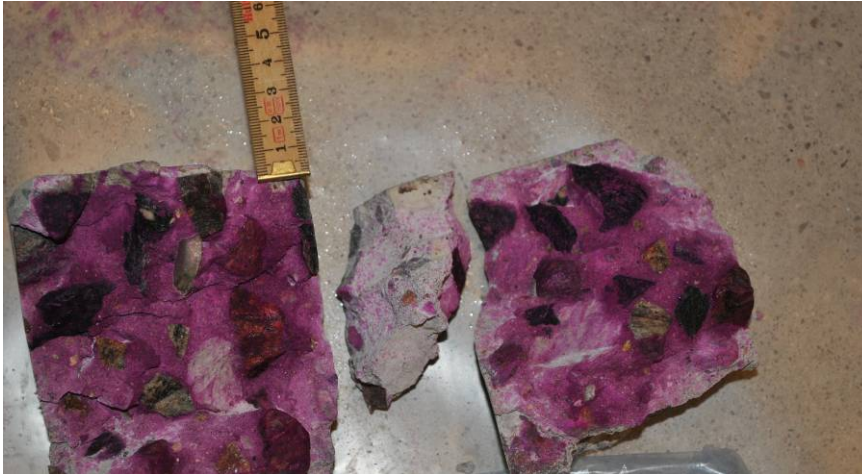
This core was taken from an external wall, figure 2.11, to be able to compare the different measurements from internal concrete with concrete exposed to outdoor climate. The core was 100 mm long and had no surface cover.

Figure 2.11. Core 7: External wall

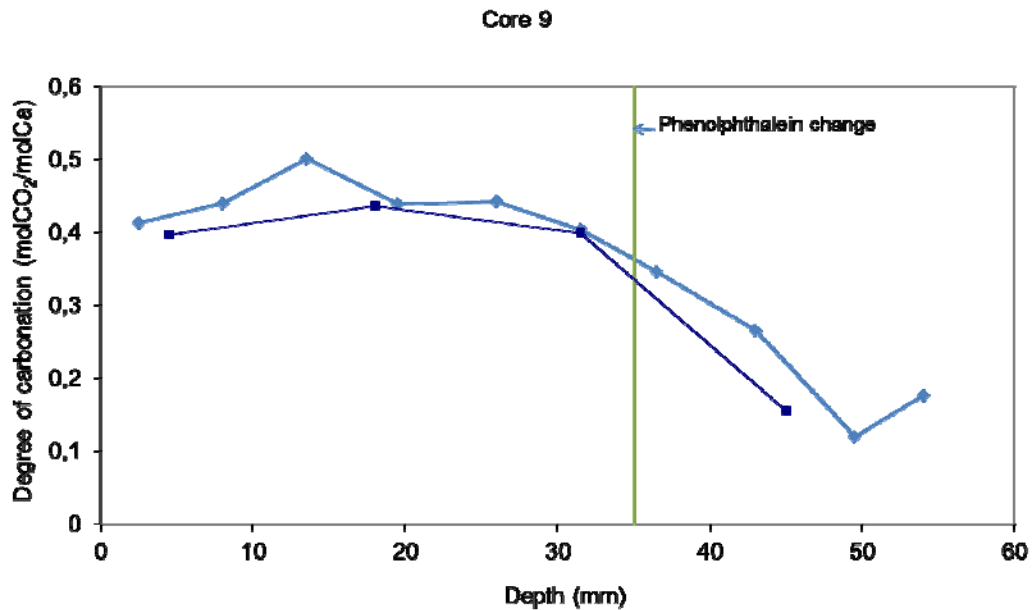
To investigate the degree of carbonation four slices (11 mm each) were sawed from one end of the core and ten slices (5 mm each) from the other end was investigated, figure 2.14.

Figure 2.14. Core 9: Degree of carbonation at different depths. Depth is centre of each slice and the figure shows two different measurements from opposite sides of the core.

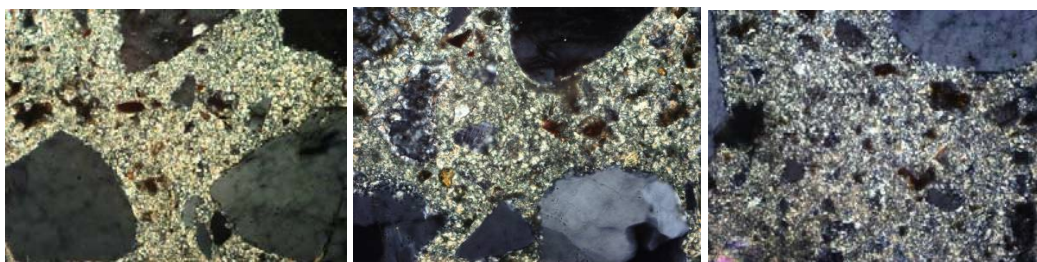
The concrete was completely carbonated about 30 mm, partly carbonated 15 mm and vaguely carbonated for the rest of the thin section (see figure 2.15) and the w/c equivalent was 0.60-0.65. Un-reacted cement grains are found in the entire sample. The fine aggregate contains some limestone particles.

Figure 2.15. Thin section pictures. Crossed polarizers. From the surface (left side) to a depth of 35 mm (right side). Pictures 0.3 mm. Carbonatisation can be observed by a lighter more yellow colour. From this it is possible to observe that the cement paste at the surface layer is much more carbonated than the interior.

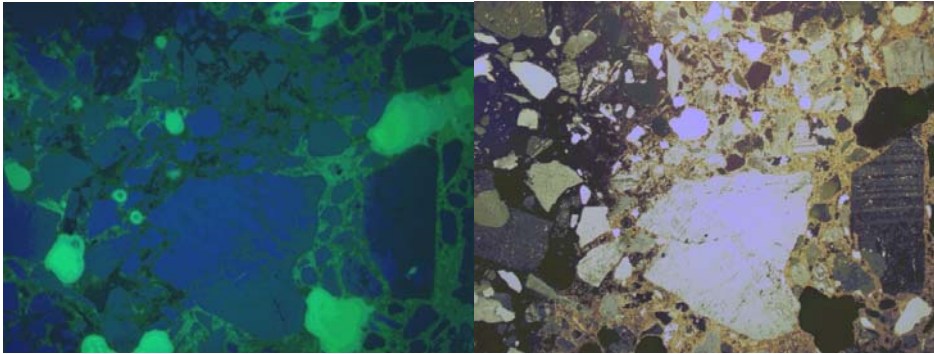
There is a thick layer of paint on the concrete. The concrete is rather porous and badly compacted. The carbonated cement paste has a more homogeneous paste than the uncarbonated. This can be seen in the thin sections when analysed in UV-light, figure 3.1. The lighter colour shows a larger amount of absorbed fluorescent dye and shows that the carbonated paste is more porous. The depth of carbonation

is 20 mm and the carbonated paste contains large amounts of remaining unhydrated cement grains.

Figure 3.1. Thin section pictures. On the left side with UV-light and on the right side with crossed polarisers. Carbonated paste on the right side. Picture is 5 mm.

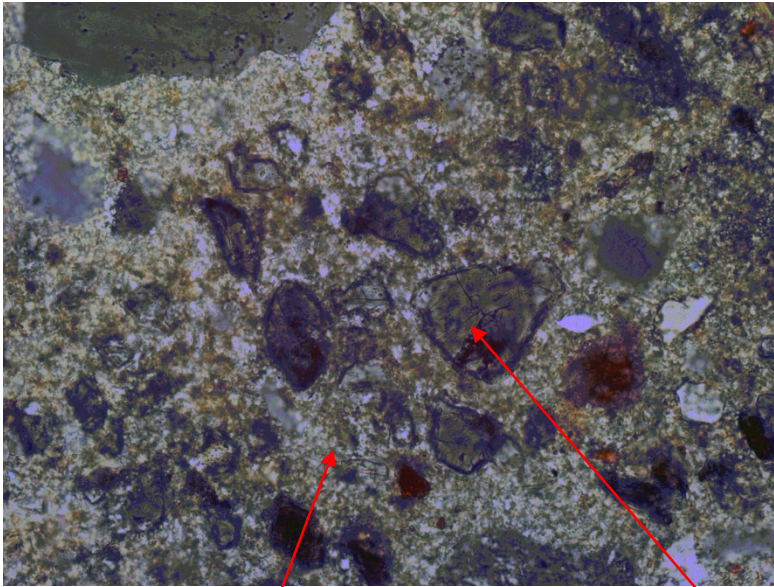
The depth of carbonation varies between 10 and 14 mm. The carbonated paste is more inhomogeneous than uncarbonated. The carbonated cement paste contains remaining cement grains, figure 3.2.

Figure 3.2. Carbonated cement paste with remaining unhydrated cement grains.

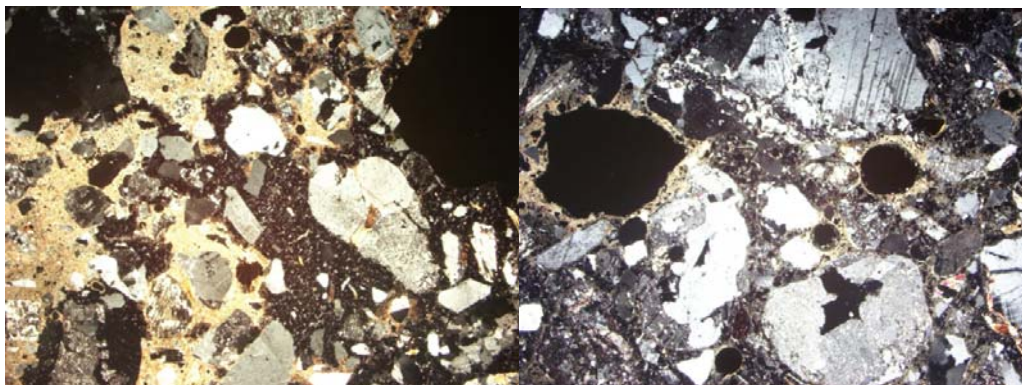
Thin section shows that the w/c equivalent in is 0.55-0.60, figure 4.1. No carbonation below the linoleum carpet. From below, above the capillarity breaking layer, the concrete is carbonated for 5 mm and partly carbonated another 5 mm. It is also possible to observe carbonation at the rim of air bubbles.

Figure 4.1. Thin section photos. Crossed polarisers. To the left, patchy carbonation front. To the right carbonation at air bubbles.
