**AUTOMATION OF RAILWAY SWITCH AND  
CROSSING INSPECTION**

**A thesis submitted to the University of Birmingham for  
the degree of DOCTOR OF PHILOSOPHY**

School of Electronic,  
Electrical and Systems  
Engineering  
University of Birmingham  
December 2015

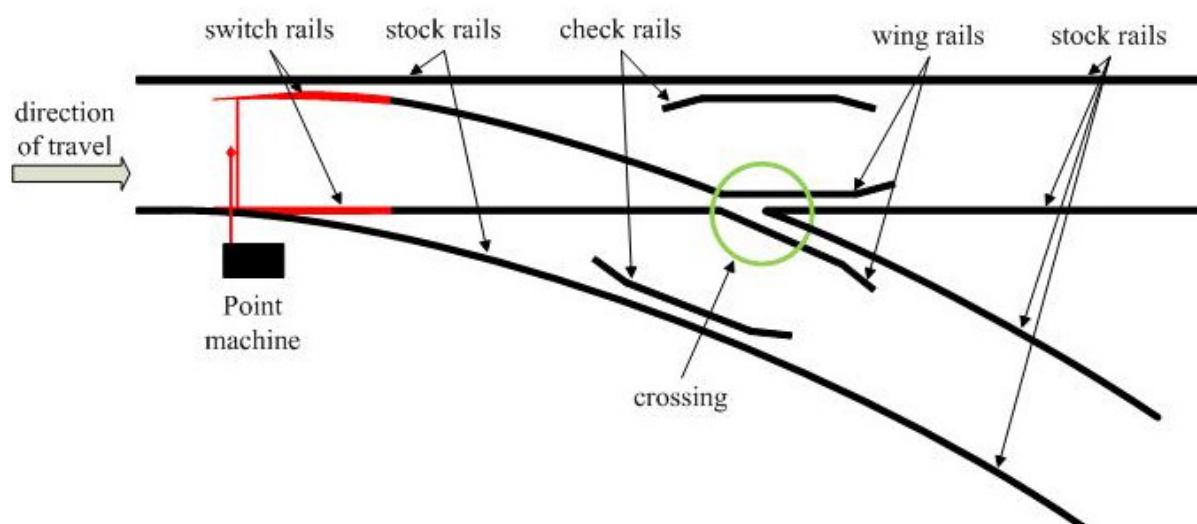
*Figure 1-1 Diagram of a common S&C design*

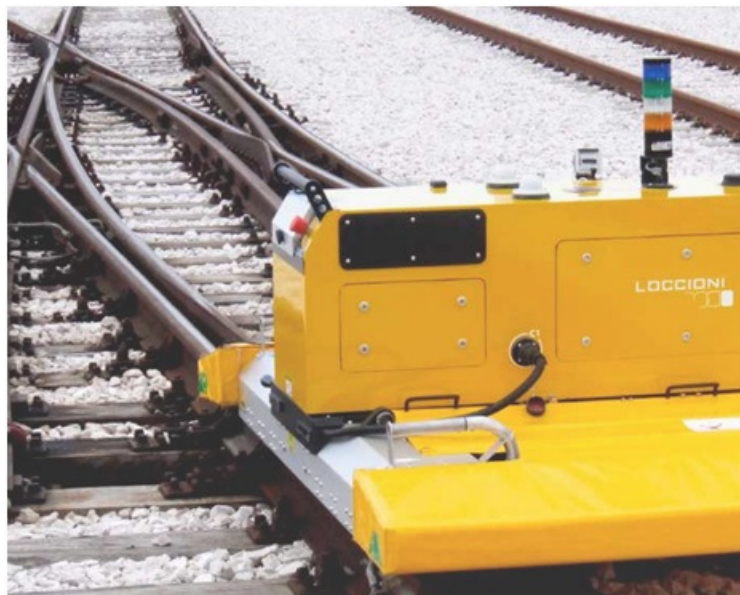
Loccioni, an Italian-based company founded in 1968, have developed an S&C inspection robot named FELIX [49]. The robot is capable of measuring the profile of rails (and crossing) as well as the geometry of the switch. The robot weights around 150 kg when assembled and the heaviest part when disassembled is 47 kg. Thus, it is brought to the railway site in parts and assembled there. The robot can be controlled remotely from a short distance and its autonomy is 6 hours. The measurements are taken at around 5 km/h.

*Figure 2-6 Felix robot  
Courtesy and Copyright Loccioni*

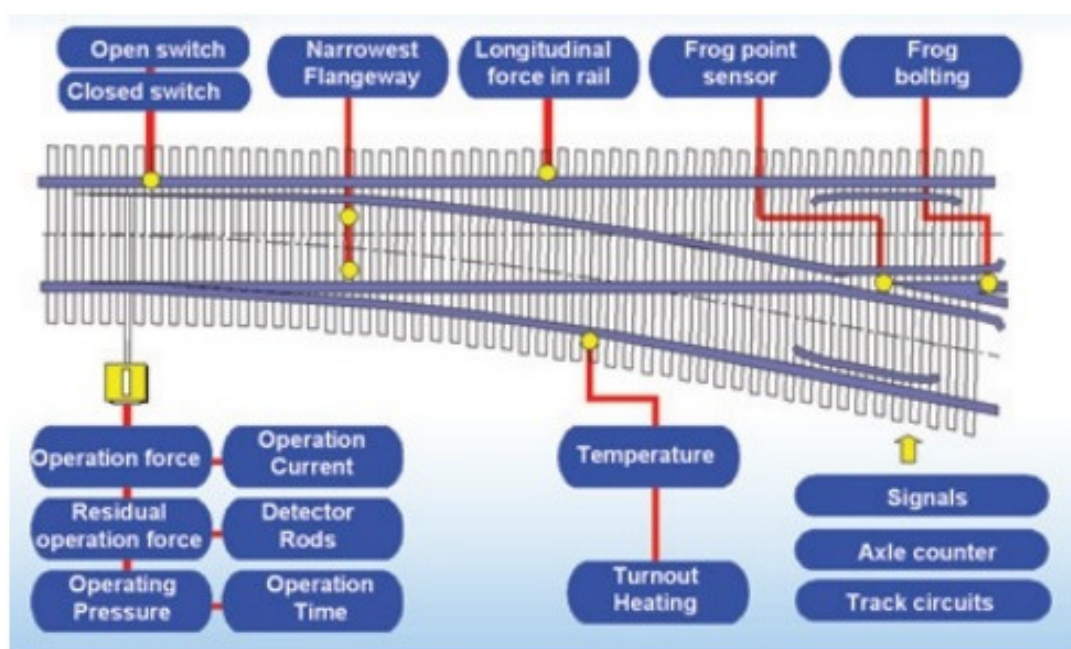
Voestalpine is a steel-based technology group operating on all five continents which developed an asset monitoring system called VAE ROADMASTER 2000. The system comes in three versions: light, advanced and pro. The pro system is able to monitor the condition of S&Cs through the installation of a wide range of sensors as shown in Figure 2-8.

*Figure 2-8 Voestalpine's switch monitoring capabilities  
Courtesy and Copyright Voestalpine*

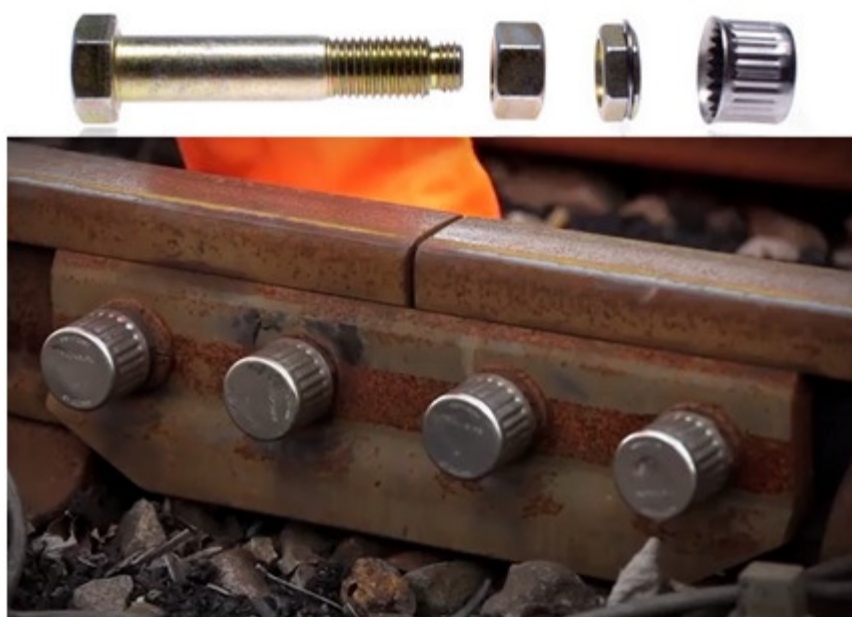
Wheelsure Holdings is a UK based limited company which supplies an innovative mechanical device for securing bolts. The device is based on the use of a reverse thread preceded by a normal one. Two nuts are fitted on the bolt and a cover forces them to rotate synchronously (i.e. in the same direction and same amount). The loosening of the nuts is achievable only when they rotate in opposite directions. For this to happen, significant damage has to occur (e.g. on the thread, cover, etc) making the mechanical device very resistant to loosening.

*Figure 2-10 Tracksure locking mechanism  
Courtesy and Copyright Wheelsure Holdings*

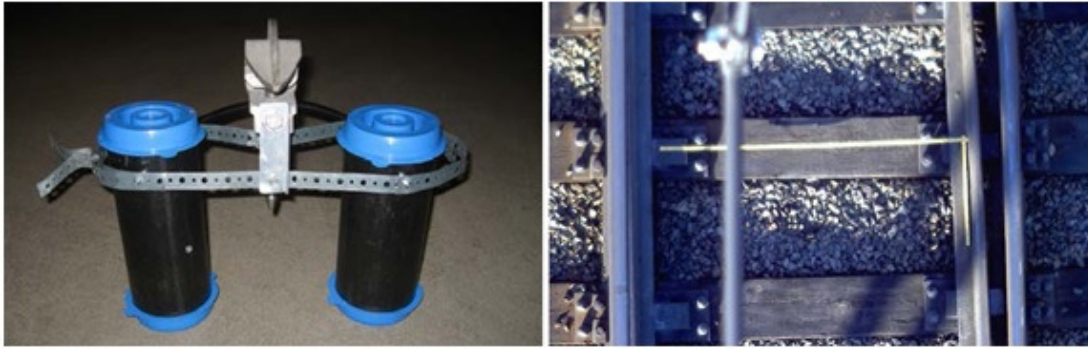
As a response to the need for S&C inspection, Asplund [55] considered the inspection of railway S&Cs using a fixed CCD camera mounted on the overhead line. He concluded that zoom and tilt capabilities are desirable in order to record good resolution footage of various parts of the S&C. The types of inspection tasks carried out by such a system are mostly visual, while measured inspection tasks are also possible depending on the performance of the camera. Measured tasks may include track gauge, flangeway gap, switch toe opening and residual switch opening.

*Figure 2-12 Overhead line mounted CCD camera prototype (left) and sample image (right)  
Courtesy and Copyright Matthias Asplund*

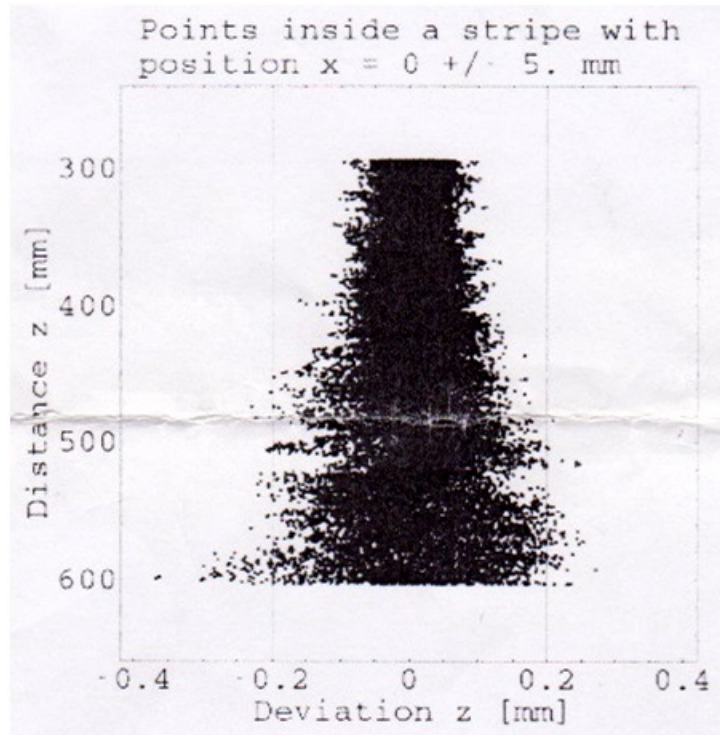
Figure 5-2 Z axis linearity errors of a scanCONTROL 2700-100(500) laser scanner

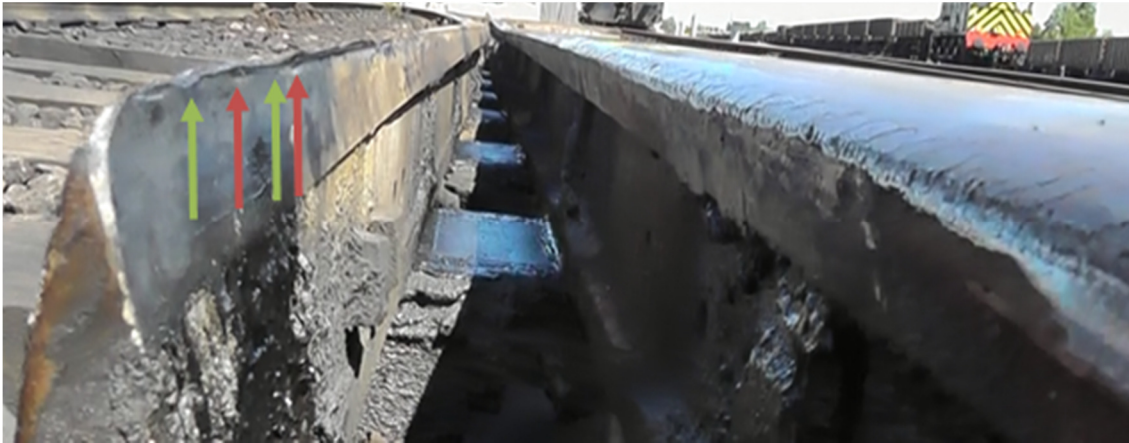
One surveyed switch was affected by derailment hazard 1 and was used to evaluate the algorithm. The switch is pictured in Figure 5-19 and Figure 5-20. Figure 5-19 shows the bent tip of the rail as well as the stock rail sidewear scar.

*Figure 5-19 A switch that failed Derailment Hazard 1 (photo 1)*

*Figure 5-20 A switch that failed Derailment Hazard 1 (photo 2)*

- Seven to eleven centimetres along the switch (first red arrow), the switch rail covers part of the sidewear scar and is visibly bent in Figure 5-19. The algorithm fails it with 2 to 3 mm
- Twelve to fifteen centimetres along the switch rail (second green arrow), the switch rail has a low height but Figure 5-19 shows that its tip is slightly bent. The algorithm fails it with 1 to 2 mm
- Seventeen centimetres along the switch (second red arrow), the switch shows one of the most pronounced failures. The algorithm fails the area with almost 5 mm of excessive height difference.

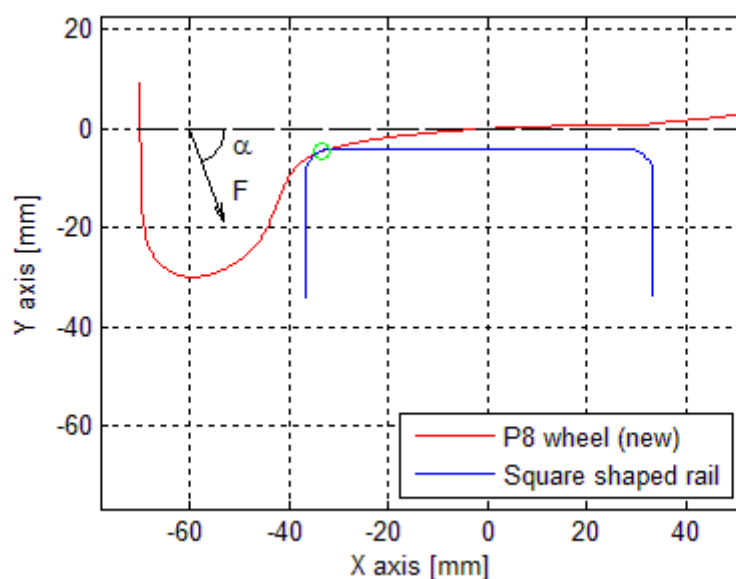
Figure 5-31 Fitting example for a square shaped rail using the 20 degrees criterion (to scale)

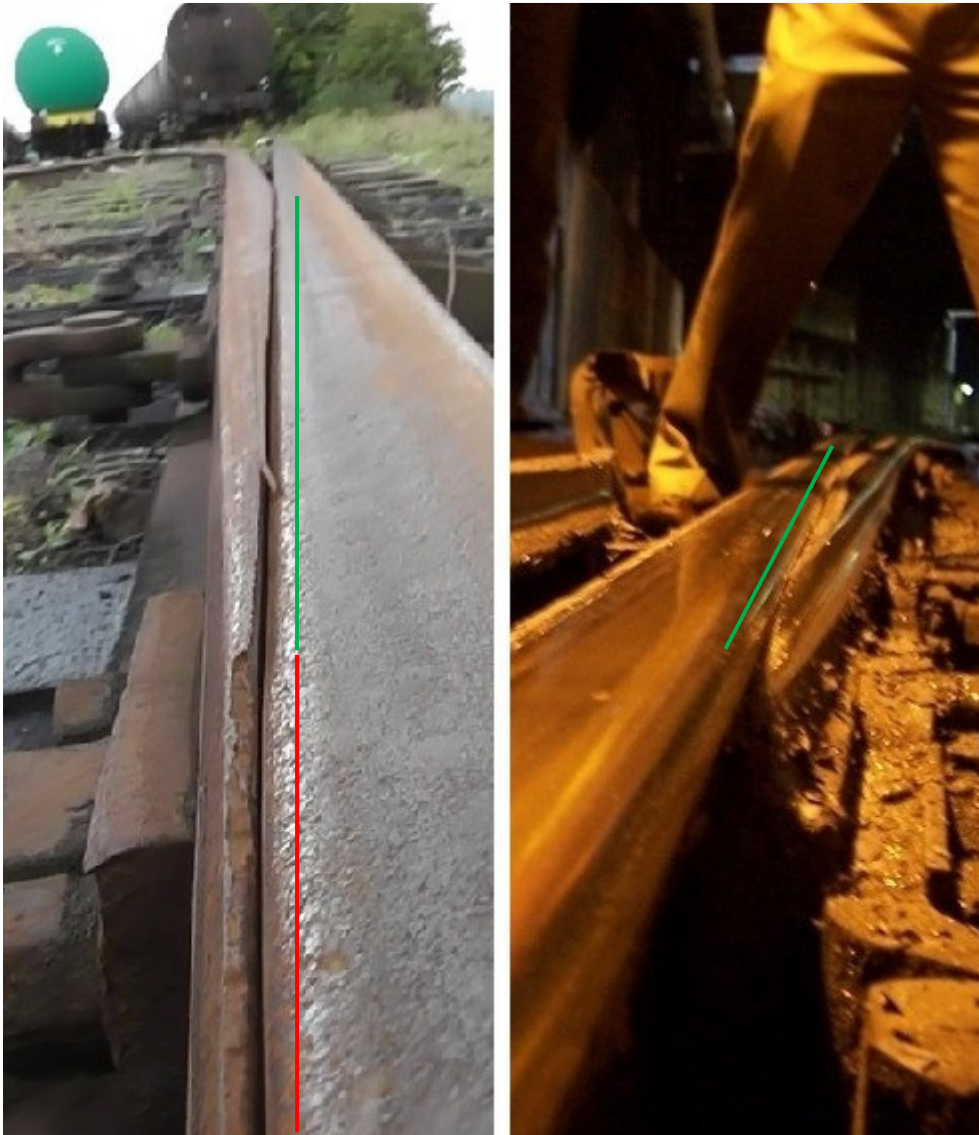
*Figure 5-38 Example of damaged switch rail (photos 3 and 4)  
right: Courtesy and Copyright Joss Apps*

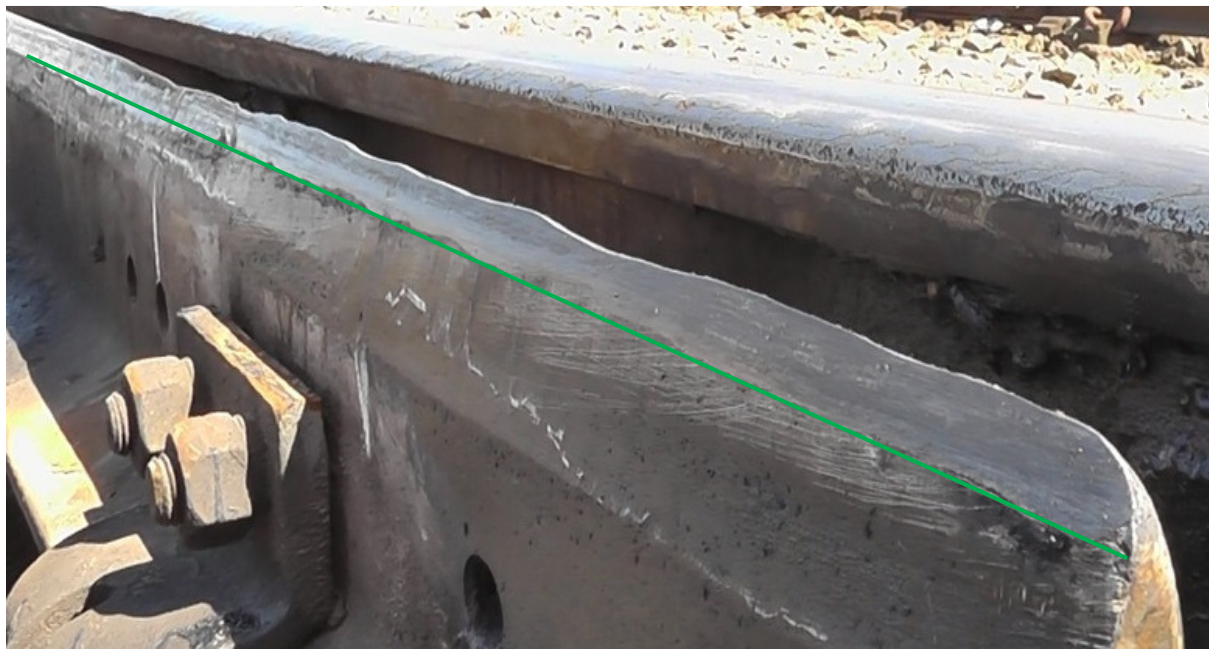
*Figure 5-41 Example of damaged switch rail (photo 7)*

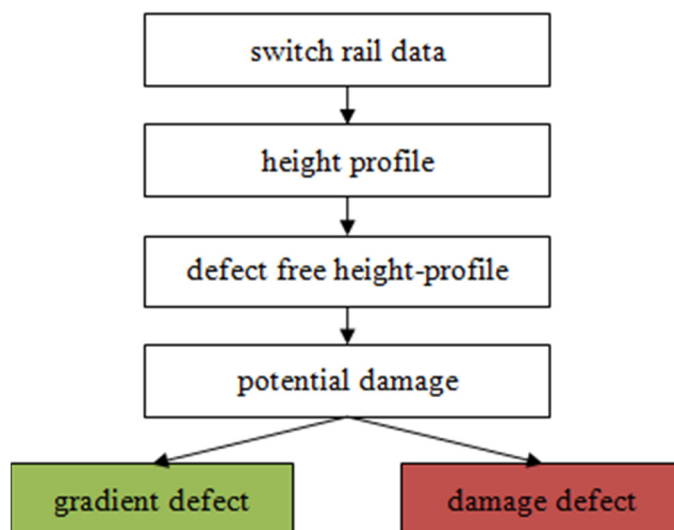
Figure 5-42 Damage identification process

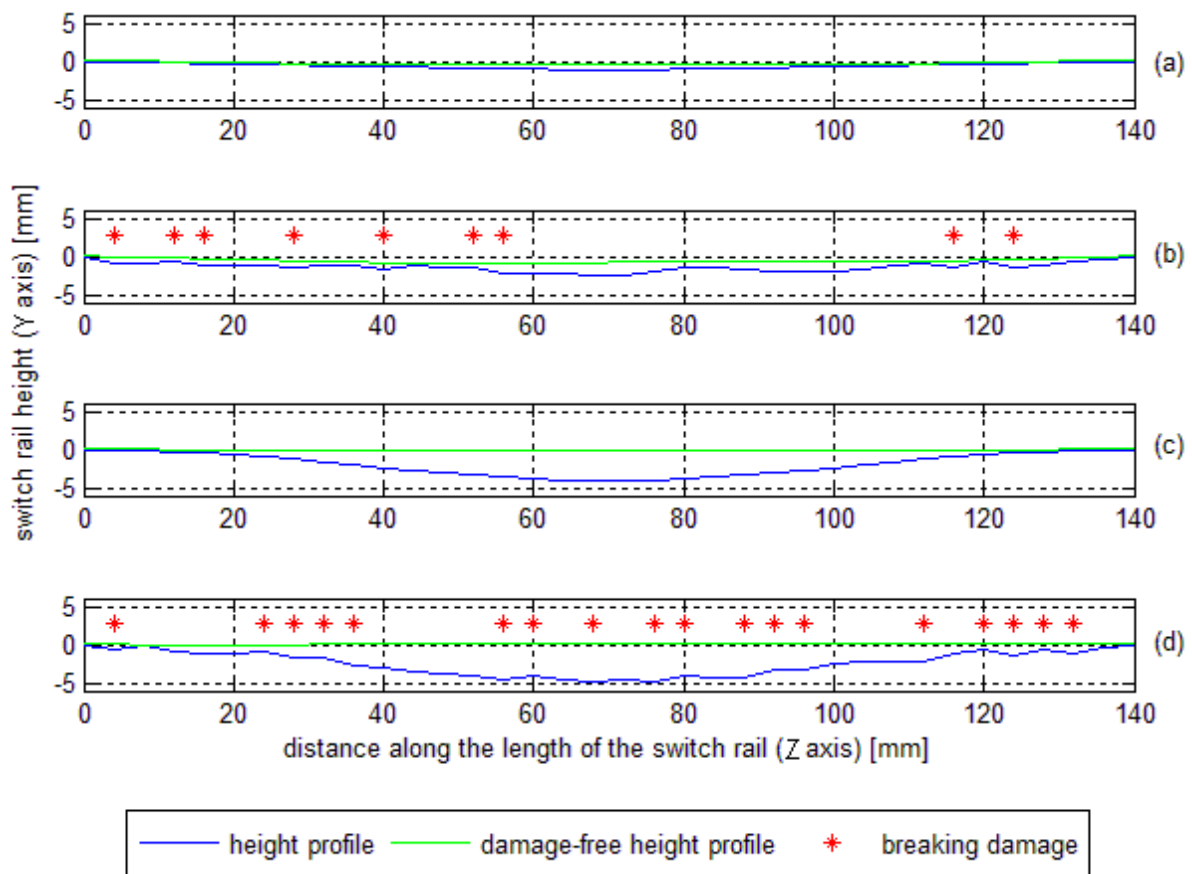
Figure 5-46 Identified damage defects in four hypothetical scenarios (1:1 scale)

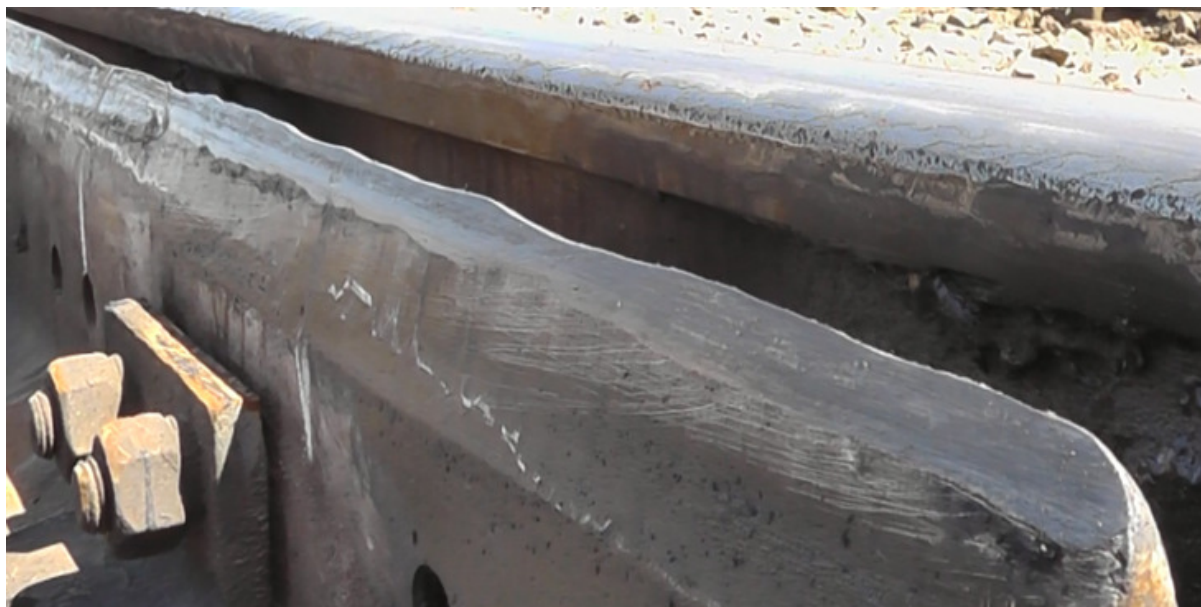
*Figure 5-47 Photo of a measured switch (13 PTS, Whitemoor Rail Recycling Centre, photo 1)*

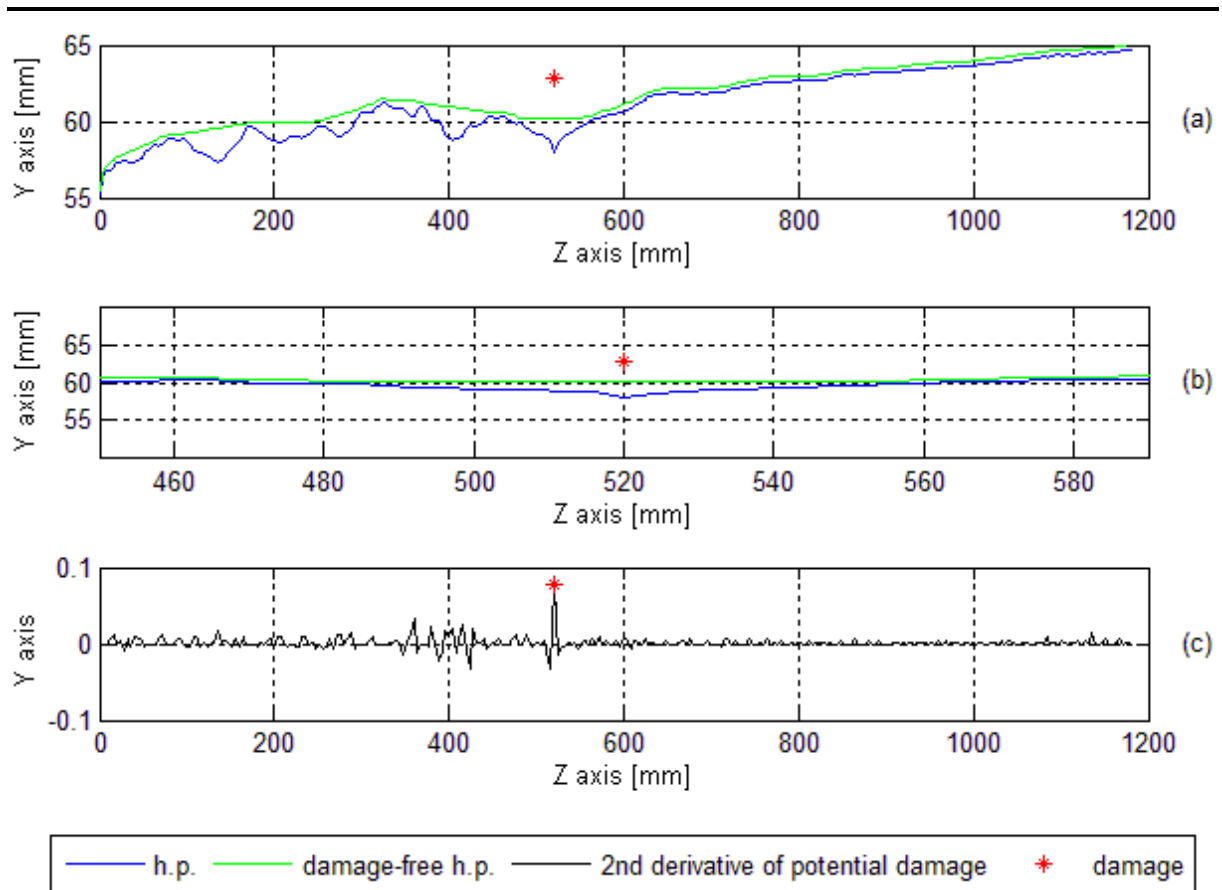
Figure 5-48 Switch rail damage analysis (plot b to scale 1:1)
