Effects of a travelling fire on a concrete columns - Tisova Fire Test

EFFECTS OF A TRAVELLING FIRE ON A CONCRETE COLUMN – TISOVA FIRE TEST

Keywords: concrete column, travelling fire, large scale structural fire test, Tisova Fire Test

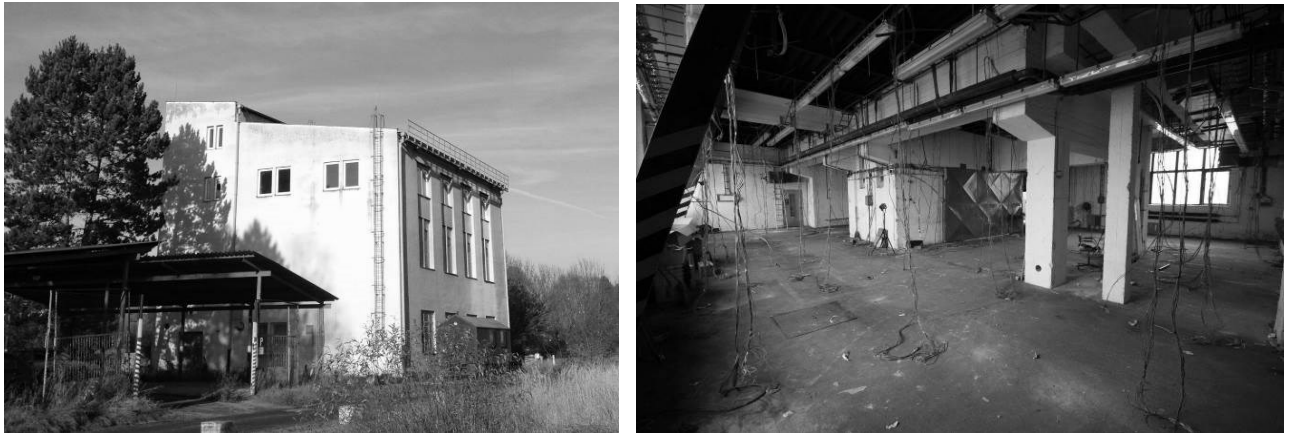
Figure 1: Left – Southwest corner of test building, and Right – fire compartment

The Tisova Fire Test was carried out in January of 2015 by a team from SP, the University of Edinburgh, Imperial College London, Luleå Technical University, and Technical University Ostrava, Majaczech, CSTB and CERIB. The fire test was conducted inside of a real building, Figure 1, which

was scheduled for demolition. The building was constructed in 1958 as a powdered coal boiler and comprised of a reinforced concrete frame and slab construction. In 1980 the buildings use was changed to a combination of workshops and offices and additional floors and slabs were added using composite slab construction tied in to the original frame. The aim of the test was to achieve a structurally challenging travelling fire.
