STRUCTURAL HEALTH MONITORING OF AN INNOVATIVE TIMBER BUILDING

Claude Leyder ^{1,*}, Eleni Chatzi ¹ and Andrea Frangi ¹

¹ Institute of Structural Engineering (IBK),

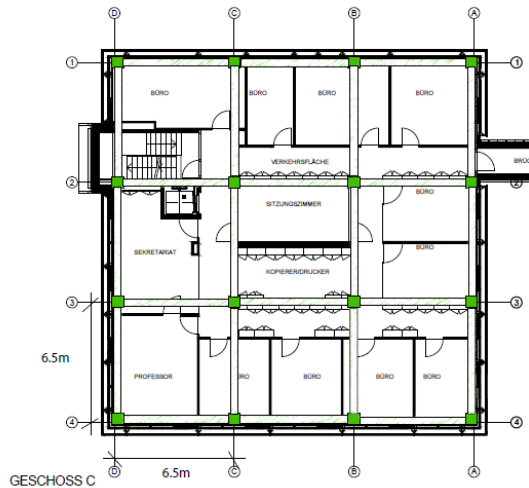
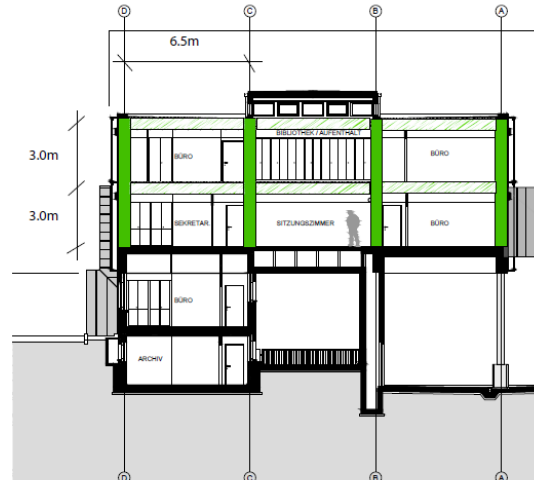
Figure 1 Floor plan and section of the ETH HONR building (Post-tensioned timber frame highlighted in green) (by mml architects)

For the top floor (roof structure) two further innovative systems were implemented. One is a slab purely made of beech wood, with a bi-axial load-carrying capacity (Wanninger and Frangi 2012). This structure was only implemented in the centre field (elevated roof section in Figure 1), with an area of 6.5m*6.5m. The slab is composed of a 120mm thick 5-ply beech CLT plate (ply thicknesses: 20mm-30mm-20mm-30mm-20mm), rectangular posts in beech LVL (170mm high) and 40mm thick beech lamellas running cross-wise. The CLT plate was separated into three elements, which were then screwed together on site (transportable dimensions of 2.17m*6.5m). The addition of the lower cross-wise lamellas leads to a significant increase in stiffness and favours the bi-directional load distribution. Figure 2 b) shows a picture of the structure of the bi-axial floor from below (visible ceiling). The structure of the remaining 8 fields of the roof is a hollow timber-concrete composite floor. The lower plate of the hollow section is also a 40mm thick beech LVL plate, connected via posts (240mm high) to the top plate, a 70mm thick prefabricated concrete plate. The concrete plate is connected to the posts via diagonal screws, a system developed by the company Häring.

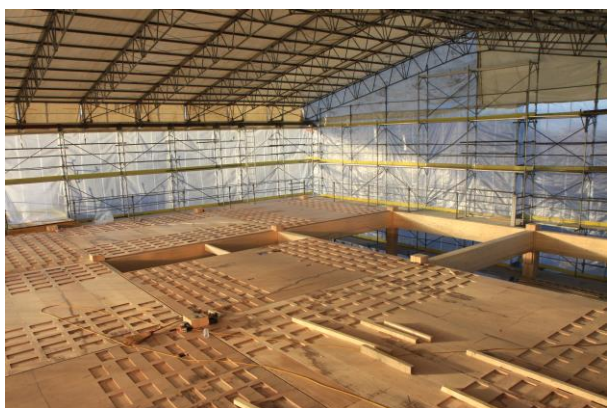
Figure 2 a) Beech plates for the timber-concrete composite floor b) Bi-axial timber floor in beech wood

The second innovative structural system is the mid-floor. It is a concrete-timber composite floor, composed of 40mm thick beech LVL plates and a 160mm concrete plate. The beech plates span also 6.5m and are supported on the frame. The concrete plate was cast on-site as a continuous element. This floor system was also developed at ETH Zürich, as described in Boccadoro and Frangi 2013. Figure 2 a) shows the installation of the beech LVL plates on the construction site of the ETH HoNR before the pouring of the concrete.

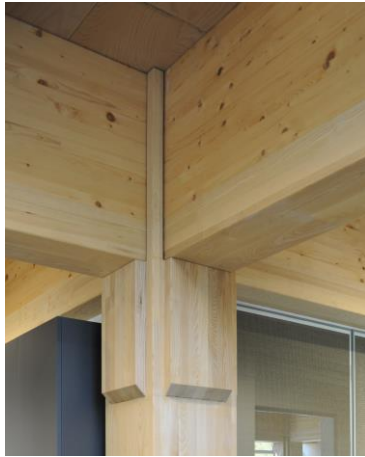
Figure 3 a) Joint between the column and the beams b) Installation of a load cell (tendon anchorage point)

elements are necessary. Therefore the construction of the frame is very fast (1) positioning of the columns, 2) mounting of the beams and 3) post-tensioning). The post-tension cables are post-tensioned to 700kN, which corresponds to a compressive stress of 3.5MPa in the beams. The small support attached to the column is mostly used for the mounting of the beams. Figure 3 a) shows a picture of the joint.

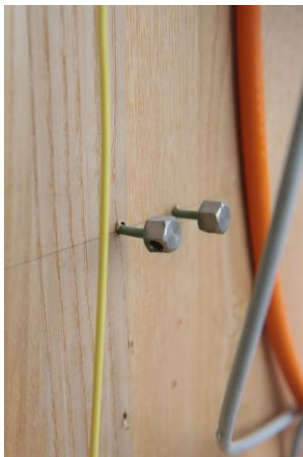
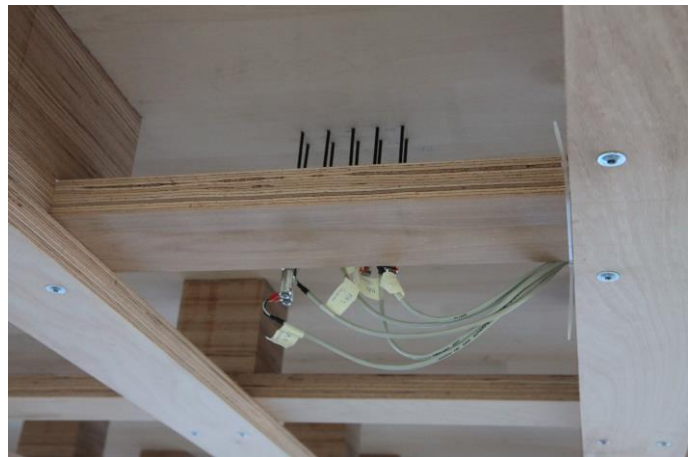
Figure 4 Moisture content measurement inside the timber a) Insulated steel needles inside a timber column b) Insulated steel needles inside the beech CLT plate at 5 different depths

In order to better understand the relation between creep, shrinkage and post-tension losses, the moisture content inside the timber is monitored. The moisture content of the timber is measured via the electric resistance method, where insulated steel needles are drilled into the timber to a certain depth (measurement at the tip of the needle). A detailed overview of moisture content measurements in timber is given in Forsén and Tarvainen 2000, where also advantages and disadvantages of different measurement methods are discussed. In the building, several moisture content sensors (a pair of insulated steel needles) are implemented along the timber frame at a depth of 6cm (Figure 4 a)). On each floor 20 measurement points in beams and columns were installed. In the hybrid beams measurement points were installed in the ash wood and in the spruce wood. Furthermore the moisture content is also recorded in the beech CLT plate of the roof structure in the central field. In the 5-ply 120mm thick CLT plate the insulated steel needles were installed at 5 different depths (middle of each ply – depths of 10mm, 35mm, 60mm, 85mm, 110mm) (Figure 4 b)). As the 6.5m*6.5m CLT plate was assembled from 3 separate plates (2.17m*6.5m), 5*3 measurement points were installed.

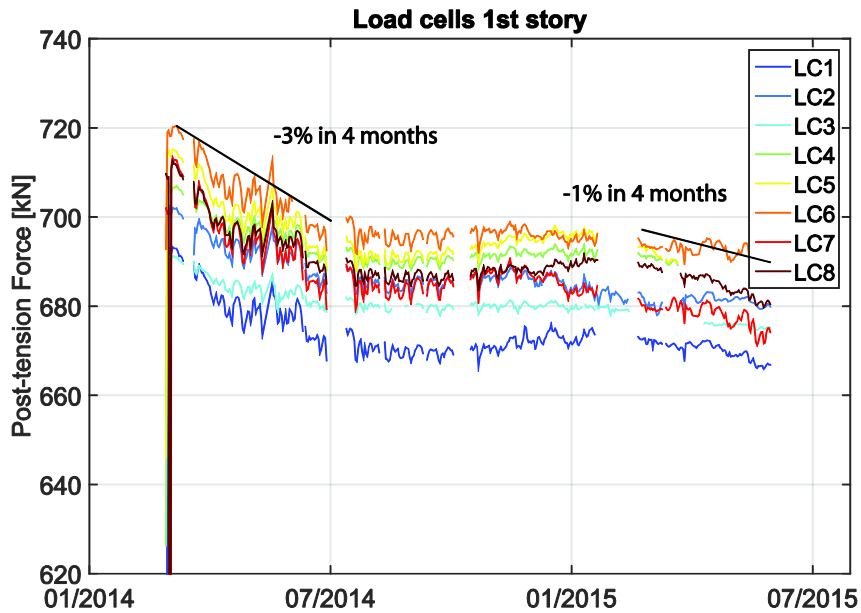
Figure 5 Post-tension forces on the 1st story (LC1-LC8)

The following 2 figures (Fig 5 and 6) show the evaluation of the post-tension force in the 16 frames (LC1-LC8 on the 1st story, LC9-LC16 on the 2nd story), measured via the load cells. For the first story only values after March 2014 are reported, even though the frame was post-tensioned in January 2014. In March 2014 the frame was re-post-tensioned in order to calibrate the load cells. Therefore the data is presented starting from March 2014.

From the graphs it can be noted that all 8 load cells per story follow a similar pattern. The percentage of loss / gain in post-tensioning force is also indicated in the graphs. On the first story a 3% loss occurred during the first 4 months, followed by a stable phase of 6 months and then followed by another decrease of 1% in 4 months. On the second story the pattern is different, where first a 1.5% gain in post-tension force occurred during the first 4 months, followed then by a drop of 4.7% in the following 6.5 months.

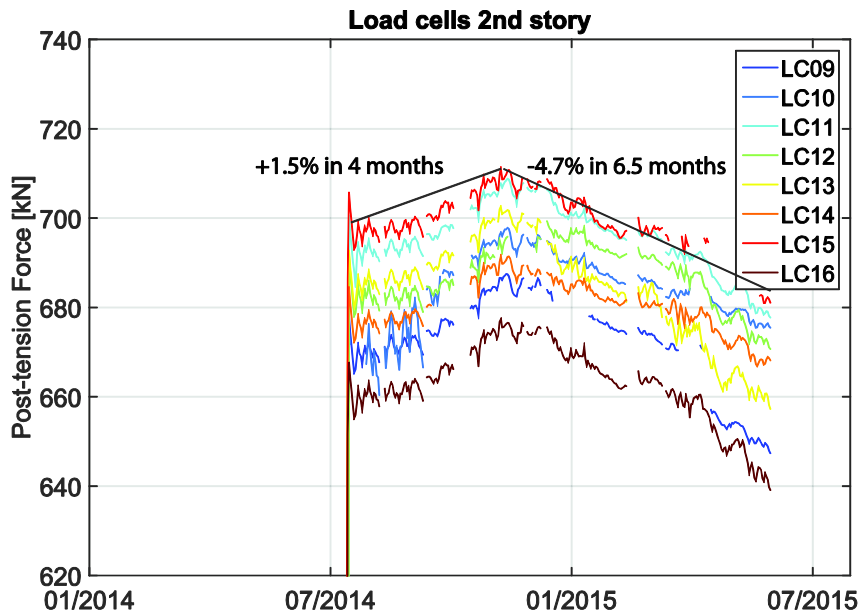
Figure 6 Post-tension forces on the 2nd story (LC9-LC12)

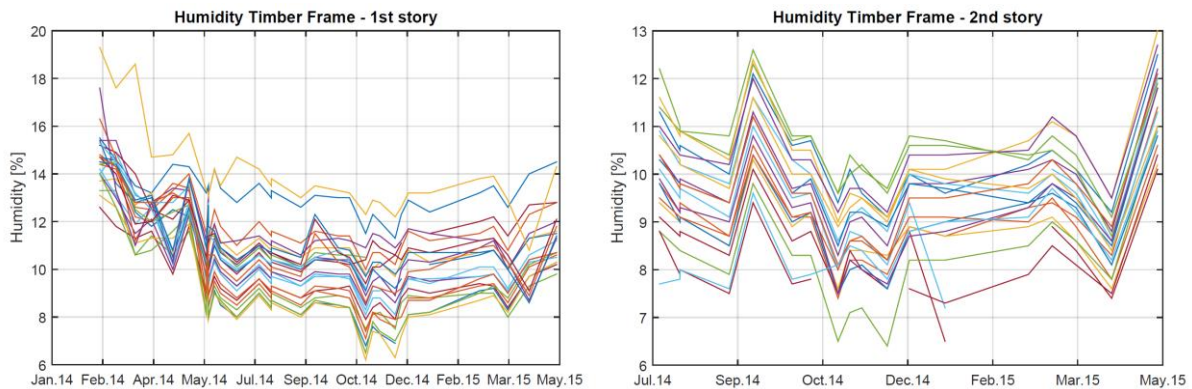
Figure 7 Moisture content in the post-tensioned timber frame at a depth of 6cm at different locations a) 1st story timber frame 2) 2nd story timber frame

The moisture content of the timber was recorded periodically (approximately every 3-4 weeks). In figure 7 the measured values are shown for the 1st story frame (Fig 7a) and for the 2nd story frame (Fig 7b).

For the 1st story frame the measurements in the timber frame show very high moisture content at the beginning of the construction. Indeed, due to several reasons the weather-proof membrane was not a 100% watertight and some parts of the frame were exposed to rain on a few occasions. Meanwhile the 1st story frame has dried out to a normal level (8 to 12% timber moisture content, except for 2 positions). On the 2nd story the moisture content inside the timber frame remained more or less constant over the entire measuring period (values between 8 and 12% moisture content). All measurement points show a similar trend and there is no trend difference between ash and spruce wood.

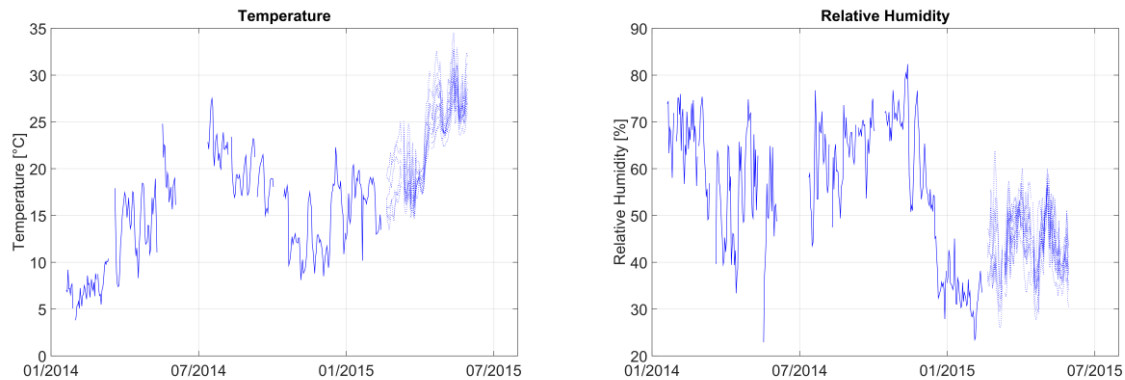
Figure 9 a) Temperature and b) Relative humidity (straight line until Feb 2015: climate during construction, dashed lines from Feb 2015 (climate after the building envelope was closed))

In addition to the moisture content inside the timber also the temperature and the relative humidity on the construction site and later inside the building have been recorded. As mentioned before, the climate was first recorded at a single point (continuous line in Figure 9), and second recorded at 12 different locations (dashed lines in Figure 9).

Before the completion of the building envelope in winter 2014/2015 the temperature and relative humidity measurements show a very high variability, as expected for outdoor climate. Temperatures increased during summer 2014 followed by a decrease towards winter. The heating inside the building was switched on in December 2014, the measurement system was however only switched to multiple locations in February 2015. The completion of the building envelope and the activation of the floor heating created a large drop in relative humidity (approximately from 60-70% to 30-50%). Since timber with small cross-section strongly reacts to large changes in relative humidity (Niemz 1993, Fragiaco *et al.* 2011), several humidifiers were installed inside the building in order to avoid a further drop of relative humidity. The humidifiers shifted the relative humidity range from ~30-40% to ~40-50%.

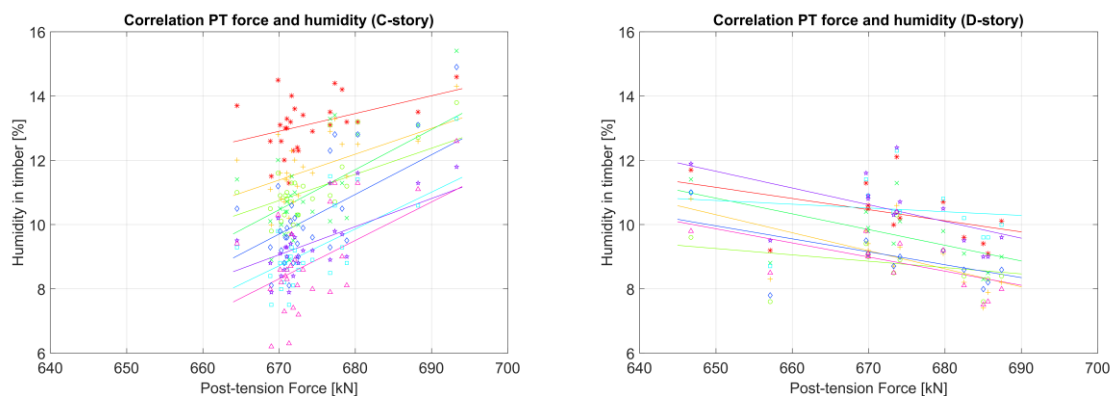
Figure 10 Example of the correlation between the post-tension force in a frame from the 1st story (left-hand figure) and 2nd story (right-hand figure) and the moisture content measurement at 8 locations along the frame (each location is denoted with a different symbol and colour). The linear regression lines were added in the same colour.

Indeed, the correlation coefficients between the relative humidity measurements and the losses / gains in post-tension force were calculated and were found to be very low for the building frame. In addition however also the correlation coefficients between the load cell measurements and the moisture content inside the timber cross-section were calculated. As an example, Figure 10 illustrates the correlation for one load cell and moisture measurements along the corresponding frame (at 6cm depth). For the 1st story frame a mean correlation coefficient of 0.74 with a standard deviation of 0.1 could be found. For the 2nd story the mean correlation coefficient is -0.55 with a standard deviation of 0.2. This indicates that for the 1st story there is a clear correlation between the initial drop in post-tension force and the initial drying of the timber (shrinkage). During the summer period of 2014 the drying of the timber cross-section stopped (high outdoor relative humidity), which is manifested by a stable phase in the post-tension force. The final decrease phase (Feb – May 2015) cannot be clearly correlated to the moisture content. For the 2nd story, the correlation is clearly less significant. Indeed the timber moisture content is nearly constant, whereas however the load cells indicate an increase and decrease in post-tension force. The moisture content measurements were only carried out every 3-4 weeks, this period may have been too long to clearly indicate a significant trend. The measurement frequency will therefore be increased to bi-weekly measurements in the future. Furthermore there might be a strong moisture gradient over the cross-section which also influences the post-tension force and cannot be measured by the current setup. A hypothesis is, that the timber members of the 2nd story were well dried (moisture content of ~10%) when they arrived at the construction site, so that the moisture content would first increase (high relative humidity) and then decrease with the start of winter and the heating period. This would then linearly correlate with the post-tension force (increase in moisture content leading to an increase in post-tension force and decrease in moisture content leading to a decrease in post-tension force). Indeed an increase in moisture content would lead to swelling of especially the column section and therefore induce higher stresses in the column-beam joint. Unfortunately, this trend could not be captured by the moisture content measurements. Other factors like creep, in combination with the addition / removal of loads may also have influenced the post-tension force. These factors will be further investigated in the future.
