AFRP RETROFIT OF REINFORCED CONCRETE COLUMNS AGAINST IMPACT LOADING

Tuba Gurbuz^{1,*}, Alper Ilki¹, David P. Thambiratnam², Nimal Perera²

¹ Istanbul Technical University (ITU), Civil Engineering Faculty, 34469 Maslak Istanbul Turkey.

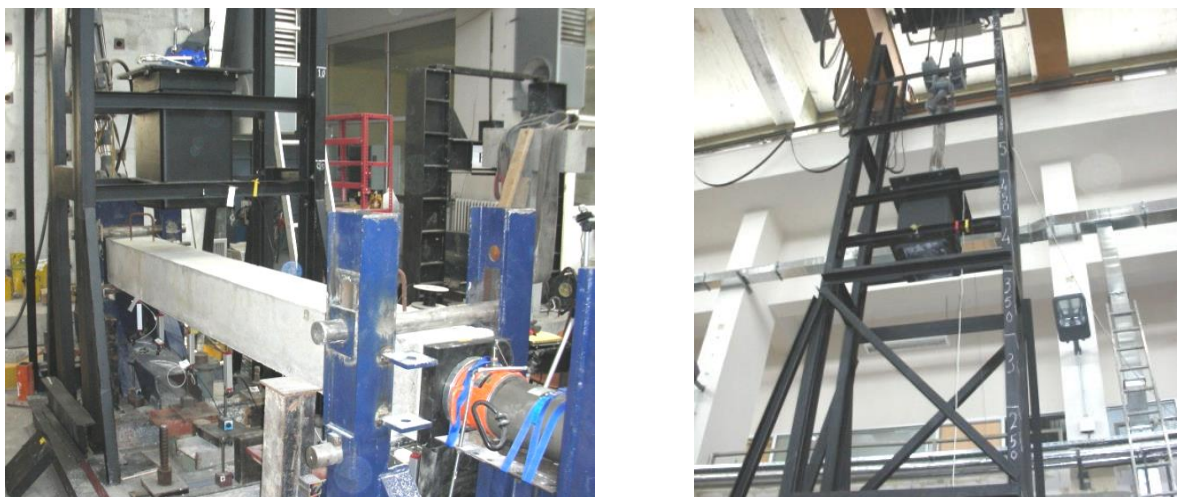
An existing test set-up in ITU Structural and Earthquake Engineering Laboratory was modified to be used for drop weight impact tests, as shown in Figure 2. In the existing test set-up, the steel construction was designed to provide desired support conditions at both ends of the column. The west support point, where the axial load was applied by hydraulic jack and cylinders (60 t capacity), was designed to allow axial translations and rotations. A load cell (100 t capacity) was used to measure the axial load and the axial load was tried to keep constant during the tests. The load cell and the cylinder were clamped to prevent bouncing after the impact. Under the effect of drop weight the specimen could shift laterally or lift up. Therefore column ends were clamped by high strength steel rollers (70 mm in diameter) prevent uplifting and lateral movements. These rollers were placed at the top and the bottom surfaces of both column ends. Thus the supports allowed for some rotation and lateral contraction caused by the axial load application. The steel profiles supporting the whole specimen from the two end points were fixed to prestressed strong floor (120 cm thickness) by 32 mm high strength steel rods. The steel supports were designed to be stiff enough to support the loading without significant deformation.

Figure 2 Test set-up

The drop weight test apparatus (steel frame towers and the impactor) was added afterwards to the existing test set-up. The specimens were placed horizontally in the set-up and the impactor was dropped to the 2/3th length of the column (2 m away from the west support of the specimen). Impact load was induced by a freely dropping impactor from a specific height. Impactor can be dropped from a maximum height of 6.0 meters due to the constraints of the test set-up. The impactor was raised and carried by the crane. It could be moved up and down to a designated height by the crane. When the impactor reached the predefined height, it was released resulting free fall of the weight.

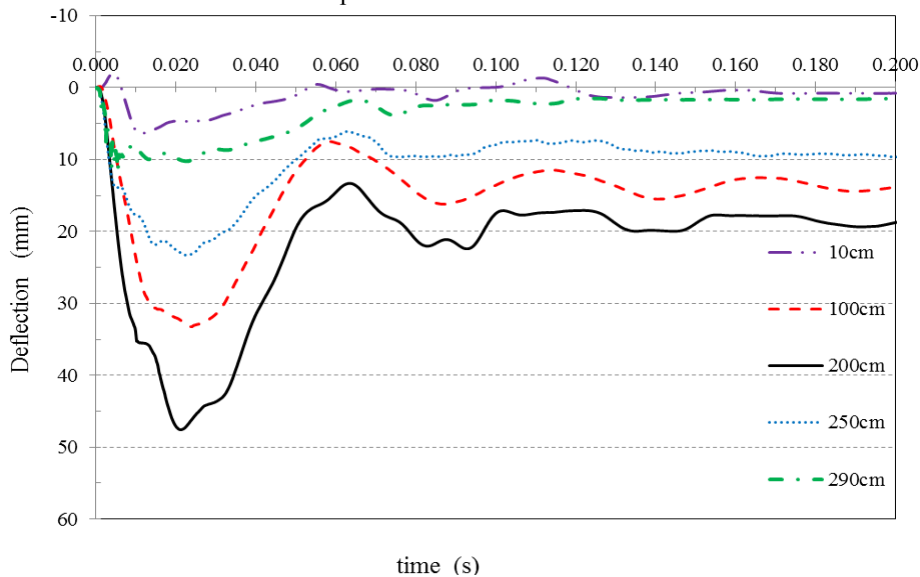
The first impacted column, ImpR1 was a control specimen. ImpR1 was subjected to impact load of 585 kg dropped from 3.0 m (17000J). Deflection data at the locations of 10 cm, 100 cm, 200 cm, 250 cm and 290 cm from the west support were accurately collected from the performed test. Deformation versus time curves, recorded by each potentiometer along the specimen length are presented in Figure 4.

Deflection time histories are typical in shape and in period. They act as a half-sine waves with period of 60 ms. The loading point deflection readings (potentiometer at 200 cm, @200cm) indicated that the column deflected a maximum of 47.6 mm. The peak deflection of 47.6 mm occurs at about 20 ms after the impact, and then deflection rapidly drops at the failure and oscillates around 19 mm, which is the permanent deflection. In the time history curve of the potentiometer at 10 cm location (from the west support), negative deflections were recorded 6 ms after the induced impact, which shows the uplifting movement of the specimen. Due to the post vibration of the specimen, deflection at this point ends up with almost zero value deflection, which verifies successfully restrained movement of the end points.

Figure 4 Deflection time history of ImpR1

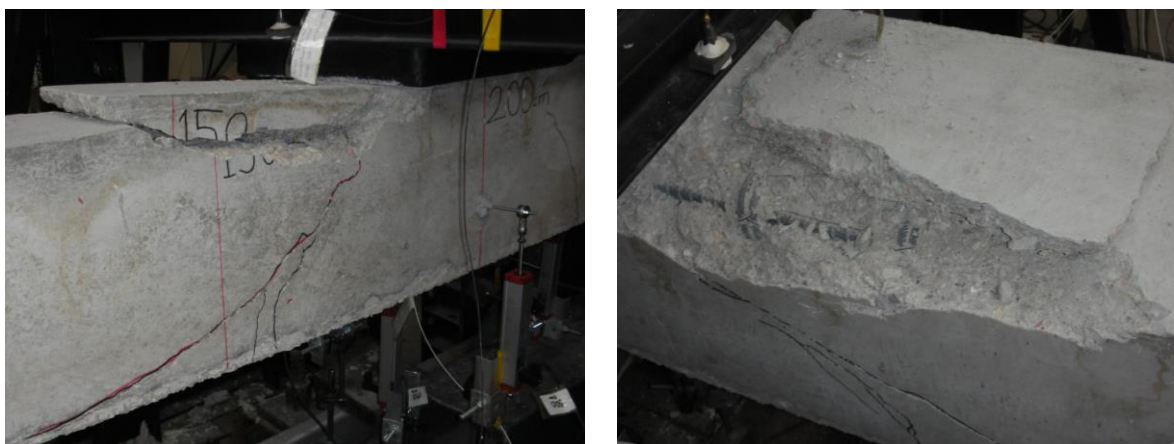
Damage after the induced impact is presented in Figures 5-6. Concrete crushed and the concrete cover spalled at the top face just near the impactor and extended in the direction of the west support. This damage at the top concrete was due to the compression stresses caused by the impactor and the flexure effect. The concrete cover was extensively damaged that the top longitudinal reinforcement exposed, Figure 5.

Figure 5 Concrete cover disintegration and concrete crushing at the top next to the contact surface

Inclined shear cracks at both sides of the loading zone and minor flexural cracks just under impactor at the tensile zone indicated the formation of the shear-flexure type failure of the specimen (Figures 5-6) and no cracks

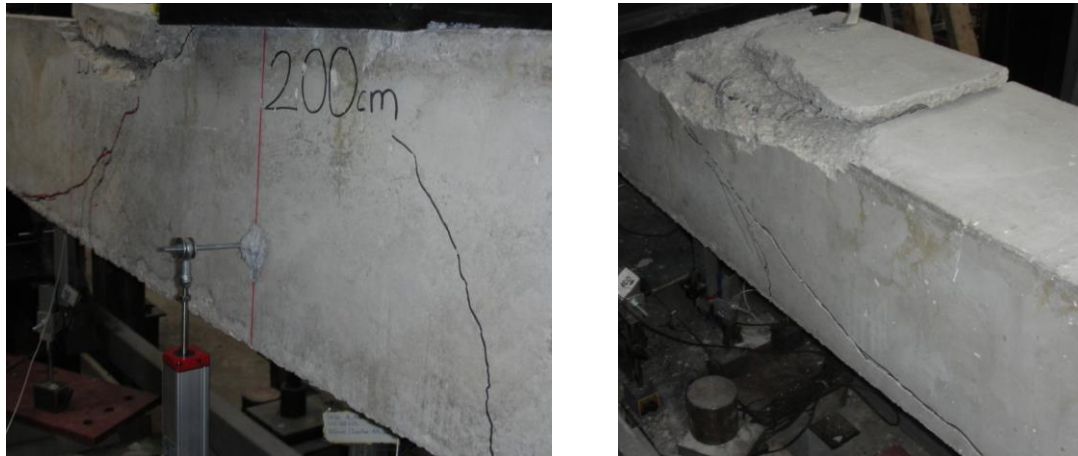
were observed close to the support points. The shear-flexure failure was demonstrated by the widening of diagonal shear and vertical flexural cracks. The shear cracks started from the outer side of loading surface and extended towards the bottom face of the specimen. However the shear crack that extended towards the west support was more inclined (Figure 6a) while the crack that extended to the east support was steeper (Figure 6b). Damage was dominated by shear with little flexure involved. Visible excessive permanent damage and residual deflection associated with shear was observed after the impact.

a. steeper cracks close to east support b. inclined cracks close to the west support
Figure 6 Inclined shear cracks

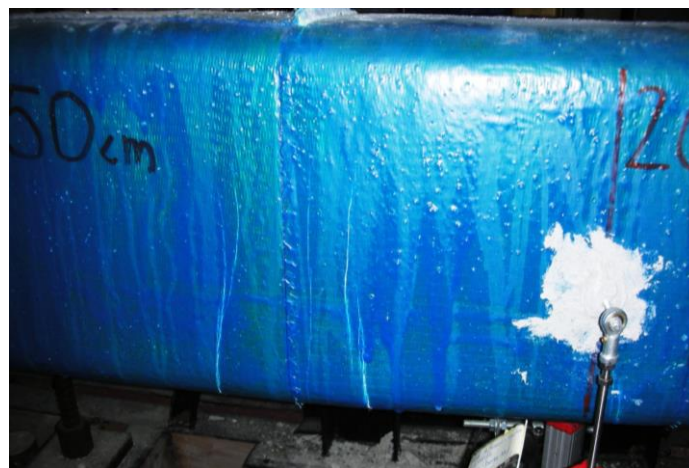
After the first impact, the crack formation of ImpA1 between the distances 150 cm to 200 cm (under impact zone) from the west support is presented in Figure 9. Two vertical minor flexure cracks initiated at the outermost bottom tension zone. No visible damage/rupture was seen on the AFRP sheets. The formed damage was like a matrix cracking. Impact load is short in duration and causes high stress concentration at the loading region and forms cracks that expand along limited impacted area.

Figure 9 Cracks of ImpA1 after the first impact

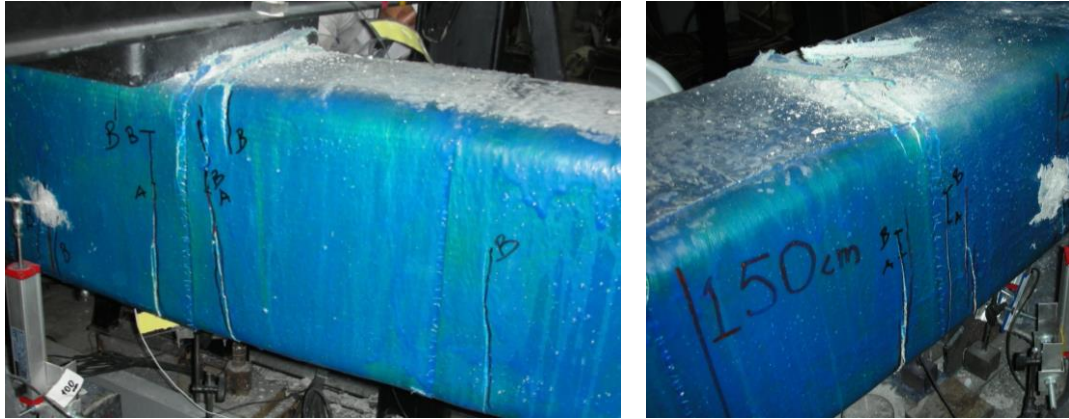
After the second impact, the previous vertical flexure cracks (marked as A) at bottom tension zone propagated further up (marked as B), as in Figure 11. Additionally, new vertical flexure cracks formed as a result of the second impact. AFRP sheets ruptured at the top surface next to the impact region, Figure 11. Aramid fibers ruptured at the top face due to the local effect of the impact loading.

a. Vertical cracks at the loading region b. Rupture of the Aramid fibers at the top surface
 Figure 11 Damage of ImpA1, after the second impact

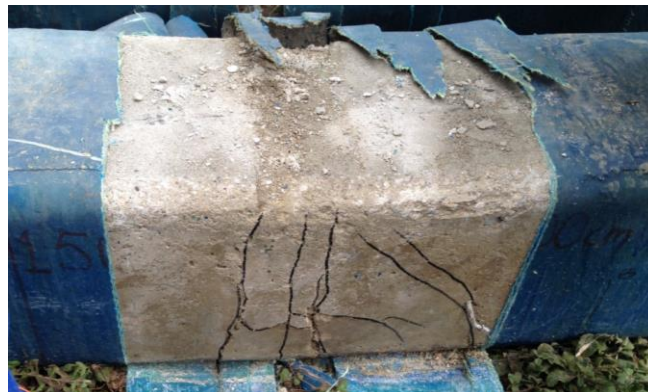
By the end of the impact test, the aramid jacket was removed from the concrete surface in order to observe the failure/damage mechanism closely. The general crack pattern of the impacted area is presented in the autopsy photo given Figure 13. After the first impact, vertical flexure cracks formed on the AFRP as matrix cracks then the cracks were widened and spread into the concrete surface of the specimen during the second impact. These damages on concrete were flexural cracks formed on tension side of the region with no significant crushing on the top concrete. Since the concrete damage on the top compression zone was limited, the AFRP fibers ruptured due to the local impact effect of the drop weight. The failure mode of retrofitted RC specimen subjected to impact load can be categorized as flexural failure.

Figure 13 Autopsy of ImpA1, after the second impact
