FIELD EXPERIENCE AND THE LONG-TERM DURABILITY OF REINFORCED CONCRETE STRUCTURES

Robert E. Melchers

Centre for Infrastructure Performance and Reliability, Faculty of Engineering and the Built Environment,
University of Newcastle, Newcastle, Australia, 2308. *Email: rob.melchers@newcastle.edu.au

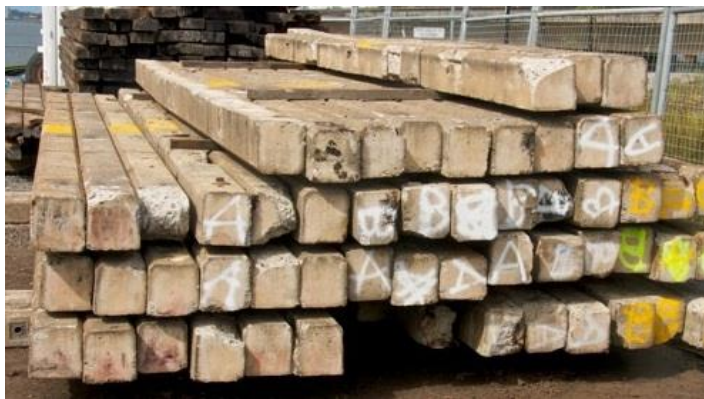
Figure 1 Sample piles after demolition showing no exterior evidence of internal corrosion.

In 2010 the 2.7km long, timber superstructure, reinforced concrete substructure, bridge at Bramble Bay, Brisbane was demolished, with considerable difficulty, after some 80 years service immediately adjacent to the Pacific Ocean. Although the vehicular capacity of the bridge was no longer adequate, its substructure was largely in excellent condition. It consisted of 879 reinforced concrete driven piles, each 400 x 400mm in cross-section with (in most cases) only 4 reinforcing bars of 32 mm (1-1/4") diam. with 40 mm cover. The crossheads over the piles were in less good condition. The piles were removed from the seabed with considerable difficulty, in some cases having to be cut just above the seabed because they could not be withdrawn from the soil. With few exceptions, there was no visible evidence of reinforcement corrosion for any of the piles. Figure 1 shows a number of piles in the demolition yard. Several samples of the piles were taken to the Civil Engineering Laboratory, The University of Newcastle for detailed investigation. An early report on this is available (Pape and Melchers 2013) and a detailed paper is in preparation.

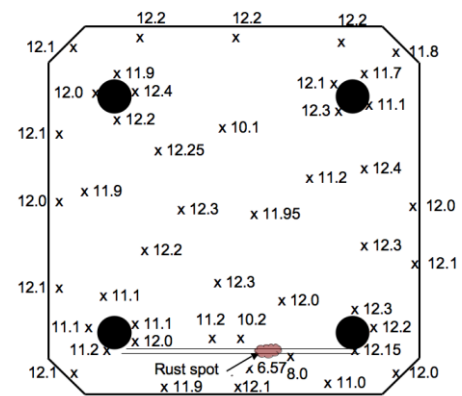
Figure 2 pH map of typical pile cross-section. The pH at the rust spot is about 7.

Schmidt hammer readings were high and compressive tests on cores showed concrete strength of 65-75MPa. This was confirmed empirically by the difficulty laboratory staff experienced in breaking open the samples for examination of the reinforcement. None of the samples showed signs of corrosion although some showed some surface discoloration. Some samples were cut across with a concrete saw and the pH sampled over the cross-sections. Figure 3 gives one example. It shows, as did all others so far examined, that even after some 80 years almost all the concrete still has a pH of at least 9 and mostly around 12. Mostly the cross-sections show no sign of reinforcement corrosion. Petrographic examination of the concrete indicated very minor evidence of alkali-silicate reactions and none of alkali-aggregate reactions. The chloride levels were very high, some 0.6% to 3% by weight of cement – much higher than any permitted by conventional design requirements.

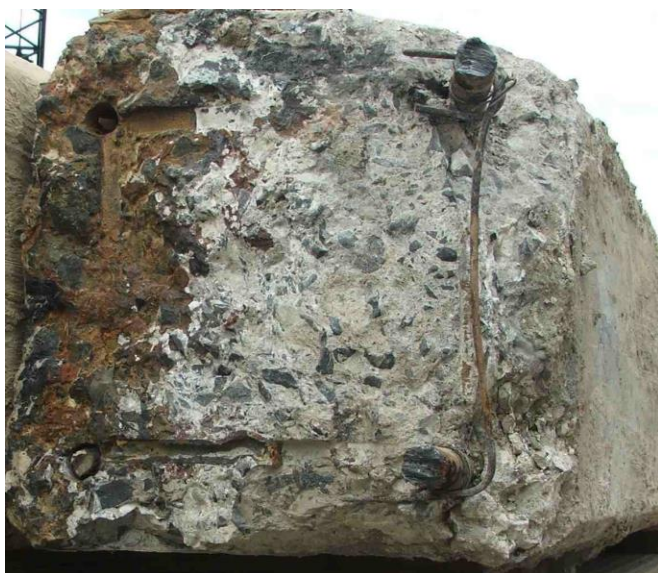
Figure 3 Cross-section of cracked pile showing rust-stained cracking (left) and flame cut bars and freshly broken concrete (right). (Photo courtesy of Clayton Smith).

During demolition the contractor noted that one pile, on being pulled out of the soil, was obviously cracked about half-way up. Investigation of the cracked area showed the cross-section in Figure 3. It has half the concrete cross-section cracked and showing signs of watery-looking rust stains – the other half was broken during recovery and the reinforcing bars flame-cut. There are no reinforcement bars visible in the area of the rust-stained crack. Evidently, these bars have corroded away almost completely some distance into the concrete (Figure 4). There were no rust stains visible on the exterior concrete surfaces. This means that a routine visual inspection is unlikely to have signalled there were problems with the reinforcement inside.

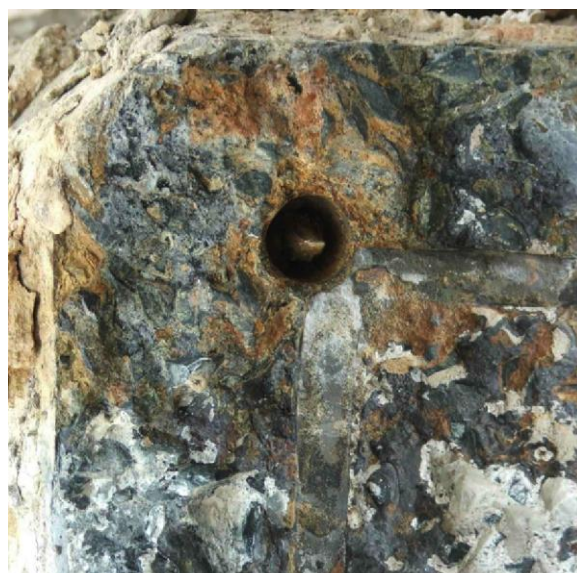
Figure 4 Close-up of reinforcing bar at top left of Figure 3 showing extensive inwards corrosion. (Photo courtesy of Clayton Smith).

Consider now the severe corrosion such as seen in Figure 4. As noted above, for the cases in which this occurred, the concrete showed cracking, usually transverse to the reinforcement but little or no trace of corrosion products, despite the significant loss of steel reinforcement. The immediate question is where did the steel go, and how? The watery rust stains are a direct indicator that the chlorides present in waters reacted with Fe to form highly soluble, almost clear coloured, FeCl_2 that, in wet conditions, such as in the tidal zone (Hornibrook), or under frequent periodic rain (Arbroath, Yucatan), can easily diffuse away. In so doing it leaves little trace, and what is there is oxidized to conventional insoluble rusts. These are the visible watery-looking stains on the cross-section.

The only mechanism consistent with the dissolution of Fe by chlorides is that of highly aggressive pitting or crevice corrosion under anoxic conditions within pits (Wranglen 1974). The fine crack in the concrete adjacent to and interacting with the steel reinforcing bar permits such anoxic conditions. It can be seen as a pitting or crevice corrosion initiator, noting that MnS inclusions, always present in steels, are involved also (Wranglen 1974). No other mechanism is known to cause such aggressive localized corrosion, although it may be aggravated by microbiologically influenced corrosion particularly in nutrient-polluted marine conditions (Melchers 2014b).

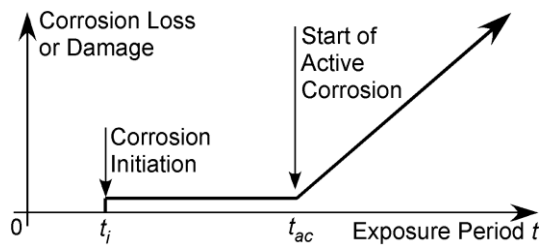
Figure 5 Model for corrosion initiation at time t_i and active corrosion at t_{ac} .

Answers to these questions largely are available in the existing corrosion literature but appear not well-known. It is useful to begin with the fundamentals of corrosion of ferrous materials such as steel. The key recognition is that the structures that behave very well are those for which reinforcement corrosion has not yet become active. Earlier this was idealized as a bi-linear function attributed to Tuuti (1982) but more properly it should consider the possibility that some minor corrosion may occur when small reservoirs of oxygen and water are available immediately around the bars, left over from the casting process and perhaps inadequate compaction (Melchers and Li 2006). Typically the early corrosion will be minor, unless the concrete is of poor quality. For the following, let this possibility be ignored and attention focussed on good quality concretes. Figure 5 shows the modified behaviour. The important time is thus t_{ac} at which active corrosion commences.

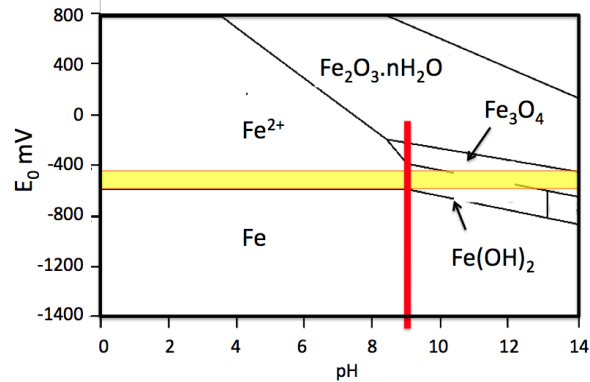
Figure 6 Schematic Pourbaix diagram showing main rust products and pH for initiation.

Corrosion initiation of reinforcing steel (essentially iron, Fe) must follow corrosion science principles. It can occur only when the reaction(s) involved becomes feasible, and this is when the net free (Gibbs) energy ΔG becomes negative (Brown and LeMay 1981). In the corrosion literature this is usually summarized in a Pourbaix diagram for Fe (Figure 6). It shows the various relationships for different reaction outcomes in terms of electrochemical potential E and pH. For Fe in water the relevant potential E_0 at which corrosion products are formed is around -440 mV (SHE) and the pH for corrosion initiation occurs is about 9-9.5 (the exact value depending on the energy level taken as 'zero' corrosion). These values are not changed very much by the presence of chlorides (Garrels and Christ 1965; Jones 1996; Huet et al. 2005). Note that this value corresponds with the observations for actual structures with very high chloride levels for which reinforcement corrosion has not yet occurred (e.g. Figure 2). The important point is that corrosion initiation cannot occur as long as the pH of the concrete (or pore space fluid) in the immediate vicinity of the reinforcement bar is maintained above 9-9.5. Obviously this condition can be violated by cracking of the concrete along, or across, the bar if this results in a mechanism that allows the local pH to reduce below 9-9.5 in value. This possibility is discussed further below.
