# BENDING BEHAVIOR TEST AND ASSESSMENT FOR FULL-SCALE PC BOX GIRDER REINFORCED BY PRESTRESSED CFRP PLATE

Chunsheng Wang<sup>1,2,\*</sup>, Lan Duan<sup>1,2</sup>, Qiao Luo<sup>1,2</sup> and Yuxiao Zhang<sup>1,2</sup>

<sup>1</sup>Institute of Bridge Engineering, College of Highways, Chang'an University, Xi'an, 710064, China.

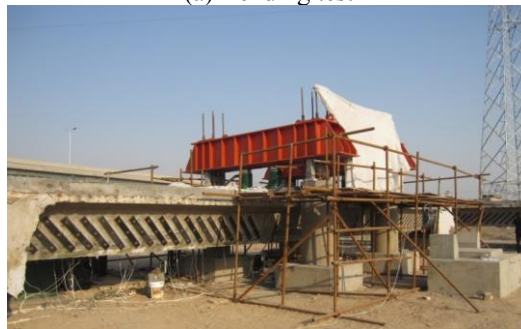
Figure 2 Test setup

(a) Bending test

(b) In-situ bending test

Four-point loading were adopted during the bending test. The test setup were mainly composed with four ant-pull piles, screw-thread steel rebar, steel diaphragms and hydraulic jack, shown in Figure 2. The test girders were all located in east-west direction, while the west side was fixing supporting section and the east side was movable supporting section. During the bending test, strain and deformation were recorded by TDS-602 machine. The strain measure points were mainly arranged at mid-span region in concrete, longitudinal rebar and CFRP plate. These measure points were arranged for testing plastic region length and the neutral axle location.

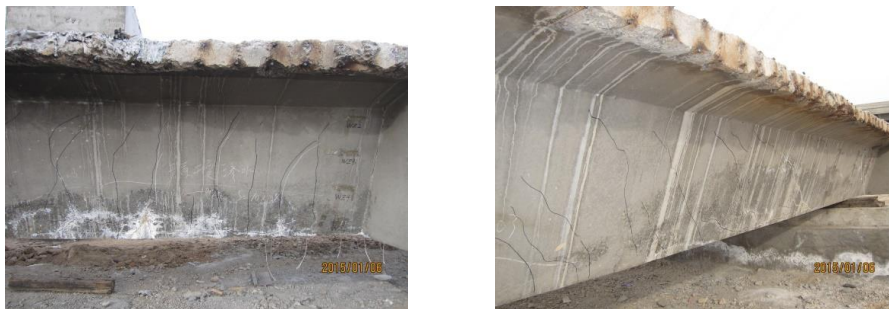
(a) Vertical cracks near mid-span region (b) Inclined cracks outside of pure bending region  
Figure 3 Failure mode of full scale test girder without strengthening

During bending test for full scale test girder without strengthening, no new crack was found in concrete when loading was less than 340kN. The test girder showed very well overall performance and the strain of main strengthening was much less than yield strain. When the load increased beyond 340kN, there was continuous sound and new vertical cracks were appeared. A big sound was heard as loading to 362.6kN, the concrete slag dropped out and crack width turned wider at bottom flange near middle span at 392kN. When the load reached 588kN, vertical crack extended to 1/2 height of the girder. The inclined cracks appeared in the web at 1/4 span section when loading to 784kN. As loading to 980kN, severe cracks with maximum crack width of 3mm were appeared at bottom flange and web. These cracks extended quickly and part of them extended to the top flange. When loading to 1048.6kN, the concrete strain at top flange did not reach ultimate strain, but there was 30cm deflection at middle span. This excessive deflection marked termination of bending test. At this moment, the bending test girder attained plastic ultimate limit state. There were lots of vertical cracks at middle span region and inclined cracks in web outside of pure bending region. The maximum width of these cracks reached to 3~4mm. The failure mode of test girder without strengthening is shown in the Figure 3.

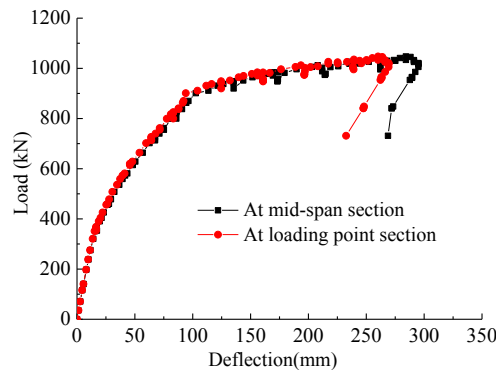
Figure 7 Load and deformation curves for test girder without strengthening

For the test girder without strengthening, the load and deformation curves at both mid-span and loading points are shown in Figure 7. Learn from Figure 7, the load-deformation curve in the mid span and loading point is basically identical with each other. The deformation increases continuously with the increase of loading, leading to concrete cracking, stiffness decreasing gradually and deformation growth rate increasing gradually. Learn from Figure 7, the bending process of the test girder can be divided into three stages. The first stage is elastic stage. In this stage, the deformation of each section increases linearly with loading, and the load is less than 340kN, which indicated no crack appearing and the girder deflection was less than 15mm. The second stage is elastic-plastic stage, corresponding to load between 340kN and 880kN. In the second stage, the load and deformation curves turned nonlinear and the stiffness of test girder declined, which indicated new cracks appeared in the test girder and both old and new cracks expanded continuously. The third stage is plastic stage, corresponding to load exceeded 880kN. In this stage, the growth of deflection increased, and the load-deformation curves tended to be horizontal. When the load reached 1047.4kN, the test girder was close to the limit state of plastic bending, and the maximum deflection is 300mm. Then the bending test was terminated due to the excessive deflection of test girder.

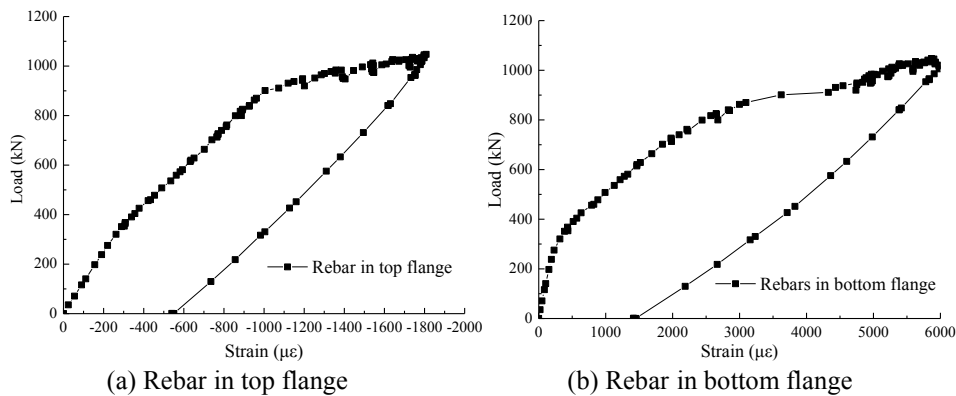
Figure 8 Load and strain curves at mid-span section

Figure 8 shows the load-strain curves of rebars in the top flange and bottom flange respectively. Learn from Figure 8, the strain has three symbols in the whole loading process, including new crack appeared in concrete, yield of rebar at bottom flange and failure of test girder. After the test, the cracking load, the yielding load and the ultimate load of the test girder were 340kN, 880kN and 1047.4kN respectively. There was no new crack in the test girder at the initial loading stage, and the strain of rebar was growing linearly. When the load reached about 300kN to 380kN, the concrete appeared new cracks, and the strain growth of rebar began to speed up. With the propagation of concrete cracks, the strain of rebar grew obviously. When the load reached 800~900kN, the rebar at bottom flange was gradually yielding, corresponding to the second typical point. As the continued increase of load, the strain growth rate of rebar still increased, corresponding to leap-growth of the strain in Figure 8. In this stage, the rebar at bottom flange showed obvious plastic characteristic. When loading to 1047.4kN, the test girder was close to the plastic bending limit state, and then the bending test was terminated.

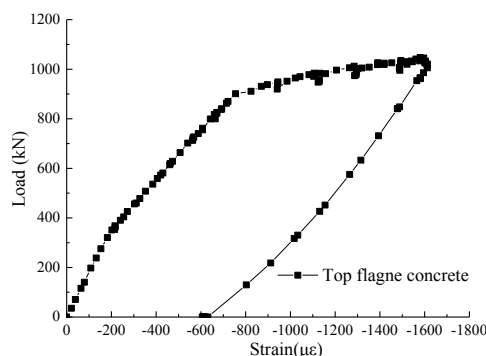
Figure 9 Load and concrete strain curve at top flange of mid-span section

Figure 9 shows load and concrete strain curve at top flange at mid-span section. Learn from Figure 9, the concrete strain increased linearly with the increase of load under 340kN, and the test girder was in the elastic stage. With the loading continued, the concrete strain growth rate accelerated and the load-strain curve turned nonlinear. New cracks appeared continuously and the original cracks continued propagation. Then the load and concrete strain curve appeared mutation again, and the rebar at bottom flange was yielded. The concrete strain growth rate of the test girder turned greater, and the load - strain curve in Figure 9 reached horizontal stage. When loading to 1047.4kN, bending test was terminated. The residual strain was about 600 $\mu\epsilon$  which can be seen from the Figure 9.

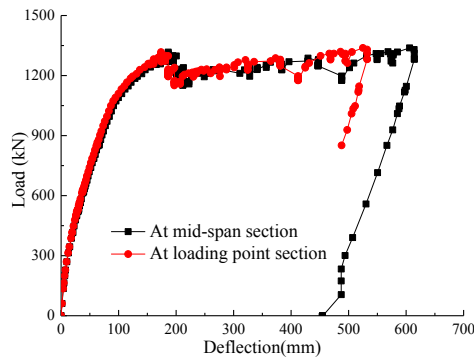
Figure 10 Load and deformation curves for test girder after strengthening

Figure 10 shows the load-displacement curves for reinforced test girder. Learn from Figure 10, the deflection curves at mid-span and at loading point were basically coincident. When loading less than 200kN, the load and displacement had linear relationship, which illustrated no new concrete crack appeared and the test girder was in elastic stage. The deflection in this stage was small, which was less than 8mm. When loading between 200kN and 1000kN, the test girder appeared new cracks, the stiffness decreased and the deflection increased. The relation between the load and displacement turned nonlinear, corresponding to elastic-plastic stage. During the loading process, both the old and new concrete cracks were propagated and the crack widths increased. When

the load exceeded 1000kN, the prestressed CFRP plate was split, and the displacement increased. When the load reached 1317.4kN, the curves in Figure 10 appeared sudden drop due to the successively fracture of the prestressed CFRP plate and the test girder was unloaded to about 1200kN automatically, which demonstrated the brittle failure of prestressed CFRP plate. Then, the displacement increased rapidly and the curves tended to be flat, although the load was still increasing. Learn from test result, the prestressed CFRP plate strengthening technique would not increase the bending capacity of the test girder, but it could enhance bending rigidity to a great extent. The load did not increased anymore when reaching 1338.1kN, which indicated attaining fully plastic state, and the maximum deflection reached 61.4cm.

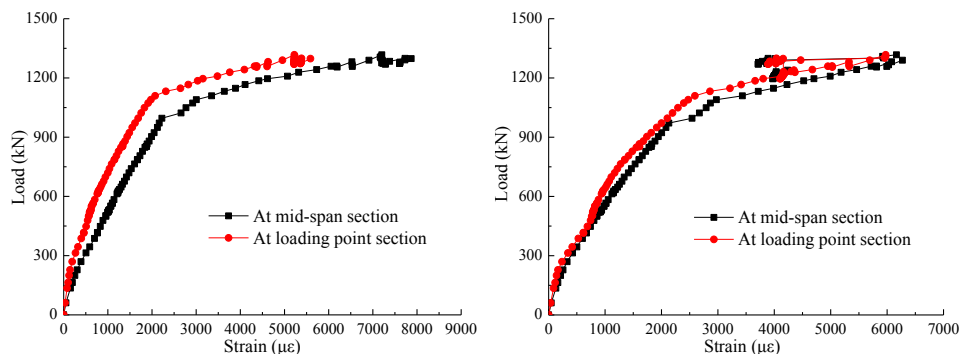
(a) Prestressed CFRP plate at north side (b) Prestressed CFRP plate at south side  
Figure 11 Load and prestressed CFRP plate strain curves

When the prestressed CFRP plate was close to collapse, the relative displacement between the prestressed CFRP plates and concrete was less than 0.1mm, which could be neglected. Figure 11 (a) and (b) show the curves between load and strain of the prestressed CFRP plate at the mid-span section and the loading point section, respectively. Learn from Figure 11, the strain increasing rate of prestressed CFRP plate was increased gradually with the continuous decrease of test girder stiffness. There are two obvious mutation points in Figure 11 at about 200kN and 1000kN respectively, corresponded to new concrete cracking development and the rebar yielding at bottom flange. After that, the strain increase of prestressed CFRP plate was not stable, because the prestressed carbon fiber plate splitting continuously after 1000kN. When the load reached about 1300kN, the prestressed CFRP plate in the south broke partly, leading to the sudden drop of strain curve in Figure 11 (b). When load fell to about 1200kN and then loading again to 1239.6kN, prestressed CFRP plate in the south side broke off. Learn from test result, prestressed CFRP plate occurred brittle failure. The strain of prestressed CFRP plate at south side was relatively uniform, and the strain differences at the mid span and the loading point were not obvious. However, for prestressed CFRP plate at north side, the strain in the mid span was significantly higher than that in the loading point.

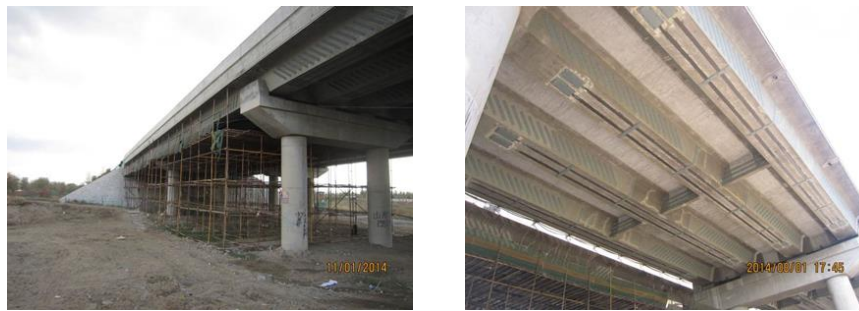
(a) Right half of bridge (b) Strengthening at bottom plate and web  
Figure 12 In-situ bridge after strengthening

According to the inspection result, the specific strengthening measures were determined. Firstly, prestressed CFRP plate was tensioned at the bottom plate to decrease the rebar stress at bottom plate. Three prestressed CFRP plates were tensioned in the exterior girder while two prestressed CFRP plates were tensioned in interior girder. Secondly, strengthening rebars were added in negative moment at pier top to ensure continuous system and increase safety factor. Thirdly, steel plate was pasted on webs within the range of 1.5m to 6.5m away from supporting section, in order to decrease rebar stress at the supporting section and to prevent development of inclined concrete cracking in web. Fourthly, the existing bridge deck pavement was milled and then 16cm thick C45 waterproof concrete layer was paved as well as 8cm thick asphalt concrete surfacing course, to improve flexural rigidity and capacity of the bridge. Double-layer reinforcing mesh was arranged in the bridge deck,

improving transverse integrity of the bridge deck and structural transverse stress condition. The bridge after strengthening is shown in Figure 12.
