Full-scale load tests of Pearl-Chain arches

Published in:
Engineering Structures

Full-Scale Load Tests of Pearl-Chain Arches

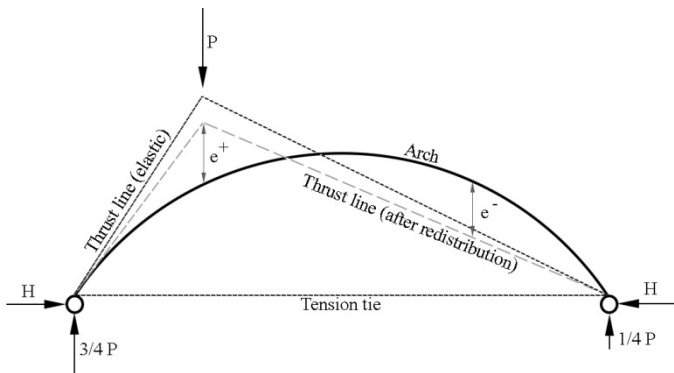
Figure 1: Thrust lines of arch loaded in $\frac{1}{4}$ point of span.

In the figure the thrust line is shown for the elastic case and for the case with moment redistribution from plastic hinges. The optimal condition was a situation where the concrete could undergo enough angular deformation in the plastic hinge for the bending moment to reach the same level in the non-loaded $\frac{1}{4}$ point of the span as in the loaded $\frac{1}{4}$ point of the span. The eccentricity of the thrust line to the arch shape is shown in Figure 1 in the loaded-, e^+ , and the non-loaded side, e^- . The horizontal reaction including plastic hinges was:

The parameter, y , is the equation of the arch shape, and μ is the bending moment distribution of a similar beam (with no horizontal force). The small length, ds , is along the arch centerline axis. From having the arch reactions he calculated the thrust line, and found the normal force in the arch at any point on the span. The positive bending moment was much larger below the load compared to the negative moment in the non-loaded $\frac{1}{4}$ point. To achieve the optimal load carrying capacity, moment redistribution had to occur. That happened when the first plastic hinge was formed below the load where the moment was largest. At a certain length of the span below the point load, the concrete was in the plastic domain of the working curve. This additional angular deformation generated an increase in the horizontal reaction force and the line of thrust therefore became less inclined, compared to the purely elastic case. This change is illustrated in Figure 1.

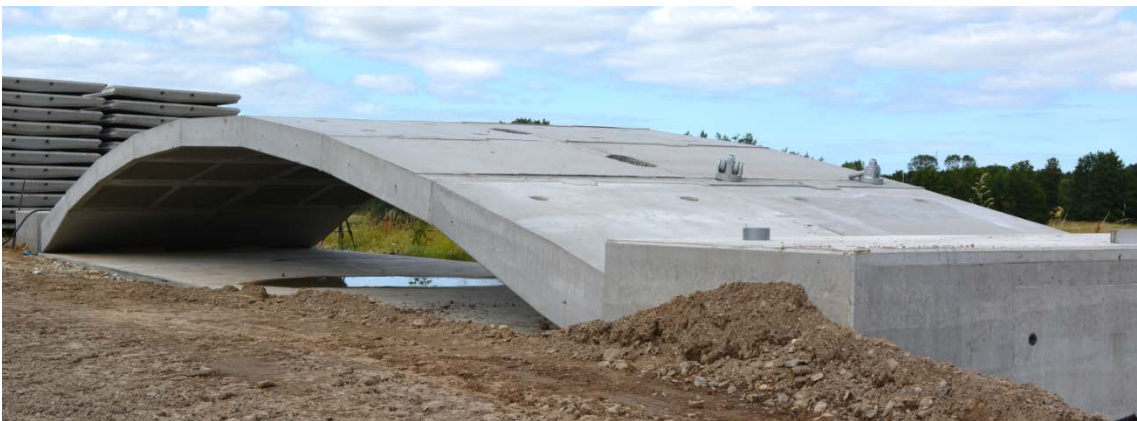
Figure 2: Two adjacent PC-Arches after assembly and lifting.

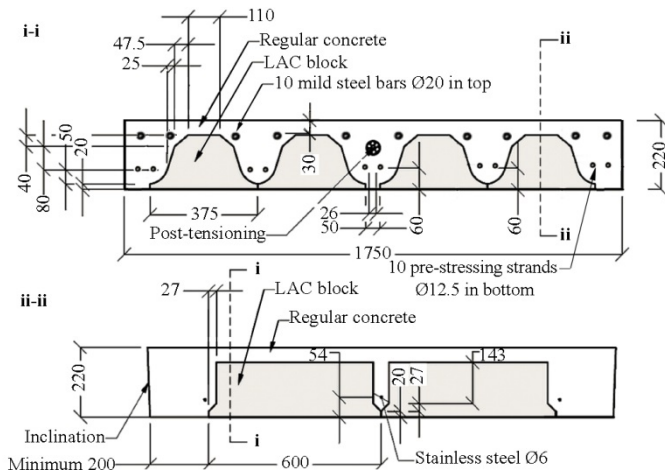
Figure 3: Detailed section cuts of SL-Deck type in the test arches.

Each arch consisted of eight elements (six SL-Decks and two abutment elements), which were post-tensioned together by 7C15 cables. All elements were made of the same concrete mix. The cables were first tensioned to 90% of the 0.1% proof stress of the steel ($f_{p0,1k} = 1634$ MPa), and then grouted. The SL-Decks were approximately 1.60 m long, 1.75 m wide, and 220 mm in section height. This gave space for four LAC blocks across and two lengthwise in each deck element. The resulting area of the normal concrete in an arch cross section with LAC blocks was 0.196 m². The SL-Decks had 10 pre-stressed mono strands in the bottom of the cross section with a concrete cover of 60 mm, and 10Y20 bars (550 MPa mild steel) in the top of the cross section with concrete cover of 30 mm. The material properties of the strands were the same as the previously mentioned post-tensioning cables. See Figure 3 for section cuts of the SL-Decks.

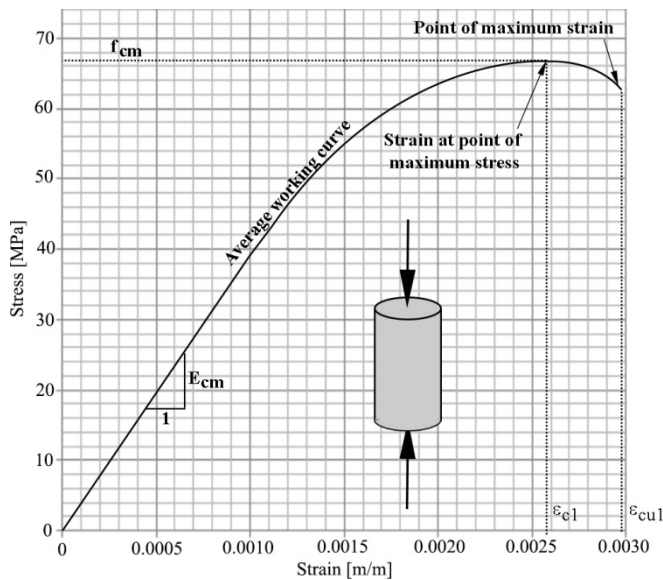
The normal concrete had a characteristic compressive cylinder strength of $f_{ck} = 59 \text{ MPa}$ and a Young's modulus of $E_{cm} = 39 \text{ GPa}$. The concrete's theoretical strain at maximum stress was $\epsilon_{c1} = 0.26\%$. Figure 4 is based on 28 day tests of the uniaxial compressive strength (f_{cm}) combined with values of the Young's modulus (E_{cm}) and strains (ϵ_{c1} and ϵ_{cu1}) calculated with the Eurocode 2 [10]. Cored specimens were tested after the collapse in Test 2 and gave approximately the same Young's modulus and strength.

The true curve would have been dependent on a variety of factors (e.g., mix design, aggregate size and type, and admixtures).

Figure 4: Theoretical working curve for the normal concrete in the SL-Decks.

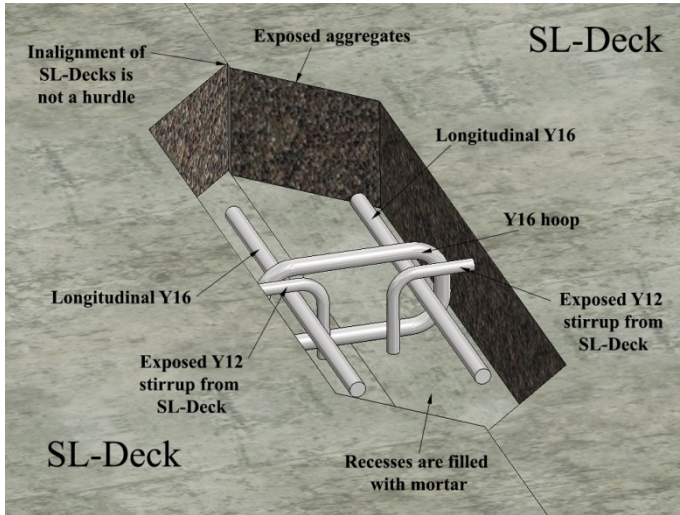
The two arches were tied together with Hammerhead joints. These connections were designed to transfer forces from one arch to the other, and are shown in Figure 5. The connections are completed by first forming recesses in the sides of the SL-Deck elements. Once the arches are erected and aligned, a series of rebars are used to tie adjacent deck elements together. Finally, each recess is filled with mortar. The Hammerhead joint mortar had compressive cylinder strength of 12MPa, and a Young's modulus of 23 GPa. The rebar of a Hammerhead joint consists of Y12 (550 MPa mild steel) stirrups that protrude from the side of each SL-Deck, which are connected

to a Y16 hoop with a Y16 steel bar. The connection detail is often used between deck elements in buildings, and is explained further in [9].

Figure 5: Explanation of transverse Hammerhead joint.

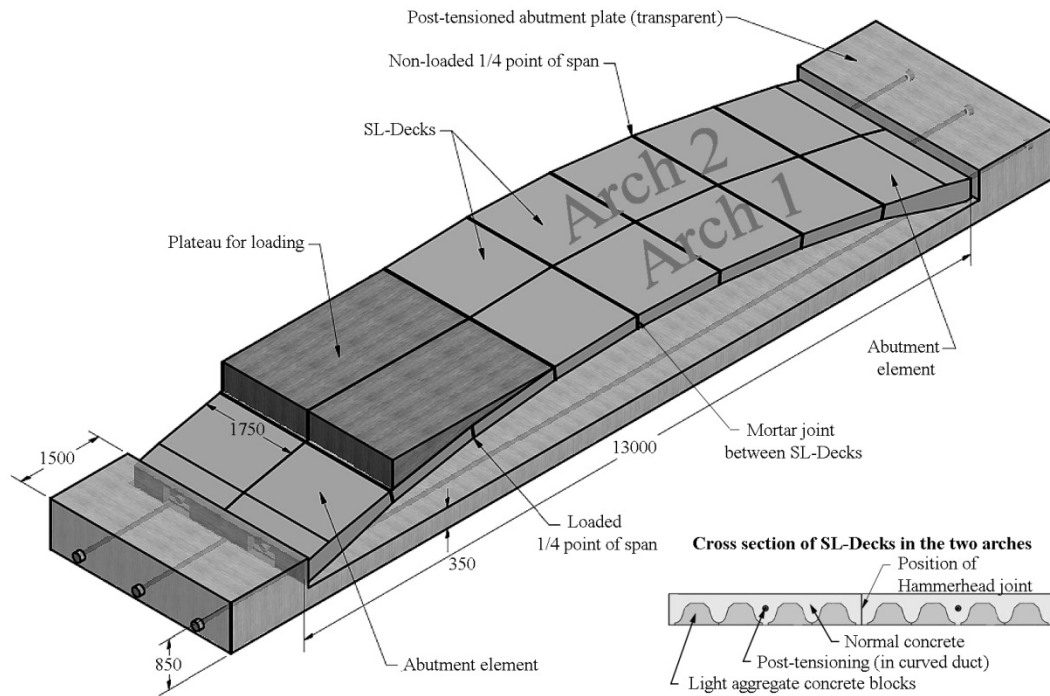
To avoid test result interference from horizontal settlement of the abutments, a post-tensioned abutment plate was cast as a foundation for the test arches. It consisted of concrete with characteristic compressive cylinder strength of 43 MPa, and a corresponding Young's modulus of 36 GPa. Three 7C15 post-tensioning cables were used to post-tension the abutment plate (similar to those in the arches). The distance between the ducts was 1.2 m. The ends of the abutment plate were also heavily reinforced with mild steel. Figures 6 shows the test setup.

Figure 6: Test setup of two 13 m span PC-Arches placed on a post-tensioned abutment plate. All given dimensions are in mm.

Mortar was poured between the PC-Arches and the abutment plate. This mortar had similar properties as the one used in the Hammerhead joints. This was done to provide a smooth, continuous bearing surface for the lateral and vertical support reactions. Statically, it was expected that these joints – which lacked any sort of crossing reinforcement – would behave as hinges, so that the whole system would behave as a two-hinged arch.

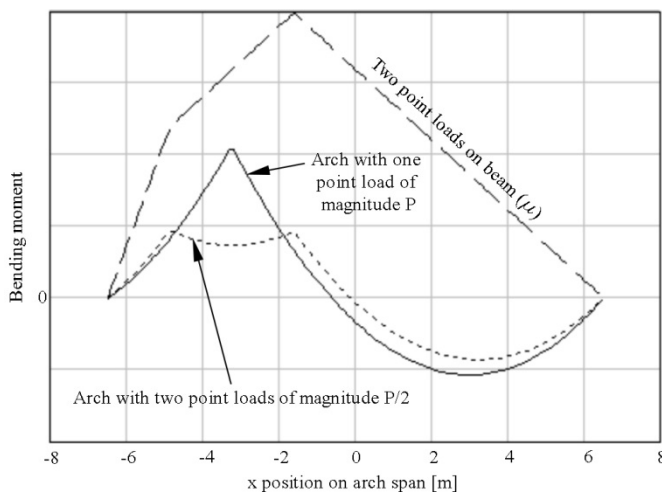
Then the bending moment, $M(x)$, and normal force, $N(x)$, is found. An example of the shape of the moment distributions is seen in Figure 10.

Figure 10: Bending moment in the arch from applied load.

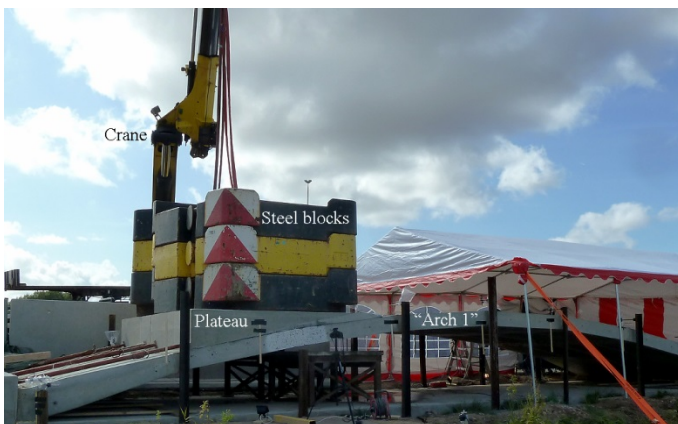
The bridge assembly was tested with two separate phases, with different investigative objectives for each test. In Test 1, deflections and strains were measured during loading to 66 tonnes (648 kN), when the test was stopped for safety reasons. This first test gave evidence for the transfer of forces through the Hammerhead joints, and permitted the study of the distribution of strains within an SL-Deck. Test 2, on the other hand, was conducted in order to determine the specimen's ultimate load capacity, and to observe its collapse mechanism. Figure 11 shows a photograph taken during Test 1.

Figure 11: Test 1. Six steel blocks, each weighing 10 tonnes, were set on the plateaus on “arch 1” (near side in photograph) and “arch 2”.

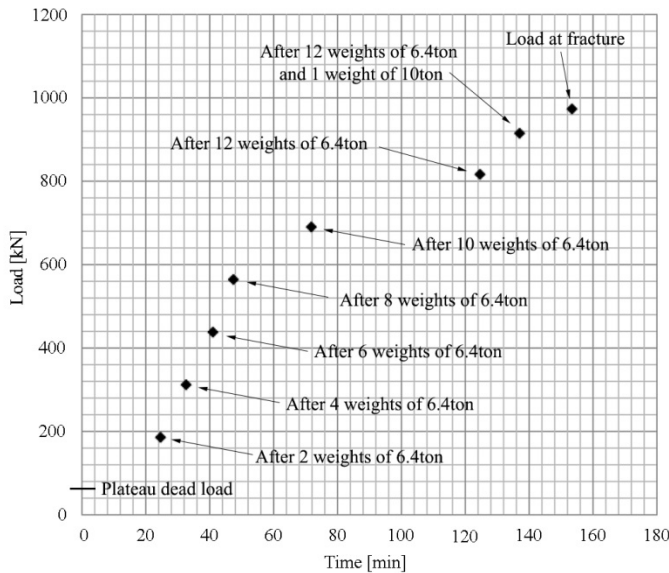
Test 1 was performed with the following procedure. The two arches were loaded with steel blocks, each weighing 10 tonnes (98 kN). First “arch 1” was loaded with one block, and then “arch 2” was loaded with one block. This sequence repeated until three blocks were positioned on each arch, and then the arches were unloaded in reverse order. In Test 1, the maximum applied load at the ¼ point of the span was 66 tonnes (648 kN), which included the mass of the plateaus. Test 2 was executed similarly, but with blocks weighing 6.4 and 10 tonnes. The specimen was loaded to failure of the arches, which occurred at a total load of 98.8 tonnes (970 kN). Figure 12 shows the loading as function of time for Test 2.

Figure 12: Loading sequence for Test 2.

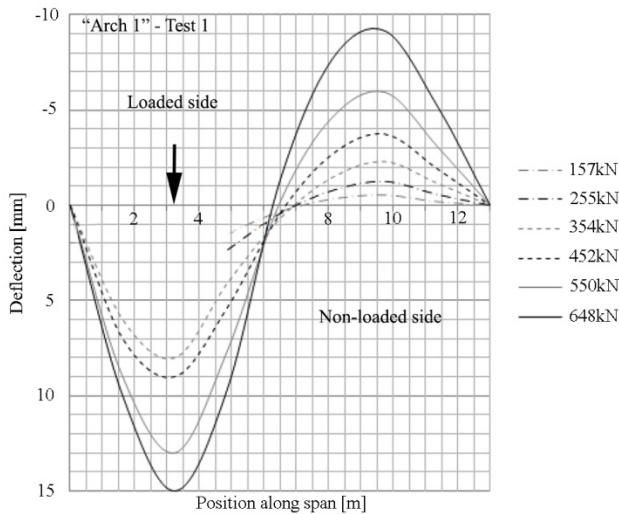
The deflections measurements from the LVDT’s were similar to those measured by the leveling instrument. Because of the LVDT’s gave readings every five seconds, whereas the rulers were only read after every change in loading, only the LVDT data is presented here. In Figure 13, the deflection of “arch 1” is given, and in locations of no LVDT instruments, the deflections given by adjacent LVDT’s have been supplemented with readings from the leveling instrument. For very small deflections, however, the leveling instrument lacked the resolution needed for useful results. During Test 1, the largest deflection on the loaded side was 15 mm. In Test 2, this value was 32 mm at the load level before fracture.

Figure 13: Deflection of “arch 1” for various total loads (accumulated from both arches) at the $\frac{1}{4}$ point of the span, not including self-weight.

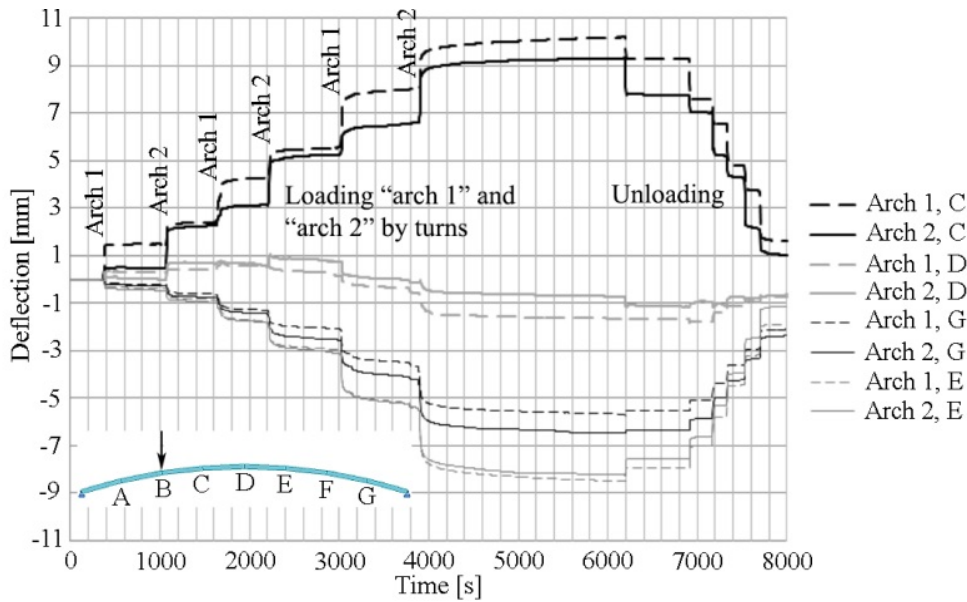
Figure 14 shows the measured deflections of each arch as the loading progressed. The plot indicates that the Hammerhead joints transferred forces between the arches. However, there was some deviation between the deflections because of the unsymmetrical loading. The deflection in “arch 1” increased both when load was applied to “arch 1”, but also when applied to “arch 2”. The results from LVDT 1 and LVDT 2, measuring horizontal settlement of the abutments, showed insignificant deflections of less than $\frac{1}{3}$ of a mm. Therefore, all deflections in “arch 1” when applying load on “arch 2” must come from forces being transferred through the Hammerhead joints.

By comparing the arches’ deflections at locations C, D, E, and G, it appears that the position closest to the loading plateau, had the largest difference in the deflection between the two arches. In Figure 14, it is seen that at position C, “arch 1” deflected more than “arch 2” when the load was applied to “arch 1”, and vice versa. This did not happen in the same way for positions D, E, and G. This trend was expected because the forces being transferred through the Hammerhead joints were likely largest at the location of applied load, but were smaller when moving away from that position. The Hammerhead joints for the test bridge were designed to transfer more than 100 kN each.

Figure 14: Test 1. Comparison of deflections of “arch 1” and “arch 2” at location C, D, E, and G (downwards is considered positive).

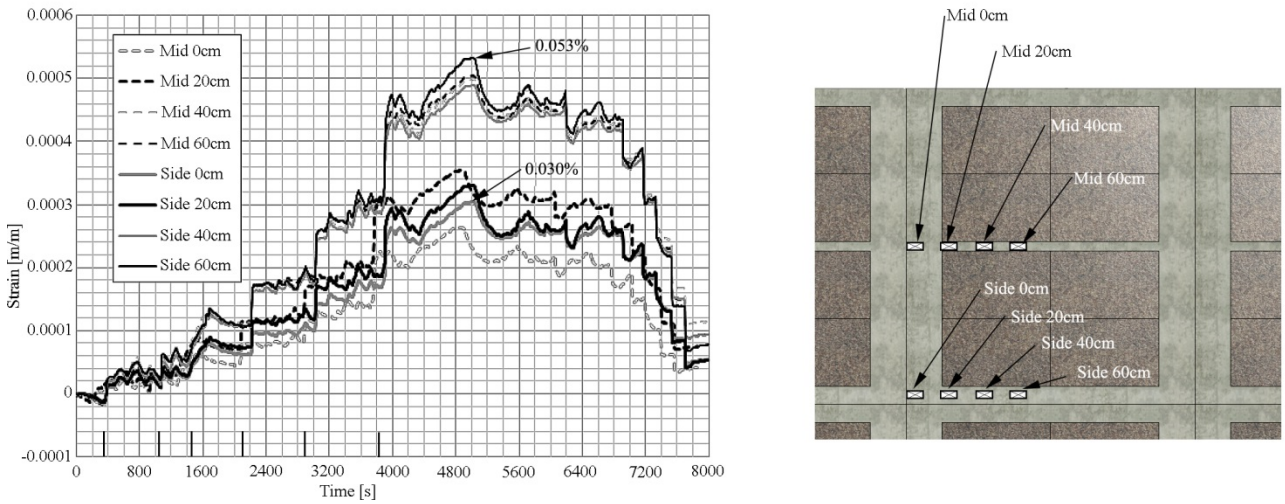
At location F on “arch 2”, concrete strain gauges were attached to the underside of the arch, see Figure 8. The measured strains (in the longitudinal direction of the span) are shown in Figure 16. The vertical tick marks on the time axis indicate the time when each new 98 kN load was applied.

Figure 16: Strains from the eight strain gauges during Test 1 (not including initial strains).

The results show that the largest measured strains developed in the concrete ribs in a cross section of the SL-Deck where the LAC blocks were located. This was expected, since the cross sectional area of the normal concrete was smaller in this zone compared to the zone with no LAC blocks at the ends of an SL-Deck. The thinnest rib was in the middle of the element, and the strains there were approximately 100% larger (at location “Mid 60 cm”) compared to the cross section without LAC blocks (at location “Mid 0 cm”). The strain gauge at “Mid 20 cm” was positioned at the transition between the cross sections with and without LAC blocks. Here, the

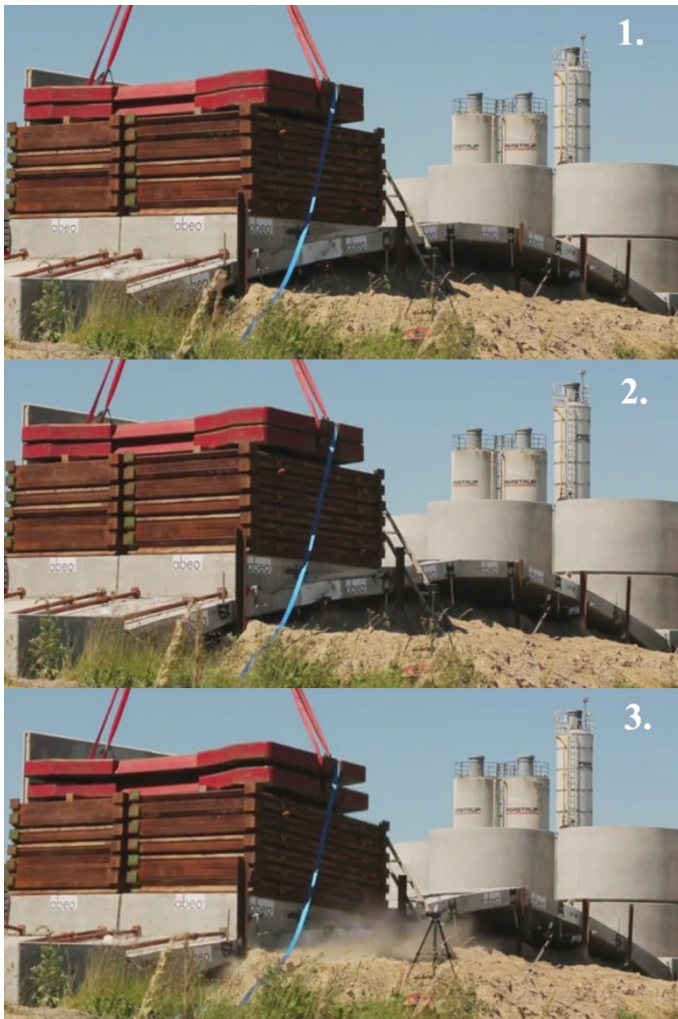
Several different damage warnings were observed in the structure before the ultimate capacity was applied. Figure 17 shows three photographs at the moment of collapse: 1. Plastic hinges forming on the loaded side, and then on the non-loaded side. 2. Loss of structural stability (a four hinged arch which is free to move) at the moment of fracture. 3. Final collapse.

Figure 17: Sequence of observed failures preceding collapse.

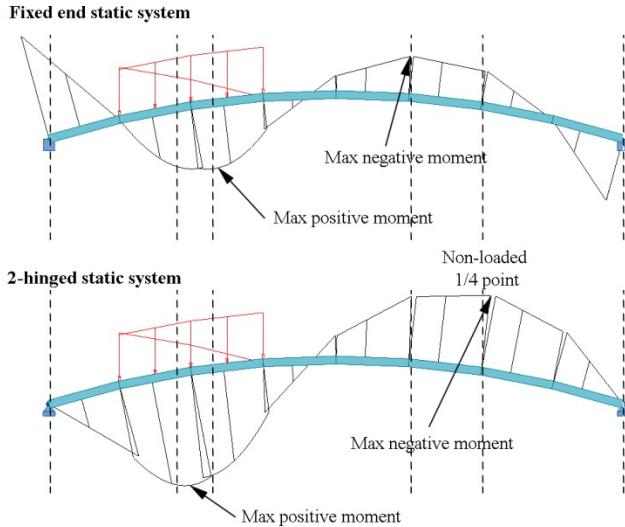
remained far from an ideal hinge with zero bending moment. A plot based on numerical calculations in the program Robot Structural Analysis [12] shows the difference in bending moment distributions, see Figure 18.

Figure 18: Bending moment distribution in fixed vs. 2-hinged arch of same geometry as the tested arches.

The true static system would have been somewhere between the two extremes. This may be the reason why the fracture occurred closer to the crown of the arch in the non-loaded side. Also, a small degree of fixation in the hinges may have reduced the bending moments and hereby give an increase in the load carrying capacity compared to the calculated value. In fact, when checking the load carrying capacity based on an arch with fixed ends, and a load corresponding to the fracture load from the test, there would still be a remaining moment capacity of +102 kNm and -105 kNm in the loaded and non-loaded side, respectively.

The first visible cracks were seen at the connection to the abutments where the hinge rotation took place. Figure 18 compared analyses of the two-hinged and fixed end static systems, and showed that the largest bending moment resulted at the abutments if fixed.

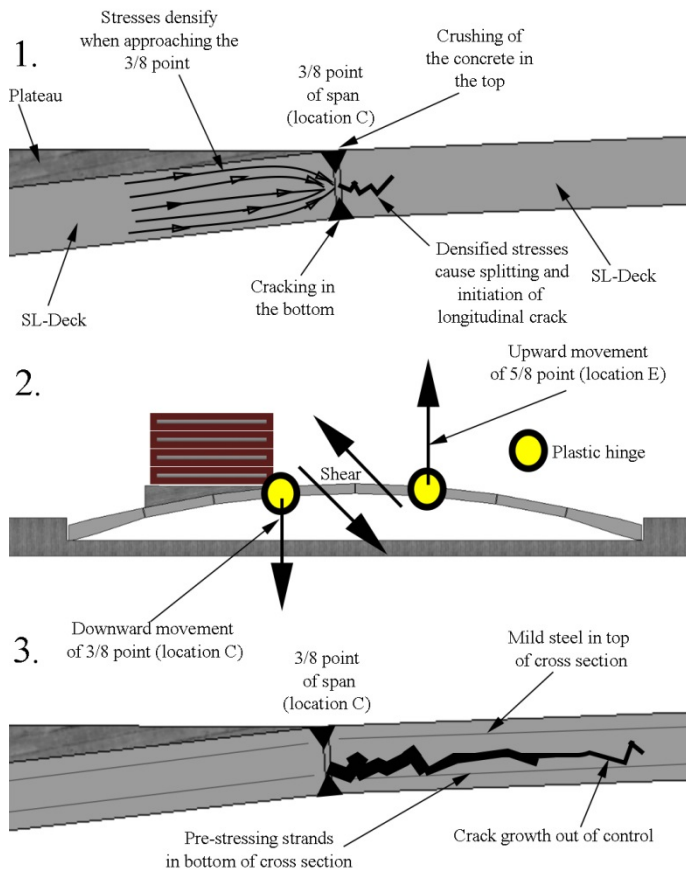
1. A plastic hinge formed at the $3/8$ point of the span on the loaded side of the arch. The plastic hinge concentrated the stresses in that location, since the concrete crushed at the top and a transverse crack opened at the bottom. A longitudinal crack developed in the middle of the adjacent deck element, which was likely caused by a splitting mechanism that resulted from the concentrated normal load being transferred between the deck elements.
2. A plastic hinge formed in the $5/8$ point of the span, at which point the arch became an unstable structure (having four hinges). The $3/8$ point was pushed downwards, and the $5/8$ point was lifted upwards. This

movement would have created a shear force, which would exacerbate the cracking at the 3/8 point of the span.

3. The deflections and crack propagation occurred very quickly. As the plastic hinges moved upwards and downwards, the longitudinal crack lengthened in the mid-depth of the SL-Deck. The crack stayed in the middle of the cross section, probably because of the mild steel reinforcement and the pre-stressing strands in the top and bottom of the cross section.

Figure 19 depicts the observations leading to collapse.

Figure 19: Sequence of events leading to final collapse.

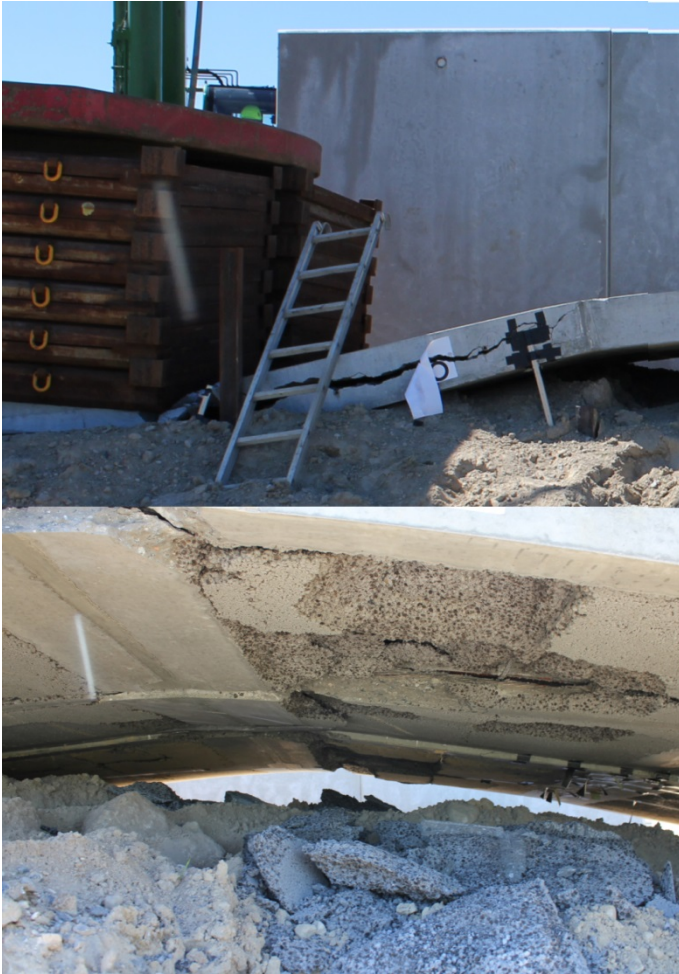
Figure 20 shows photographs of the large longitudinal crack in the loaded side (3/8 point of span – location C), and crushing of concrete on the underside of the arch in the non-loaded side (5/8 point of span – location E).

Figure 20: Photographs taken after collapse: longitudinal crack at 3/8 point (top) and crushed concrete at 5/8 point (bottom).

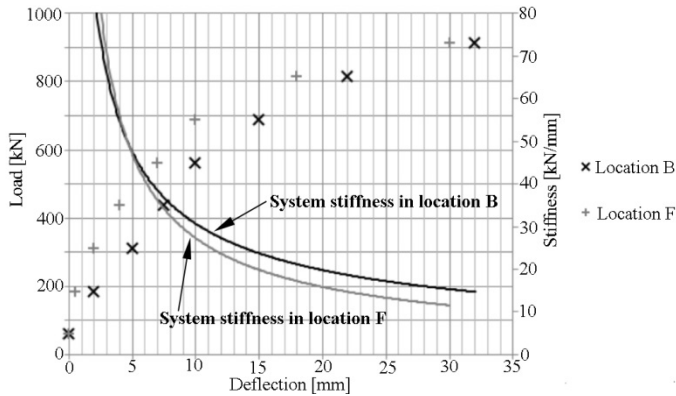
Highly pre-stressed construction members (arches in particular) are often assumed to have a brittle, unwarned fracture. However, the tested PC-Arches showed several warning signs before the collapse occurred. Figure 21 shows the change in system stiffness. On the main vertical axis the load is plotted as function of the deflections for all load levels in the loaded $\frac{1}{4}$ point – locations B – and the non-loaded $\frac{1}{4}$ point – location F. On the secondary vertical axis the corresponding stiffnesses are seen. There is clear system ductility since the stiffness decreases as the load and deflections increase. The figure is based on data from Test 2.

Figure 21: Deflections in location B and F at different loads, and corresponding system stiffness.
