## Electro-desalination of sulfate contaminated carbonaceous sandstone – risk for salt induced decay during the process

Ottosen, Lisbeth M.

*Published in:*  
Science and Art: A Future for Stone

*Publication date:*  
2016

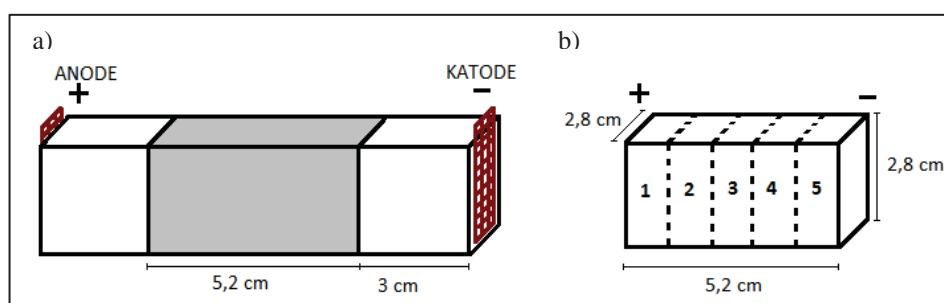
Fig. 2: a) ED setup with clay poultice and electrode mesh; b) segmentation of the stone after ED.

Electrode compartments with the size  $3 \times 3 \times 3 \text{ cm}^3$  were placed at each end of the sandstone piece (Fig. 2A). The frame of the electrode compartments were folded in thin plastic and jointed with tape to fit the ends of the stones. The frames were filled with poultice; a mixture of kaolinite and  $\text{CaCO}_3$  (Rörig-Dalgaard, 2009). Inert electrode meshes (electrodes, which do not take part in the electrode processes themselves) were placed at the end of each electrode compartments, see Fig. 2a. The sandstone and electrode compartments were wrapped in plastic film to hinder evaporation. A constant current of 2 mA was applied. The durations of the ED experiments were 2, 4 or 7 days (denoted ED<sub>2</sub>, ED<sub>4</sub> and ED<sub>7</sub> respectively).

After ED the stones were segmented with hammer and chisel into five segments; numbered from the anode end (Fig. 2b). A reference stone (Ref.) was segmented directly after vacuum saturation by 30 g/l Na<sub>2</sub>SO<sub>4</sub> to get the concentration profiles before ED. The water content in the five segments was measured and calculated as weight loss after drying at 105°C per dry weight. The dried segments were grinded in a mechanical mortar. Following 10 g powder was suspended in 25 ml distilled water and agitated for 24 h. The samples settled for 10 min and *pH* was measured. The samples were filtered through 0.45 µm filter. Na concentrations were analysed by ICP-OES. SO<sub>4</sub><sup>2-</sup> (and for the reference sample also Cl) concentrations were analysed by ion chromatography (IC, Dionex DX-120). For each segment the concentrations were measured as double determinations.

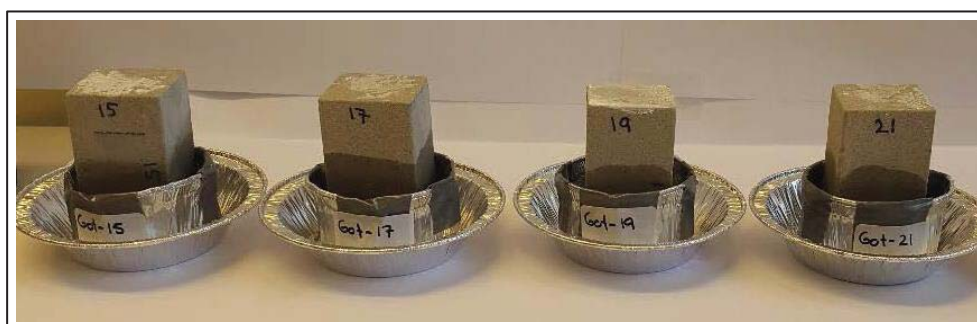
Fig. 3: Suction test after ED.

The present experimental work focuses on stone decay caused by calcium sulfate formed during ED and since this salt has a low solubility it will not necessarily be seen in the concentration profiles measured in the suspension of powdered sandstone in water. Thus it is necessary to evaluate the ED process based also on the decay pattern. Two drying/wetting cycles were performed just after ED: the stone pieces were dried to constant weight at 50°C. They were placed in distilled water to a height of 1 cm (Fig. 3). The surface where the cathode poultice had been placed was placed in the water. The water level in the beaker was kept constant manually. When water had been sucked all the way through the stone piece, the stones were left for 1 day in the setup. The stones were dried again to constant weight at 50°C and the suction procedure was repeated. After the second suction was completed, the stone pieces were inspected visually and compressive strength tests were performed.

Pictures of the stones Ref and ED's after two cycles of water suction are shown in Fig. 5. Some of the thin white layer on the upper horizontal surface originates from the poultice (see also Fig. 3). During the suction, the soluble salts are transported towards the top of the stone, which means a concentration of salt in this part and a lower concentration in the remaining stone. It is seen that the upper corners were damaged for the Ref and ED<sub>2</sub> experiments whereas similar damage was not seen for ED<sub>4</sub> and ED<sub>7</sub> revealing that the overall concentration was lowered sufficiently after 4 days.

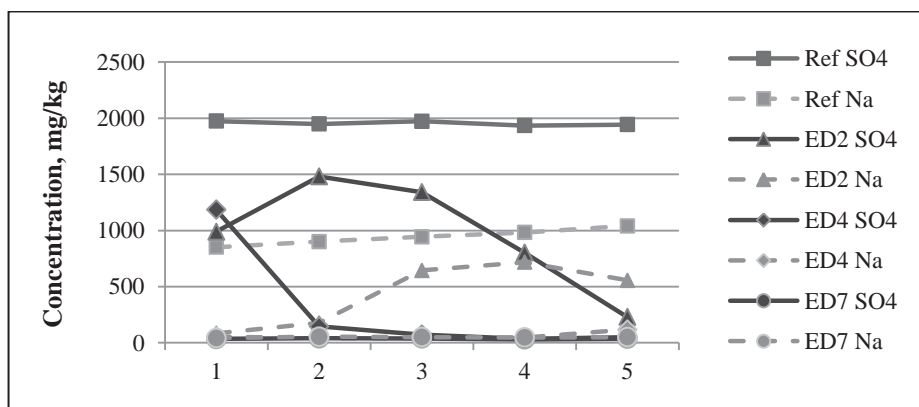
Fig. 4 shows the concentration profiles of SO<sub>4</sub><sup>2-</sup> and Na through the stone piece at the end of the ED experiments. It is seen, that SO<sub>4</sub><sup>2-</sup> electromigrated towards the anode and Na towards the cathode, as it could be expected. The initial concentrations (Ref.) were 1950 ± 35 mg SO<sub>4</sub><sup>2-</sup>/kg and 940 ± 80 mg Na/kg. At the end of ED<sub>7</sub> the concentrations were decreased to 36 ± 4 mg SO<sub>4</sub><sup>2-</sup>/kg and 49 ± 5 mg Na/kg. This corresponds to removal percentages of 98% SO<sub>4</sub><sup>2-</sup> and 95% Na during 7 days.

Fig. 4: SO<sub>4</sub><sup>2-</sup> and Na concentration profiles of Ref and ED stones.

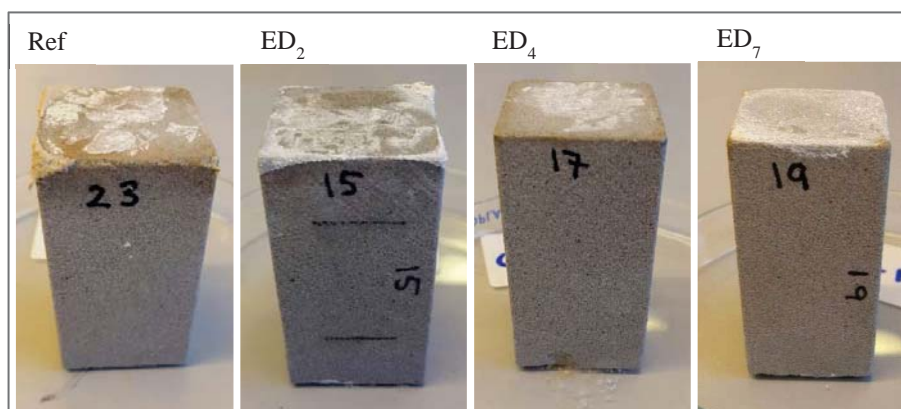
Fig. 5: Ref and ED stones after two water suction cycles.

It is noticed, that the soft material/crystals at the damaged corners of the Ref and ED<sub>2</sub> stone differs. At the Ref. it has the colour of the sandstone and at ED<sub>2</sub> the salt crystals are white. It might be different salts responsible to the decay in the two cases, but it is not determined in this investigation. In the Ref stone the  $\text{Na}_2\text{SO}_4$  in which the stone was submerged is considered the major salt, whereas in ED<sub>2</sub> also  $\text{Ca}^{2+}$  may have been transported from the anode poultice into the stone. The calcium sulphate will dissolve again as long as  $\text{Ca}^{2+}$  and  $\text{SO}_4^{2-}$  are removed from the pore solution in the applied electric field as equilibrium supports the dissolution. The lack of crystals on ED<sub>4</sub> and ED<sub>7</sub> support this hypothesis.

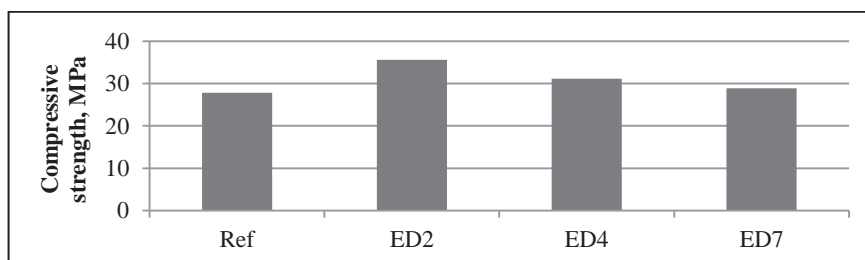
Fig. 6: compressive strength after ED and 2 suction cycles (single determinations).

The fact that the  $pH$  did not change from the anode side is not a proof that  $H^+$  did not electromigrate into the stone. Gotlandic sandstone has a buffering capacity towards acid as it is calcite bound, which was shown experimentally in Skibsted (2014). In case an acidification had occurred during the ED treatment, this would decrease the compressive strength of the stone as result of dissolution of calcite. Thus it was decided to make compressive test measurements. The compressive strength tests were conducted after the suction cycles, and the stone compressive strength could be influenced from both acidification and salt weathering. The result is shown in fig. 6 and 7. A quite large variation in compressive strength was observable between the four stones. The Ref. stone had the lowest compressive strength of all four stones, which may indicate that ED does not lower the strength significantly by dissolving the bonding calcite phases, but the data are too scarce to make a final conclusion on this point. Fig. 7 shows that the pattern with which the stones were broken during the compressive strength tests differed. The pattern was linked to the compressive strength in that for the Ref and ED<sub>7</sub> stones with the lowest compressive strength, the stones were damaged by flaking from the surface, whereas the two stronger stones ED<sub>2</sub> and ED<sub>4</sub> were broken in the expected pattern hourglass figure for a homogeneous sample.

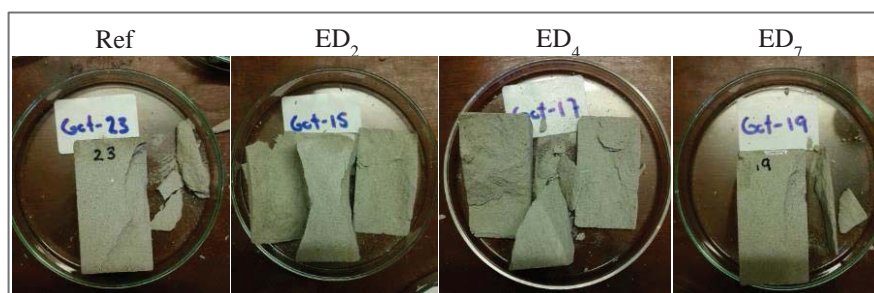
Fig. 7: The stones after compressive strength measurements.
