Electro-desalination of glazed tile panels - discussion of possibilities

International RILEM Conference on Materials, Systems and Structures in Civil Engineering

ELECTRO-DESALINATION OF GLAZED TILE PANELS – DISCUSSION OF POSSIBILITIES

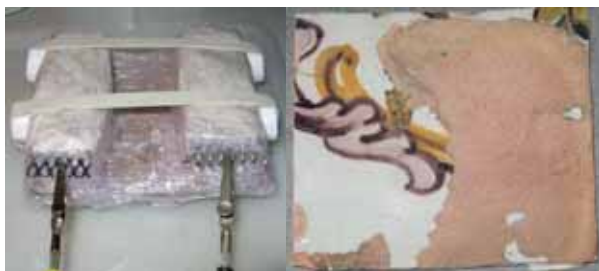
Figure 3: (a) Experimental setup for desalination of single tile; (b) 20th century tile used in lab experiment.

Experiments have been reported with electro-desalination of single tiles in the laboratory [10-12]. The experimental setup of these is illustrated in figure 3a. The tiles were placed with the glaze down and because they had dried out during indoor storage, water was sprayed on the back side before placing the electrode compartments (poultice and inert electrode mesh) as far apart as possible. The tile and electrode compartments were wrapped in plastic to hinder evaporation of water, which would hamper the passage of electric current. A constant current was then applied to the electrodes. Moist pores are needed in order to be able to have passage of current through the biscuit. In cases, where salt decay is problematic, water must be present at least during some periods and it is assumed that it is not neither necessary to add extra water or cover the wall as in the laboratory atmosphere with very low RH.

An experiment with electro-desalination of a Portuguese 20th-century tile (figure 3b) has also been conducted (not previously published). The average initial concentrations were 700 mg Cl^- /kg and 930 mg SO_4^{2-} /kg and thus the salt contamination was much less than the older tiles from Palácio Centeno. After 3 weeks with 1 mA applied 76% Cl^- and 87% SO_4^{2-} were removed. Hereby it was shown that also this biscuit type can be desalinated.

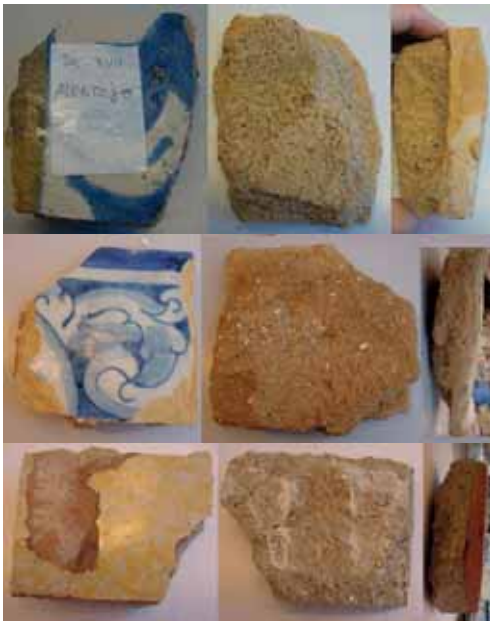
Figure 4: experimental tiles with mortar. Top: 17th century tile from Alentejo (PT); middle: 18th century tile from Palacio Centeno, Lisbon; bottom: 20th century tile of unknown origin.

Brammer & Sveegaard [15] and Ferreira et al [16] reported laboratory results with electro-desalination of three tiles from different centuries. Mortar was attached to the tiles in these investigations (see figure 4). Each of the three tiles was broken. The tiles were: 17th-century tile from the Alentejo Region (mortar very hard and unfortunately not considered original), 18th-century tile from Palácio Centeno, Lisbon (mortar very porous and loose, considered original) and 20th-century tile of unknown origin (mortar was hard, but is considered original). Initial samples were taken from both tile and mortar prior to the desalination experiments. From the first two tiles it was only one sample from both. The 20th-century tile was separated into two pieces where one was used to find the initial salt concentration and the other for the desalination experiment.

As in the experiments with single tiles, the tiles were placed with the glaze down. Water was sprayed on the mortar, which was now the upper part and the electrode compartments were placed on the mortar surface. The overall conclusions from the electro-desalination experiments with tile and mortar attached were:
