Durability of air lime mortar

Nielsen, Anders

Published in:
Proceedings of the International RILEM Conference

DURABILITY OF AIR LIME MORTAR

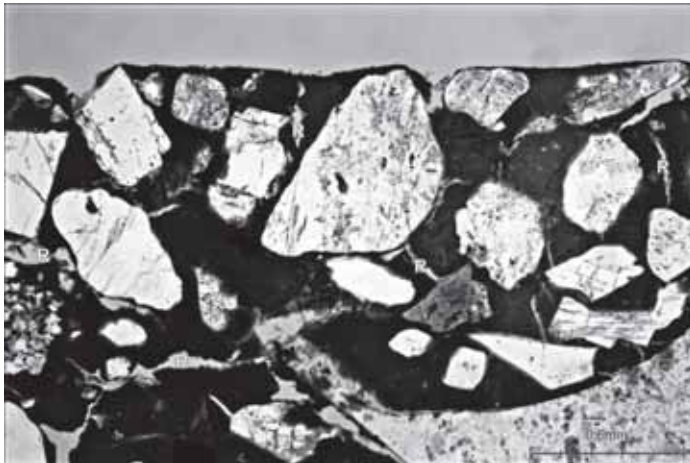
Figure 5. Enlargement of the section of the medieval mortar. The “R”s show cracks.
Transmitted light. No filters. Dark colour is lime binder. Top of the picture is the outside surface with the dense calcium carbonate layer. (Photo: SEIR-materialeanalyse A/S)

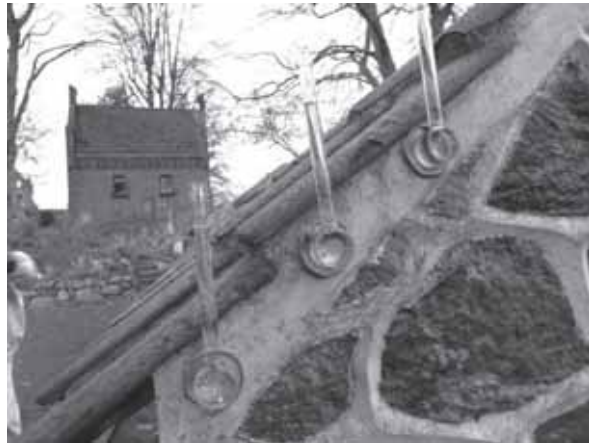
Figure 6. The 25% mortar developed by Ole Jensen was also used by the repair of a wall around the churchyard at Farum church. Picture is taken during measuring of capillarity with the Karsten tubes. (Photo: Martin Jensen)

The mortars from Kirke Værløse and Farum churches were included in a project, where the moisture properties of different air lime mortars were examined [3]. The capillary suction capacity was measured by means of the so-called Karsten tube.

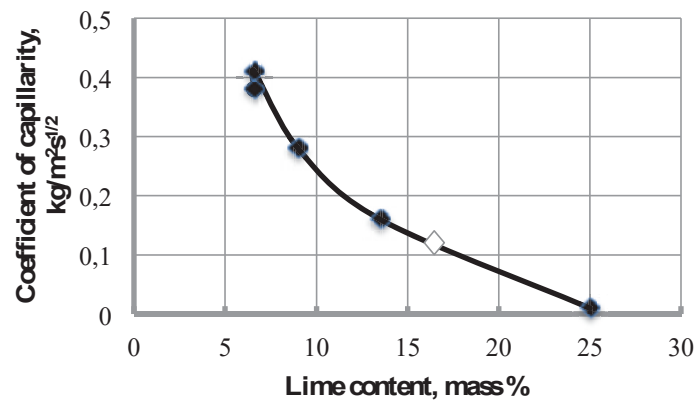
Figure 5. Coefficient of capillarity of air lime mortars. Measured by means of the Karsten tube. The white mark is the result from the very common lime-cement mortar KC50/50/700. From [3].

The coefficients of capillarity were calculated from the measurements by means of a method invented in [5]. In laboratory measurement were taken on platens of 6,6%, 9% and 13,5% air lime mortar. Specimens of the in Denmark very common used lime-cement mortar KC50/50/700 (50 kg air lime, 50 kg Portland cement, 700 kg sand) were included for comparison. The results are seen in Table 1 and Figure 5. - In a textbook [4] the coefficient of capillarity for lime mortar can be read as $0,25 \text{ kg/m}^2\text{s}^{1/2}$ and for concrete to 0,01 - 0,3 $\text{kg/m}^2\text{s}^{1/2}$.

lime was not enough to secure against frost damage. This finding coincides with the capillarity seen in Table 1 and Figure 5. Which lime content is enough to secure frost resistance should be cleared out in further research.
