# Magnesium-oxide boards cause moisture damage inside facades in new Danish buildings

International RILEM Conference on Materials, Systems and Structures in Civil Engineering 2016

Publication date: 2016

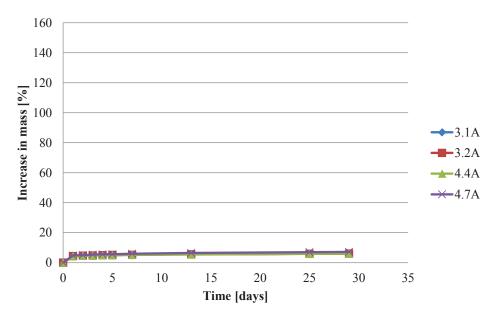
Figure 11: Course of the moisture retention at 35% RH.

The initial moisture absorption in MgO-boards from the surrounding air was measured at three different levels of relative humidity at 23 °C: 35% RH, 80% RH and 95% RH. Before start of the moisture exposure, samples of size 5 x 4 x 3 mm were dried at 105 °C for 4 days, and cooled to room temperature. MgO-samples with a total weight of about 2 g were placed in a petri glass dish, which was placed inside a basket made of Teflon. Weighing of the baskets were performed without opening the front doors of the climate chambers, as the baskets were hung up one by one below the balance by means of a steel string. Figure 9 shows the climate chamber where the actual RH is created by mixing flow of dry air with flow of saturated air. Based on a calibrated RH-sensor the connected PID-system regulates the dry airflow and the saturated air flow for obtaining the wanted RH. In this way, the RH is created in wanted steps. Figure 10 shows the specimens in the petri glass dishes placed in the baskets. The measurements were performed after 0, 1, 2, 3, 4, 5, 7 days and after 2 and 4 weeks. The results are presented in Figures 11, 12 and 13. Indication of mould growth on specimen 4.4C was seen after 30 days of exposure to 95% RH, cf. Figure 14.

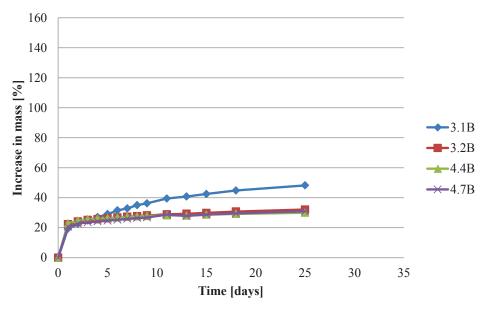
Figure 12: Course of the moisture retention at 80% RH.

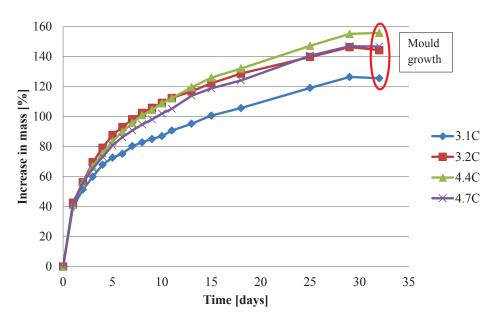
Figure 13: Course of the moisture retention at 95% RH.

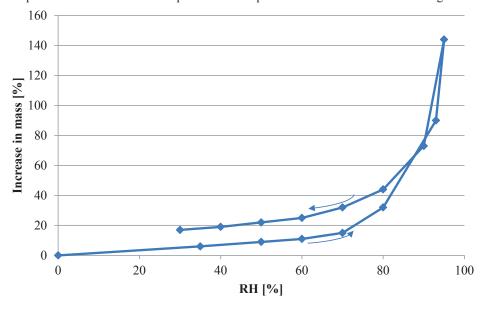
Absorption was measured for specimens that were originally used for initial moisture absorption at 35% RH. The absorption points were measured from 35% RH and up to 92% RH. An example of the results of the absorption and desorption measurements is shown in Figure 15.

Figure 15: The results of the absorption and desorption measurements for specimen 3.2.

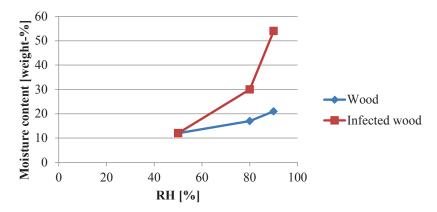
The pine wood posts supporting the adjacent MgO-boards inside the façade construction absorb the water drops ('tear' drops) from the MgO-boards. The 'tear' drops contain relatively high amounts of chloride ions. Infected wood from a post from a house, as well as non-infected wood, have been used for absorption measurements as follows: First, the infected wood and the non-infected wood pieces were conditioned to attain equilibrium at 50% RH. They were then conditioned to equilibrium at 80% RH, and finally to equilibrium at 90% RH. The absorption curves for the infected wood and the non-infected wood are shown in Figure 16.

Figure 16: The absorption curves for the infected wood and the non-infected wood.
