CRCP on the N49 – How the repair of the longitudinal joint leads to a better view on the crack formation of CRCP

Abstract

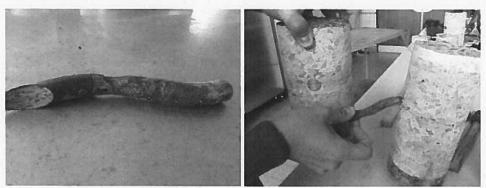
Figure 3. Elongation of a tie bar at the longitudinal joint

In the direction of Antwerp an elongation of the tie bars took place, as can be seen in Figure 3. In order to be able to straighten the tie bars, a steel quality BE 220S was used. The bars were smooth and had a diameter of 16 mm. A reduction in diameter from 16 mm to 13.13 mm was measured in the middle of the tie bar at the longitudinal joint. In this direction the bond with the concrete was very good, but the steel quality was too low to prevent the joint from opening.

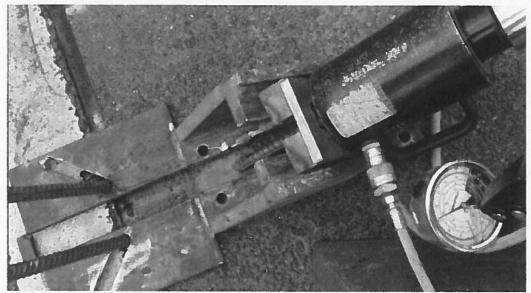
Figure 10. Tensile test on a elongated tie bar on site

In order to test the stitching system, different tension tests were carried out on tie bars placed in the concrete as can be seen in figure 10. Each time, a tensile force up to 10 ton was applied, which was the double of the required tensile force of 5 ton.
