Self-Healing Concrete
Encapsulated Polymer Precursors as Healing Agents for Active Cracks

João Luis Garcia Feiteira

Promotoren: prof. dr. ir. N. De Belie, dr. ir. E. Gruyaert
Proefschrift ingediend tot het behalen van de graad van
Doctor in de ingenieurswetenschappen: bouwkunde

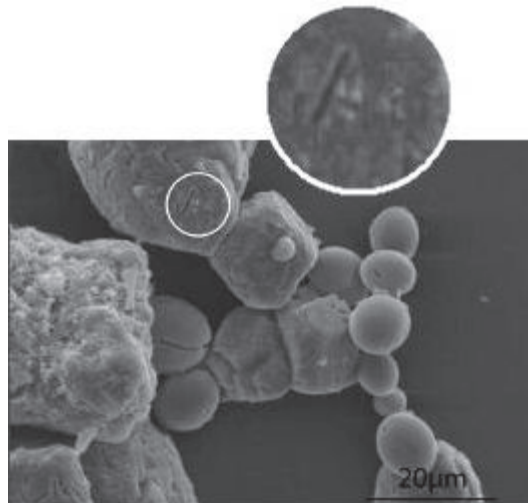
Figure 1: contrast between the large volume of CaCO_3 crystals and the size of precipitating bacteria as shown by their highlighted imprints (Xu et al. 2015).

A particularly ingenious mechanism of self-healing is the addition to concrete of bacteria that precipitate CaCO_3 . Dormant bacterial spores are added to concrete along with the required nutrients, which they metabolize as soon as abundant water and/or oxygen are available, which occurs once a crack develops in the concrete matrix. The metabolism can differ depending on the type of bacteria, but it results nonetheless in the precipitation of CaCO_3 inside the crack. However, the alkaline environment of the concrete matrix can damage the bacteria, which require protection through encapsulation or by embedding them in a protective material. An important advantage of bacterial healing is the large volume of healing material that can be generated by bacteria, with the precipitated CaCO_3 crystals occupying many times their volume inside a crack, as shown in Figure 1.

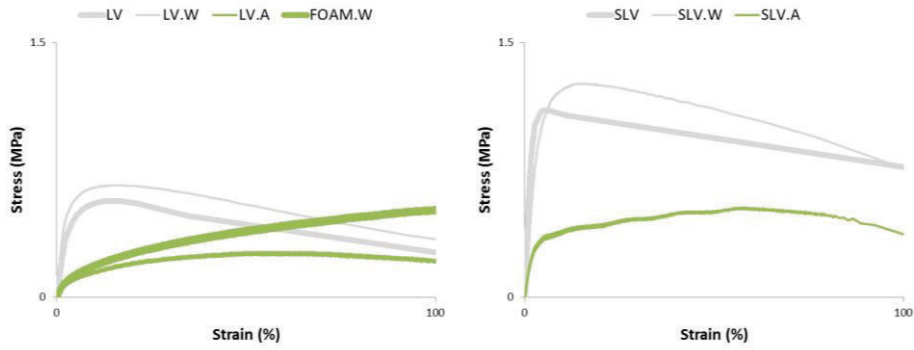
Figure 6: stress-strain curves resulting from tensile loading of cylindrical mortar specimens bonded by polymers.

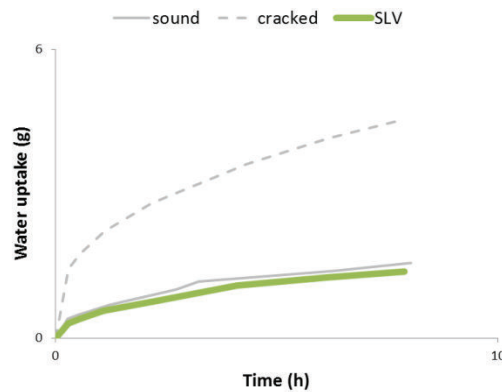
Figure 10: water uptake due to capillary sorption in sound specimens and specimens containing open (cracked) and fully healed (SLV) cracks.

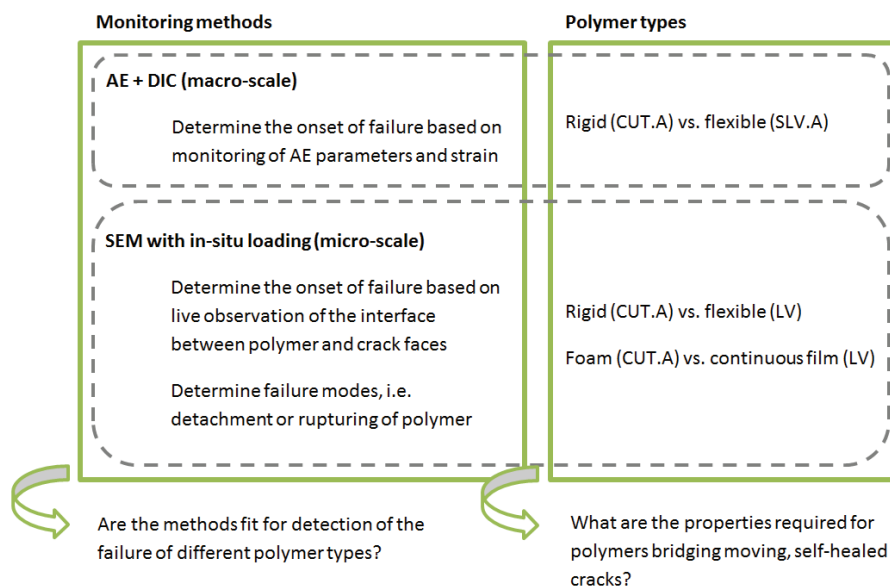
Figure 17: schematic of the research study; see tables 6 and 7 for the description of polymer series LV, SLV.A and CUT.A.

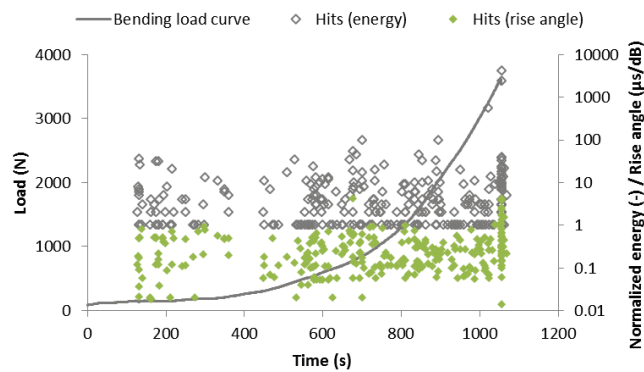
Figure 20: bending load, acoustic hits and relevant acoustic emission parameters until failure of a sound specimen; the cloud of data points acquired before failure establishes the background noise of the tests.

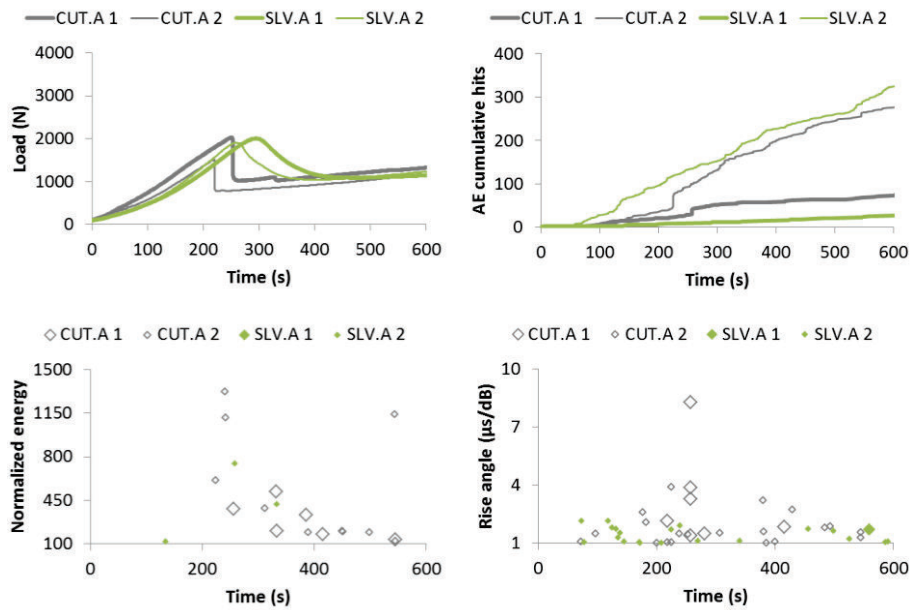
Figure 21: bending load curves, acoustic hits and relevant acoustic emission parameters during widening of healed cracks.

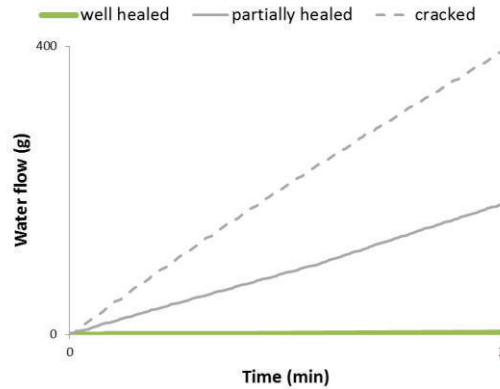
Figure 33: typical linear water flow through cracks with different degrees of healing.

$$Healing\ efficiency = \frac{WF_{cracked} - WF_{healed}}{WF_{cracked}} \times 100\%$$

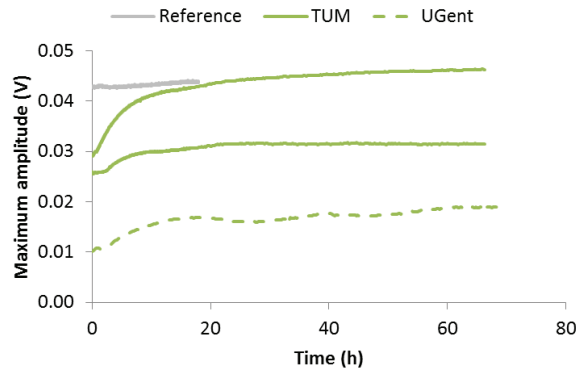
Figure 46: monitoring of ultrasonic shear waves transmitted across a cracked section in concrete specimens.

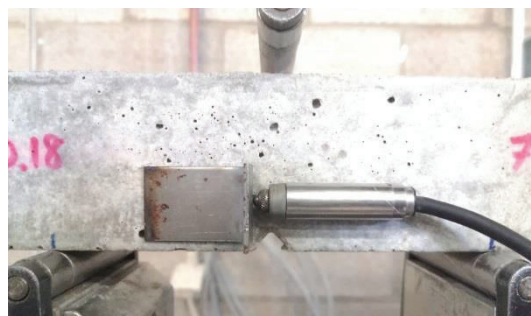
Figure 66: LVDT positioned at the side face of a specimen to measure the crack size at the height of the embedded capsule.

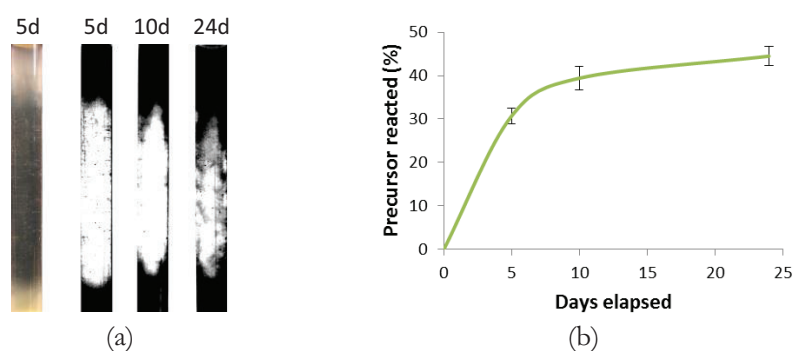
Figure 71: progressive reaction of a moisture-curing precursor inside glass tubes sealed with PMMA glue (a) and data plot of 3 specimens (b); for 5d both original and binary images are shown.

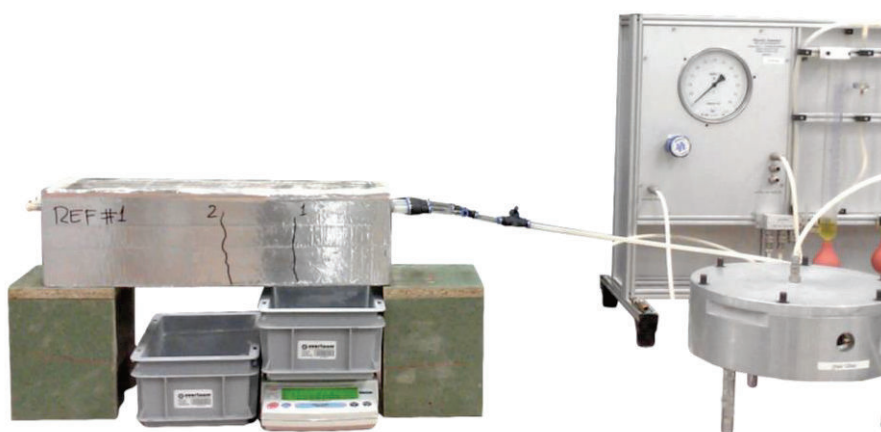
Figure 80: test setup for determination of water flow through cracked planes.
