# LOS ANGELES AIR FORCE BASE FITNESS CENTER

A Comprehensive Fire and Life Safety Analysis

Colin White  
June 2017

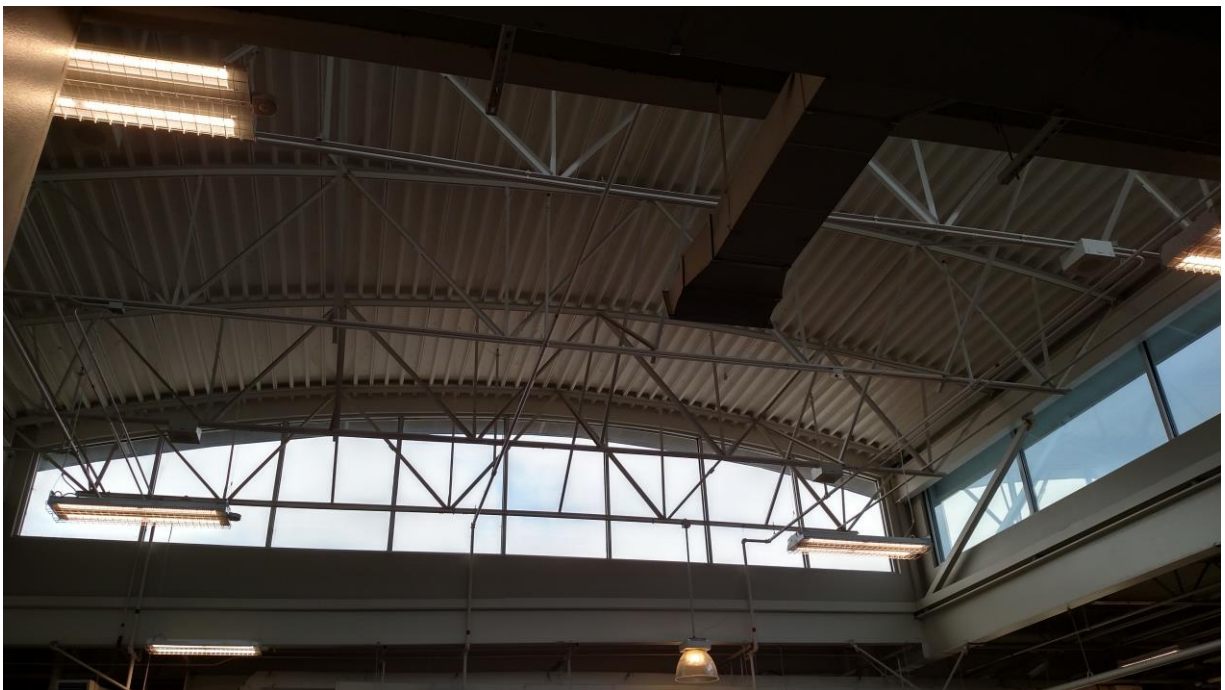
Figure 31 – Clearstory above the Weightlifting Room

There is no dedicated smoke management system for this building. Smoke is managed passively through the use of in-duct smoke detectors which, when triggered, will shut down the HVAC system in order to reduce the spread of smoke. Additionally, there are multiple clearstories (see Figure 31) which may serve as smoke reservoirs in the event of a fire. These clearstories will increase the time it takes the smoke level to drop to a point where it impacts building evacuation.

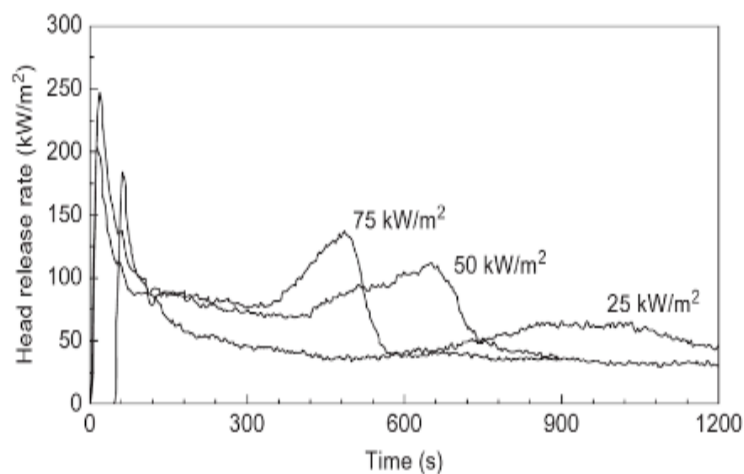
**Figure 32 – Sauna Fire Curve**

The fire starts when an occupant carelessly drops a towel on the heating element in the sauna as he is leaving the room. This towel ignites, subsequently setting the western red cedar paneling in the sauna on fire. This results in a t-squared fire with a peak heat release rate (HHR) of 250 kW/m<sup>2</sup> and a medium fire growth rate. A representative fire curve for western red cedar, taken from the Handbook of Environmental Degradation of Materials, is shown in Figure 32. Due to the condition of the sprinkler system, it does not activate and the fire burns undetected until noticed by other patrons in the locker room who activate the fire alarm via a manual pull station as they egress the building.

**Figure 9.11** Cone Calorimeter heat release rate data for western red cedar.

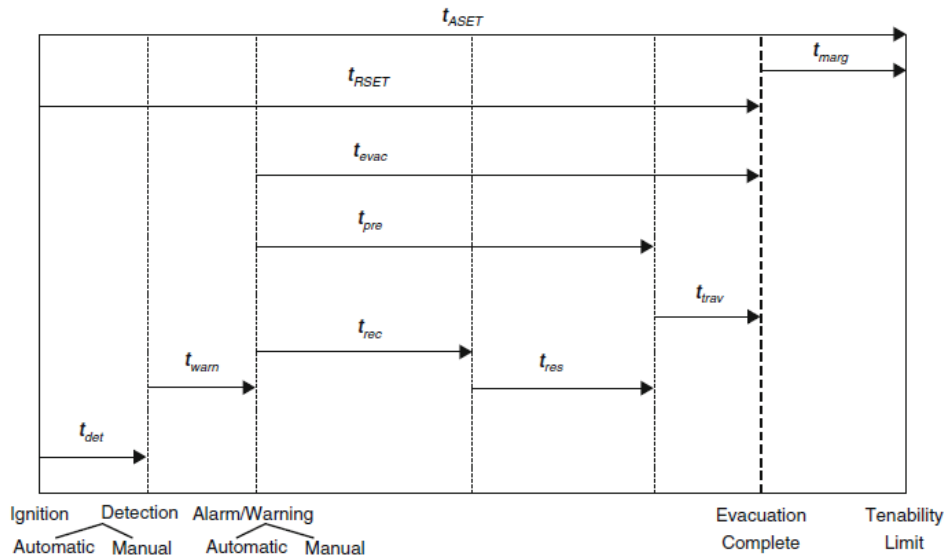
Figure 33 – Required Safe Egress Timeline

- Detection Time ( $t_{dec}$ ) – Time required for the fire to be detected

- Warning Time ( $t_{warn}$ ) – Time from detector activation to alarm sounding
- Pre Movement Time ( $t_{pre}$ ) – Composed of recognition and response time
  - Recognition Time ( $t_{rec}$ ) – Time to recognize the alarm
  - Response Time ( $t_{res}$ ) – Time to respond to the alarm and start movement
- Movement Time ( $t_{trav}$ ) – Time required to travel to exit

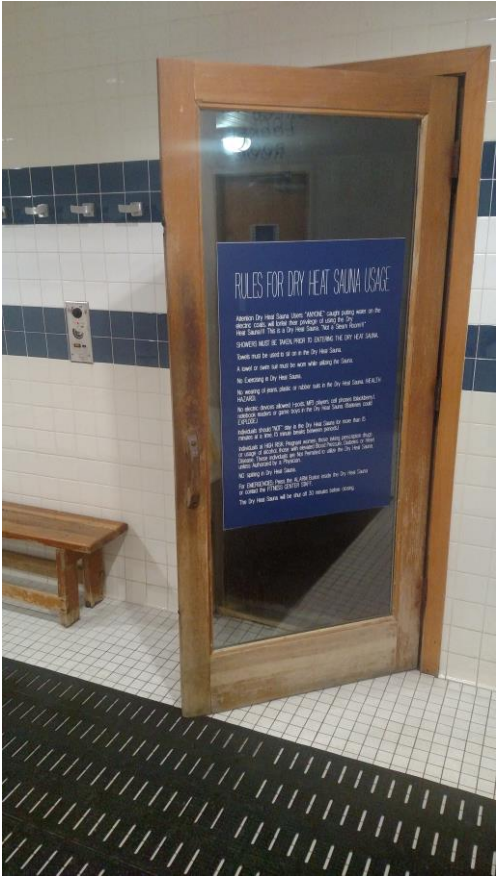
Figure 34 – Sauna Door Stuck on Non-Slip Floor Mat

In this scenario a fire starts in the sauna when a towel is inadvertently left on the sauna's heating element. This issue is exacerbated when the door to the sauna is stuck in the open position due to interference with a floor mat, see Figure 34. This results in an open door which allows smoke to flow into the room and causes conditions in the shower area to become untenable in about 70 seconds, see Figure 35. Fortunately, the occupants egress this area in about 60 seconds. Figure 36 shows the status of the evacuation at 70 seconds. However, conditions rapidly deteriorate and by 80 seconds visibility has dropped below tenability limits in the vicinity of the west exit from the room (Figure 37). At this point occupants are still in the room. By 100 seconds the locker room is empty. This is about 20 seconds before the visibility drops below 7 m throughout the entire room. Once it exits the locker room smoke flows north and south along the corridors and rapidly collects at the ends of the corridors where the primary exits are. 300 seconds after ignition conditions have dropped below tenability limits at both corridors exits (Figure 38). At this point there are still over 200 occupants in the fitness center, see Figure 39. At 396 seconds the evacuation is complete. At this point visibility throughout most of the gym has dropped below 4 m as shown in Figure 40.

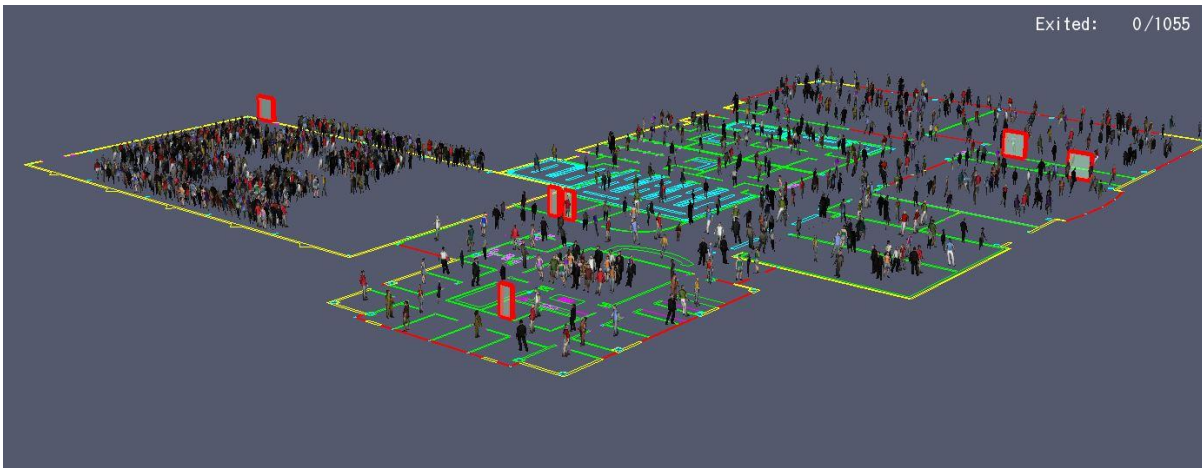
**Figure 42 – Occupancy Conditions at the Start of the Foam Mat Fire**

Figure 42 is a Pathfinder depiction of the occupancy configuration at the start of the foam mat fire. Since the fire occurs by one of the gymnasium exits, this exit will not be available during the evacuation. This scenario will evaluate the impact of this on the ability of the occupants to safely egress from the building. FDS analysis determined that visibility was the constraining tenability criteria for this scenario. Temperature conditions during the fire never exceeded 45°C. Conditions in the vicinity of the main exit in the gymnasium became untenable due to lowered visibility at 230 seconds. At this point conditions were still tenable at the other exit but due to occupants favoring the main exit a large crowd still remains in the gym. Figure 43 shows the corresponding visibility slice file for this point in the simulation. Figure 44 shows the crowd of occupants at the primary gymnasium exit at the point conditions become untenable. Complete evacuation of the gym doesn't occur until 260 seconds after ignition. Occupants in this portion of the gym were exposed to untenable conditions in the gym for approximately 30 seconds. At 360 seconds conditions became untenable throughout the gym as shown in Figure 45.
