## ***ENHANCING DUCTILITY OF WWR SLABS***

### **ABSTRACT**

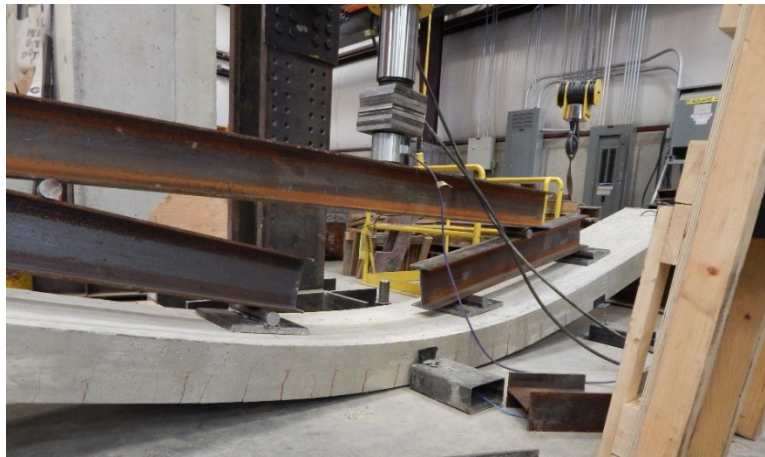
*Figure 5 – Maximum deflection of SR3, note the well distributed cracking*

Sixteen concrete one-way slabs were tested with rebar (SR3 and SR4) and WWR (SW5 through SW18). Failure modes were markedly different. Figure 5 through Figure 7 present photos of the typical failure modes for the Grade 60 rebar and the Grade 80 WWR slabs. The Grade 60 rebar presented very high ductility and in both cases touched the ground without a true failure (see Figure 5). Additional deflection could have been applied to SR3 and SR4; however, the support height prevented additional deformation (24 in.). The WWR slabs did display significant deflection, as shown in Figure 6a for SW15 and Figure 6b for SW16, that would be easily identified by an occupant as impending failure. However, the slabs with WWR did typically fail more suddenly as the WWR reached its maximum strain and ruptured (see SW14 in Figure 7).
