Urban Waterfront Rehabilitation In Pelluhue County, Chile

Affected by the Chile 2010 Earthquake and Tsunami

Submitted towards the fulfillment of the requirements for the Doctor of Architecture Degree.

University of Hawai'i at Manoa

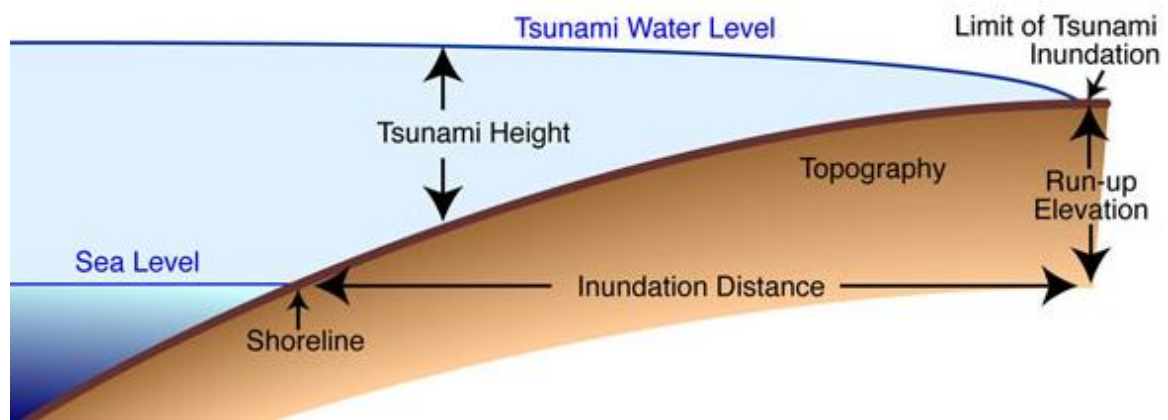
Figure 13: Tsunami Inundation Diagram
Source: Discover Tsunamis²⁹

The first tsunami waves arrived less than 30 minutes after the earthquake. The affected coastal towns reported between two and four tsunami waves. For example, in the harbor city of Talcahuano, the approximate arrival time for the first wave was at 3:54AM, the second wave at 5:30AM, the third wave was reported at 6:00 AM, and the fourth wave at 6:40 AM.²⁸ In most of Chilean coastal towns the geography allows people to move from the coast to near hills (safe zone) in a short time. People tend to evacuate coastal areas after big earthquakes right after the earthquake finishes, with no necessity of an evacuation alarm. Experience and tradition precipitate the need for an alarm.

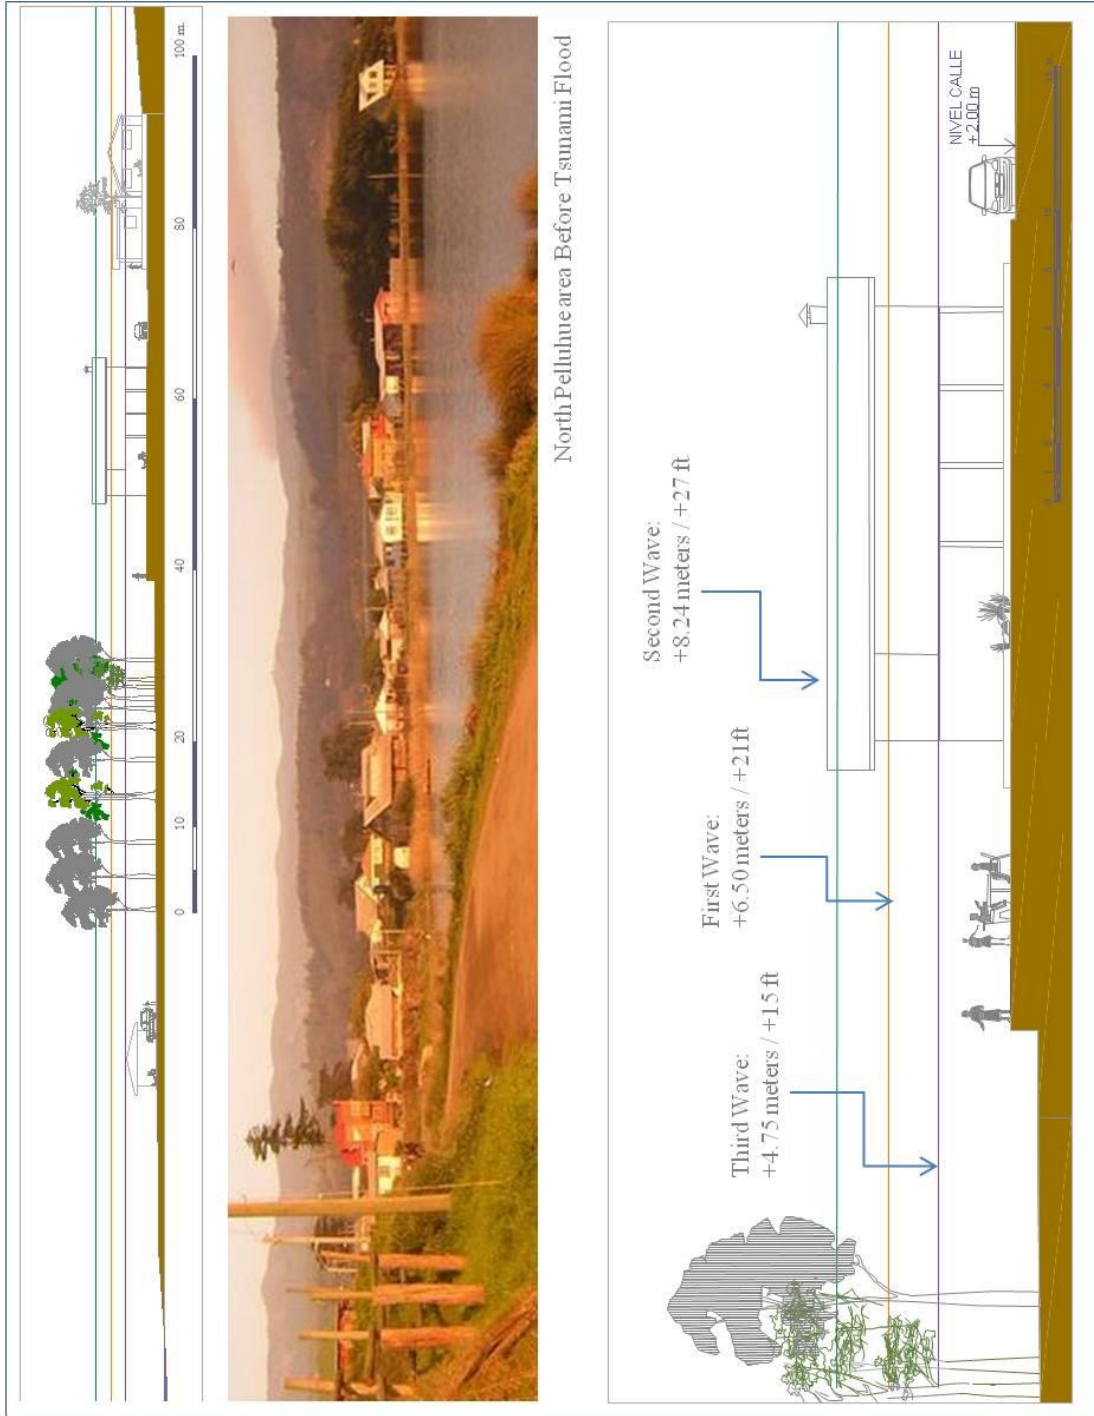
Figure 41: North Pelluhue - Dwelling Flood Analysis
Source: Felipe Igualt 2013

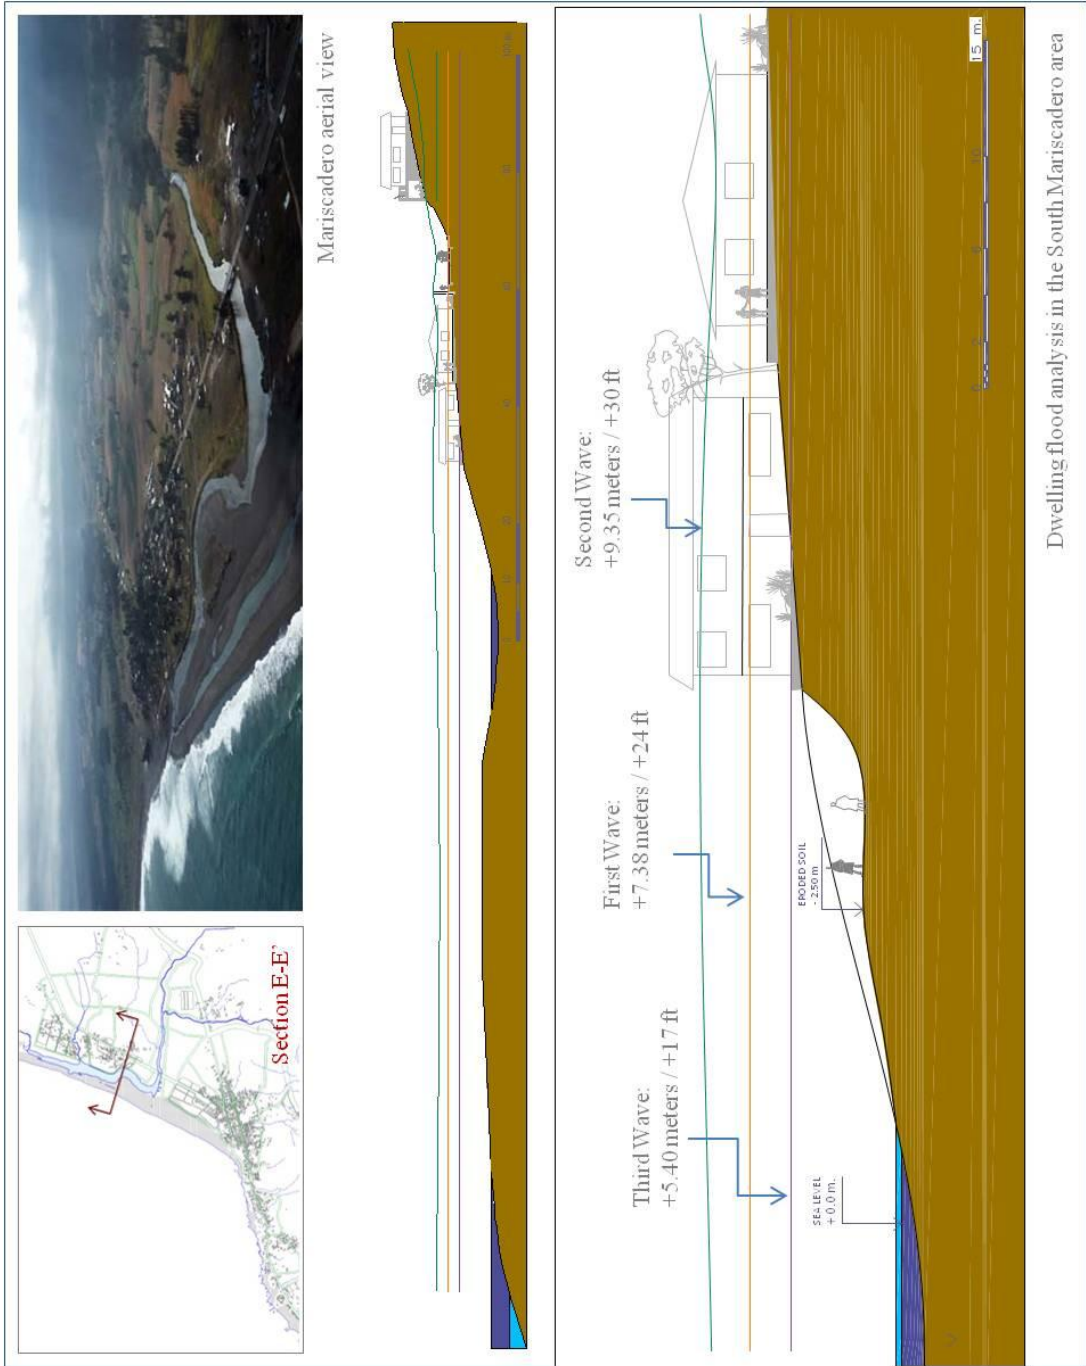
Figure 43: Flood Analysis in South Mariscadero
 Source: Felipe Igualt 2013

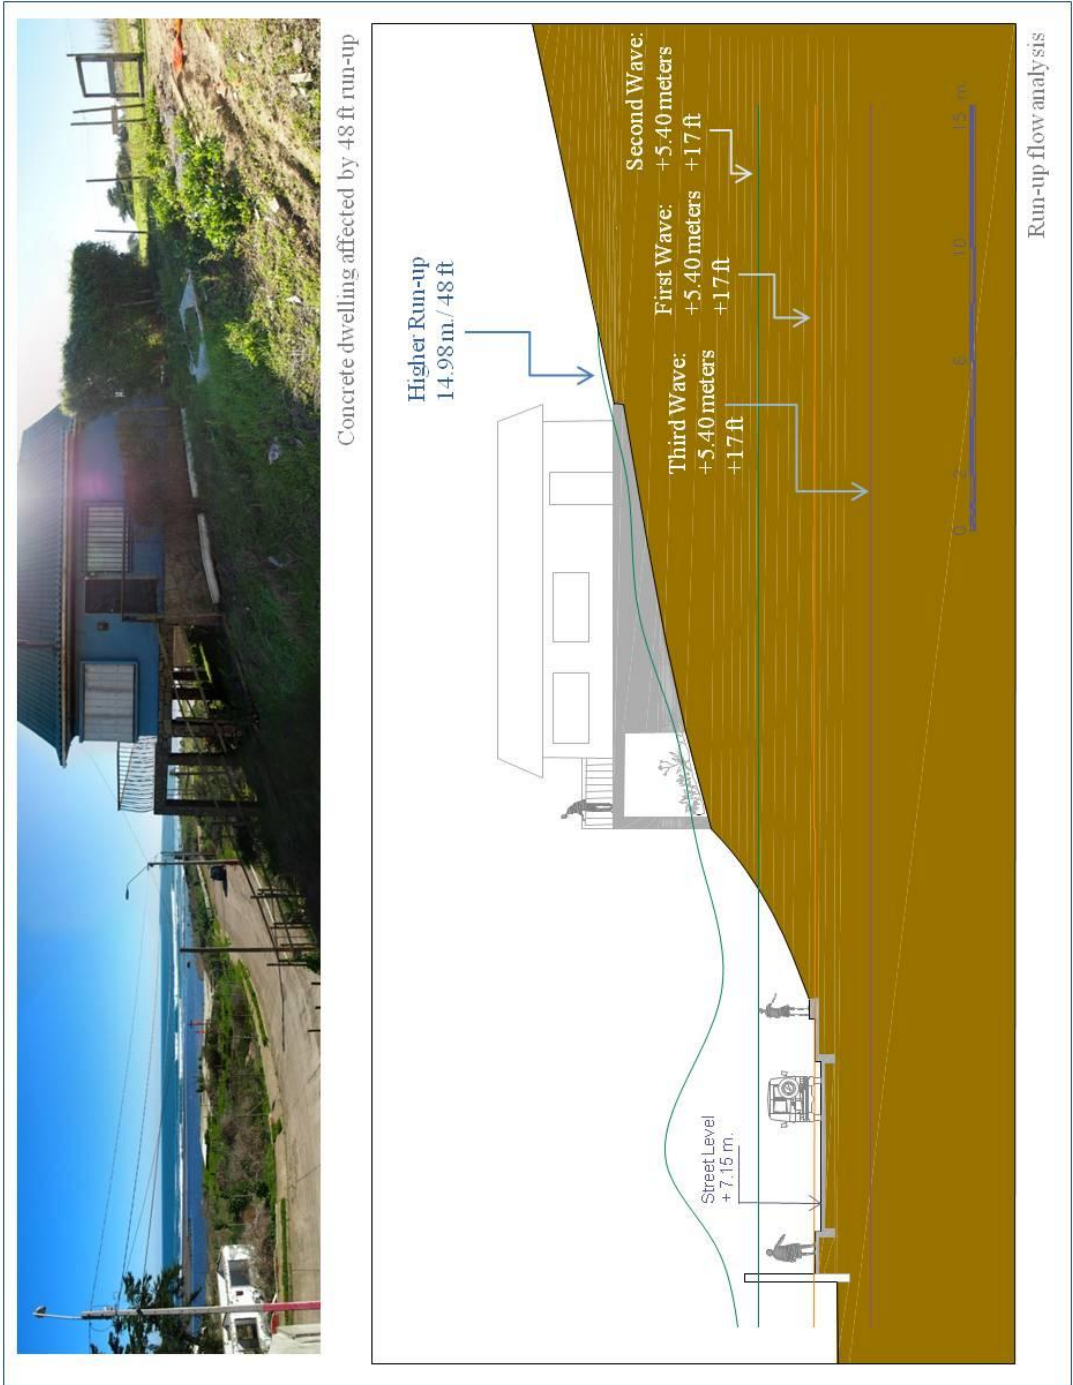
Figure 44: Run-up Mariscadero
Source: Felipe Igualt 2013

In the north area of Pelluhue County, damages were concentrated and identified along the north coastal edge in Mariscadero town where almost 70 % of the properties were destroyed. The fishing village was damaged, and the fire station and two educational establishments were flooded and sustained structural damage. There was widespread destruction along the low-lying area of Pelluhue town, mainly because of the tsunami inundation. Several tsunami run-ups took place in the north area of Pelluhue, especially in Mariscadero town. In this area a maximum run-up of 14.5m was measured (47 ft).

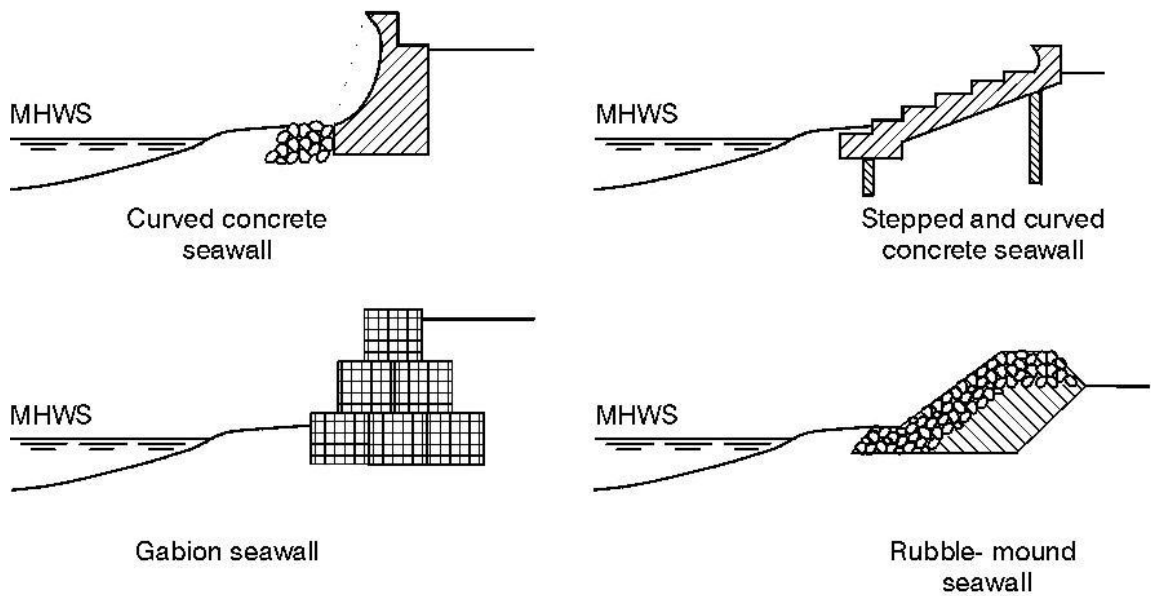
Figure 47: Examples of seawall structures
Source: Coastalwiki⁶⁰

Erosion of the beach profile, landward of a seawall, can be stopped or at least reduced by seawalls. However, erosion of the seabed immediately in front of the structure is increased due to wave reflection caused by the seawall. Because of their potential vulnerability to toe scour, seawalls are often used together with some systems of beach control, such as groins and beach nourishment.⁵⁹

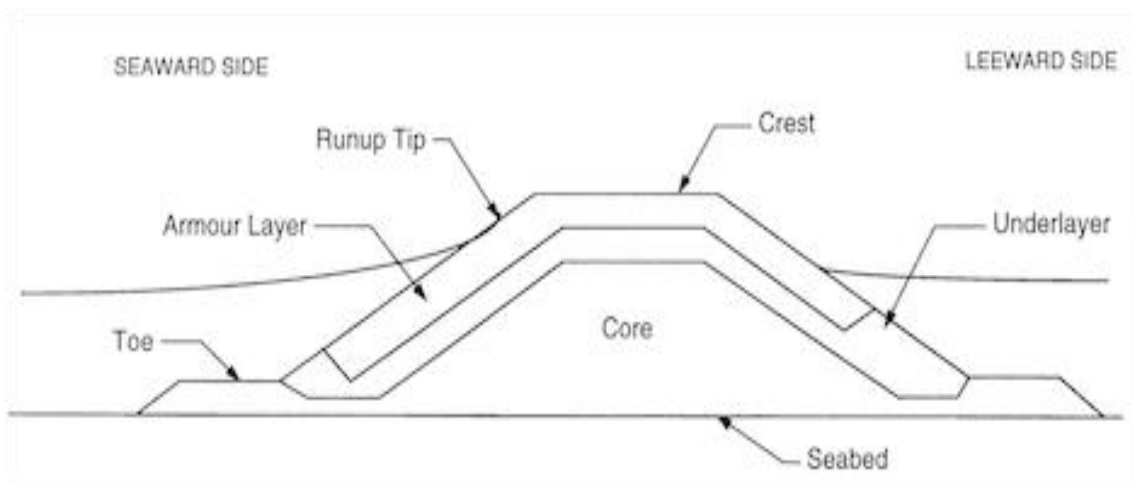
Figure 49: Cross section of sloping front breakwater
Source: University of Wisconsin Madison⁶⁶

Offshore breakwaters constructed across harbor entrances can be very effective in protection of shoreward port areas from a tsunami. Japanese breakwaters typically consist of massive precast concrete caissons on top of a rubble mound base. Precast concrete units such as tetrapods, dolos, or otherwise engineered concrete units, usually armor the seaward side of a breakwater. The cost of a breakwater increases significantly with water depth and wave severity. Poor foundational conditions also increase cost. These three environmental factors heavily influence the design and positioning of the breakwaters and the harbor or fishing village layout.

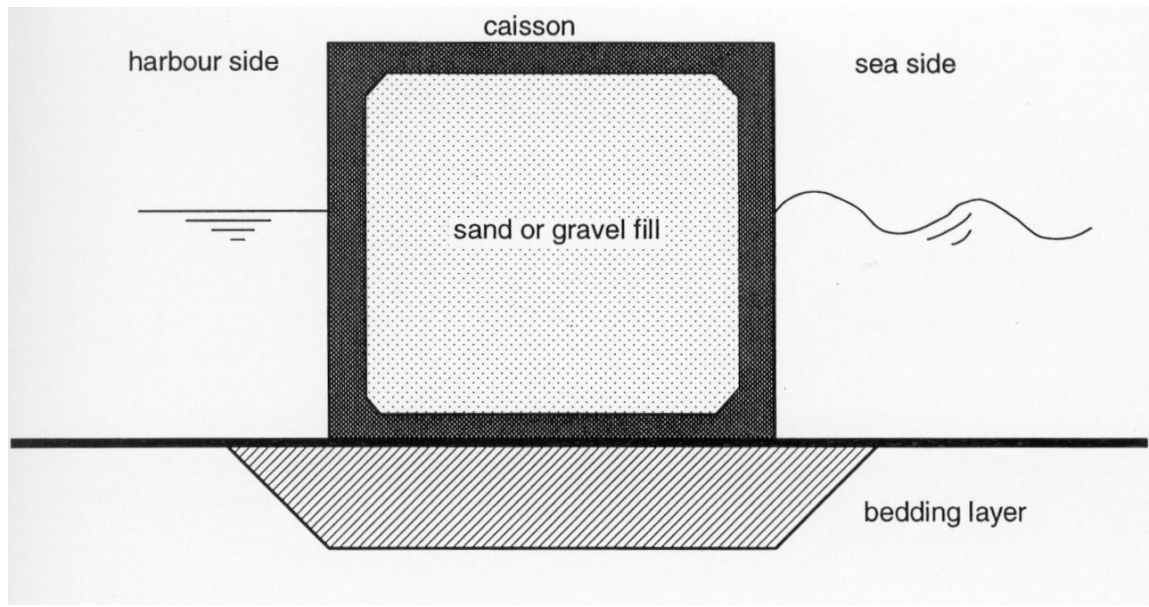
Figure 50: Cross section of vertical front breakwater
Source: Kennisbank⁶⁷

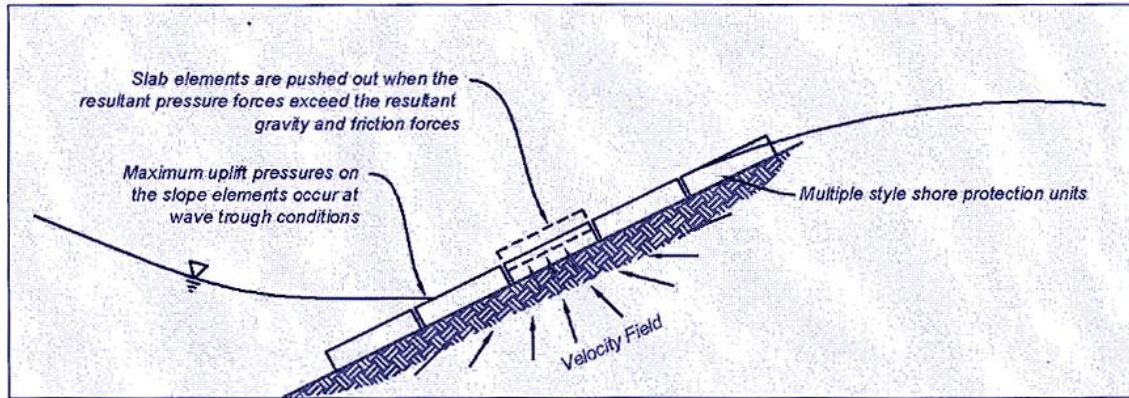
Figure 52: Hydrostatic Uplift Forces
 Source: American Society of Civil Engineers ⁷²

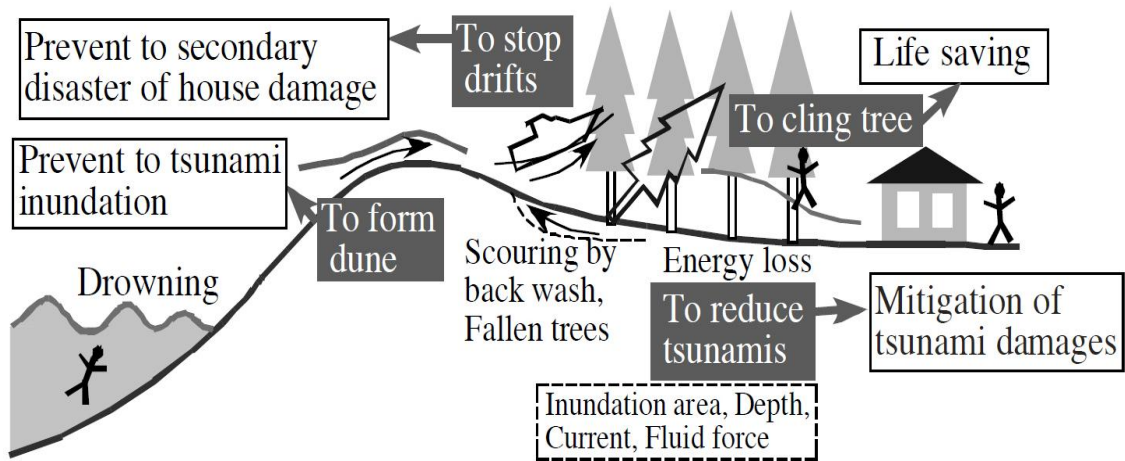
Figure 58: Tsunami Forest functions
 Source: Harada and Imamura⁸⁷

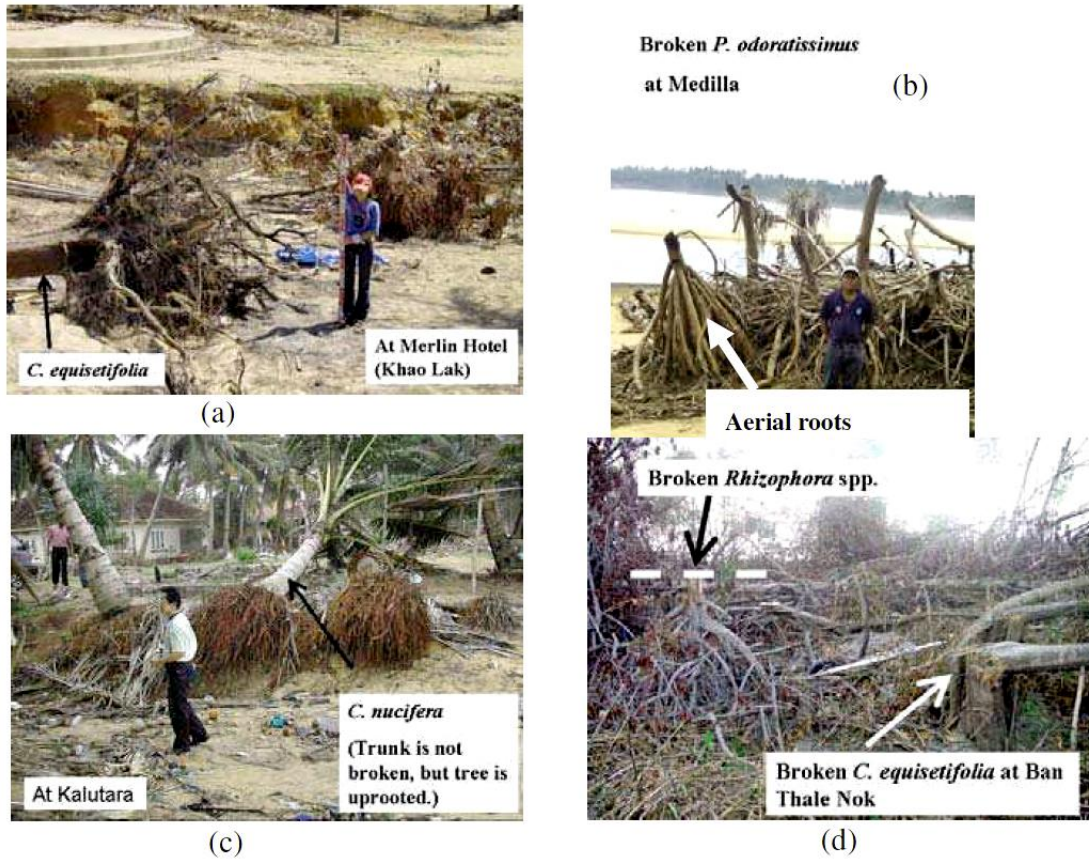
Figure 59: Damaged Tree Patterns: (a) Erosion and overturning, (b) (d) Tree trunk breakage, (c) Uprooted. Source: Tanaka 2011⁹⁷

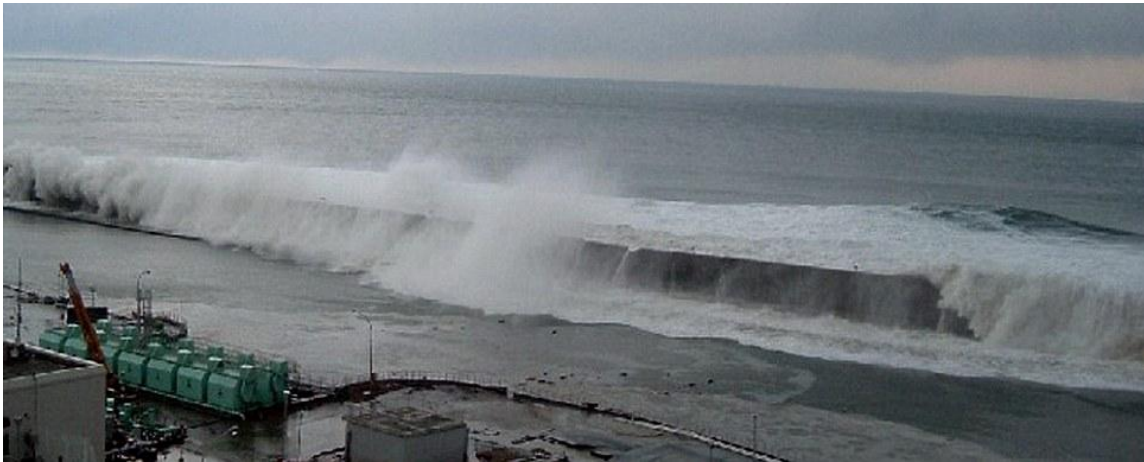
Figure 61: Seawall Collapse in Fukushima
Source: DailyMail¹⁰³

A key feature of almost every coastal area along the east coast of Japan is a large seawall or barrier built along the coast to protect upland areas from tsunami inundation. While these walls would be effective against large wind waves in severe storms, their primary purpose was to protect against tsunami wave impact. Vertical concrete floodwalls were highly affected by lateral forces produced by the tsunami flood. In most of the cases these walls survived, but with evident damage due to scour.¹⁰²

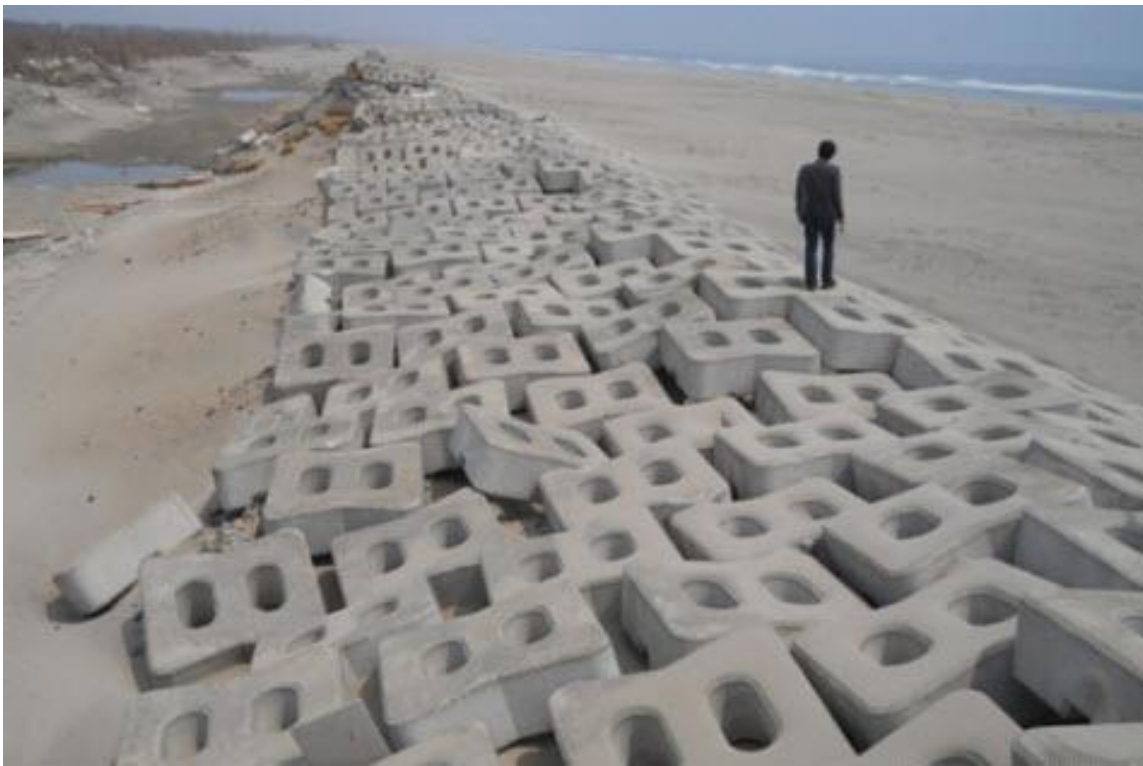
Figure 62: Failed section of Coastal Revetment
Source: ASCE 2011¹⁰⁵

Seawall damage can be comprehensive in scale and generate massive debris that can travel with the inflow. Large sections of tsunami barriers failed over shoreline lengths ranging up to several hundred meters. Failed sections allowed strong tsunami flows both as the tsunami came ashore and the tsunami water receded. Very large segmented concrete seawalls were susceptible to overturning after scouring due to the overtopping flow. Lack of continuity between elements allowed for significant failure.¹⁰⁴

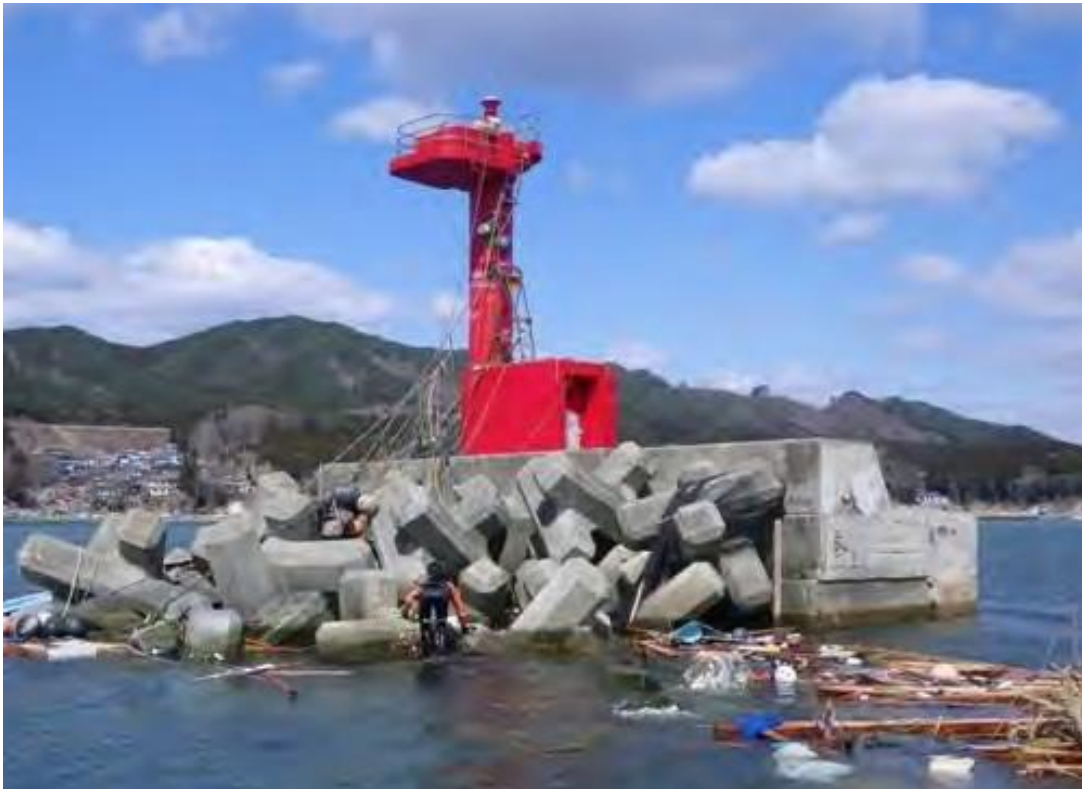
Figure 63: Collapsed Funakoshi East Breakwater
Source: UNC¹⁰⁷

barriers fared poorly. Common failure mechanisms included the removal of top or rear concrete panels slabs, with subsequent erosion and scour of the compacted earth core. In most cases, it appeared that the tsunami waves severely inundated the structures and that the design was not robust enough against massive overtopping flows.¹⁰⁶ In general the concrete-lined compact-earth barriers were not effective, and many suffered widespread failure.

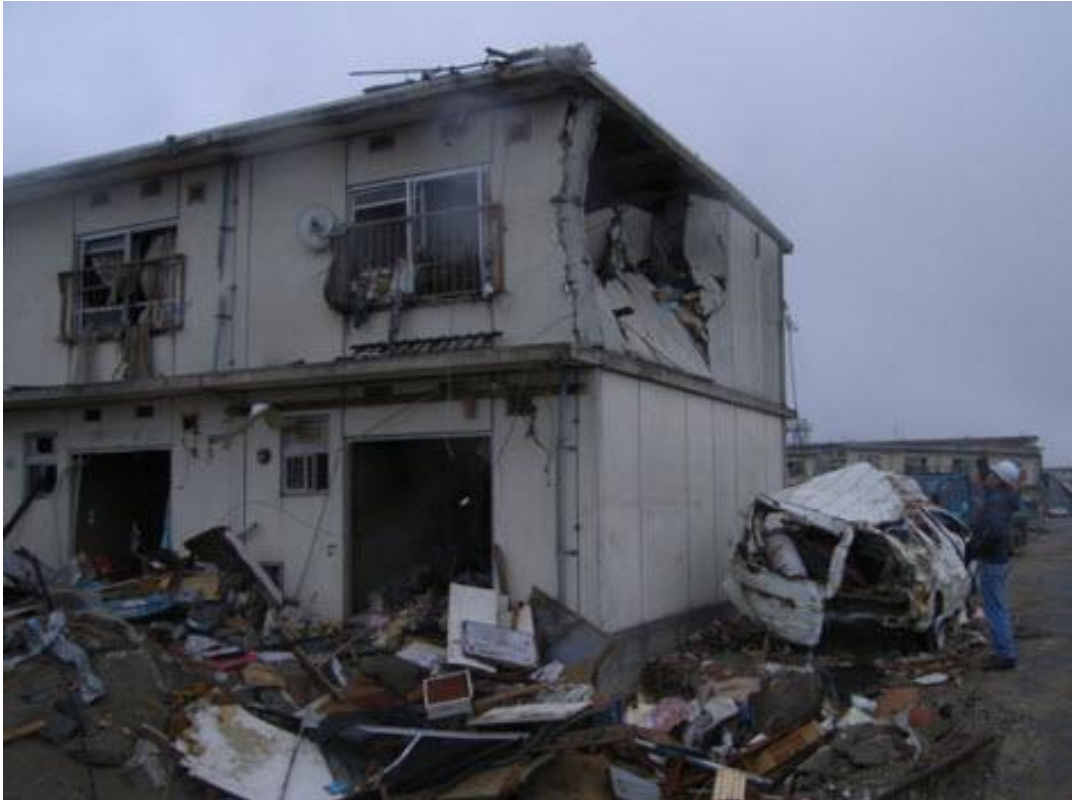
Figure 64: Debris impact damage in buildings, Natori
Source: ASCE 2011¹⁰⁹

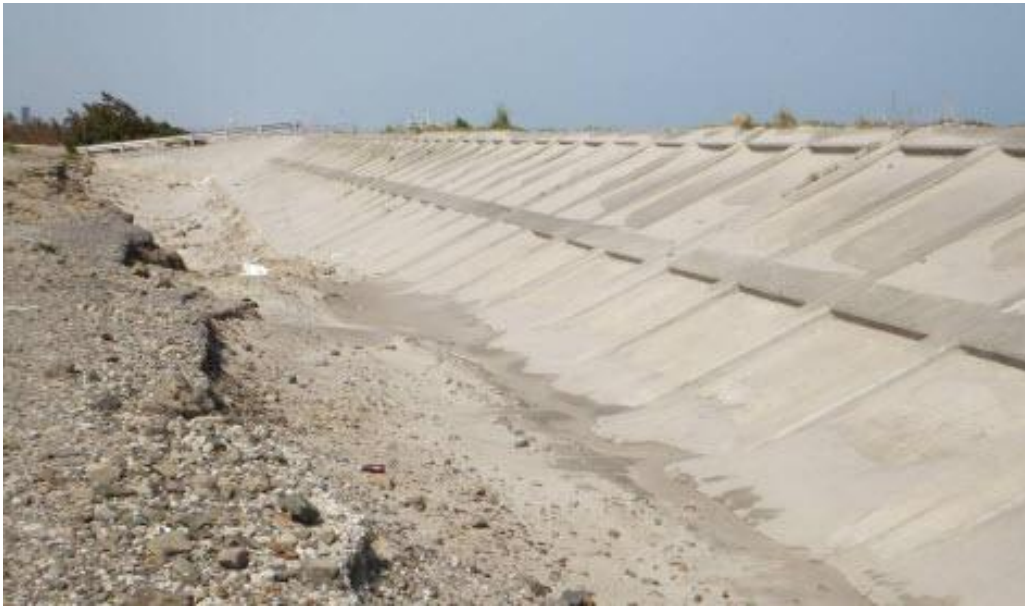
Figure 65: Scour in Sendai's Seawall
Source: ASCE 2011¹¹¹

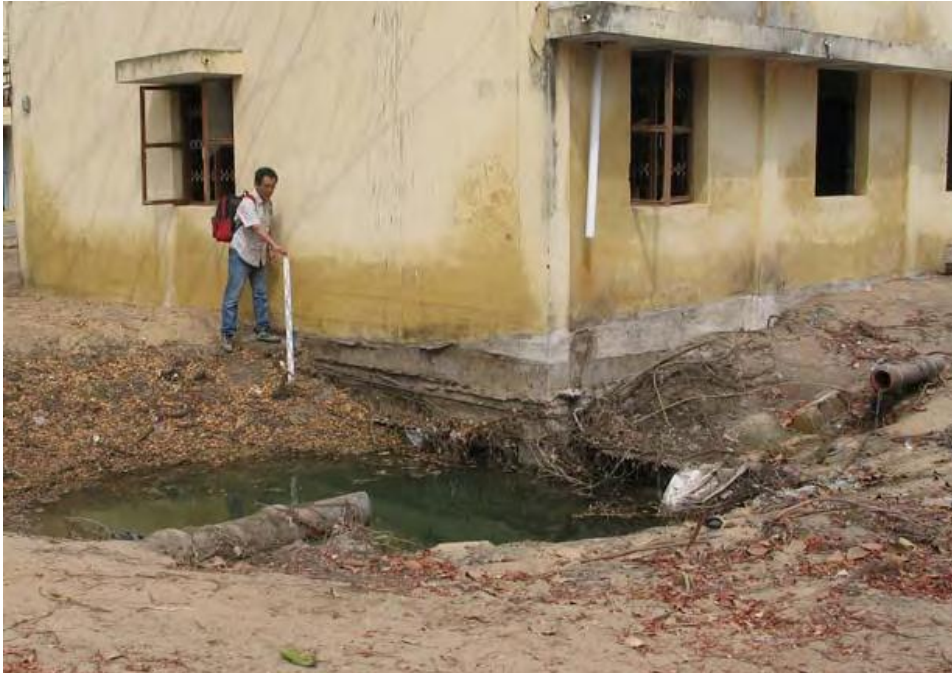
Figure 68: Failure of a sewage line due to scour
Source: ORWARN ¹¹⁵

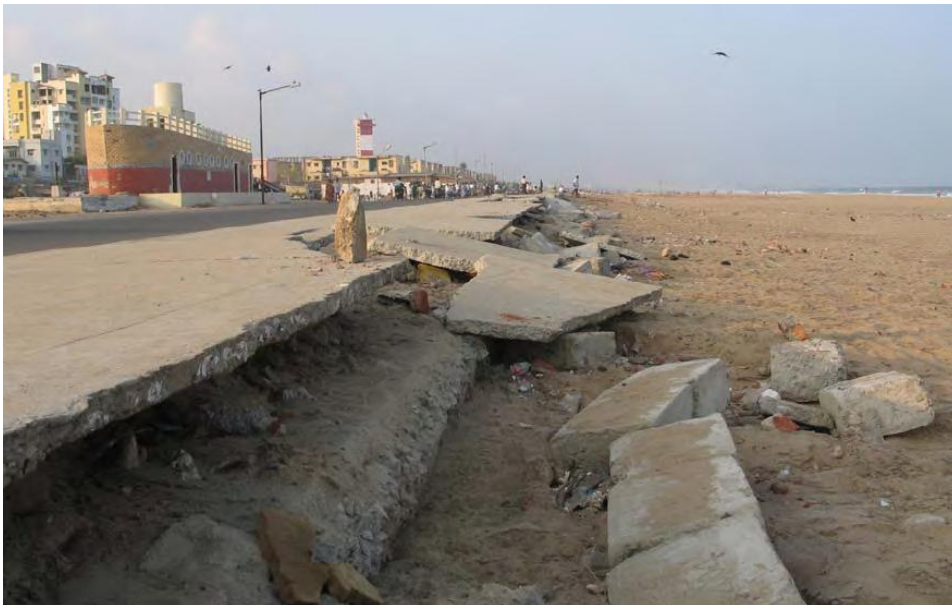
Figure 69: Collapsed concrete waterfront due to scour, Chennai
Source: ORWARN ¹¹⁶

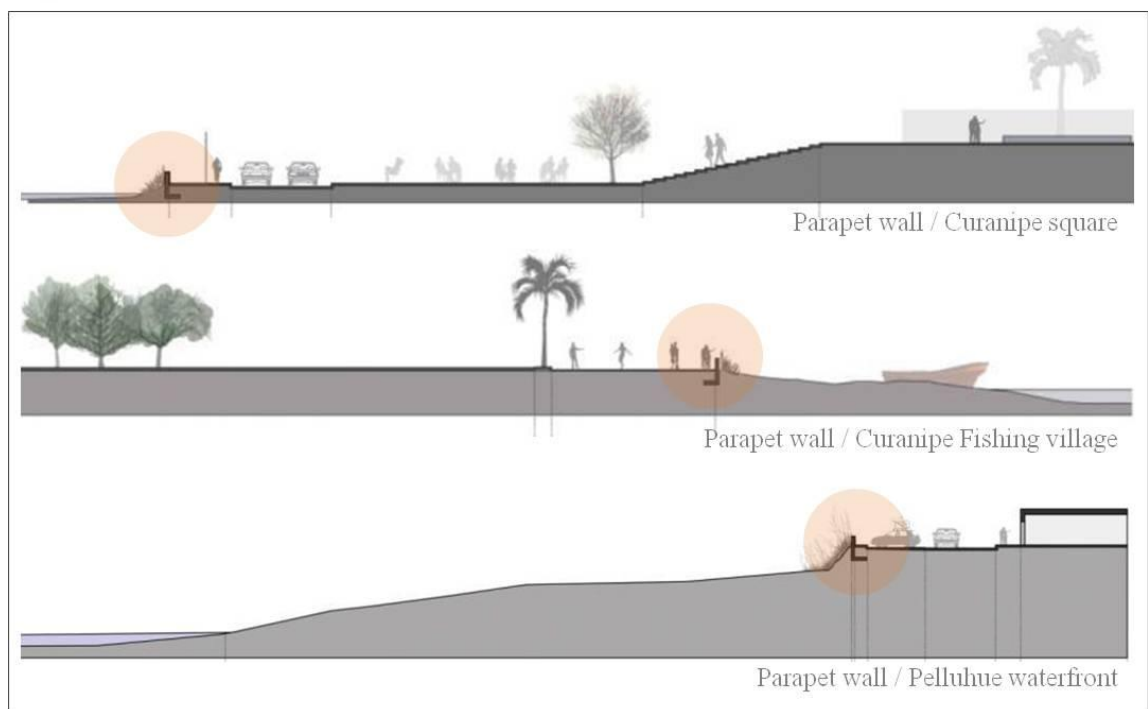
Figure 75: PRES Parapet walls interventions in Pelluhue
Source: Source: PRES Pelluhue 2010¹²⁸

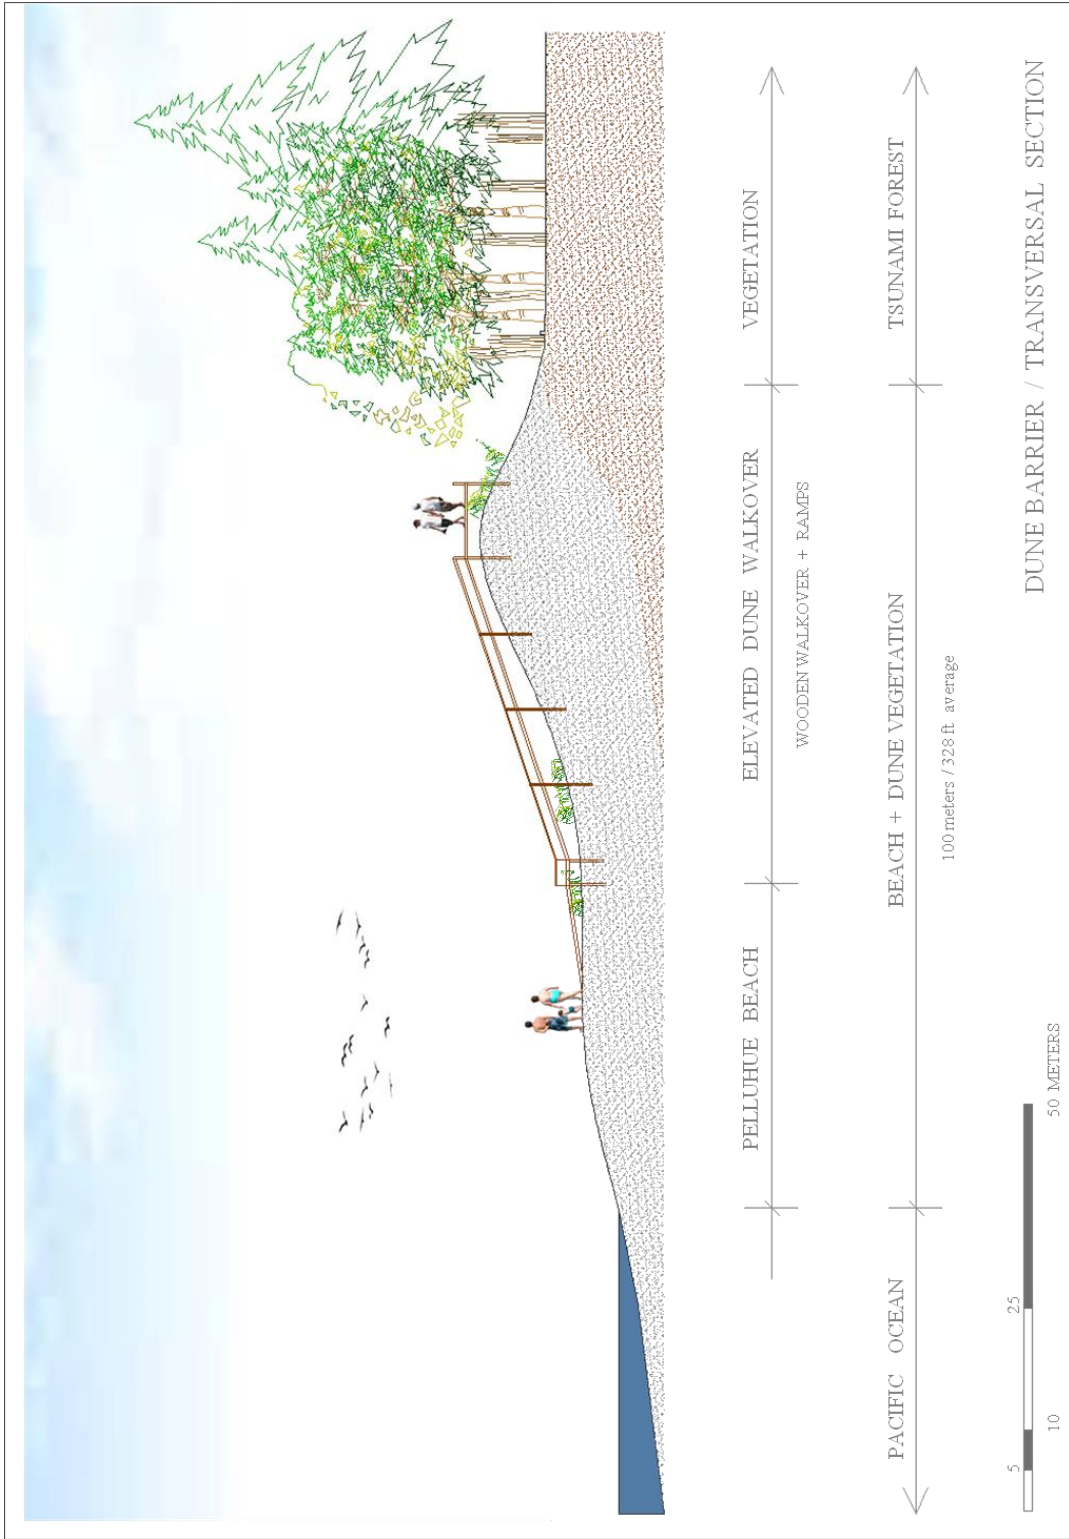
Figure 91: Dune Barrier / Transversal Section
 Source: Felipe Igualt 2014

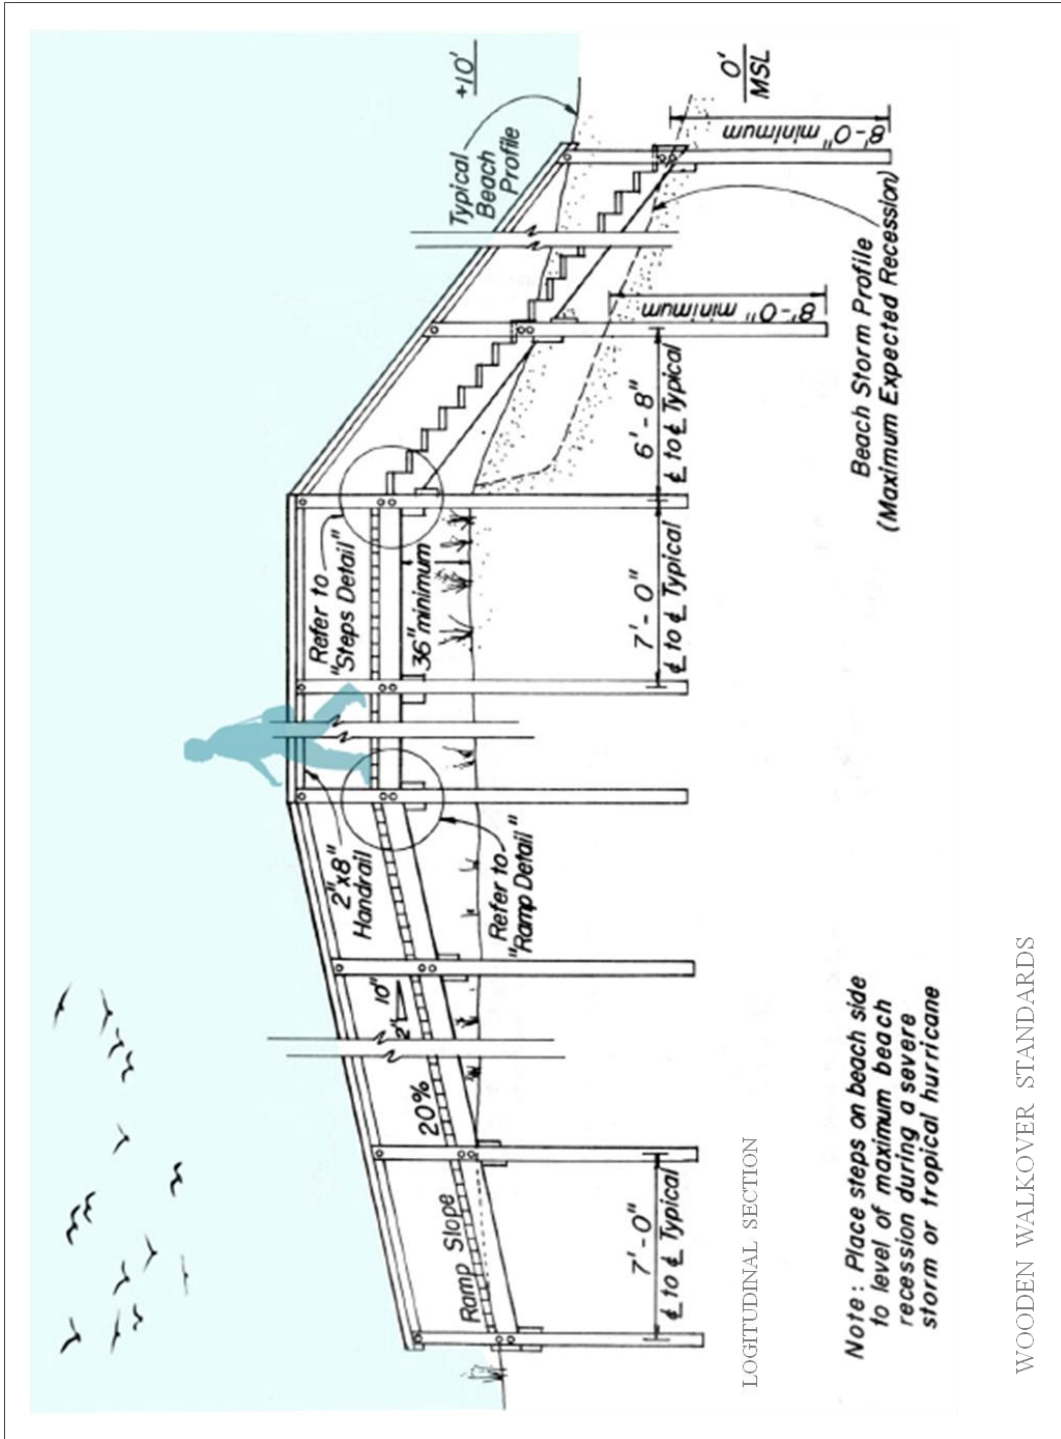
Figure 94: Wooden Walkway Standards
 Source: Florida Bureau of Beaches and Coastal Systems¹⁵⁰

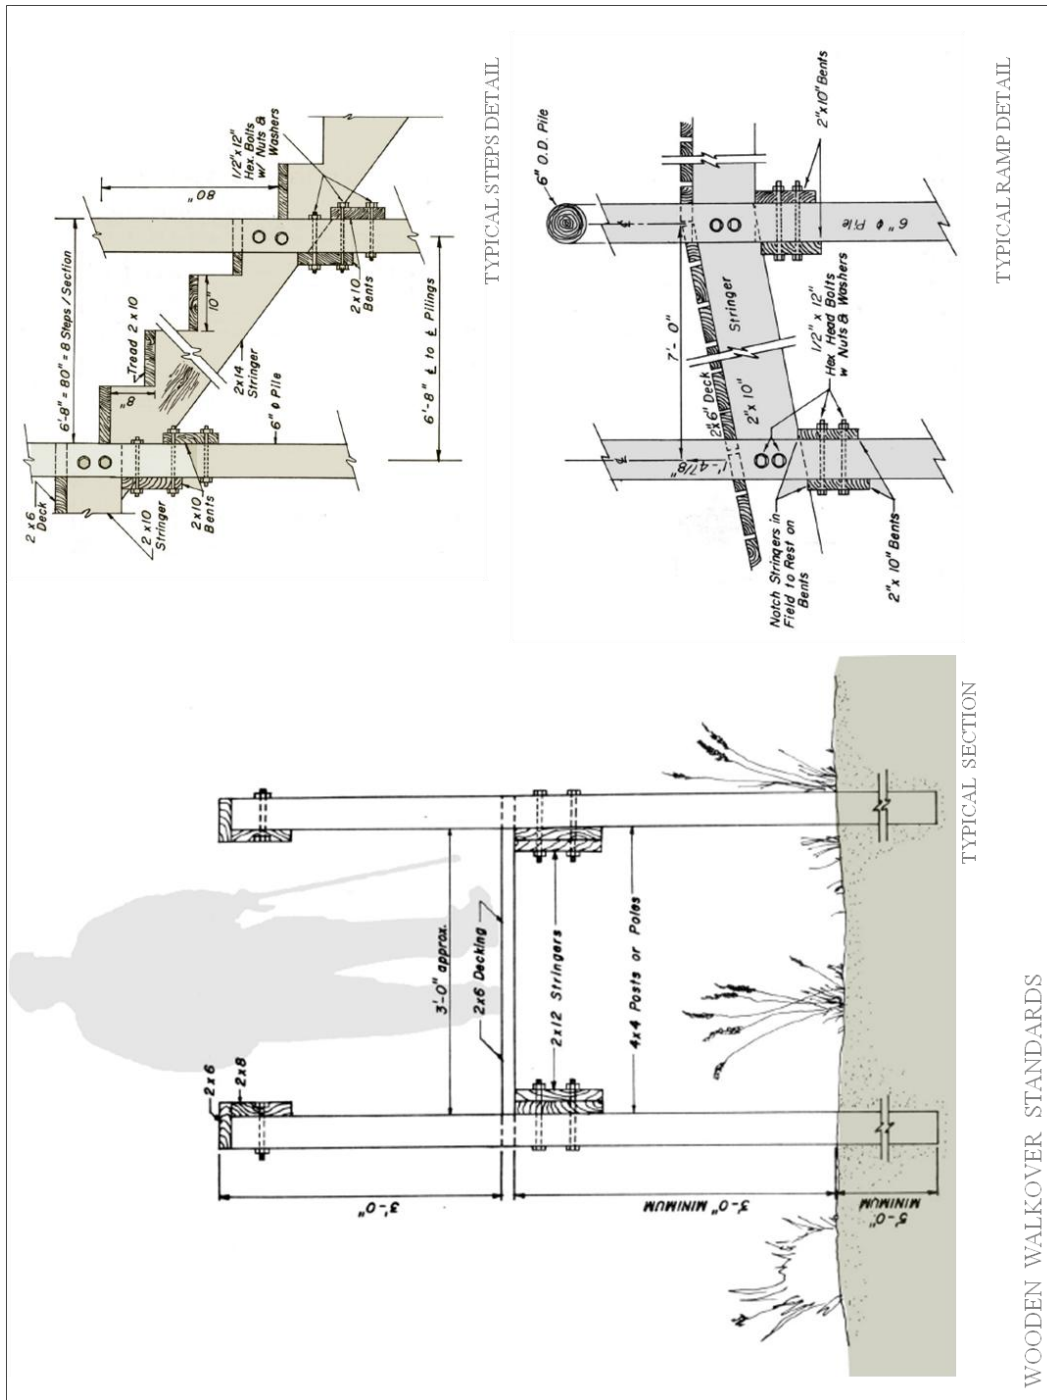
Figure 95: Wooden Walkway Standards
 Source: Florida Bureau of Beaches and Coastal Systems¹⁵¹
