# Study on Temper Embrittlement and Hydrogen Embrittlement of a Hydrogenation Reactor by Small Punch Test

**Abstract:** The study on temper embrittlement and hydrogen embrittlement of a test block from a 3Cr1Mo1/4V hydrogenation reactor after ten years of service was carried out by small punch test (SPT) at different temperatures. The SPT fracture energy  $E_{sp}$  (derived from integrating the load-displacement curve) divided by the maximum load ( $F_m$ ) of SPT was used to fit the  $E_{sp}/F_m$  versus-temperature curve to determine the energy transition temperature ( $T_{sp}$ ) which corresponded to the ductile-brittle transition temperature of the Charpy impact test. The results indicated that the ratio of  $E_{sp}/F_m$  could better represent the energy of transition in SPT compared with  $E_{sp}$ . The ductile-to-brittle transition temperature of the four different types of materials was measured using the hydrogen charging test by SPT. These four types of materials included the base metal and the weld metal in the as-received state, and the base metal and the weld metal in the de-embrittled state. The results showed that there was a degree of temper embrittlement in the bas

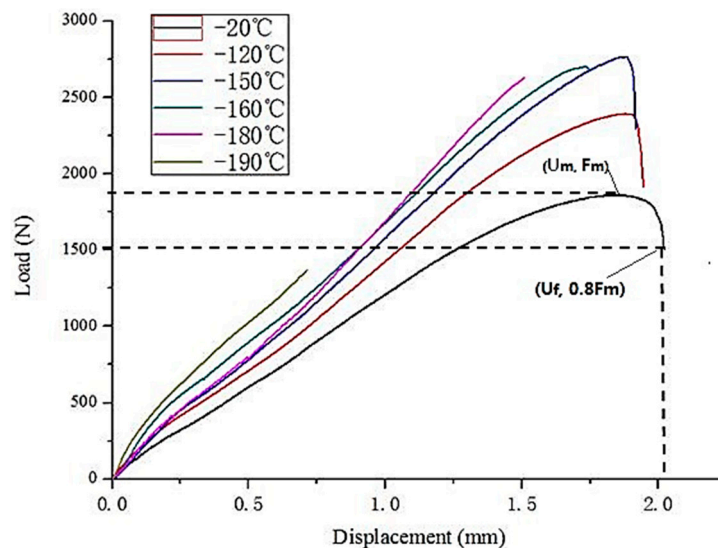
Figure 1 shows the load-displacement curves measured at different temperatures for the weld in the as-received state. From Figure 1, as the temperature decreases from  $-20\text{ }^\circ\text{C}$  to  $-150\text{ }^\circ\text{C}$ , the maximum load,  $F_m$ , increases, whilst the displacement corresponding to the fracture at 20% load drop,  $U_f$ , decreases slightly.

**Figure 1.** Load-Displacement Curve at different temperatures of the weld metal.

The shape of the load deflection curve of the investigated specimens can be divided into four typical deformation regimes. There is the elastic stage, the plastic bending regime, the membrane stretching regime, and the plastic instability regime. The curves obtained for temperatures between  $-20$  and  $-150\text{ }^\circ\text{C}$  show all the above stages, with the maximum load from 1700 to 2700 N, and the maximum displacement drops from 2 to 1.8 mm before the break. That means that the strength of the specimens firstly increases and then the plasticity decreases as the temperature decreases from  $-20$  to  $-150\text{ }^\circ\text{C}$ . However for the curves of the remaining specimens, the maximum load and the deflection illustrated in Figure 1 decreased abruptly and the curves show only the first three deformation regimes due to embrittlement in temperatures below  $-150\text{ }^\circ\text{C}$ , i.e., early crack initiation and rapid crack growth during the membrane stretching stage.

The results of  $F_m$  and  $U_f$  at different temperatures of the weld metal are shown in Table 3. Generally, with the temperature declining, the  $F_m$  first increases and then decreases whilst the  $U_f$  always decreases.

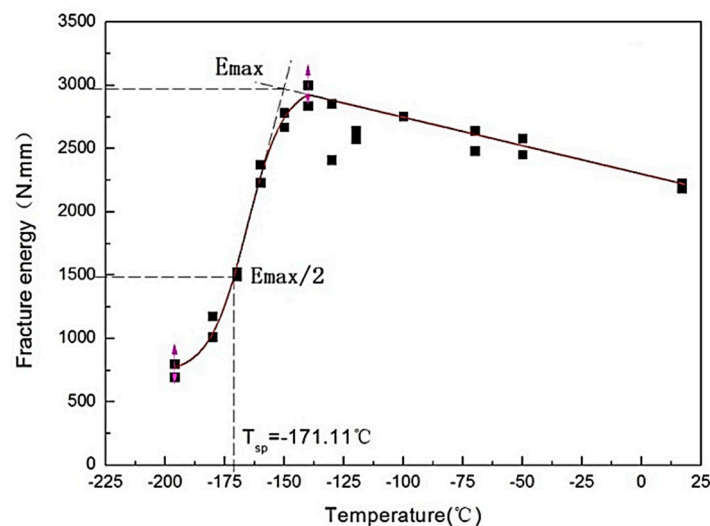
However, the obtained results show that it is unreasonable to evaluate the energy transition temperature from the energy-temperature curve corresponding to a change in the ductile-to-brittle failure, as seen in Figure 2. Firstly, the increase of the fracture energy from the ambient temperature to nearly  $-150$  °C cannot be explained, in spite of the fact that the specimens are ductile. Secondly, the two specimens can have the same level of fracture energy at totally different temperatures. Figure 3 shows the macro photograph of the fractured samples at  $25$  °C and at  $-190$  °C. They apparently have significant differences in the morphology of the failure and crack propagation path. The former is ductile fracture and the latter is brittle fracture. However, both specimens have very similar energy values,  $2.055$  J and  $2.171$  J, respectively. Thirdly, it is difficult to determine the upper shelf because the  $E_{sp}$  drops in the upper shelf with increasing temperature. The energy transition temperature  $T_{sp}$  is defined at the curve where the energy is equal to 50% of the maximum energy  $E_{max}$  in Figure 2.

**Figure 2.** Fitting Energy-Temperature Curve and  $T_{sp}$  of the as-received weld metal.

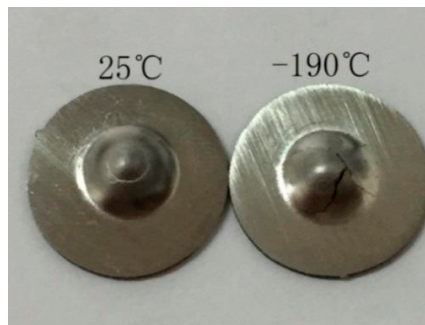
Figure 3. Macrophotograph of the fracture sample at 25 °C and −190 °C.

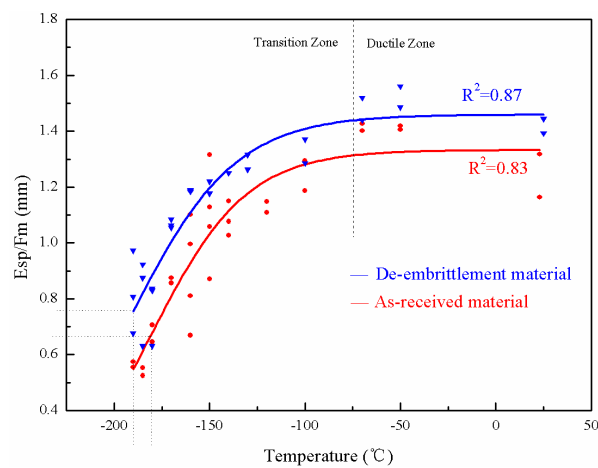
When dealing with the low temperature SPT data by fitting the Boltzmann function,  $E_{sp}$  divided by  $F_m$  could better represent the energy transition of the materials. The value of  $E_{sp}/F_m$ , being nearly constant above a certain temperature, has much in common with that of FATT or the impact energy. The curves of the de-embrittled material are slightly above the curves of the as-received material, as illustrated in Figures 4 and 5. In Figures 2, 4 and 5, the lower shelf is absent because it is lower than the liquid nitrogen temperature.  $T_{sp}$  is assigned at the curve where the energy is equal to 50% of the upper shelf, instead of the average of the upper and lower shelf.

Figure 4.  $T-E_{sp}/F_m$  curve of the base metal.

There is an offset between the as-received and the de-embrittled material curves for both the base and the weld metals, as shown in Figures 4 and 5. Compared with the as-received material test results, the de-embrittlement curve shifts to the upper-left, indicating that the transition temperature moves towards lower values. Moreover, the average value of  $E_{sp}/F_m$  of the de-embrittled samples at each temperature is higher than that of the as-received specimen.

According to Figures 4 and 5, the data in Table 4 show the specific values of  $T_{sp}$  for the base metal and the weld metal in the de-embrittled and as-received material before hydrogen charging. Compared with the data in Table 4, the  $T_{sp}$  of the base metal and the weld metal decreased by 8.9 °C and 11.2 °C, respectively, in the de-embrittled state as opposed to the as-received state before hydrogen charging. The vTr54 of the base metal and the weld metal respectively decreased by 10.7 °C and 13.7 °C in the de-embrittled state as opposed to the as-received state. Both results indicated that there is little temper embrittlement in the base metal and the weld metal of the 3Cr1Mo1/4V hydrogenation reactor after running for ten years.

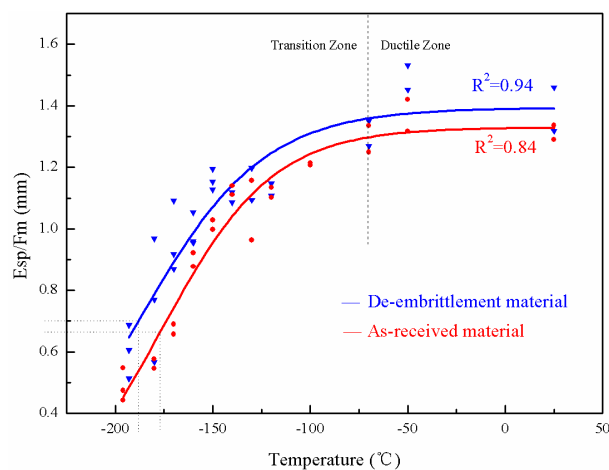
Figure 5.  $T-E_{sp}/F_m$  curve of the weld metal.

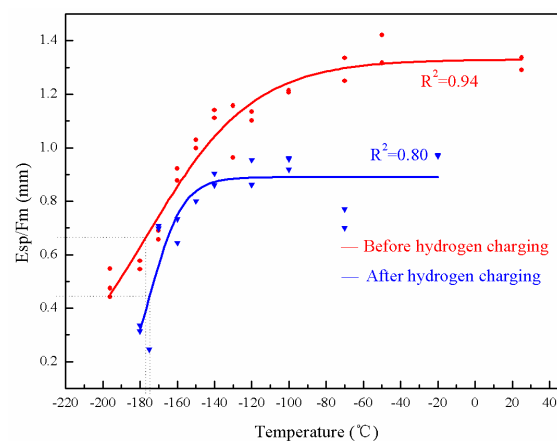
The temperature corresponding to 50% of the upper shelf value as  $T_{sp}$  was defined above. The  $T_{sp}$  of the weld metal in the as-received state and de-embrittled state were measured after hydrogen charging, as illustrated in Figures 6 and 7.

**Figure 6.**  $T$ - $E_{sp}/F_m$  curve of the weld metal in the as-received state.

Compared with Figures 6 and 7, the upper shelf value of the weld metal in the as-received state and after de-embrittlement before hydrogen charging is higher. The charged specimen shows an obviously lower  $E_{sp}$  compared with the uncharged specimen at the same temperatures, indicating the specimens become slightly more brittle after hydrogen charging. Table 5 shows more details concerning the differences between the weld metal in the de-embrittled state and the as-received state before and after hydrogen charging.

Figure 6 shows HE calculated based on TE and Figure 7 shows HE only. There is only a small difference between the curves in Figures 6 and 7, which indicates that there was no significant indication of the synergetic action concerning the TE and HE. The Japan Pressure Vessel Research Committee (JPVRC, Tokyo, Japan) found that HE sensibility for the 2.25Cr-1Mo steel increases as the degree of temper embrittlement increases [29]. TE is not obvious and leads to no HE.

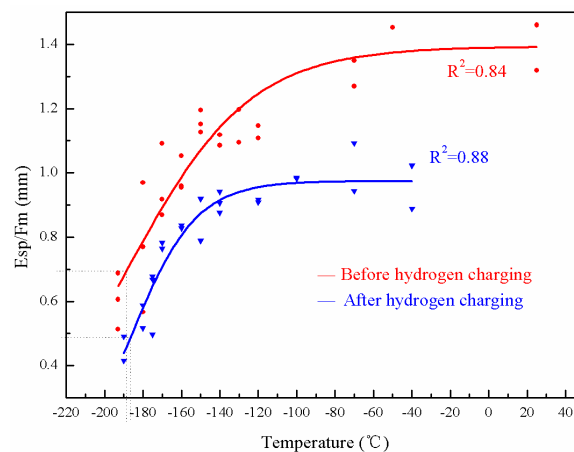
**Figure 7.**  $T$ - $E_{sp}/F_m$  curve of the weld metal in de-embrittlement.

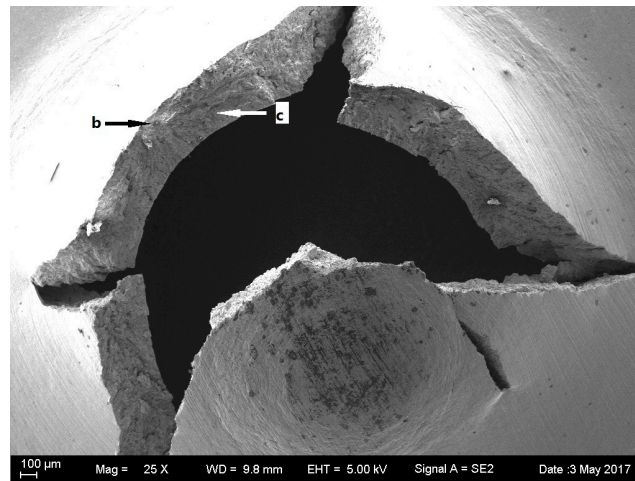
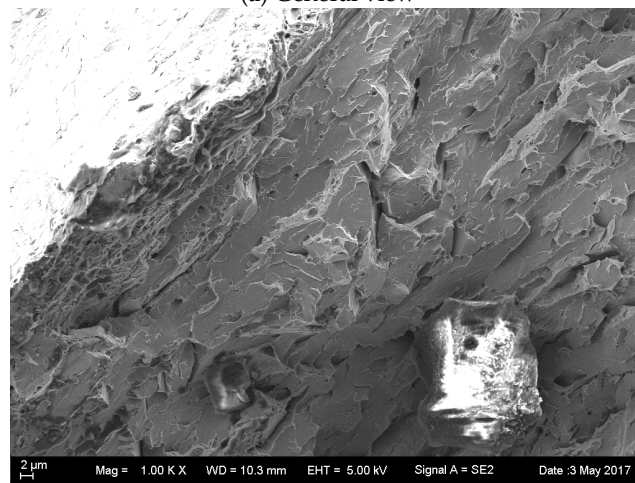
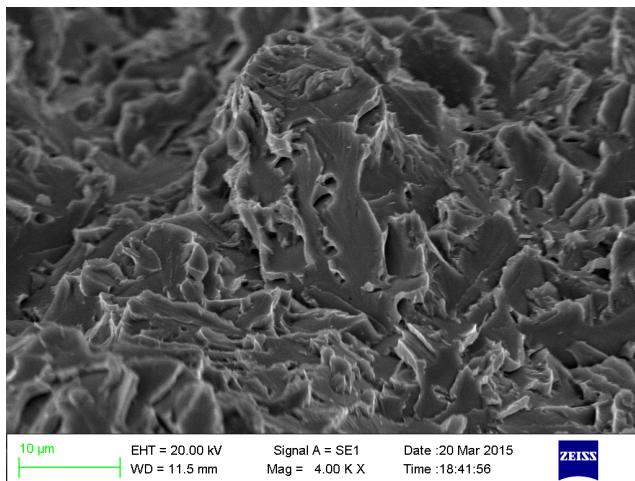
Figures 8 and 9 show the SEM morphology of the as-received base specimen before and after hydrogen charging. A general birds-eye view of the crack profiles that occurred in the vicinity of the punch indentation on the small disc samples is shown in Figures 8a and 9a. The cracking was circular in nature and confined to the actual punch indentation. Fracture initiation occurred at the bottom surface location (opposite of the punch rod). Detailed views of the initiation area are shown in Figures 8b and 9b. No actual initiation point was evident but it was significant that the outer reaches of the quasi-cleavage cracked. Figure 8c shows the quasi-cleavage fracture which is just the typical brittle fracture at low temperature. However, Figure 9c shows the typical characteristics of the HE fracture with crow's feet morphology.

(a) General view

(b) Initiation region

(c) Crack propagation zone

Figure 8. SEM images of the as-received base metal at  $-180\text{ }^{\circ}\text{C}$  without hydrogen charging.

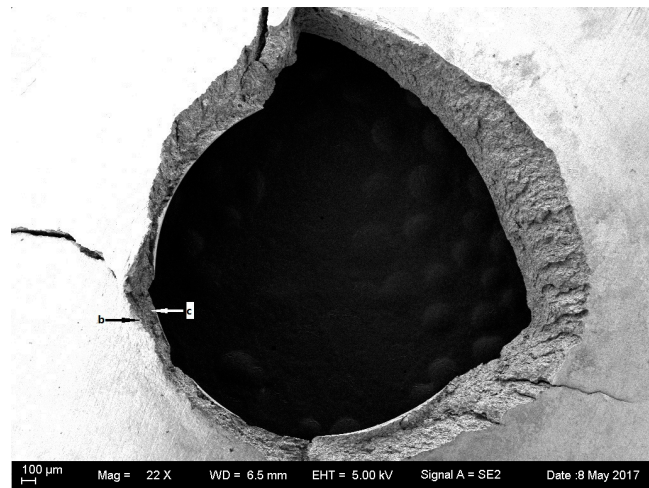
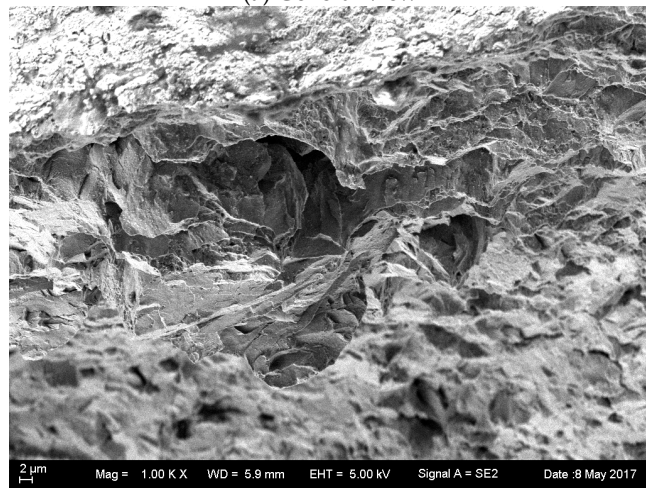
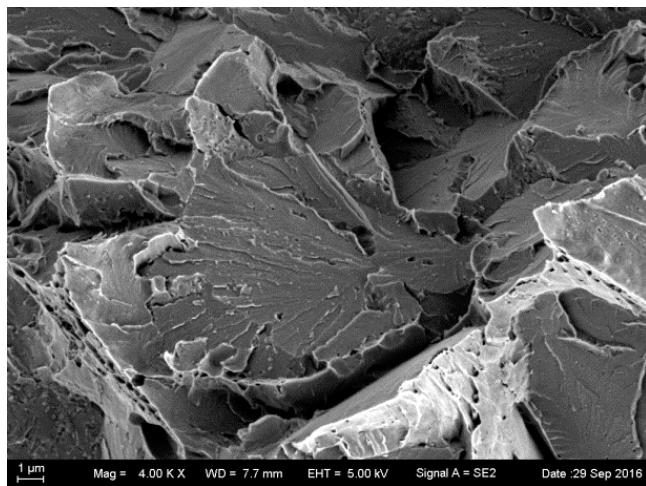
(a) General view

(b) Initiation region

(c) Crack propagation zone

**Figure 9.** SEM images of the as-received base metal at  $-180\text{ }^{\circ}\text{C}$  with hydrogen charging.
